Carteret-Craven Electrical Cooperative
Wetland Restoration
Morehead City, Onslow County, North Carolina
2004 Annual Monitoring Report

**Carteret-Craven Electrical Cooperative (CCEC)
Wetlands Restoration Site (Jumping Run Creek)
Fall 2004 Monitoring Summary**

This is the 3rd year of the 5-year monitoring plan for the completed CCEC Site.

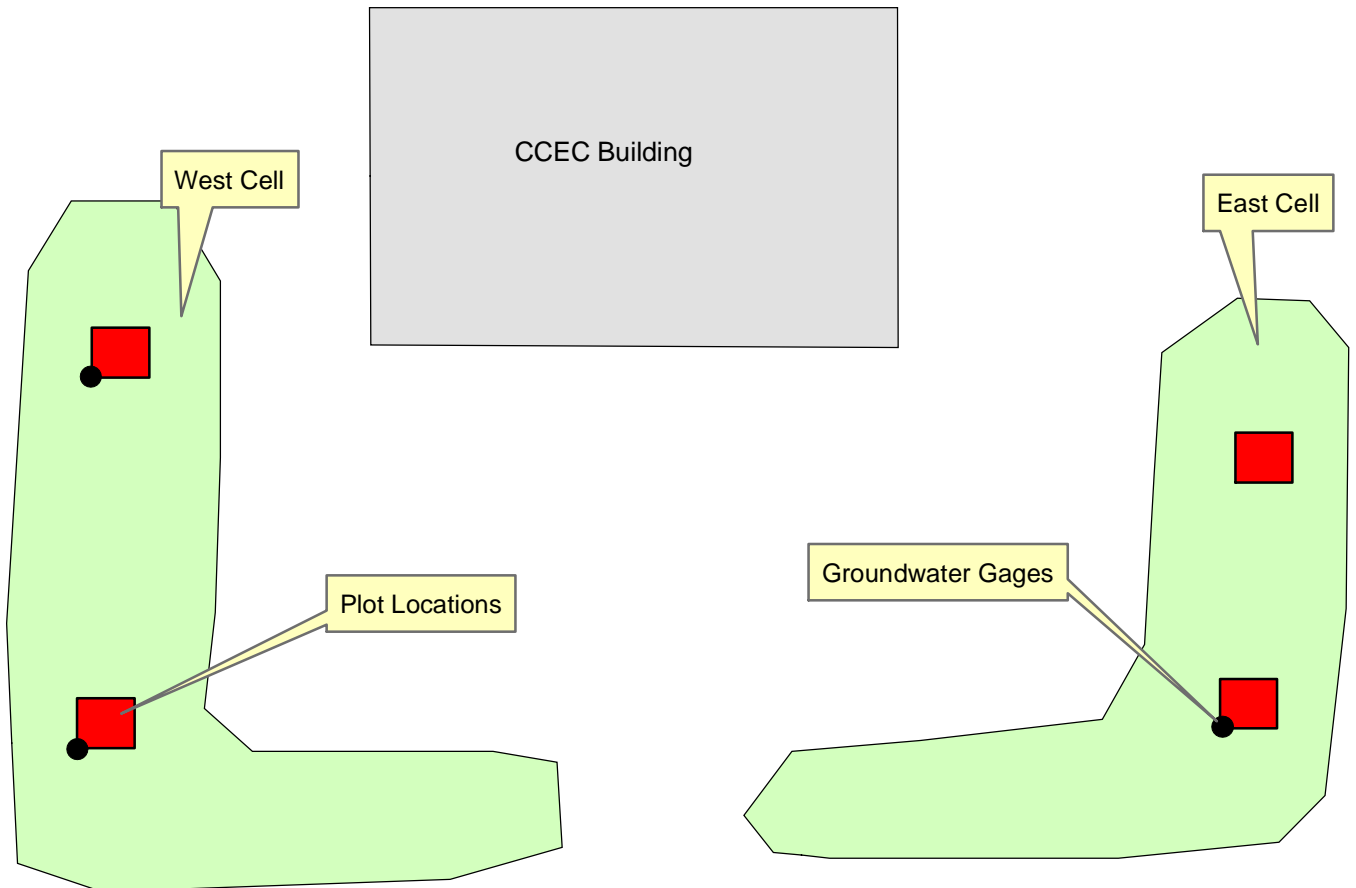
Monitoring Map

As described in the “Draft Vegetation Monitoring Plan for NCWRP Riparian Buffer and Wetland Restoration Projects” document, the monitoring set up for this site was a series of nested plots. Two 1 meter X 1 meter plots were set up in each of the wetland cells. The plots were permanently marked with pipe so measurements can be replicated in subsequent years. Smaller nested plots were set up to record shrub and herbaceous cover. The attached Vegetation Monitoring map shows the locations of the vegetation transects and plots.

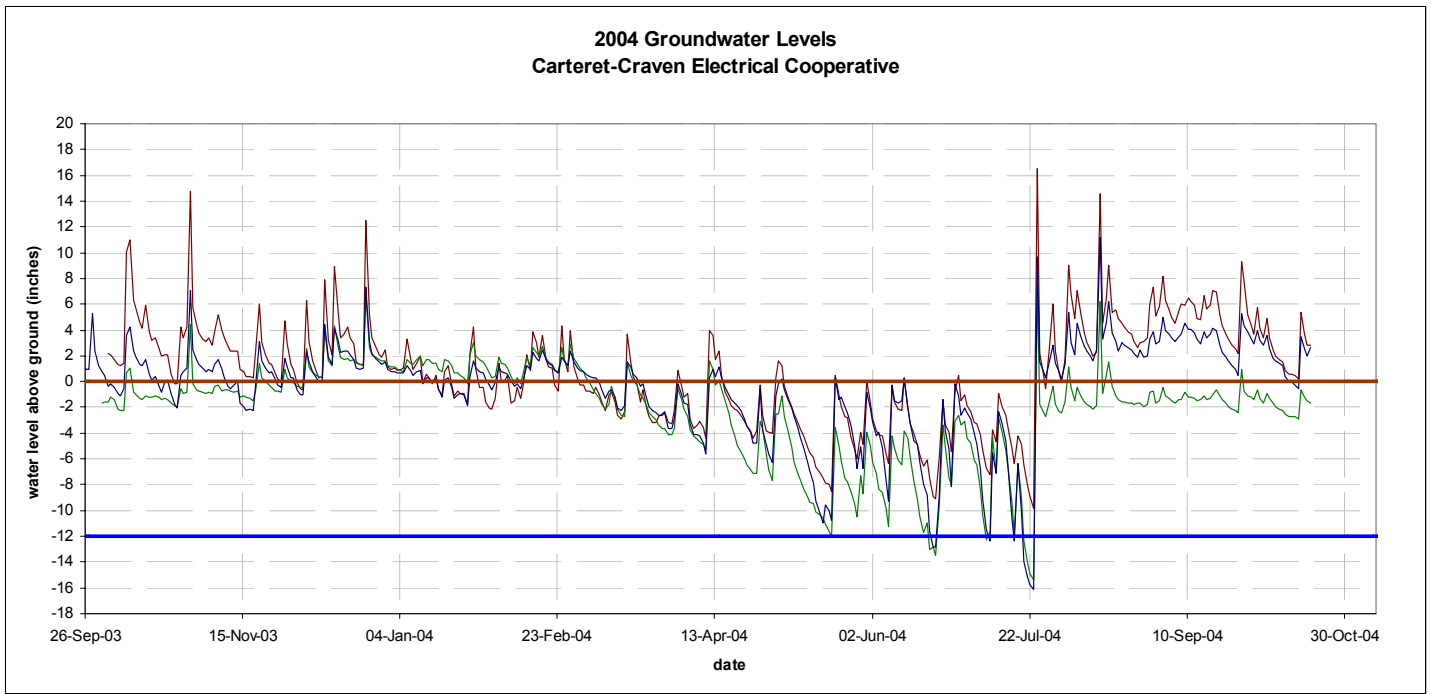
Figure 3. 2004 Groundwater Levels

Three ground water gages were set up at the site for the purposes of hydrologic monitoring after the project construction was completed. No revisions to the current hydrologic monitoring plan were proposed for this site. The data from each of the devices was downloaded during the monitoring visit. Analysis and overlay of the data showed that saturation levels well exceeded the mitigation requirements. Water levels in each area were recorded within 12 inches of the surface for a large portion of the growing season (Figure 3).

The Carteret-Craven Electrical Cooperative is currently meeting the vegetative and hydrologic success criteria for the project. Stem counts and saturation levels are well above the proposed criteria. Continued monitoring is recommended to further assess whether actions will be needed to ensure future vegetative criteria will be met and that invasives will not negatively impact the area. A soil fertility test could help determine if nutrient deficiencies are a problem in the West Cell.

The continued level of surface inundation may also be causing stress and contributing to the poor health and propagation of the trees. This type of hydroperiod, which is more similar to a constructed wetland than a natural one, may be more suitable for herbaceous wetland plants. If maximizing water quality benefits is a primary goal of the project, it may be recommended to compliment the Western Cell with a herbaceous planting.

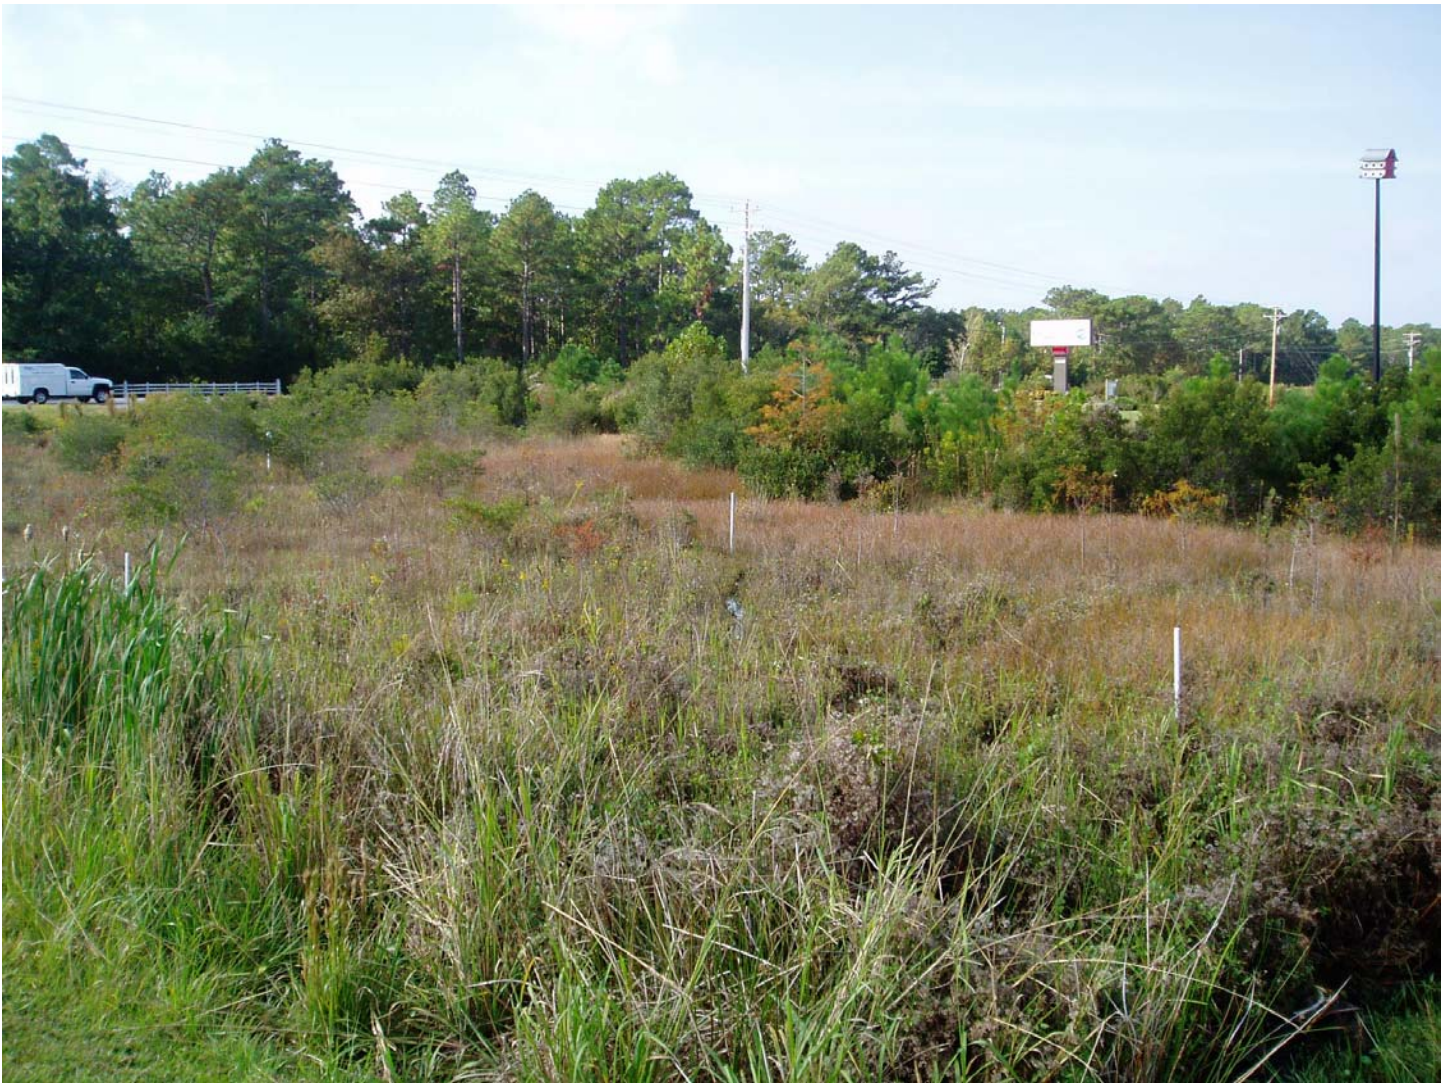
Vegetation throughout the East Cell appeared healthy and consisted of a combination of both planted trees and shrubs and volunteer shrubs and herbaceous plants. The herbaceous plants were widely diverse and thick throughout. A variety of algae was found in areas of standing water. Microtopography was heterogeneous in most areas.

Photo 1. East Cell

The east cell is currently meeting the requirements of vegetative success at this site. Recommendations for this site are to monitor the invasive plants over time and maintain them if needed. Overall, this portion of the site has a healthy, diverse vegetative population.

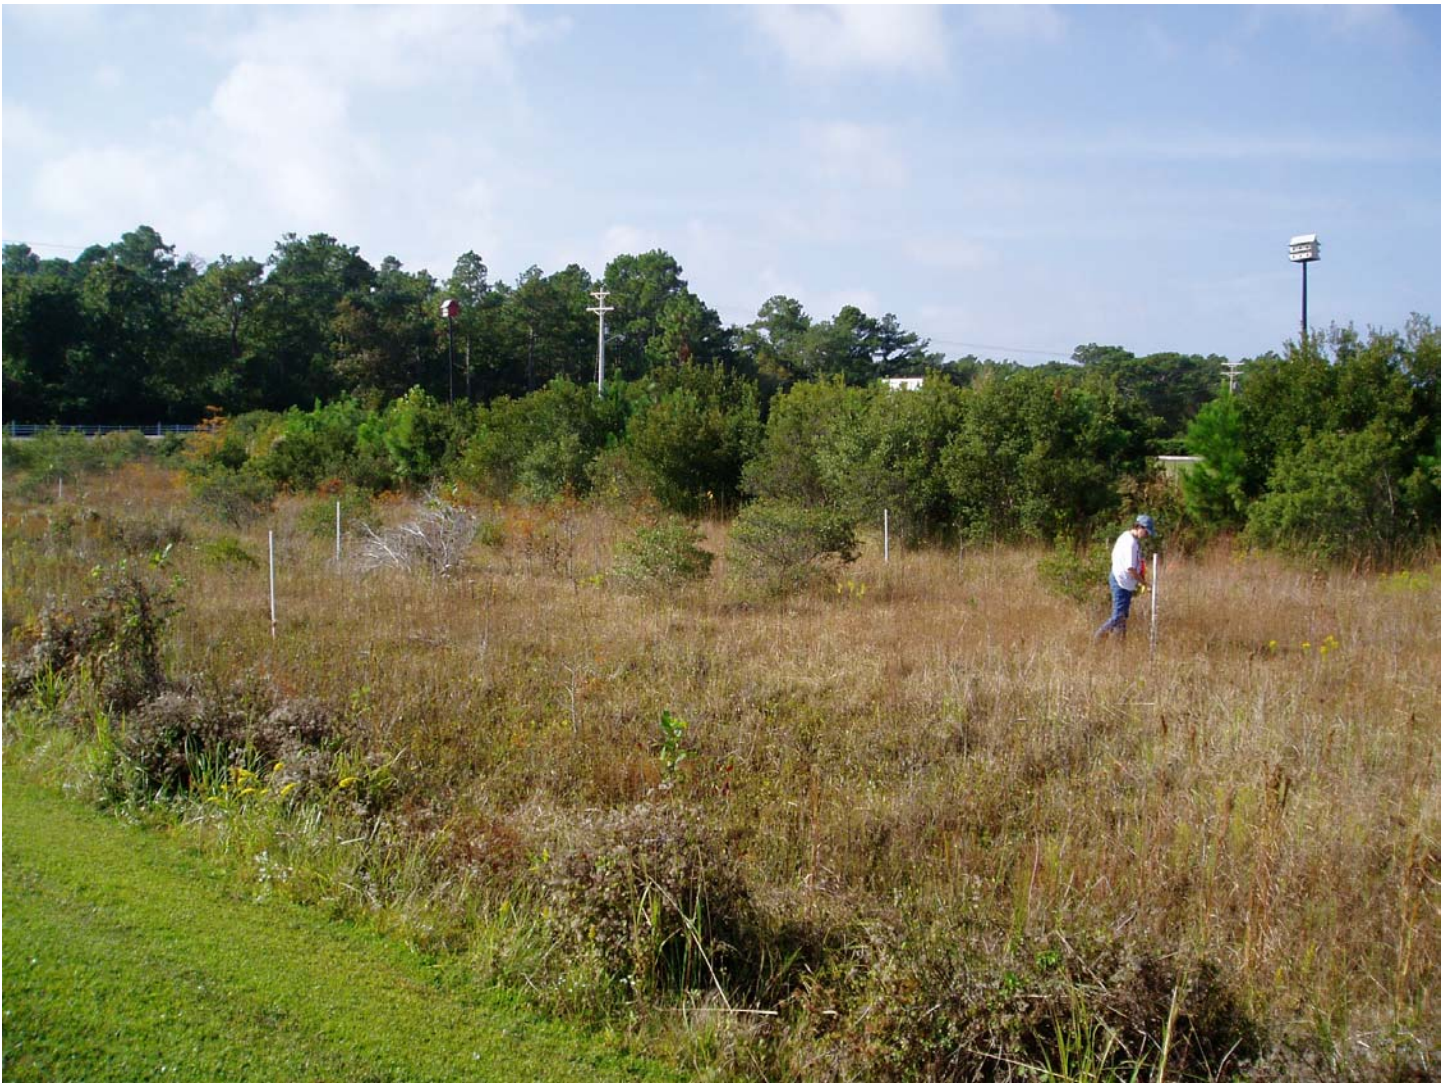
Planted trees were prevalent on this site. *Taxodium distichum* (bald cypress) and *Nyssa aquatica* (water tupelo) were the dominate trees. Planted trees were largely healthy and appeared vigorous. *Pinus serotina* (pond pine) was present, although unhealthy in appearance. Some tree mortality was noticed. Extrapolation from two plots in the East Cell resulted in an average of 900 trees per acre for this area. This number is generated from planted trees only with no naturally regenerated trees noted.

Photo 2. East Cell Vegetation Plot

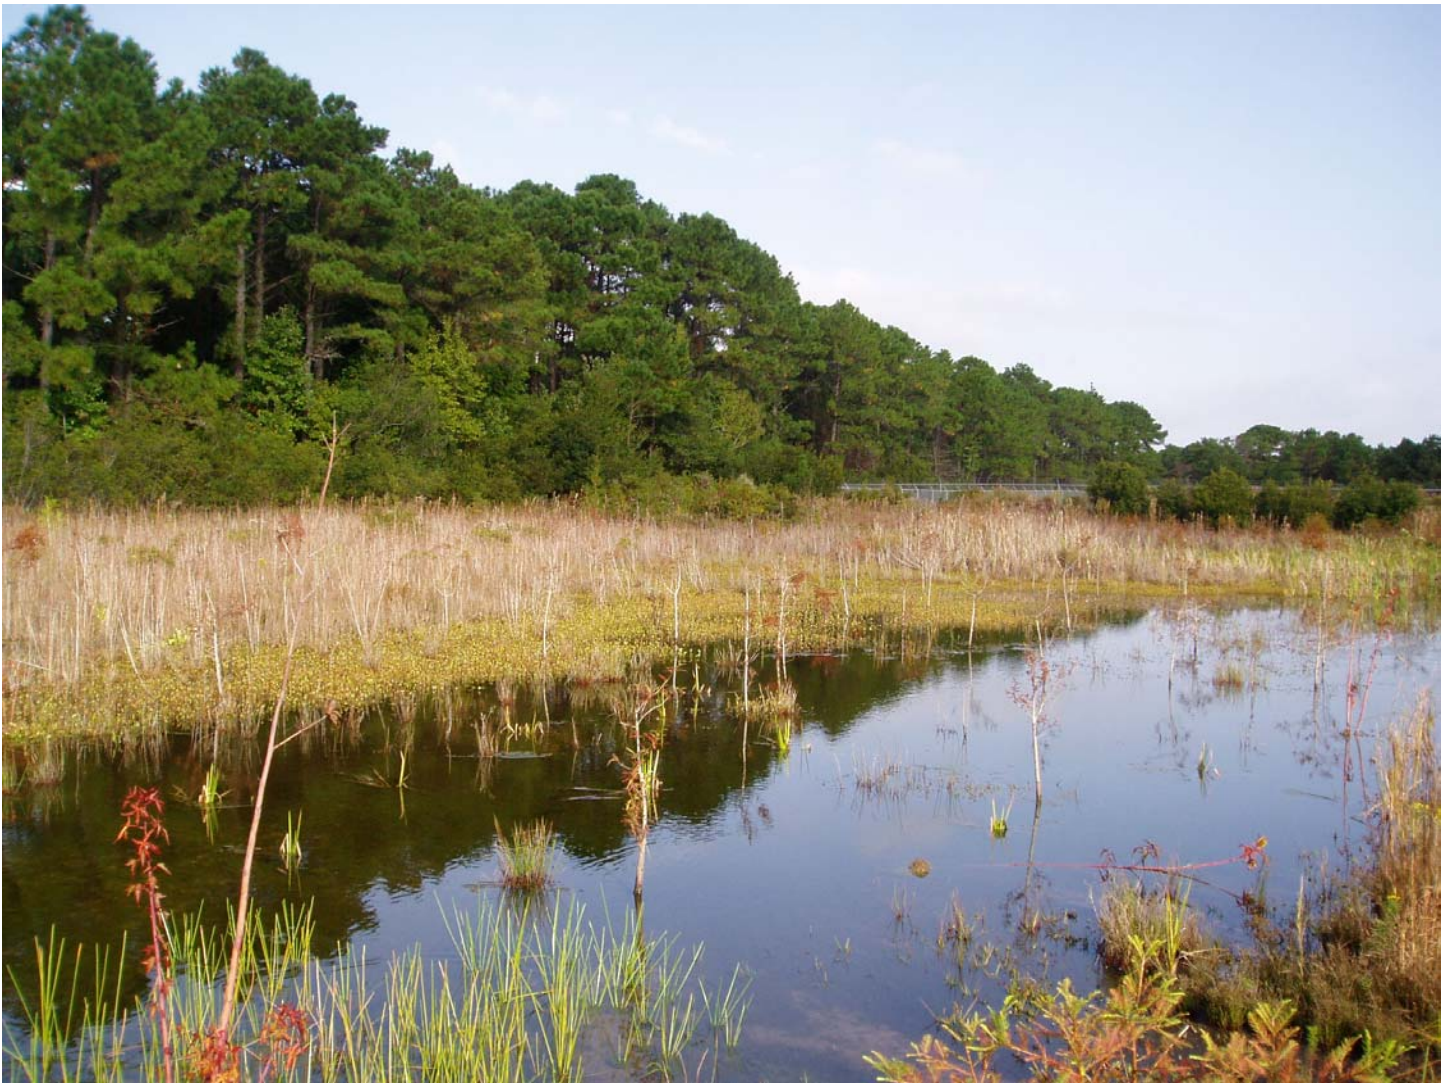
Herbaceous vegetation consisted of a variety of emergent and terrestrial plants. *Hydrocotyle* spp. and *Diodia virginiana* were dominant emergents in the area below the weir. The plot above the weir was very sparse in herbaceous vegetation. Compared to the East Cell, however, diversity of herbs was low in the West Cell. Only small species of wax myrtle represented the shrub layer. These appeared to be volunteers from a nearby hedgerow. In both areas, the shrub and herb layers were more abundant in the drier areas than the wetter areas. The herbs in the drier areas represented commonly occurring early successional species such as *Andropogon* spp. and *Panicum* spp.

Planted trees on this site included predominantly bald cypress, water tupelo, and *Fraxinus pennsylvanica* (green ash). The overall health of these trees was average. The recently planted trees appeared to be in good shape, however, older trees were struggling. Mortality of older trees was noted. The area below the weir was abundant in *Pinus* spp. volunteers, which were healthy and vigorous. Extrapolation from two plots in the West Cell resulted in an average of 480 planted trees per acre for this area. Planted trees and volunteer trees resulted in an extrapolated average of 1160 trees per acre.

Photo 3. West Cell - above weir

Recommendations for this site are to monitor the invasive plants over time and maintain them if needed. Secondly, a soil fertility test is recommended. The substrate appeared to be quite sandy with no nutrients; a possible explanation for poor health of the planted trees, particularly in the area above the weir.

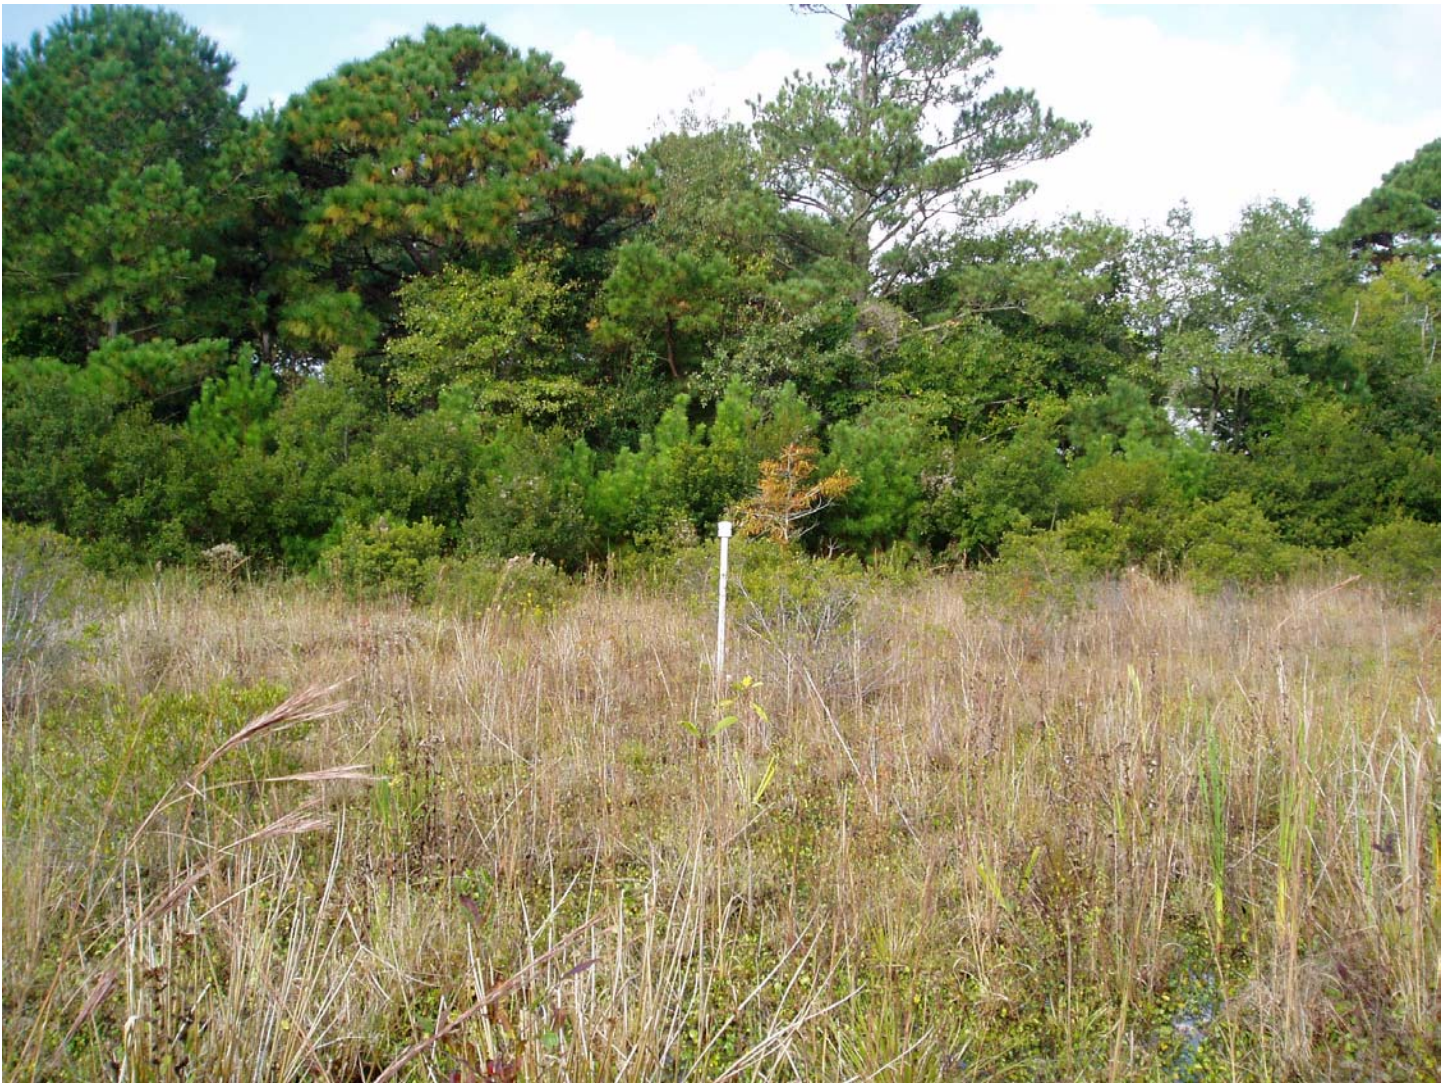
Photo 4. West Cell - groundwater gage
