# RESTORATION PLAN

*Overhills Stream and Wetland Restoration Project*

Nursery Road, Harnett County, North Carolina

March 28, 2003  
BLWI Project Number 010263

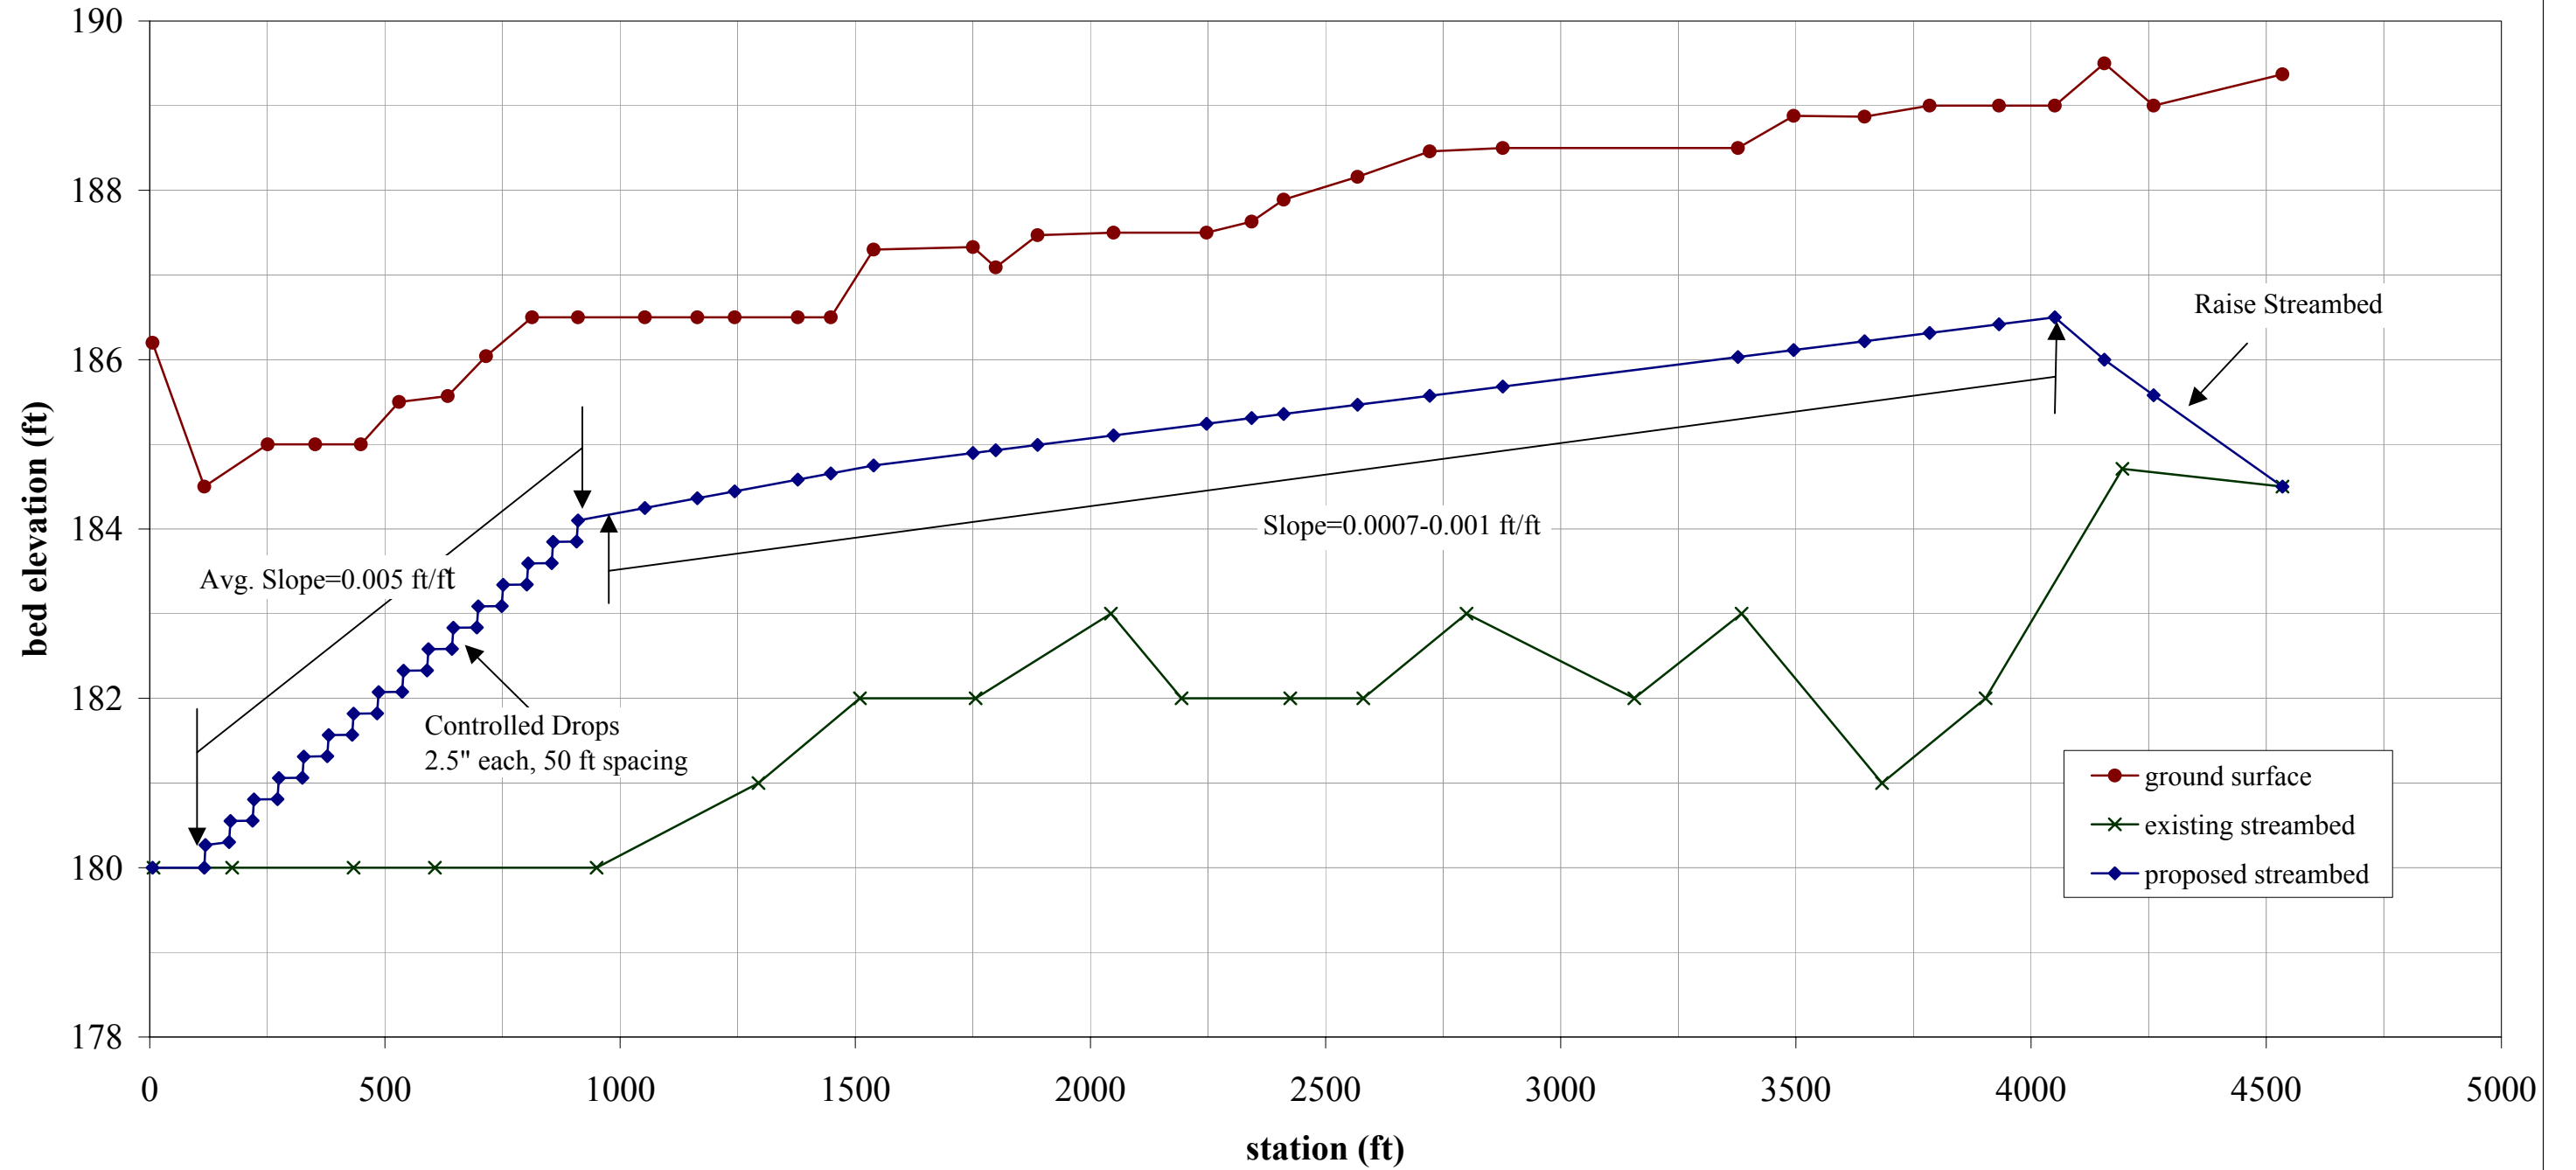
# Overhills/Jumping Run Creek Stream Restoration Profile Design

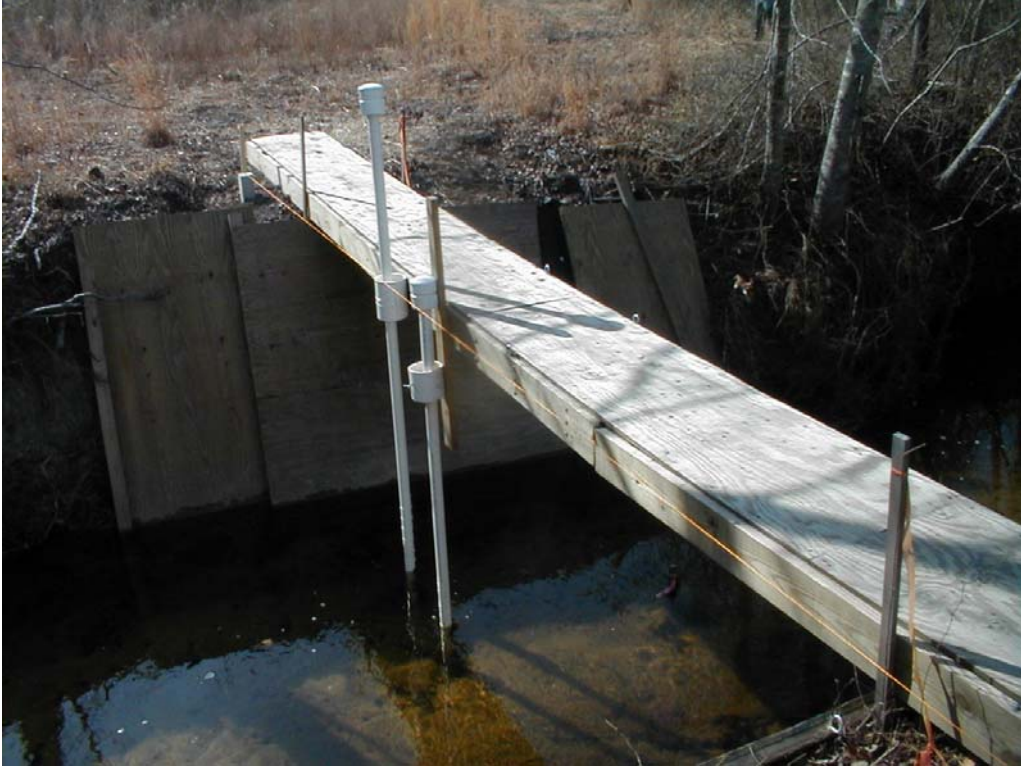
Figure 5. Gauge in Jumping Run Creek.

A water level recorder was placed in the stream to provide water level readings for further flow analysis. The recorder logs are reading of the water level in the stream every 30 minutes. When combined with rainfall information, this data provided insight to the relationship between rainfalls and various flow events. The data also provided information on the frequency of bankfull events and overbank flows. In between March and January, 10 events occurred which caused the stream stage to rise above the top of the bank or bankfull elevation.

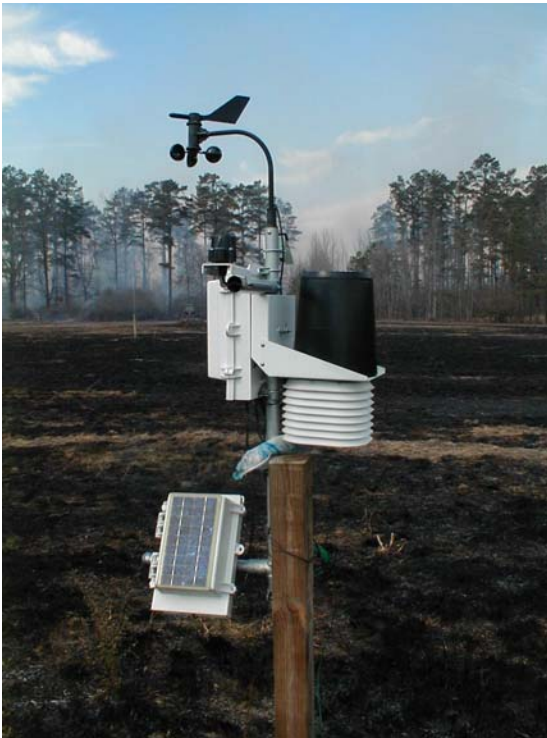
Figure 6. Weather Station – North of site.

produce the most accurate results possible. The placement of monitoring equipment throughout the watershed provided information on the spatial variability of precipitation. For the on-site meteorological monitoring we use a Davis GroWeather system. This integrated weather station and data logger measures/calculates, displays, and stores wind speed and direction, wind run, solar radiation, solar energy, air temperature, temperature/humidity index and wind chill (apparent temperature), soil temperature, humidity, dew-point, leaf wetness, barometric pressure, evapotranspiration, rainfall, and rate of rainfall. The weather station is programmed to record data hourly and the data is downloaded using a laptop computer. In addition to the weather station, we have an on-site rain gage and five rain gages placed strategically throughout the watershed. These gages are a tipping bucket type gage outfitted with a datalogger that records every hundredth of an inch (0.01") of rainfall. All of our monitoring equipment are chronologically synched and data is downloaded approximately once per month.

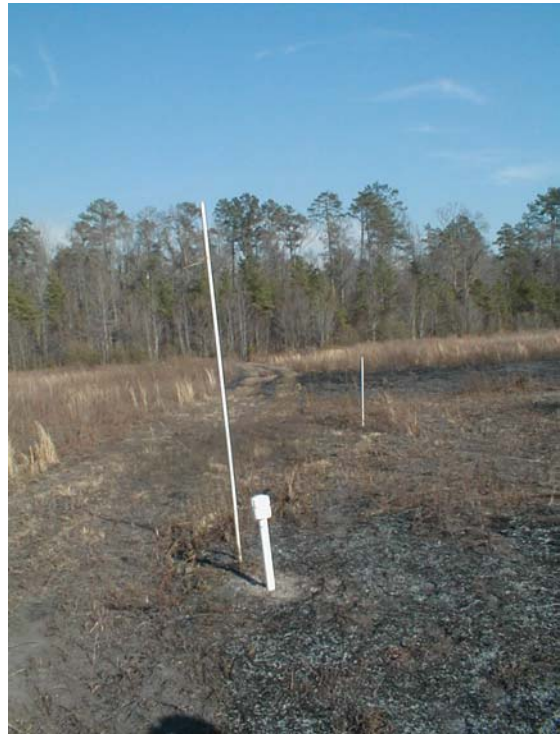
Figure 7. Groundwater gauge.

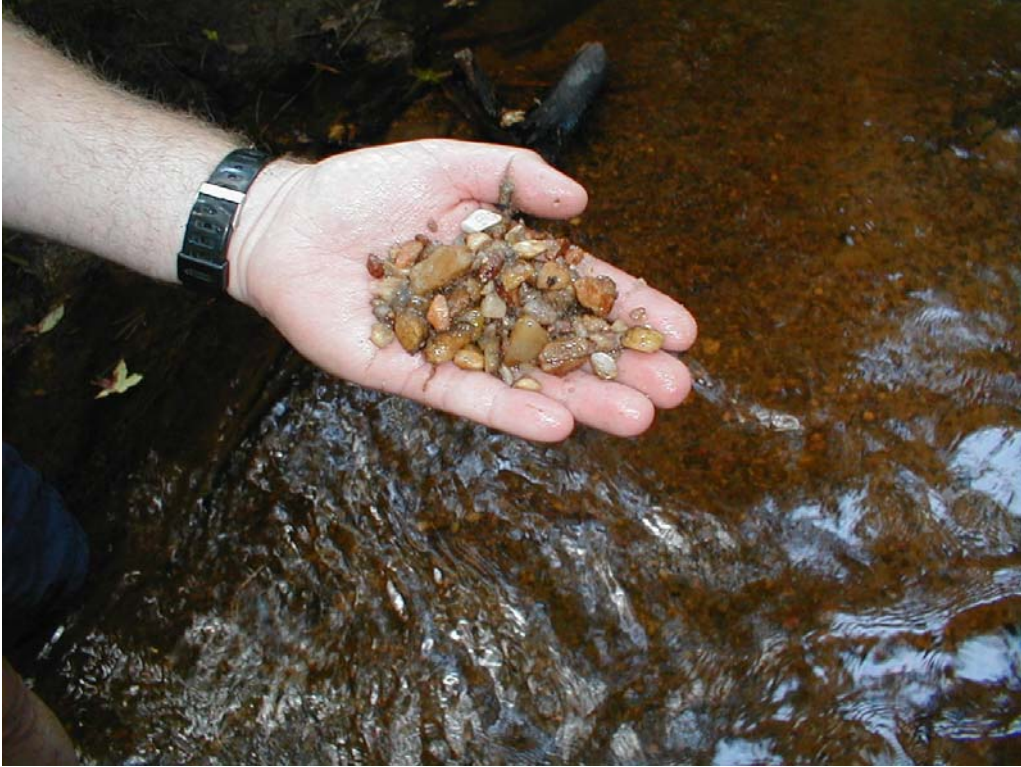
Figure 8. Gravel from Jumping Run Creek.

Streambed samples were taken and sent off to a lab for particle size analysis. Samples were taken of the dominant bed material in stable sections of the stream. The d50 of the first sample was found to be 0.5 mm, which falls into the category of medium sand. The d50 for the second sample was found to be 9 mm, which falls into the category of fine gravel (Appendix G. Existing Stream Data).

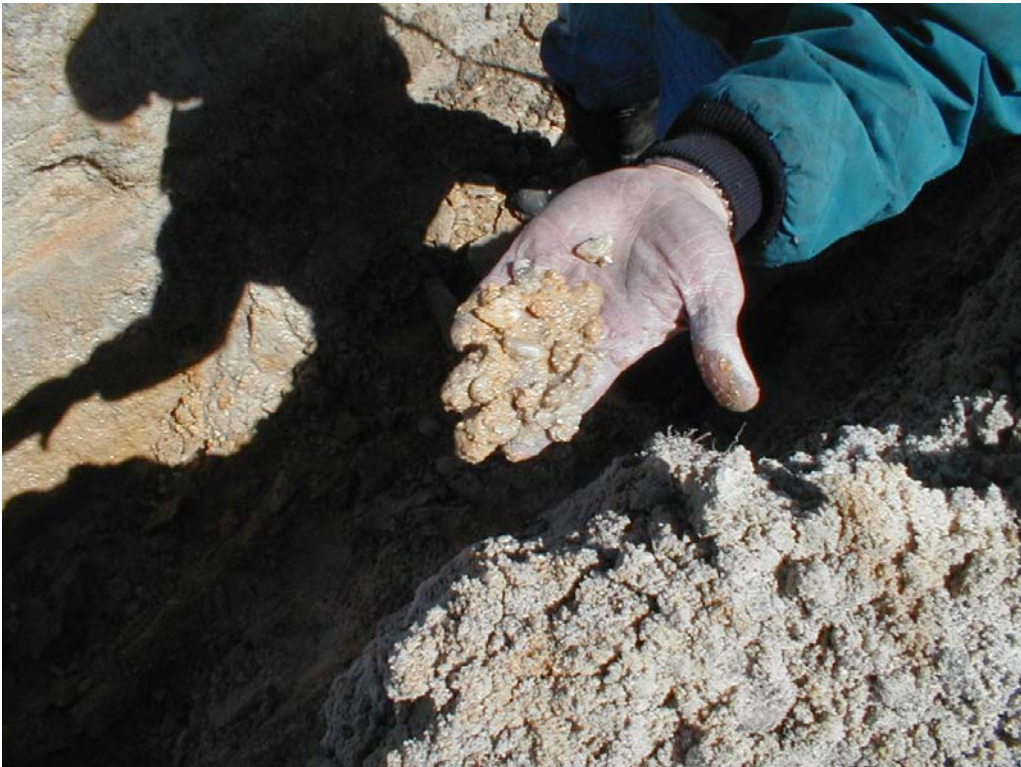
Figure 9. Sample from soil pit in interior of restoration site.

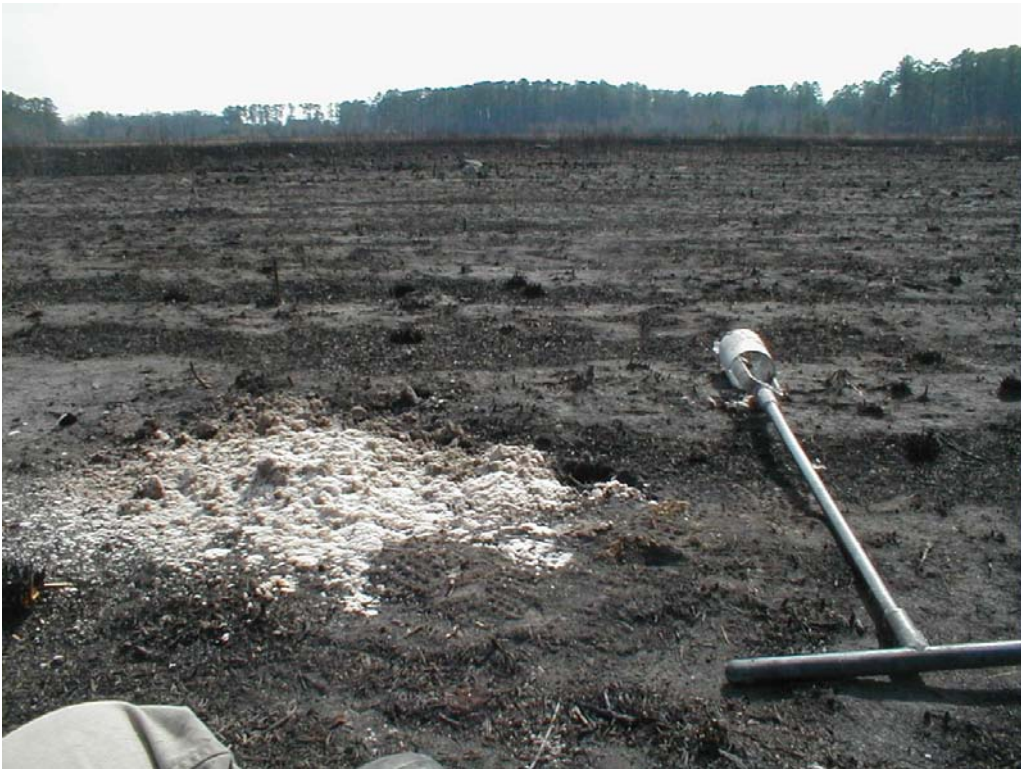
Figure 11. Bibb at North end of site, dark surface from burning.

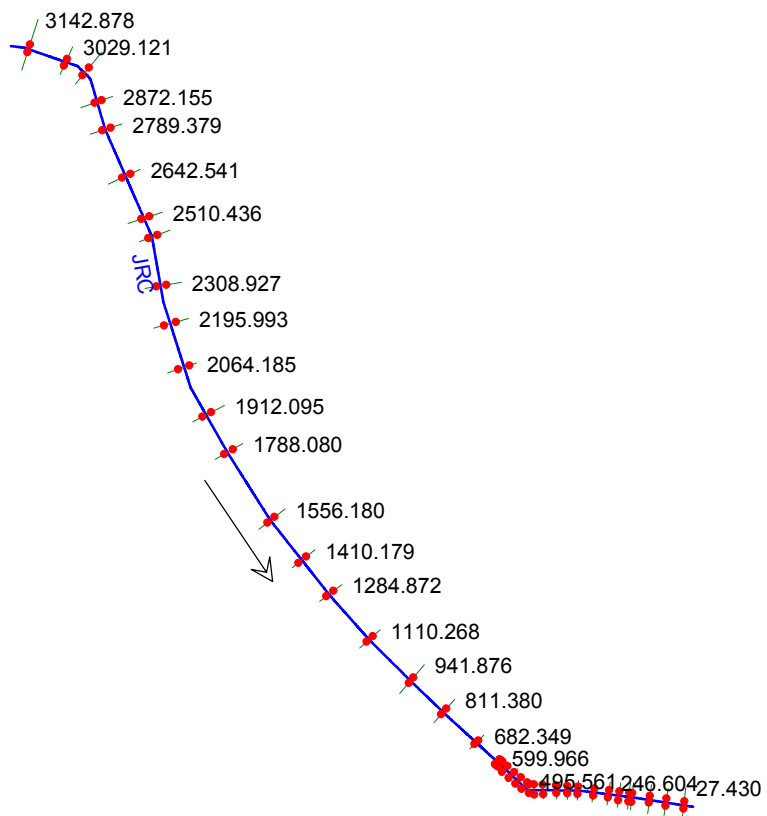
Existing Jumping Run Creek at Project Site - Plan View

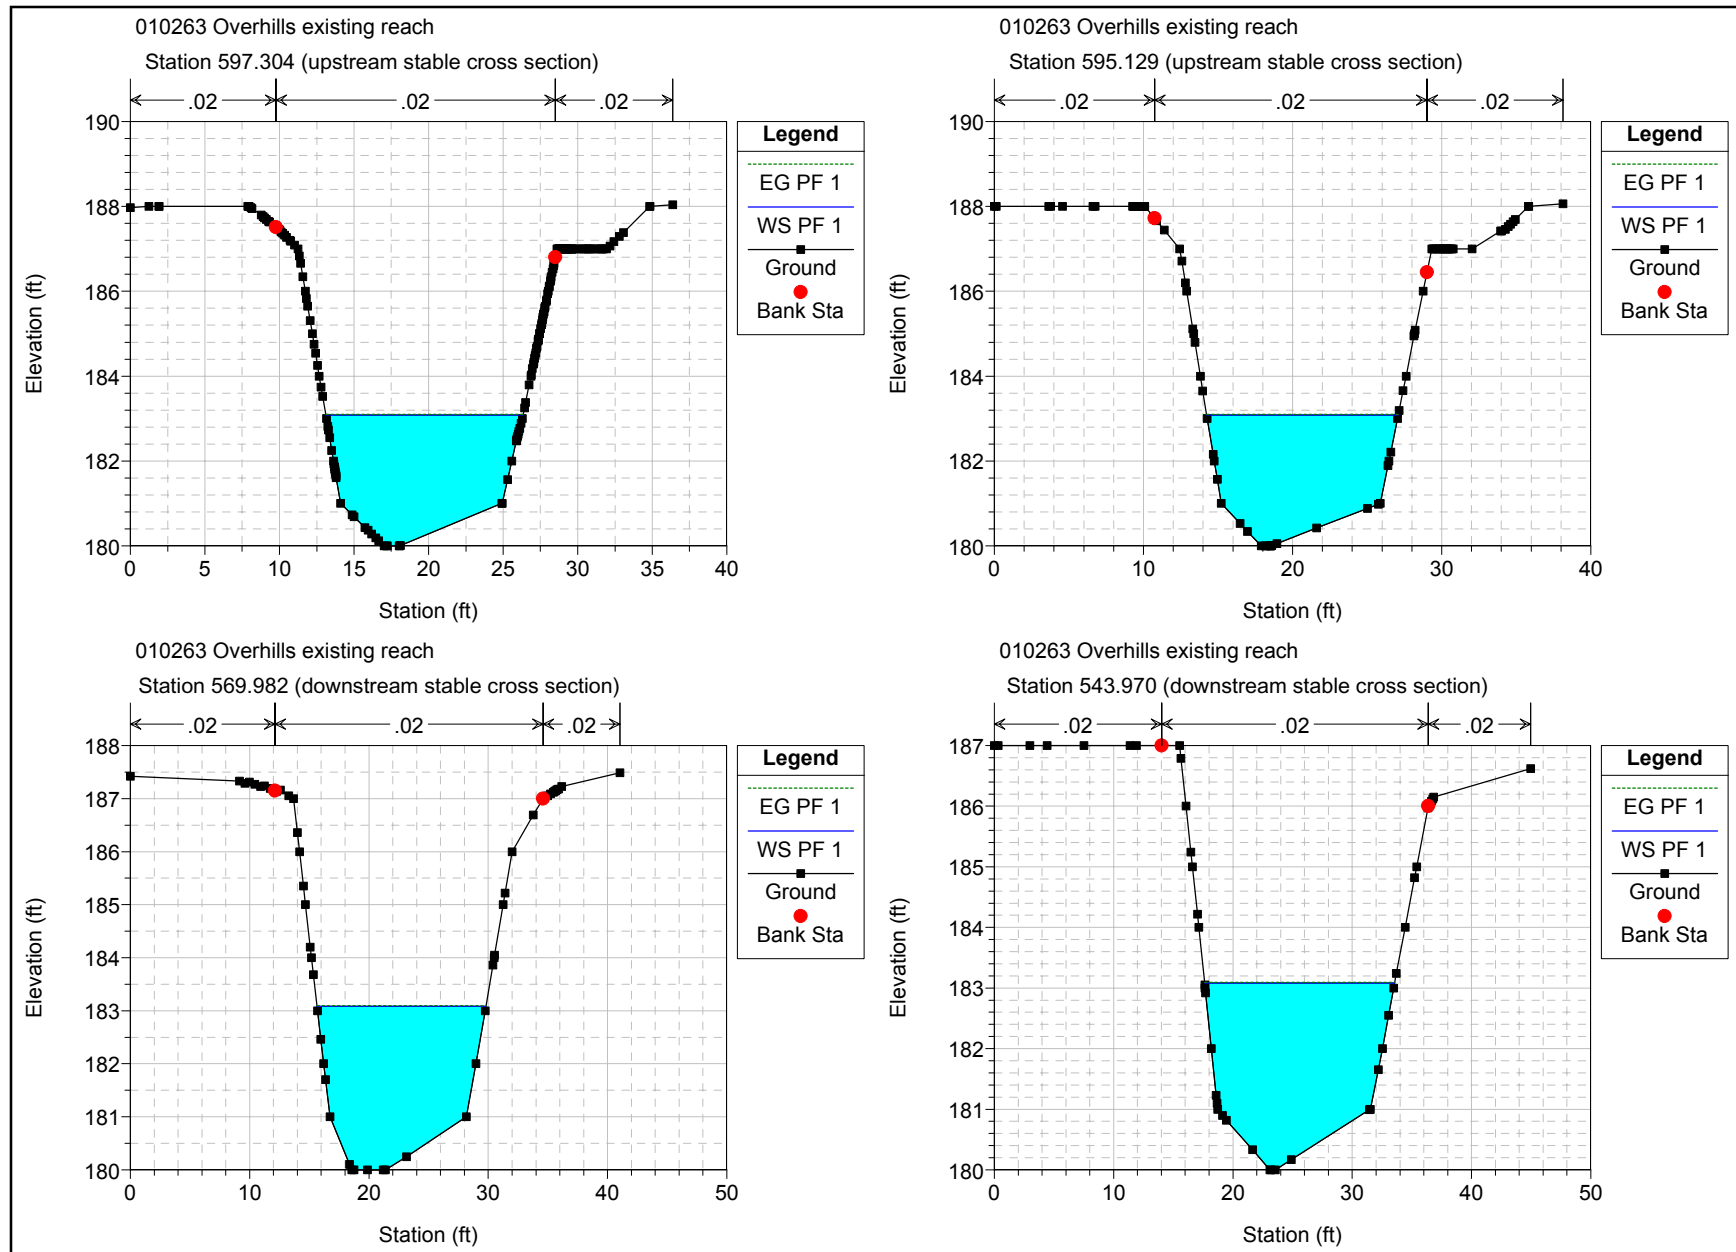
# Existing stream cross sections

The survey data was used to develop several riverine hydraulic models of Jumping Run Creek. The models were used to make initial estimates of bankfull flowrate based on the observed indicators. Another model was also developed and calibrated for use with stream water level data to calculate actual flowrates for detailed modeling efforts (Appendix G, Existing Stream Data).

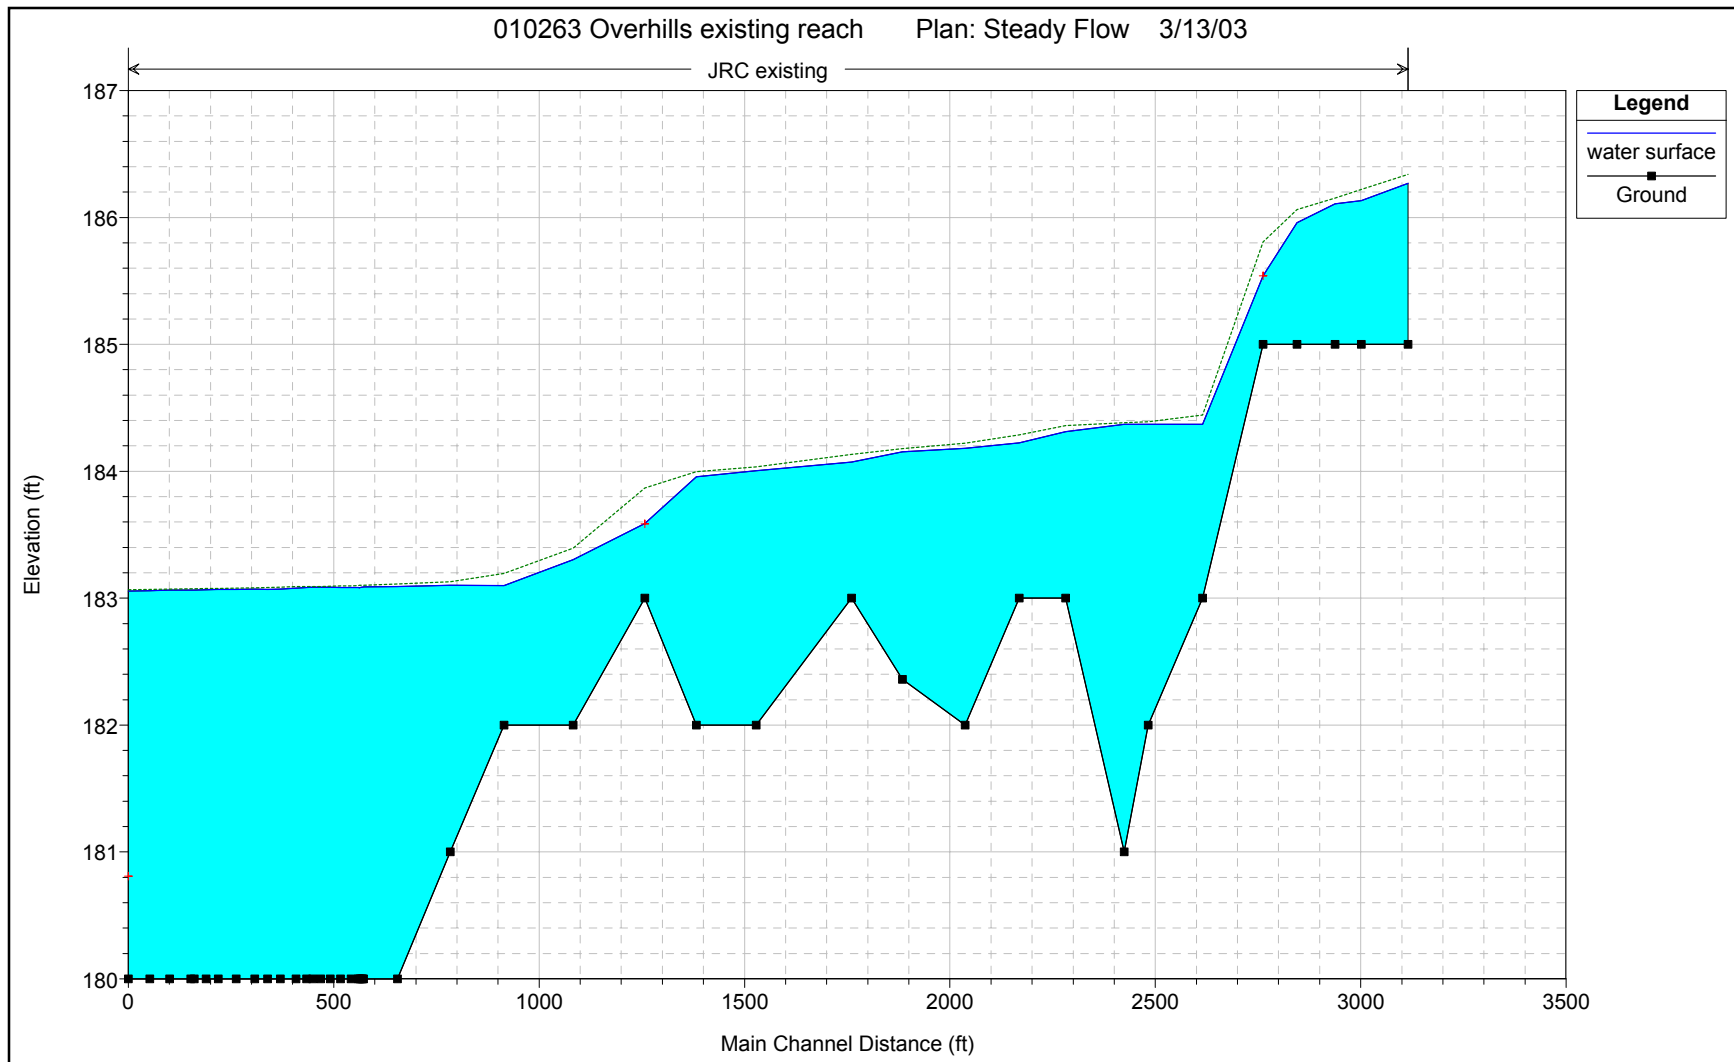
Existing stream profile showing bankfull water surface elevation and thalweg

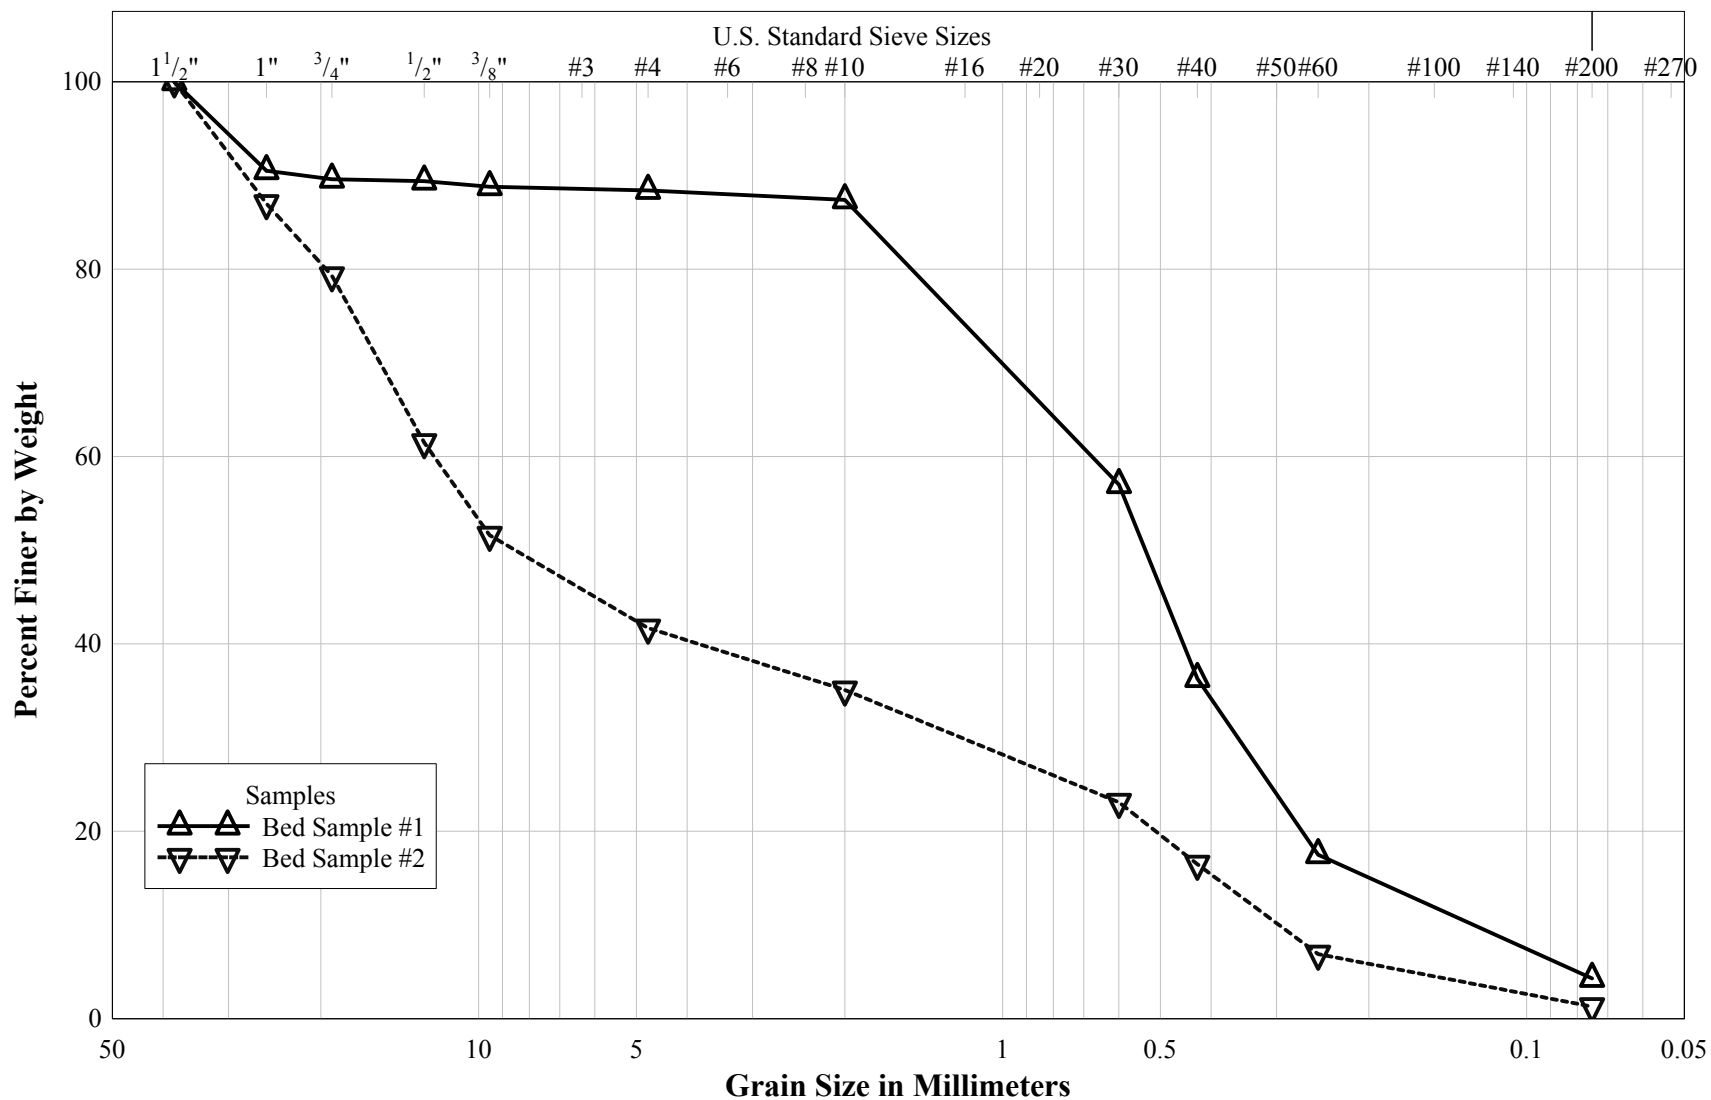
# Jumping Run Creek Streambed Particle Size Analyses

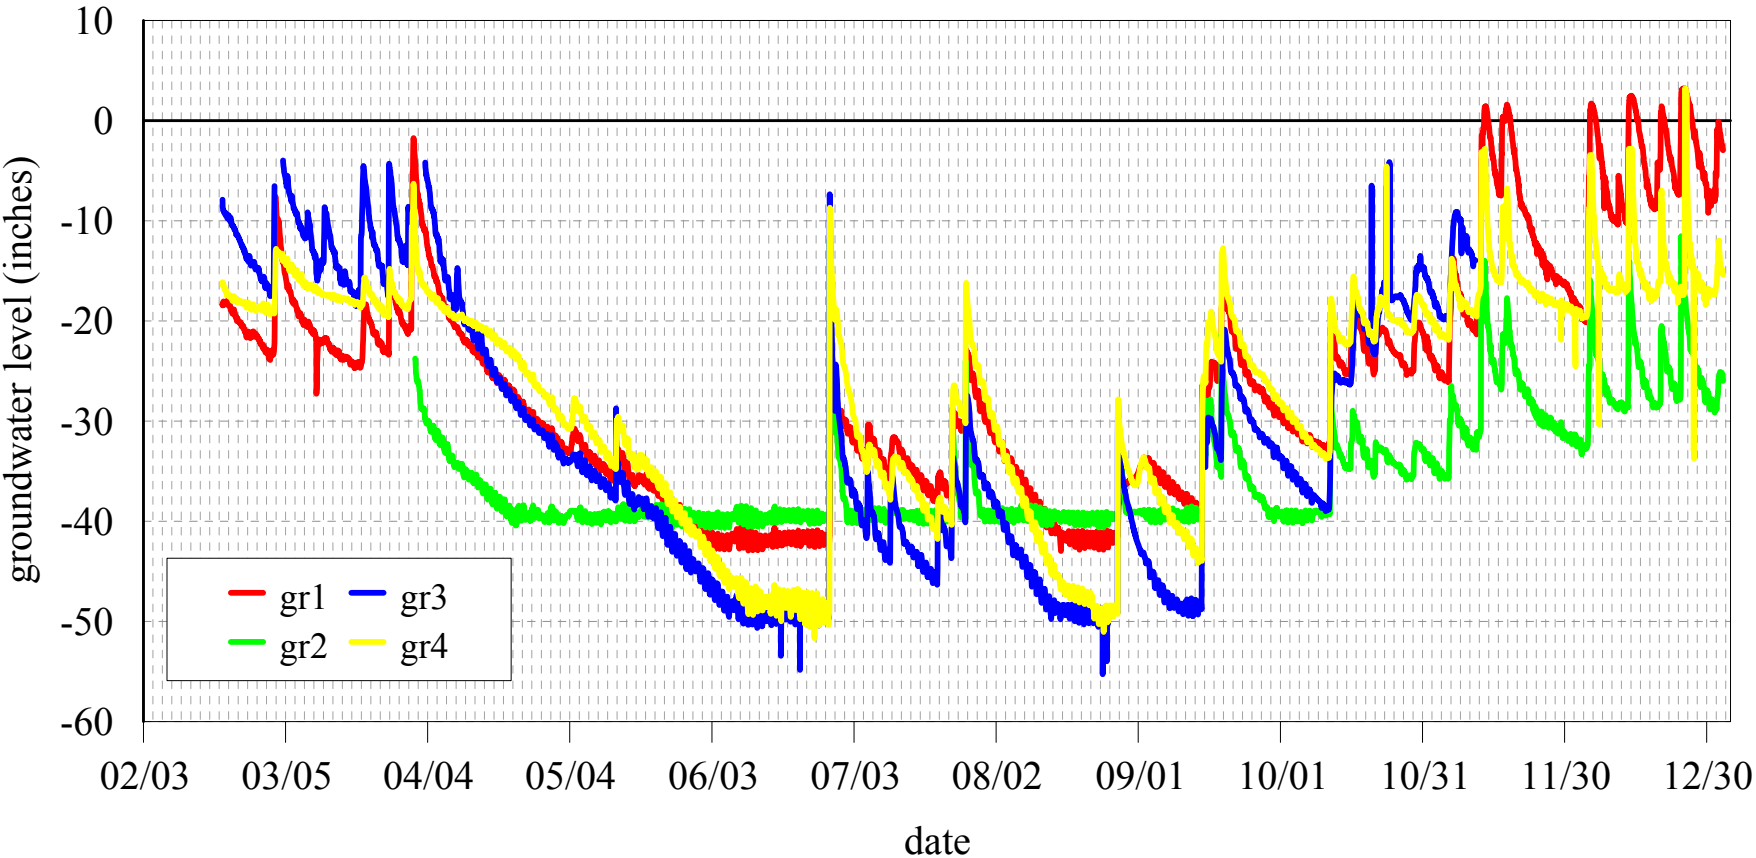
# Measured Groundwater Levels at Site

Site monitoring was undertaken to obtain an approximate data representation of the conditions and short-term history of soil and water level patterns for that area. On-site, information was gathered about groundwater levels, stream water levels, soil temperature, streambed particle fluidization and streambed aggradation/degradation (Appendix G. Existing Stream Data).

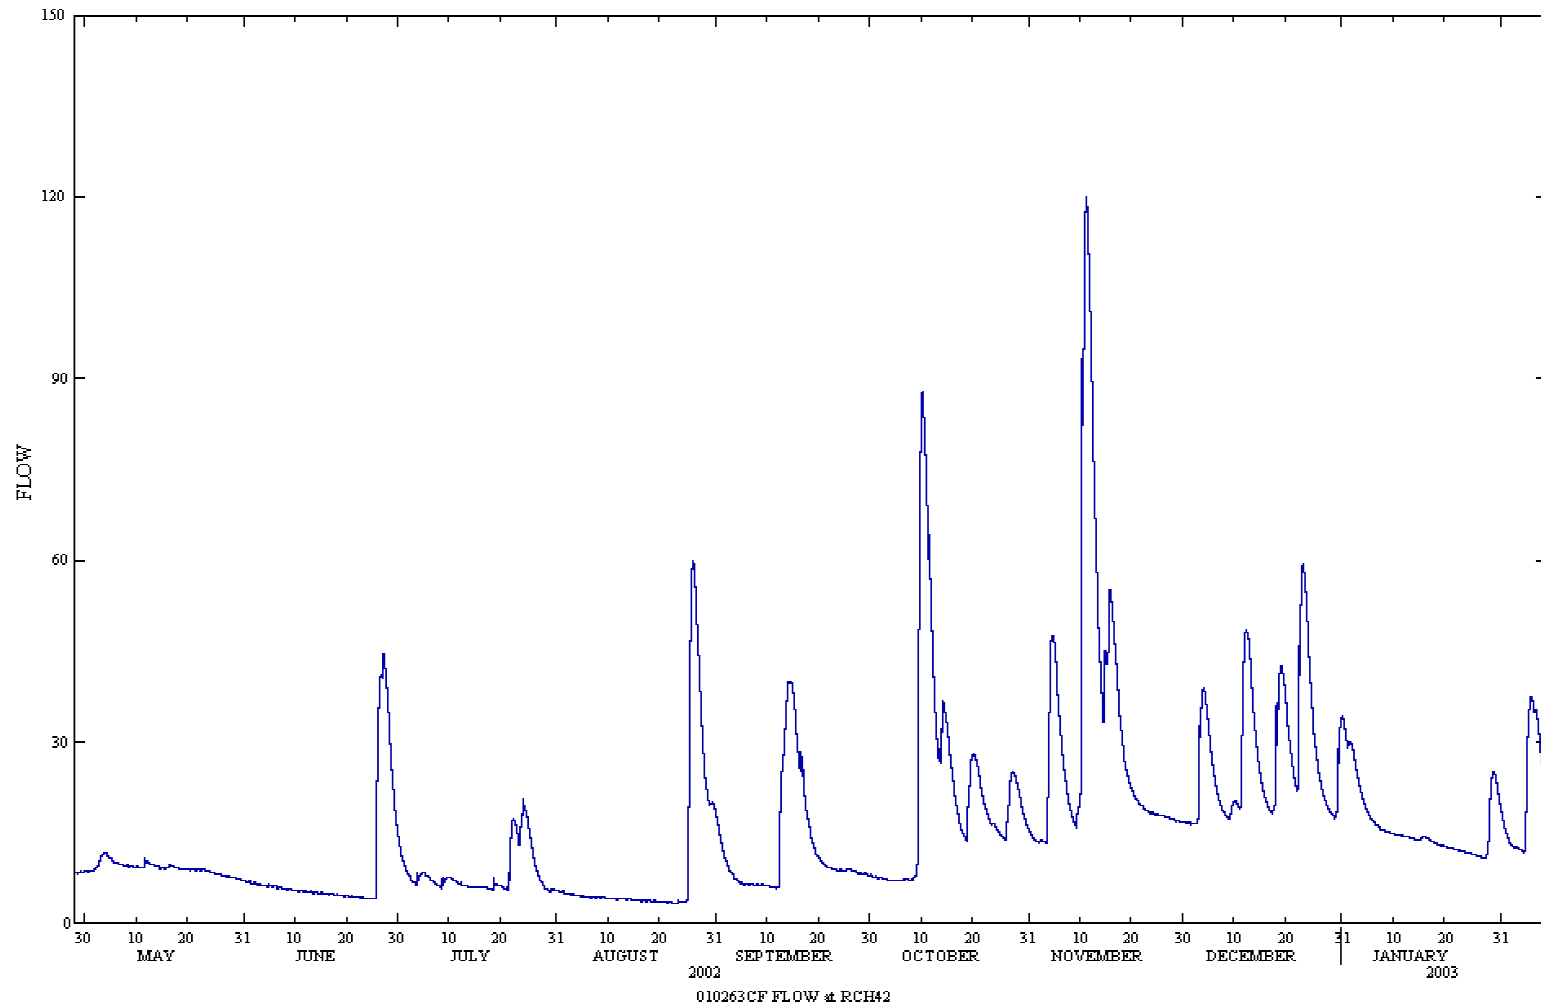
Modeled flow from HSPF watershed model for monitoring period
