OVERHILLS STREAM AND WETLAND  
RESTORATION MONITORING REPORT (YEAR 3 OF 5)  
Harnett County, North Carolina  
EEP Project No. 199

Status of Plan: Final  
Submission Date: November 2009

# Current Condition Plan View

#### EEP Project Number 199

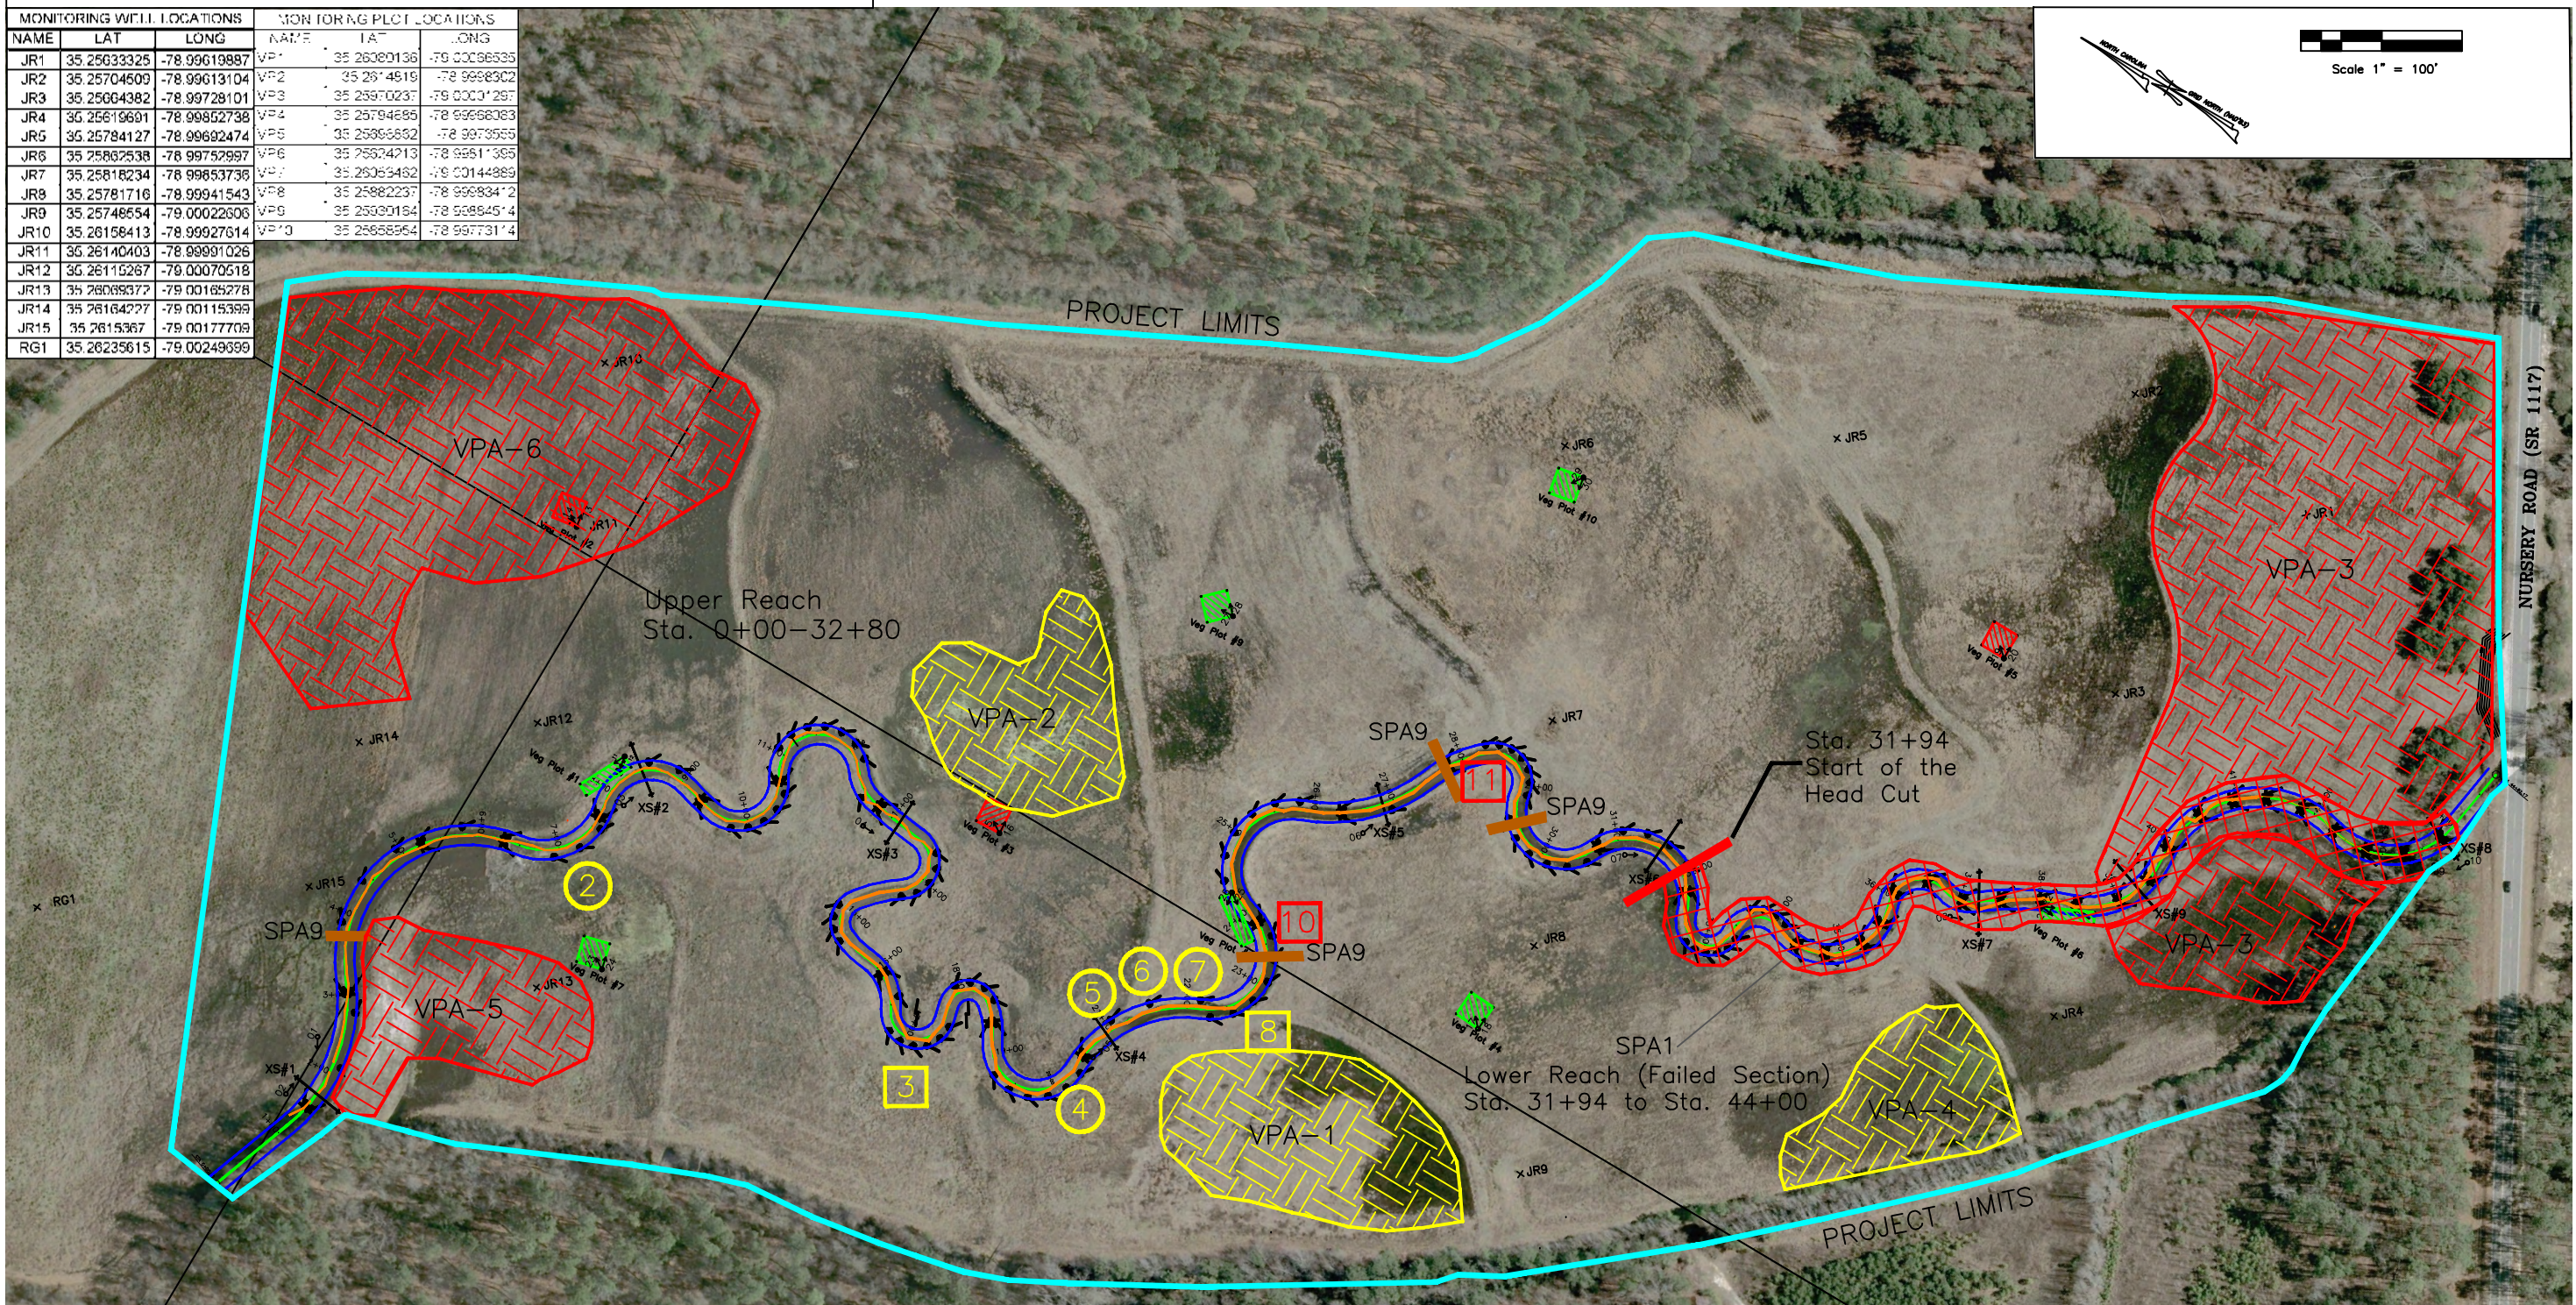
The major stream problem area continues to be the headcut (SPA Photo 1) and downstream reach located from station 31+94 to 44+00. In this area and downstream, the stream has failed. This headcut continues to move at an increasing pace upstream, appearing to have moved approximately 40 feet upstream since last year. The headcut most likely first began at the location where the design changes from a C5 to an E5 channel between the Upper and Lower reaches at Station 33+00. Downstream of this headcut, most of the in-stream structures have failed and erosion is occurring. Erosion around the structures has forced the banks to migrate as much as seven feet, making this section of stream extremely unstable (SPA Photo 2 & 3). Because of the vast migration of the stream channel, the stream has become over-widened in many sections, which has led to mid-channel bar formations (SPA Photo 2). The headcut and downstream problems are shown in the longitudinal profile in Appendix D. Upstream of the headcut, normal water surface elevations are at or near the constructed bankfull elevation, allowing the channel to access the floodplain under very small storm events. The areas immediately adjacent to this section of the channel were ponded near the channel banks. The presence of multiple beaver dams is causing large areas of the floodplain to become inundated with water, some areas over 1 foot in depth. Headcuts are occurring in areas where the inundated water reenters the stream channel from the side (SPA Photos 4, 5, & 6). These areas are located along the bank near Stations 23+50 and 28+00. The beaver dams are located near Stations 3+86, 23+14, 27+77 and 29+67.

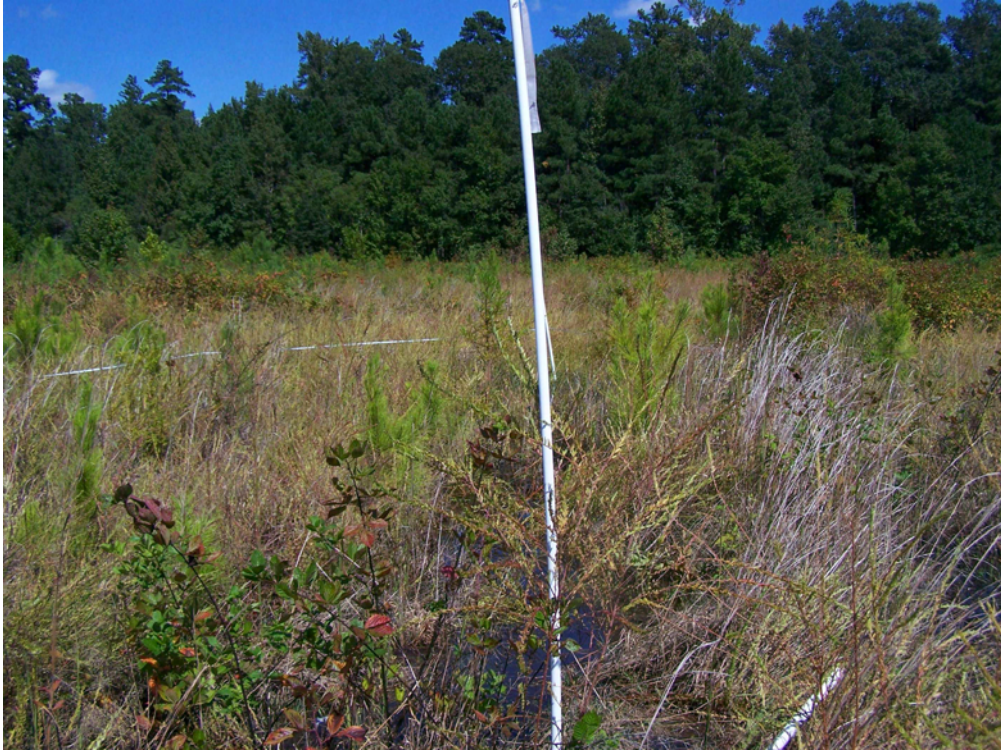
**Photo Station 13:** Vegetation Plot 2 looking northeast (9/30/09)

<b>Table 5 - Vegetation Plot Mitigation Success Summary</b>		
<b>Overhills/Jumping Run Creek Restoration Project / EEP Project No. 199</b>		
<b>Vegetation</b>	<b>Vegetation Density Met</b>	<b>Tract Mean</b>
<b>Plot ID</b>	<b>(320 stems/acre)</b>	
VP1	Y (364)	70% (408 stems/acre)
VP2	N (283)	
VP3	N (162)	
VP4	Y (324)	
VP5	N (121)	
VP6	Y (1093)	
VP7	Y (405)	
VP8	Y (567)	
VP9	Y (324)	
VP10	Y (445)

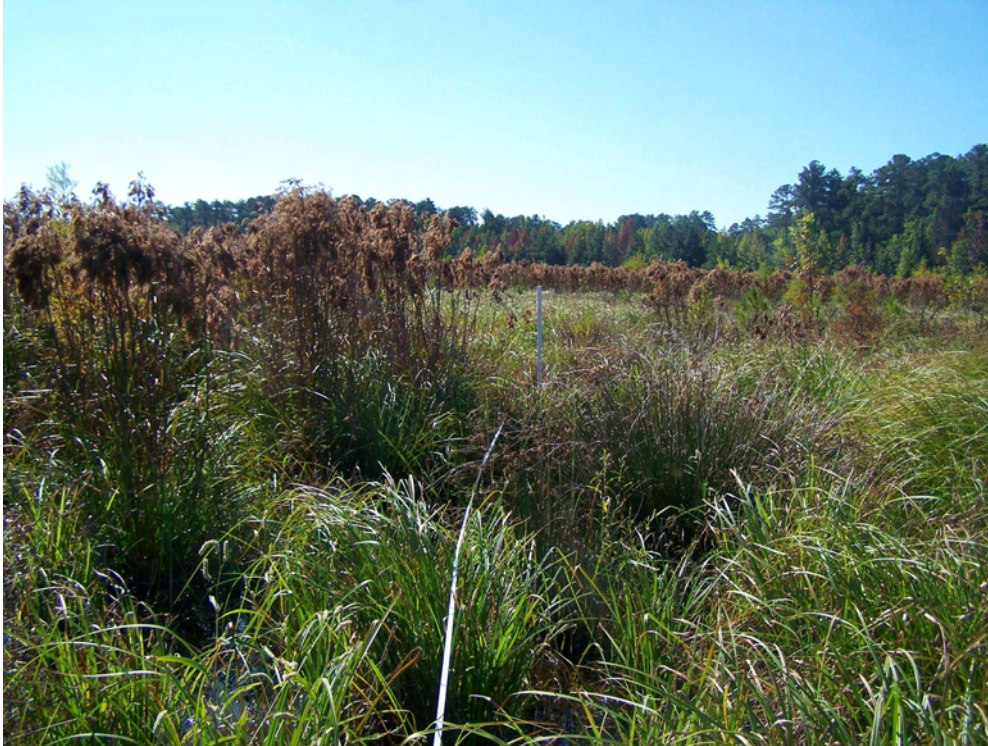
**Photo Station 15:** Vegetation Plot 3 looking northwest (9/30/09)

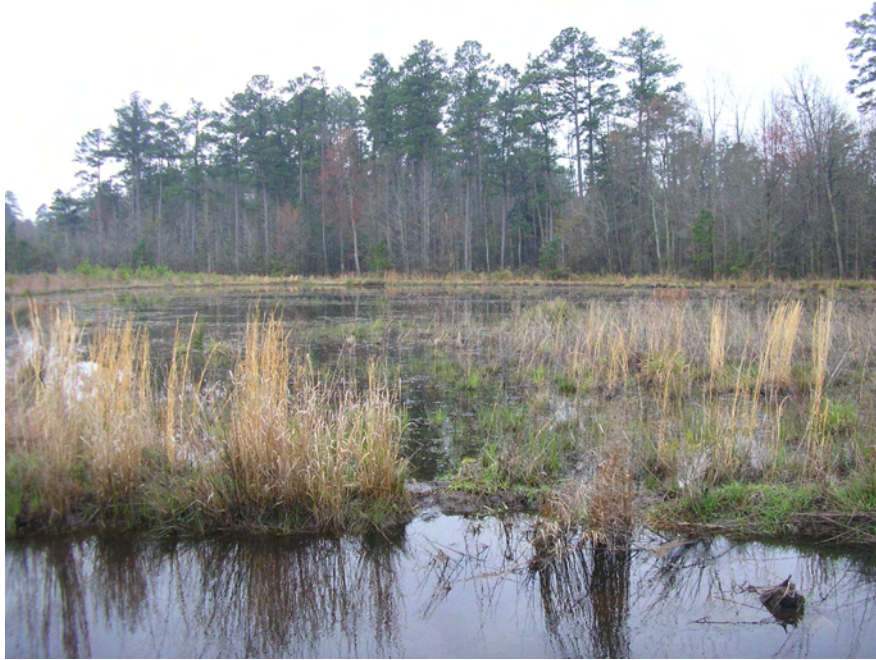
**Photo 1** – Evidence of bankfull overflow near Station 22+00 (3/26/09)

Table 9 - Verification of Bankfull Events Overhills/Jumping Run Creek Restoration Project - EEP Project No. 199			
Date of Data Collection	Date of Occurrence	Method	Photo
2009	March, 2009	Field observation	Appendix D, Photo 1

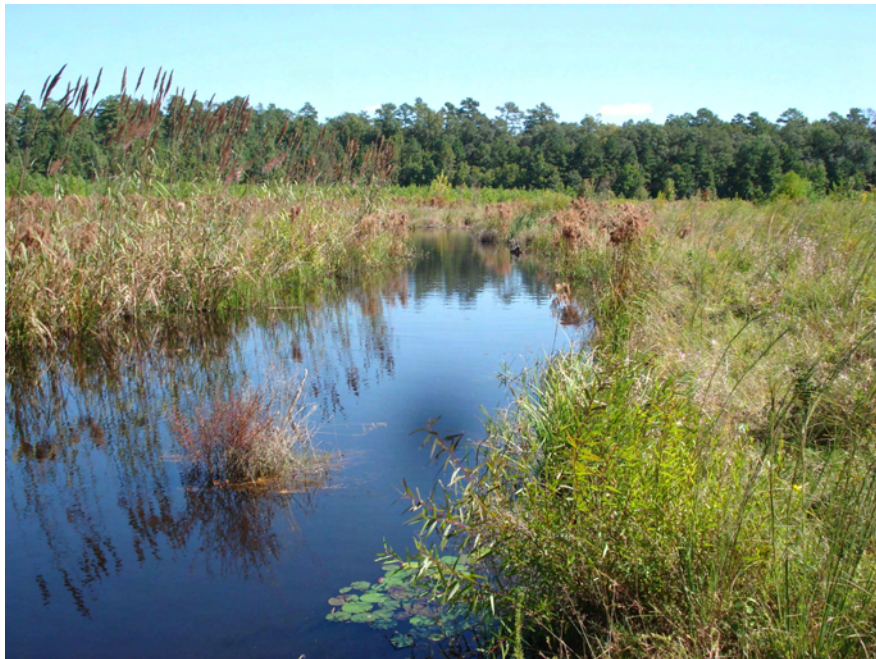
**Photo 2** – Typical example of the restored channel upstream of headcut area (9/30/09)

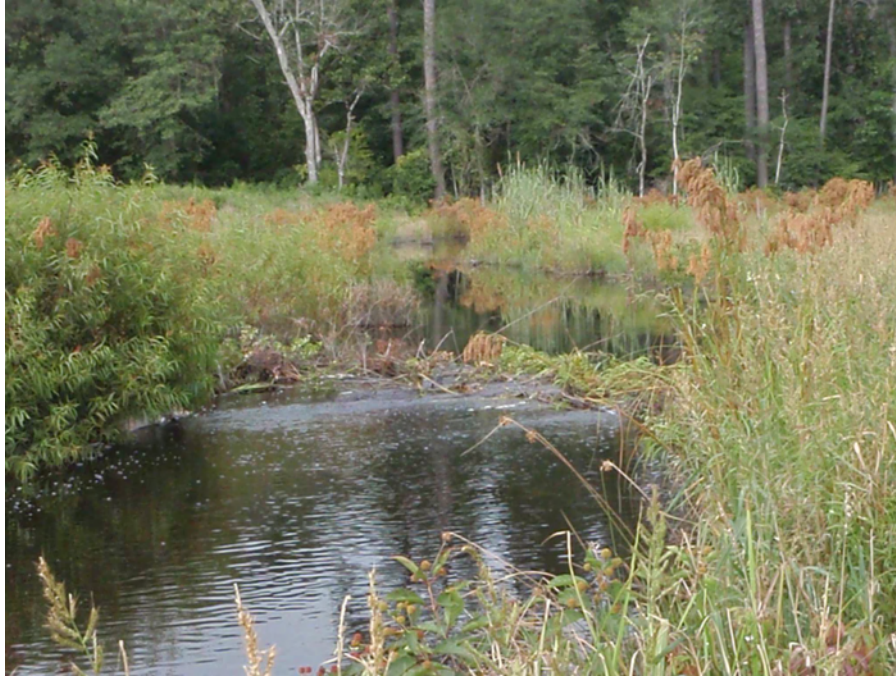
**Photo Station 1** – Beaver dam just downstream of Cross Section 1 – looking upstream (8/26/09)  
(Note: Locations of Photo Stations are located on the Current Condition Plan View in Appendix A)

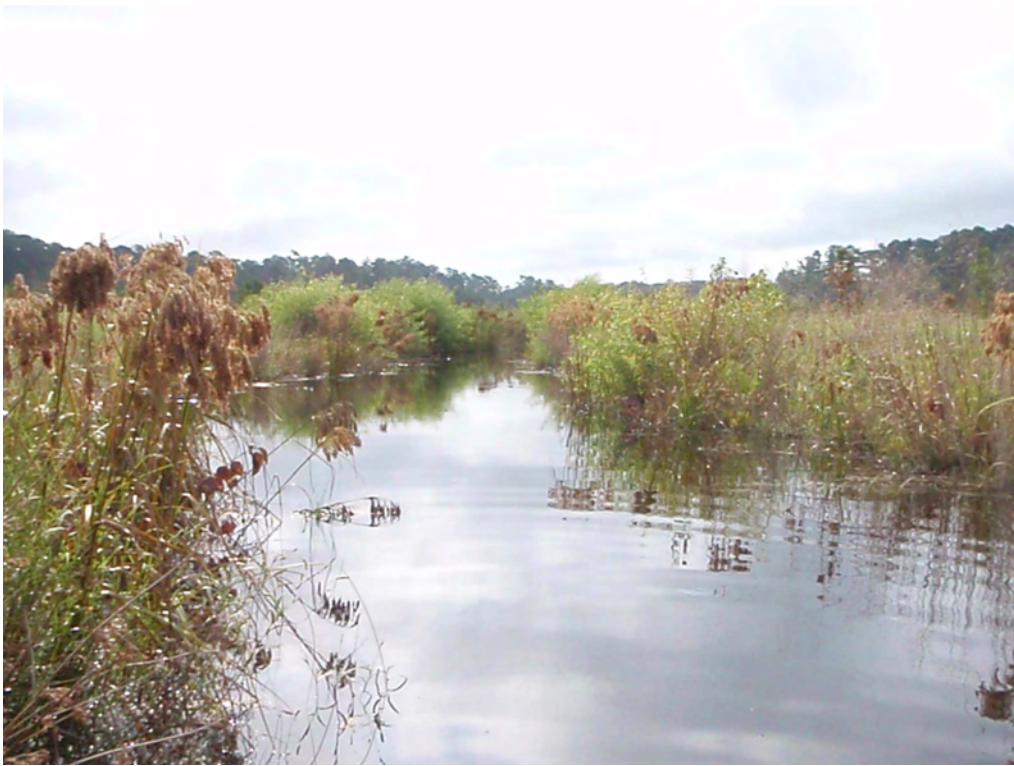
**Photo Station 5** – Cross Section 4 – looking downstream (8/26/09)

Other problems include downcutting at cross-sections (XS) 4 and 7. At XS4, the stream appears to have downcut between the baseline survey and Monitoring Year 1. However, the stream appears relatively

stable between Monitoring Year 1 and Monitoring Year 3. The initial downcutting may be attributed to an undersized channel upstream. The survey of XS7, located in the unstable downstream reach, has shown considerable change in its cross-sectional dimensions from baseline conditions. The bed will most likely continue to downcut until a less erosive bed layer emerges in the profile to stop the incising. Two log cross-vanes, both upstream and downstream of the cross-section, have failed to hold grade and may be contributing to the active degradation of the stream bed.

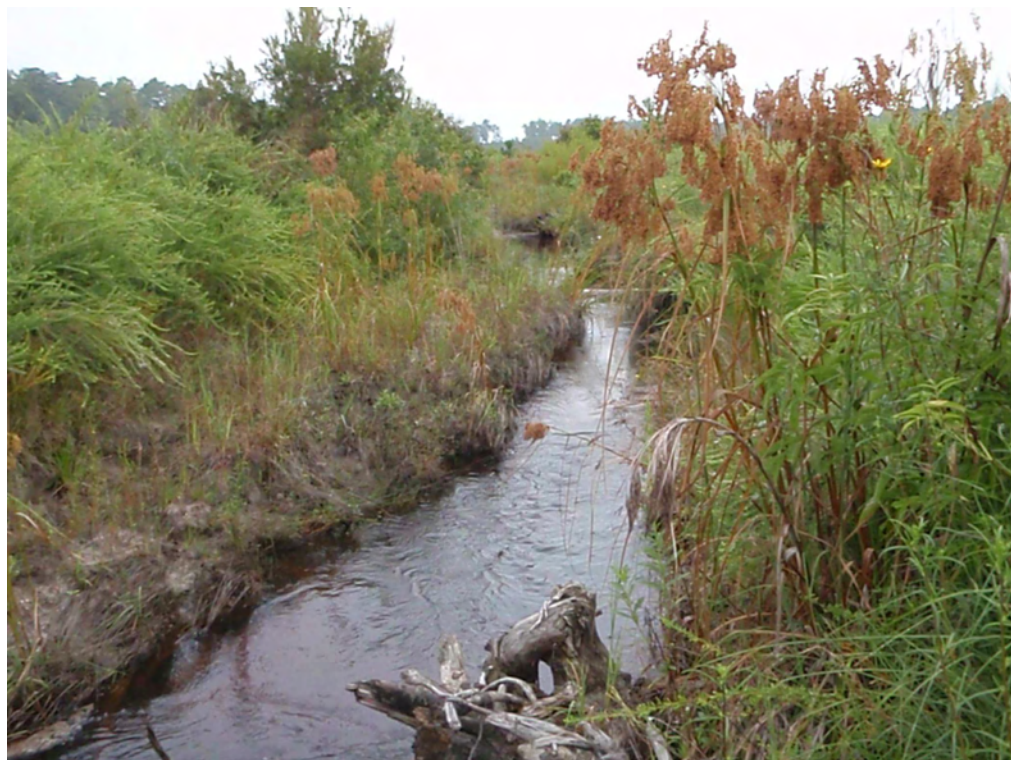
**Photo Station 8** – Cross Section 7 – looking upstream (8/26/09)

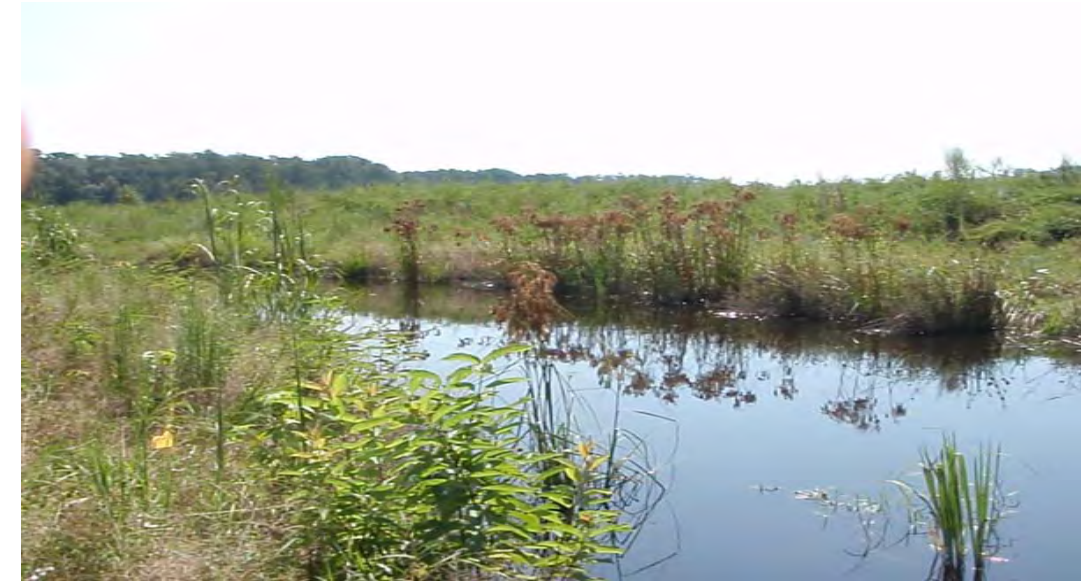
Photo of Cross-Section 1 - Looking Downstream @ STA 1+64

Year 5 - 2011	Year 4 - 2010	Year 3 - 2009	Year 2 - 2008	Year 1 - 2007	Baseline	Bench
Area			69.97	67.39	67.45	71.89	
Width			25.18	24.42	24.66	26.87	
Mean Depth			2.78	2.76	2.74	2.68	
Max Depth			4.54	4.80	4.49	4.66	
W/D			9.06	8.85	9.02	10.04

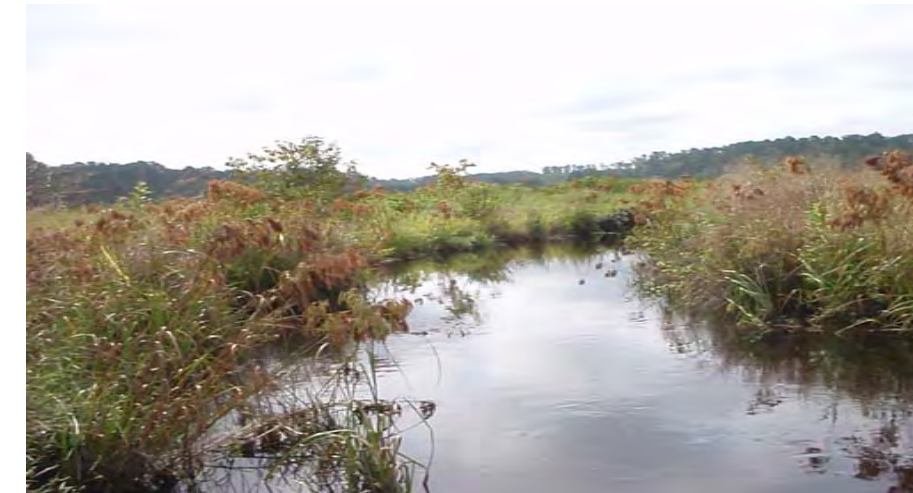
Photo of Cross-Section 2 - Looking Downstream @ STA 8+47

Year 5 - 2011	Year 4 - 2010	Year 3 - 2009	Year 2 - 2008	Year 1 - 2007	Baseline	Bench
Area			39.54	54.18	51.12	44.82	
Width			20.86	22.40	22.29	22.27	
Mean Depth			1.90	2.42	2.29	2.01	
Max Depth			3.84	4.83	4.90	4.79	
W/D			11.01	9.26	9.72	11.07

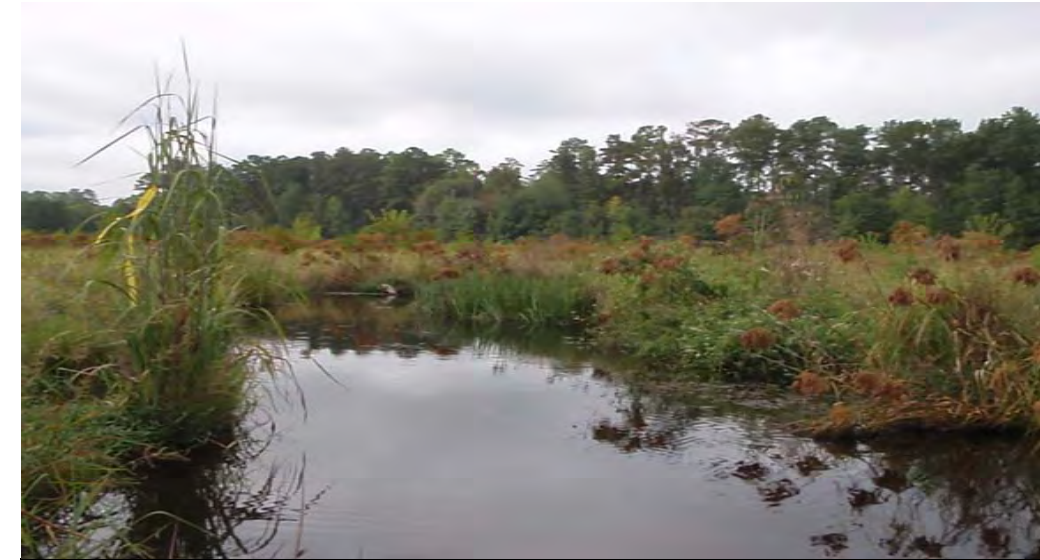
Photo of Cross-Section 3 - Looking Downstream @ STA 13+12

Year 5 - 2011	Year 4 - 2010	Year 3 - 2009	Year 2 - 2008	Year 1 - 2007	Baseline	Bench
Area			33.96	35.19	31.56	31.03	
Width			19.22	18.94	18.36	18.15	
Mean Depth			1.77	1.86	1.72	1.71	
Max Depth			2.73	2.95	2.60	2.60	
W/D			10.87	10.19	10.68	10.62

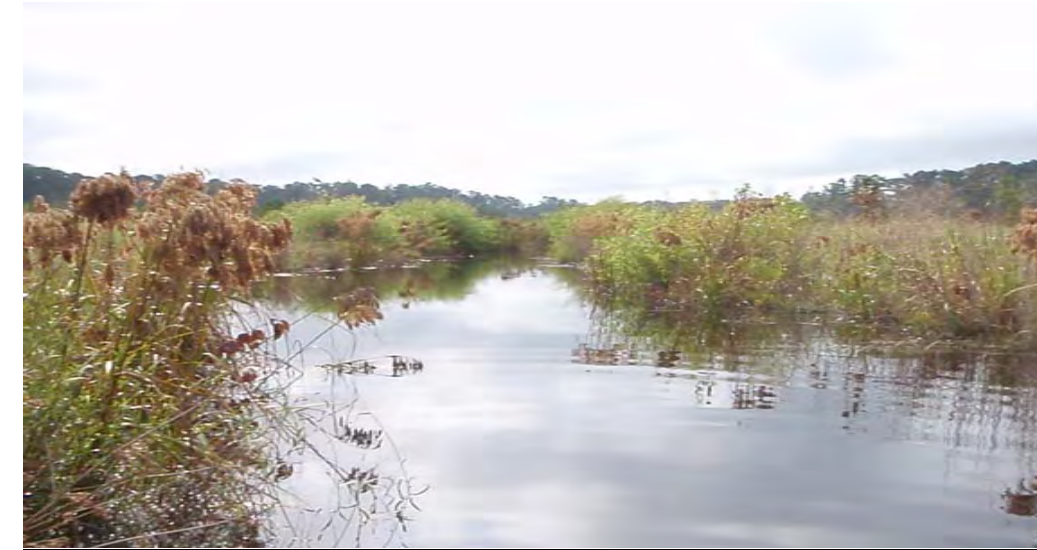
Photo of Cross-Section 4 - Looking Upstream @ STA 20+93

Year 5 - 2011	Year 4 - 2010	Year 3 - 2009	Year 2 - 2008	Year 1 - 2007	Baseline	Bench
Area			66.54	64.86	59.60	49.19	
Width			23.42	23.11	22.25	23.19	
Mean Depth			2.84	2.81	2.68	2.12	
Max Depth			5.28	5.59	5.91	4.26	
W/D			8.24	8.23	8.31	10.93

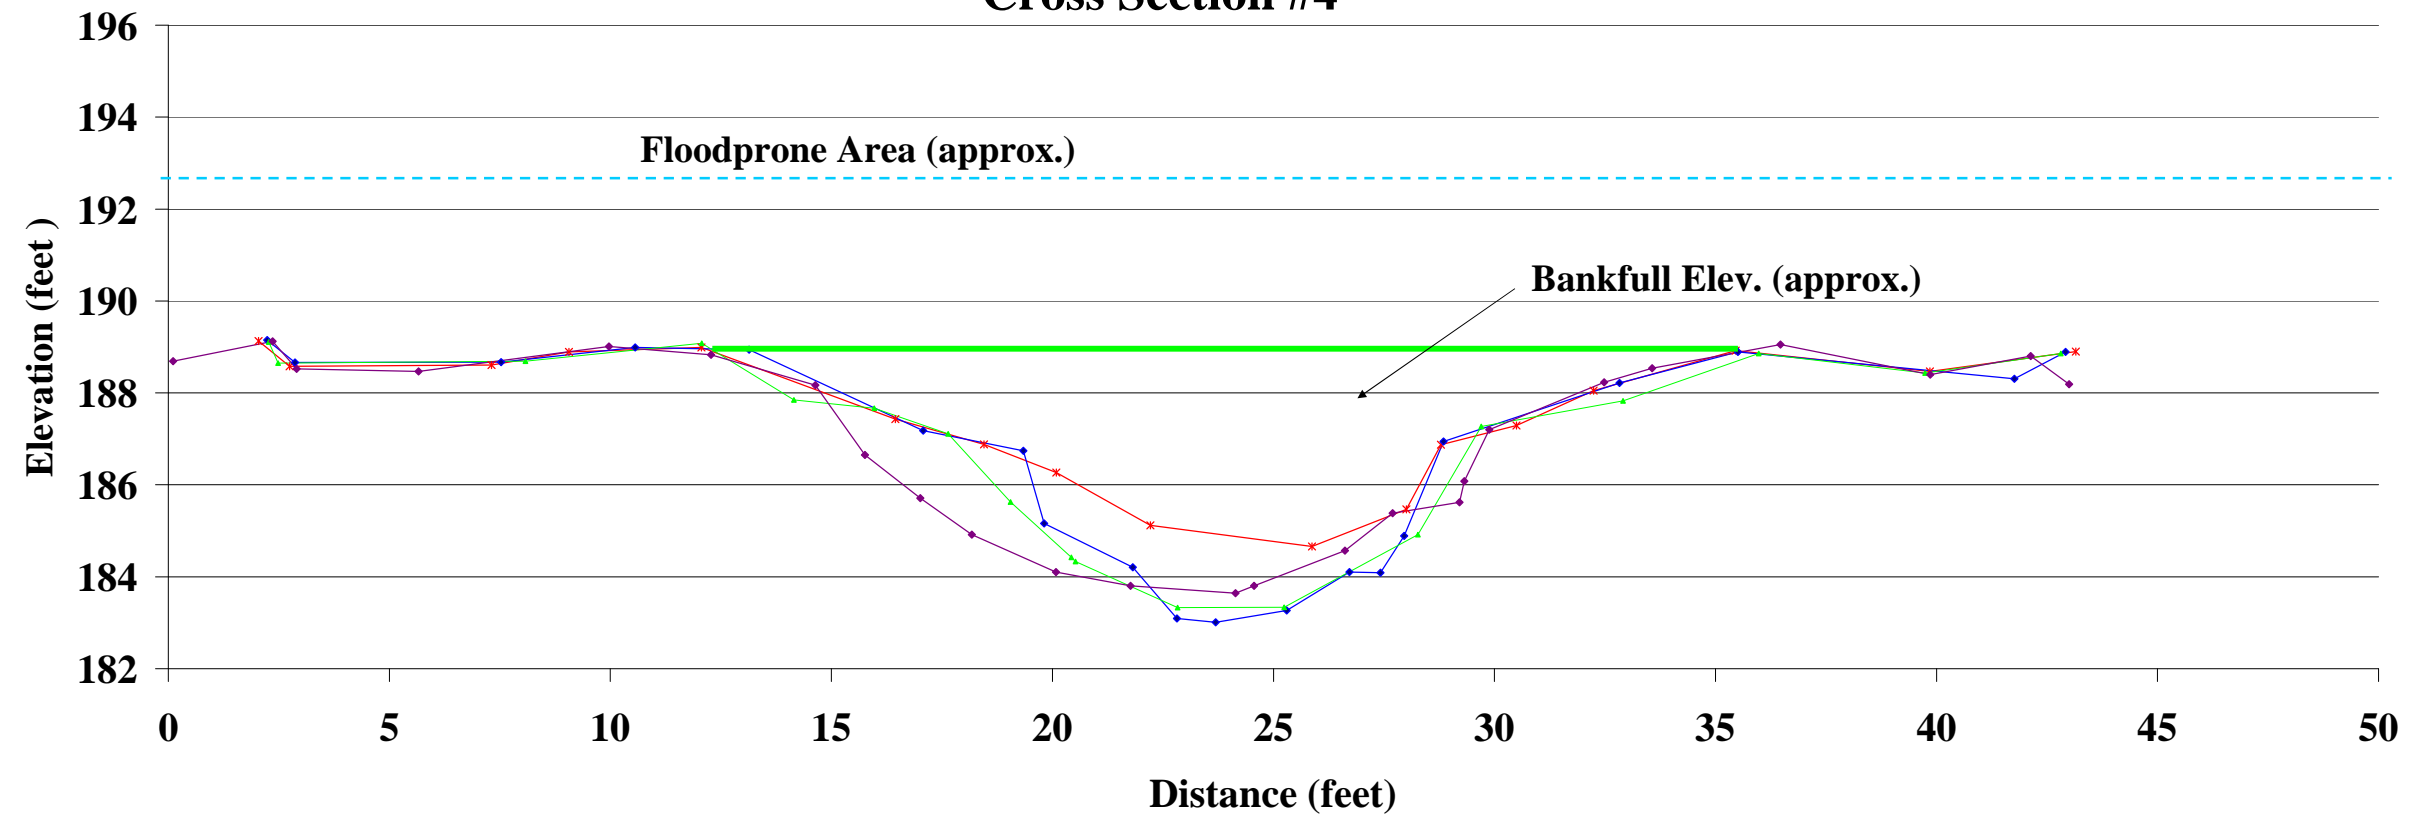
## Overhills Cross Section #4

Project Name Overhills  
 Cross Section Cross Section 4  
 Feature  
 Date As Built - 7/04/08, Year 1 - 11/09/08, Year 2 - 8/12/08, Year 3 - 8/15/09  
 Crew As Built - Bidelspach/Jean/Geenen, Year 1&2 - Geenen/Ballesterio, Year 3 - Geenen/Jean

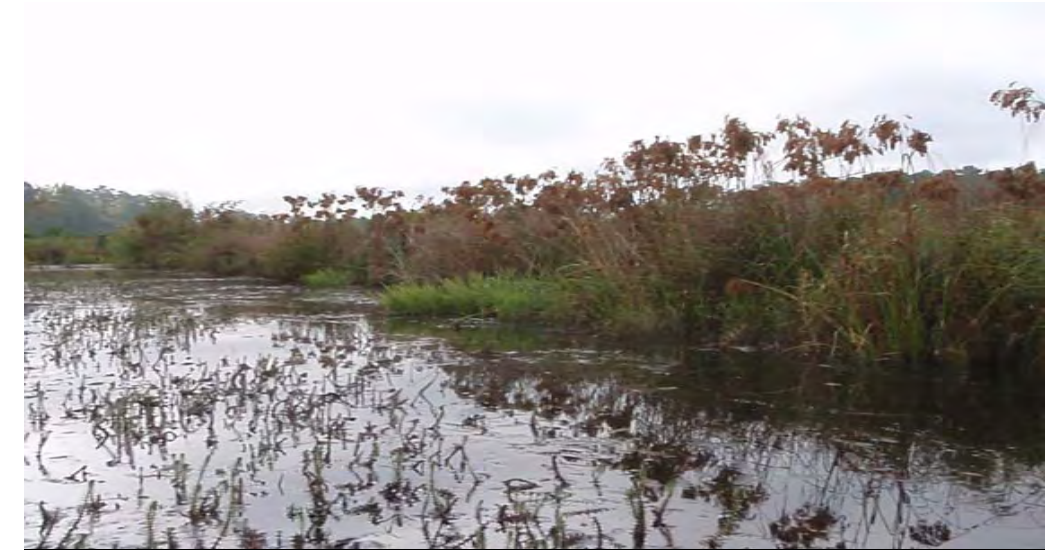
Photo of Cross-Section 5 - Looking Downstream @ STA 26+86

Year 5 - 2011	Year 4 - 2010	Year 3 - 2009	Year 2 - 2008	Year 1 - 2007	Baseline	Bench
Area			39.38	44.36	40.91	37.70	
Width			24.49	24.63	24.50	24.16	
Mean Depth			1.61	1.80	1.67	1.56	
Max Depth			2.53	2.71	2.55	2.42	
W/D			15.23	13.67	14.68	15.48

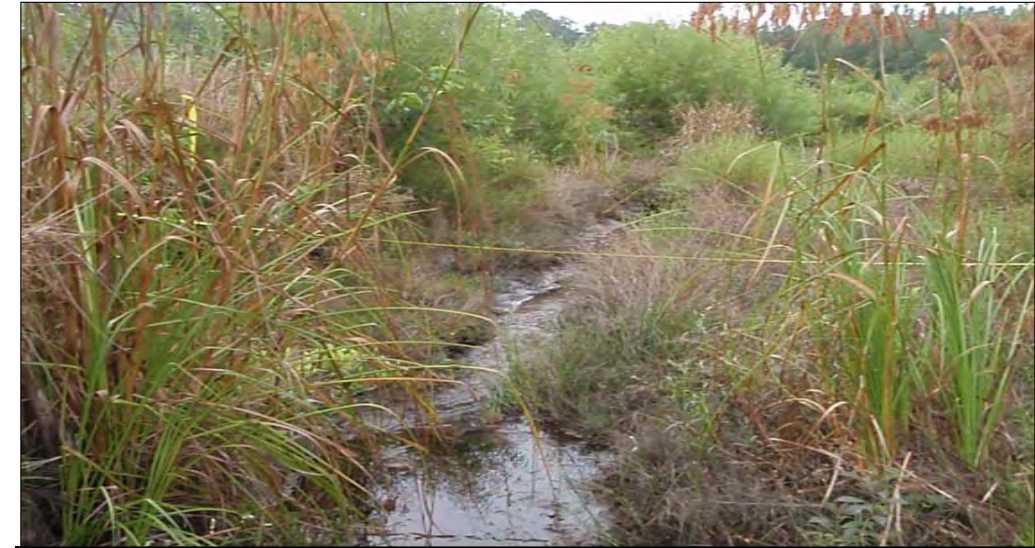
Photo of Cross-Section 6 - Looking Downstream @ STA 31+56

Year 5 - 2011	Year 4 - 2010	Year 3 - 2009	Year 2 - 2008	Year 1 - 2007	Baseline	Bench
Area			23.06	25.14	25.35	23.43	
Width			18.65	19.23	19.24	19.06	
Mean Depth			1.24	1.31	1.32	1.23	
Max Depth			2.22	2.11	2.21	1.94	
W/D			15.08	14.71	14.59	15.51

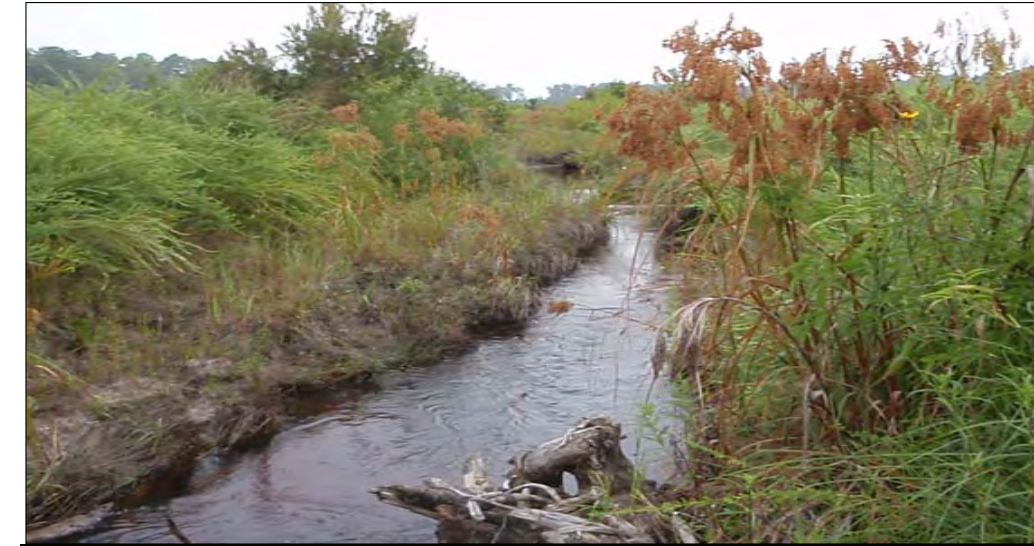
Photo of Cross-Section 7 - Looking Downstream @ STA 37+24

Year 5 - 2011	Year 4 - 2010	Year 3 - 2009	Year 2 - 2008	Year 1 - 2007	Baseline	Bench
Area			30.41	40.80	39.41	35.21	
Width			16.15	16.68	16.68	16.54	
Mean Depth			1.88	2.45	2.36	2.13	
Max Depth			3.41	4.23	3.67	3.53	
W/D			8.58	6.82	7.06	7.77

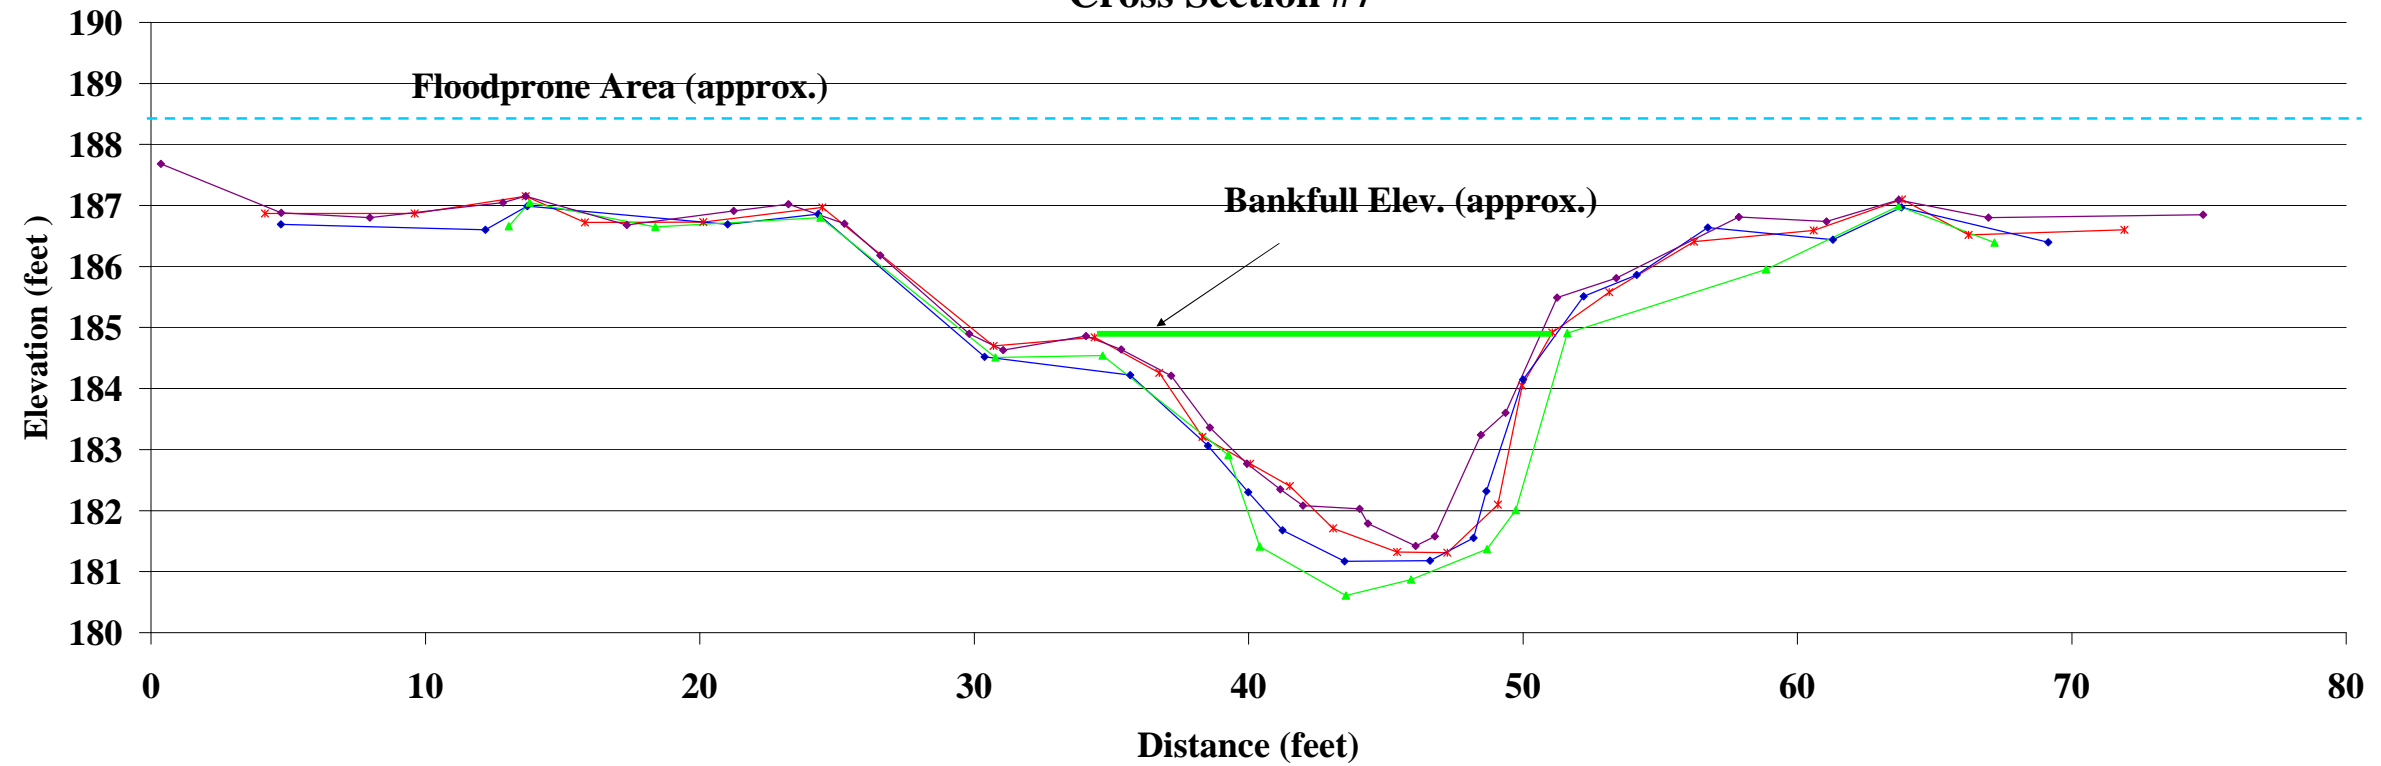
## Overhills Cross Section #7

Project Name Overhills  
 Cross Section Cross Section 7  
 Feature  
 Date As Built -7/04/08, Year 1 - 11/09/08, Year 2 - 8/12/08, Year 3 - 8/15/09  
 Crew As Built - Bidelspach/Jean/Geenen, Year 1&2 - Geenen/Ballesterro, Year 3 - Geenen/Jean

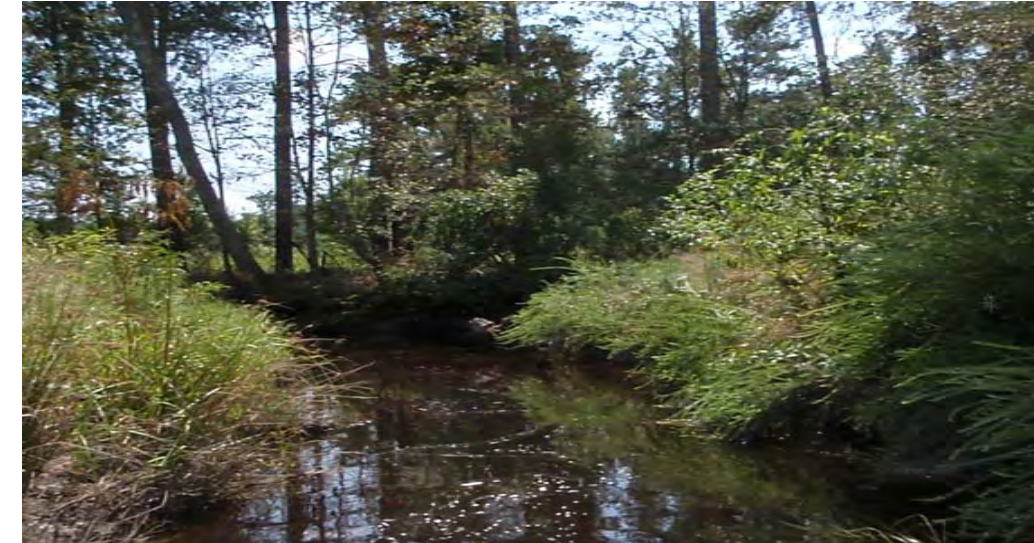
Photo of Cross-Section 8 - Looking Downstream @ STA 43+02

Year 5 - 2011	Year 4 - 2010	Year 3 - 2009	Year 2 - 2008	Year 1 - 2007	Baseline	Bench
Area			103.50	113.53	110.97	106.10	
Width			27.75	27.69	27.72	27.10	
Mean Depth			3.73	4.10	4.00	3.92	
Max Depth			6.82	6.92	7.09	7.38	
W/D			7.44	6.75	6.92	6.92

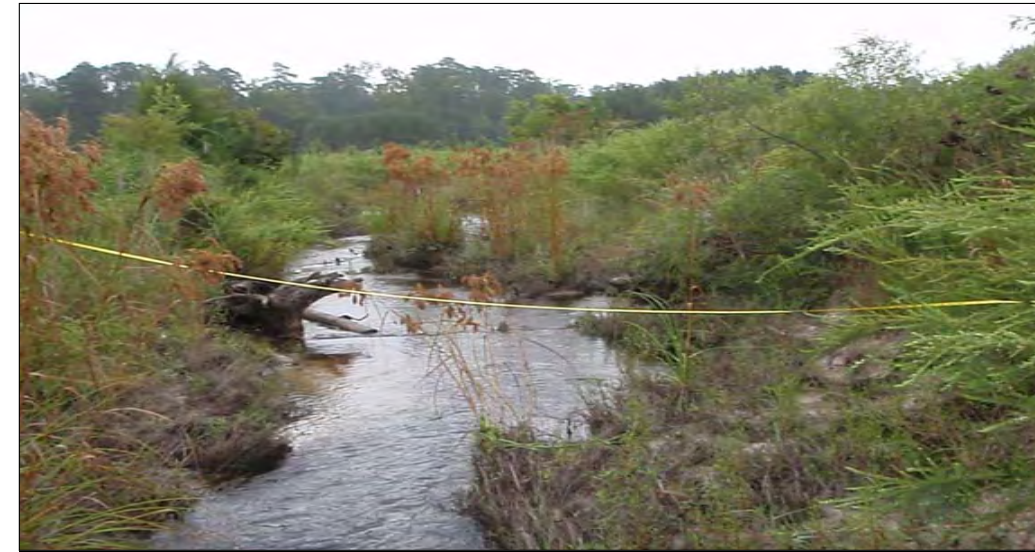
Photo of Cross-Section 9 - Looking Downstream @ STA 39+30

Year 5 - 2011	Year 4 - 2010	Year 3 - 2009	Year 2 - 2008	Year 1 - 2007	Baseline	Bench
Area			64.11	62.93			
Width			24.64	26.71			
Mean Depth			2.60	2.36			
Max Depth			5.00	4.99			
W/D			9.47	11.34

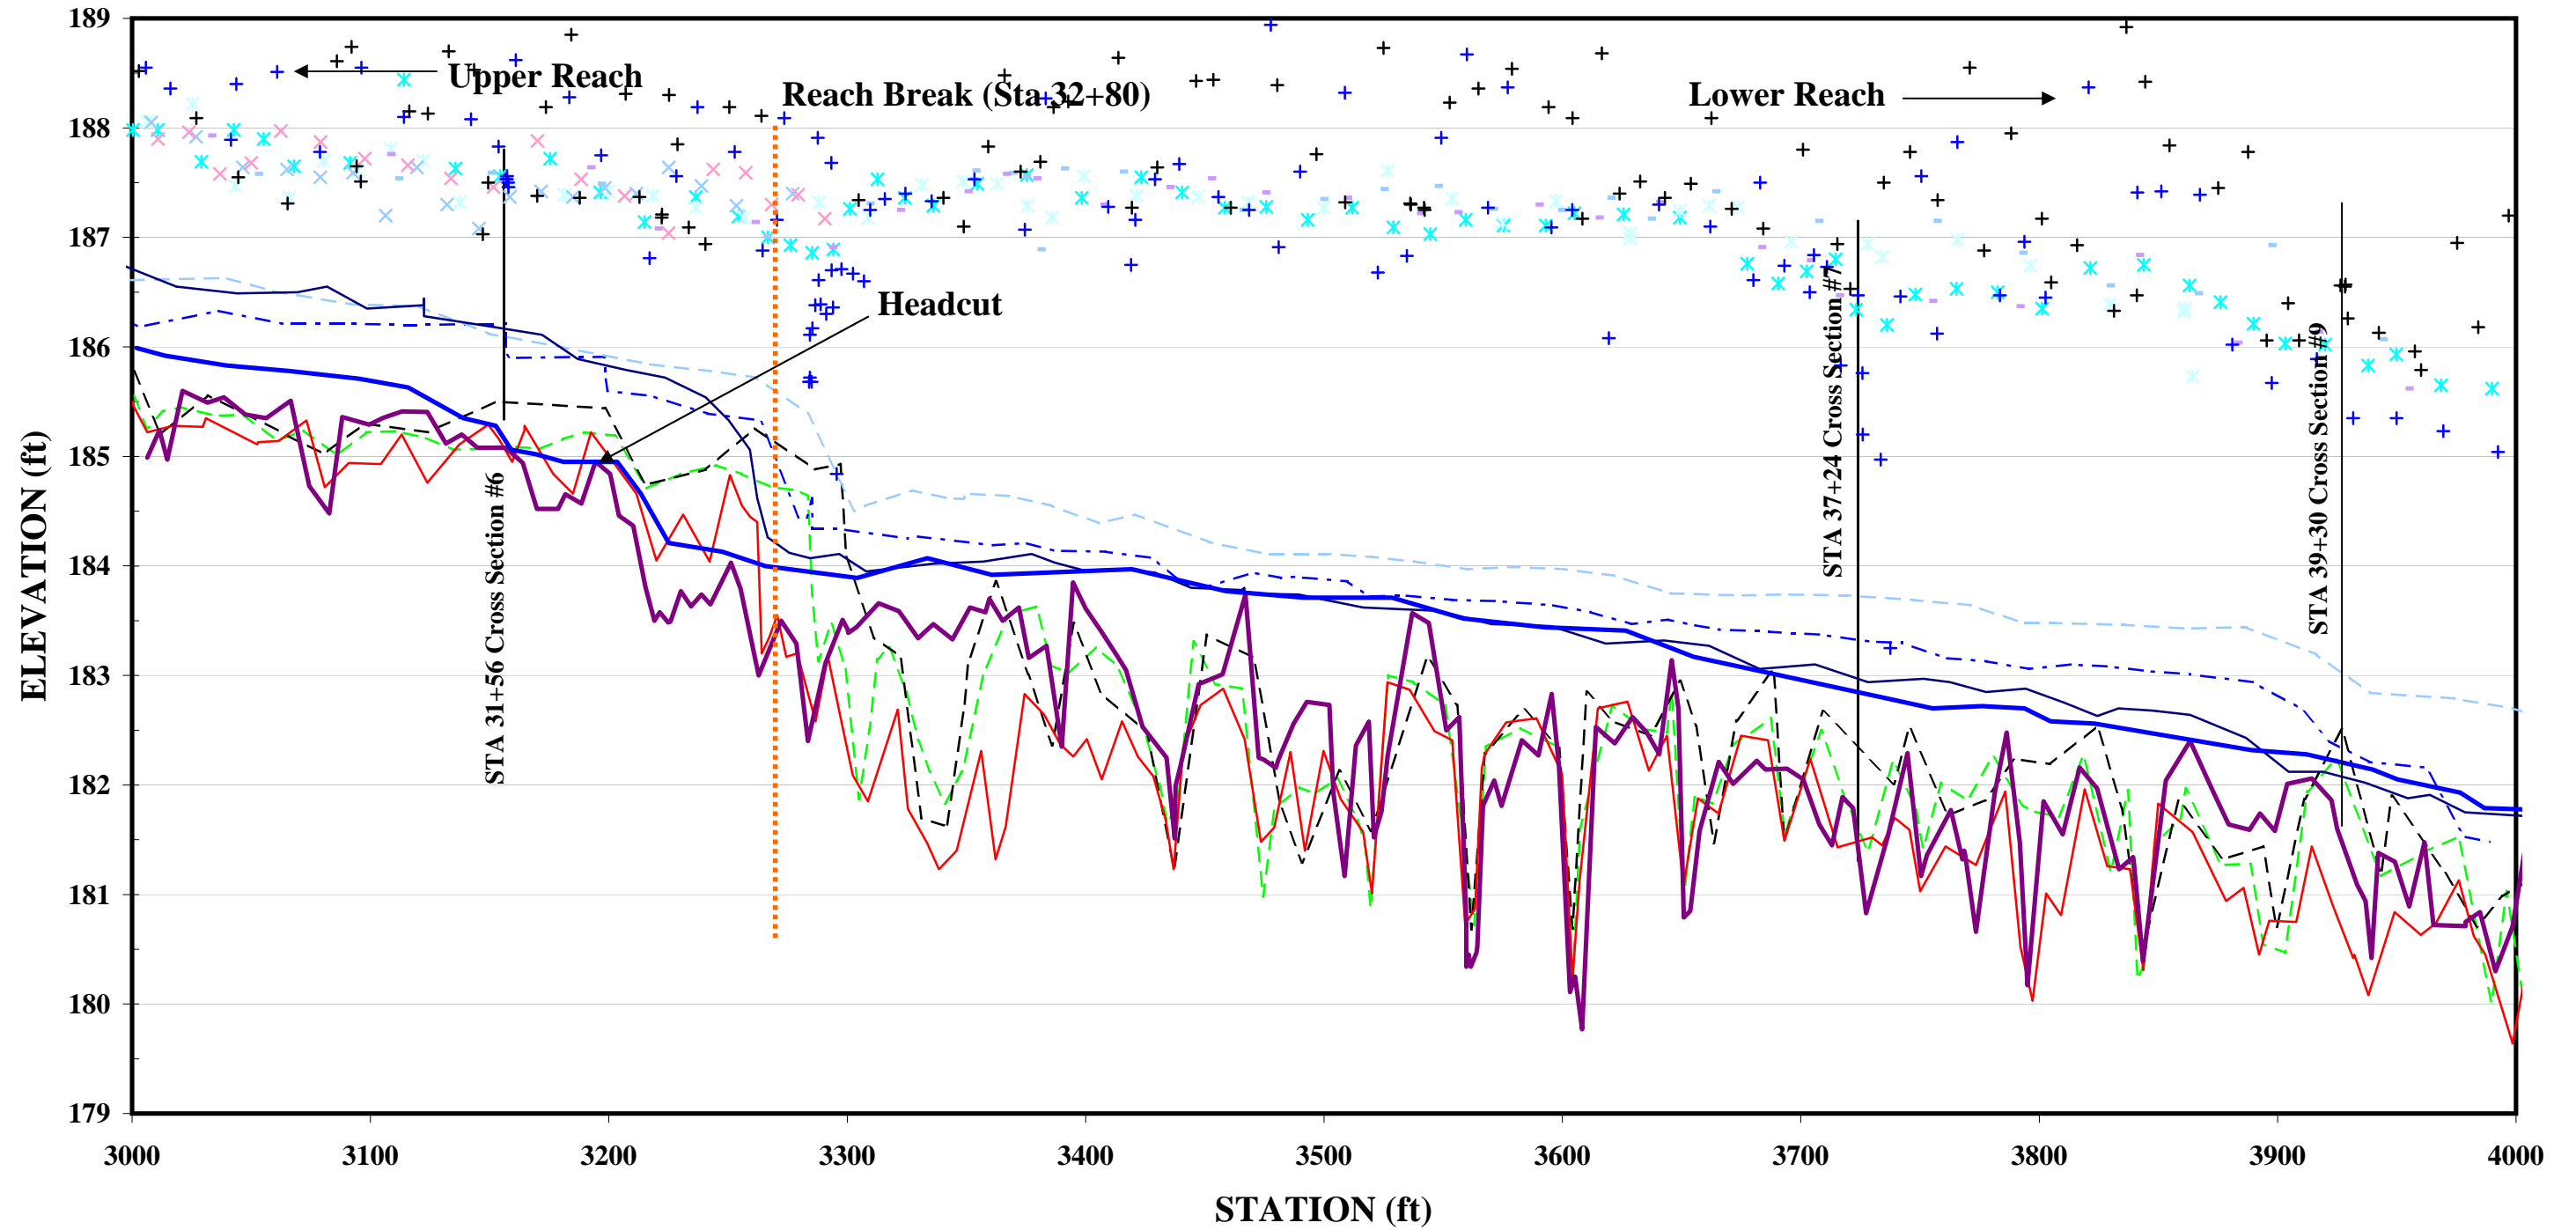
**Overhills Profile - Upper & Lower Reaches**  
**STA 30+00 - STA 40+00**  
**2009 MONITORING - Year 0, Year 01, Year 02, Year 03**
