OVERHILLS STREAM AND WETLAND  
RESTORATION MONITORING REPORT (YEAR 3 OF 5)  
Harnett County, North Carolina  
EEP Project No. 199

Status of Plan: Final  
Submission Date: November 2009

# Current Condition Plan View

#### EEP Project Number 199

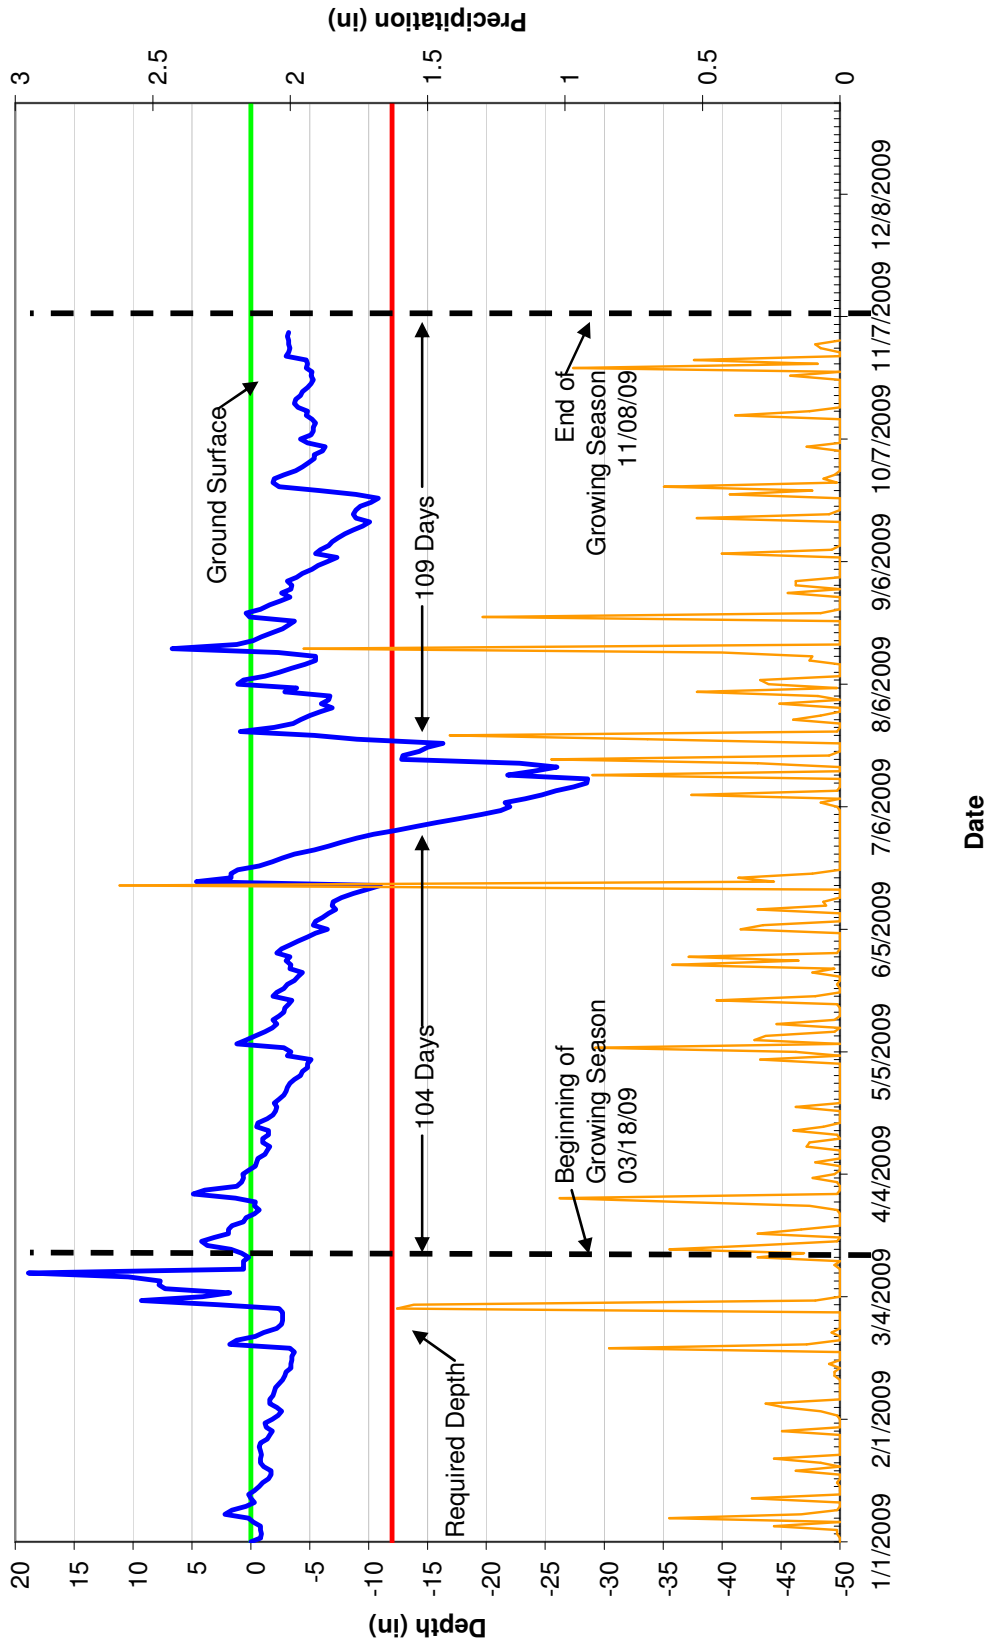
**2009 Groundwater Data  
Reference Well 1 (SN: 00000EBD001B)**

The reference well met the success criteria, with two relatively long periods of consecutive days of saturation within 12 inches of the ground surface (104 and 109 days respectively). This 213 day period comprises approximately 91% of the growing season. Additionally, all fifteen groundwater monitoring wells onsite met the success criteria, with 7 of the wells being within 12 inches of the ground surface for 100% of the growing season. Monthly precipitation averages for 2009 fell between the 30<sup>th</sup> and 70<sup>th</sup> percentiles during the growing season in March, September, and October. For the months of January, April, June, and November, precipitation fell below the 30<sup>th</sup> percentile. For the months of February, May, July, and August, precipitation fell above the 70<sup>th</sup> percentile.
