FINAL MITIGATION PLAN

**Junes Branch
Jackson County, North Carolina
Project No. 95027**

**Little Tennessee River Basin
Cataloging Unit 06010203**

April 2013

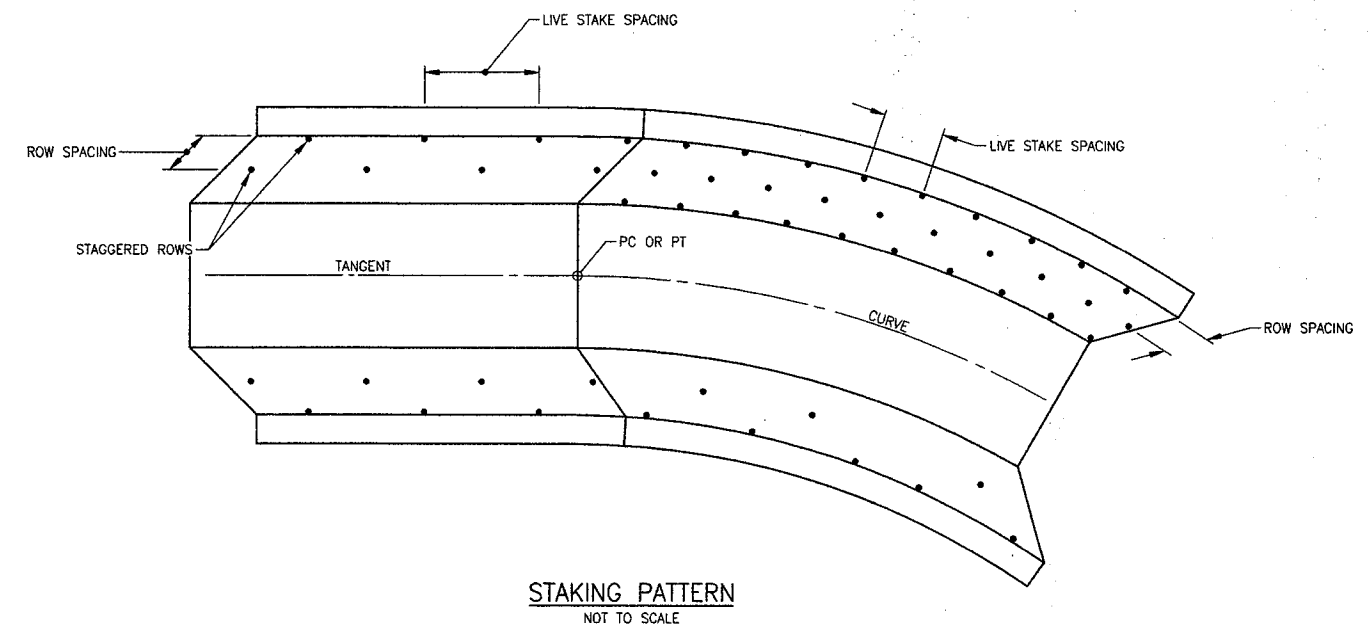
SCALE: AS NOTED	DESIGN BY: cme	PROJECT NO.: 1049	DRAWING NUMBER: P-1
DATE: 12/12/2012	CHECK BY: SGG		
DATE:	BY:	REV:	DESCRIPTION:

- PLANTING NOTES:**
- TEMPORARY AND PERMANENT SEED
- ALL DISTURBED AREAS WILL BE STABILIZED USING MULCH AND TEMPORARY SEED TO PROVIDE ADEQUATE GROUND COVER AND CONDITION THE SOIL.

1. Revised permanent seed mix: Appendix D, Sheet P-1, Permanent Seeding Table
2. Revised Performance Standards:
 - Page 31, Paragraph 1, revised first sentence to reference USACE Stream Mitigation Guidelines (2003).
 - Page 31, Paragraph 2, Deleted reference to Entrenchment Ratio requirements.
 - Page 31, Paragraph 6, Added statement that bankfull events must happen during separate monitoring years.
3. Revised Doris Branch alignment to provide more than 30' buffer: Appendix D, Sheet 10.
4. Added statement that wetland areas will be protected by fence during construction: Page 26, Paragraph 6.
5. Revised background aerial image to remove barn that no longer exists:
 - Appendix D, Sheet 1A
 - Page 29, Figure 7

- The reviewer states that the permanent seed mix contains exotic species. The seed mix included in this project is not the standard native mix that we have used in the past. This seed mix was directed by EEP on our last EEP project (Middle South Muddy Creek). There were no unusual soil conditions on that project so my understanding was that this was the preferred seed mix by EEP and was therefore carried over to this project. If this is not the case we would recommend a permanent seed mix containing Broom Sedge, Deer Tongue, Switch Grass, Indian Grass, Eastern Gama Grass and Joe-Pye-Weed.

- I had a productive and interesting discussion with Grant Ginn regarding Bumgarner Branch. The design dimension for this reach is supported by the regional curves, and the proposed design is supported by DWQ. DWQ maintains the recommendation that the permanent seeding mix consist of native riparian species, and not the list proposed in the draft plan.
