# ANNUAL REPORT FOR 2004

**Key Branch Mitigation Site**  
**Anson County**  
**WBS Element 34398.4.1**  
**TIP No. R-2239WM**

Office of Natural Environment & Roadside Environmental Unit  
North Carolina Department of Transportation  
December 2004

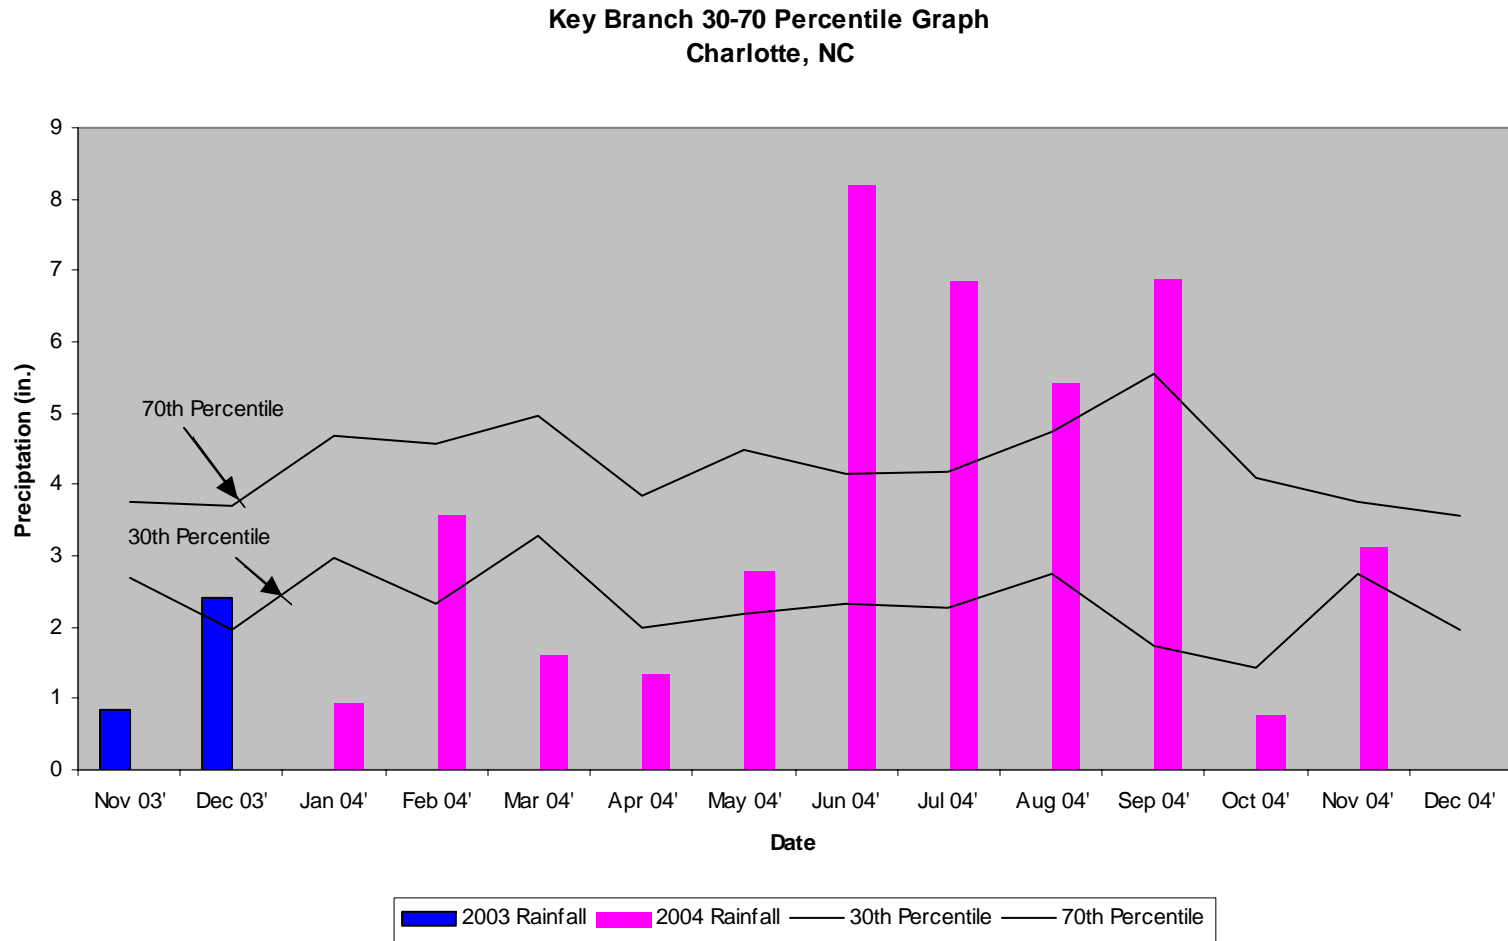
**Figure 4: 30-70 Percentile Graph**

Figure 4 is a comparison of 2003 and 2004 monthly rainfall to historical precipitation for the area. This comparison indicates whether 2004 was “average” in terms of climate conditions by comparing the rainfall to that of historical rainfall (data collected between 1973 and 2004). The NC State Climate Office provided all historical data.

For the 2004-year June, July, August and September experienced above average rainfall. The months of November (03'), January, March, April, and October recorded below average rainfall for the site. December (03'), February, May, and November experienced average rainfall. Overall, 2004 experienced an average rainfall year (with a drier than average spring and wetter than average summer and early fall).

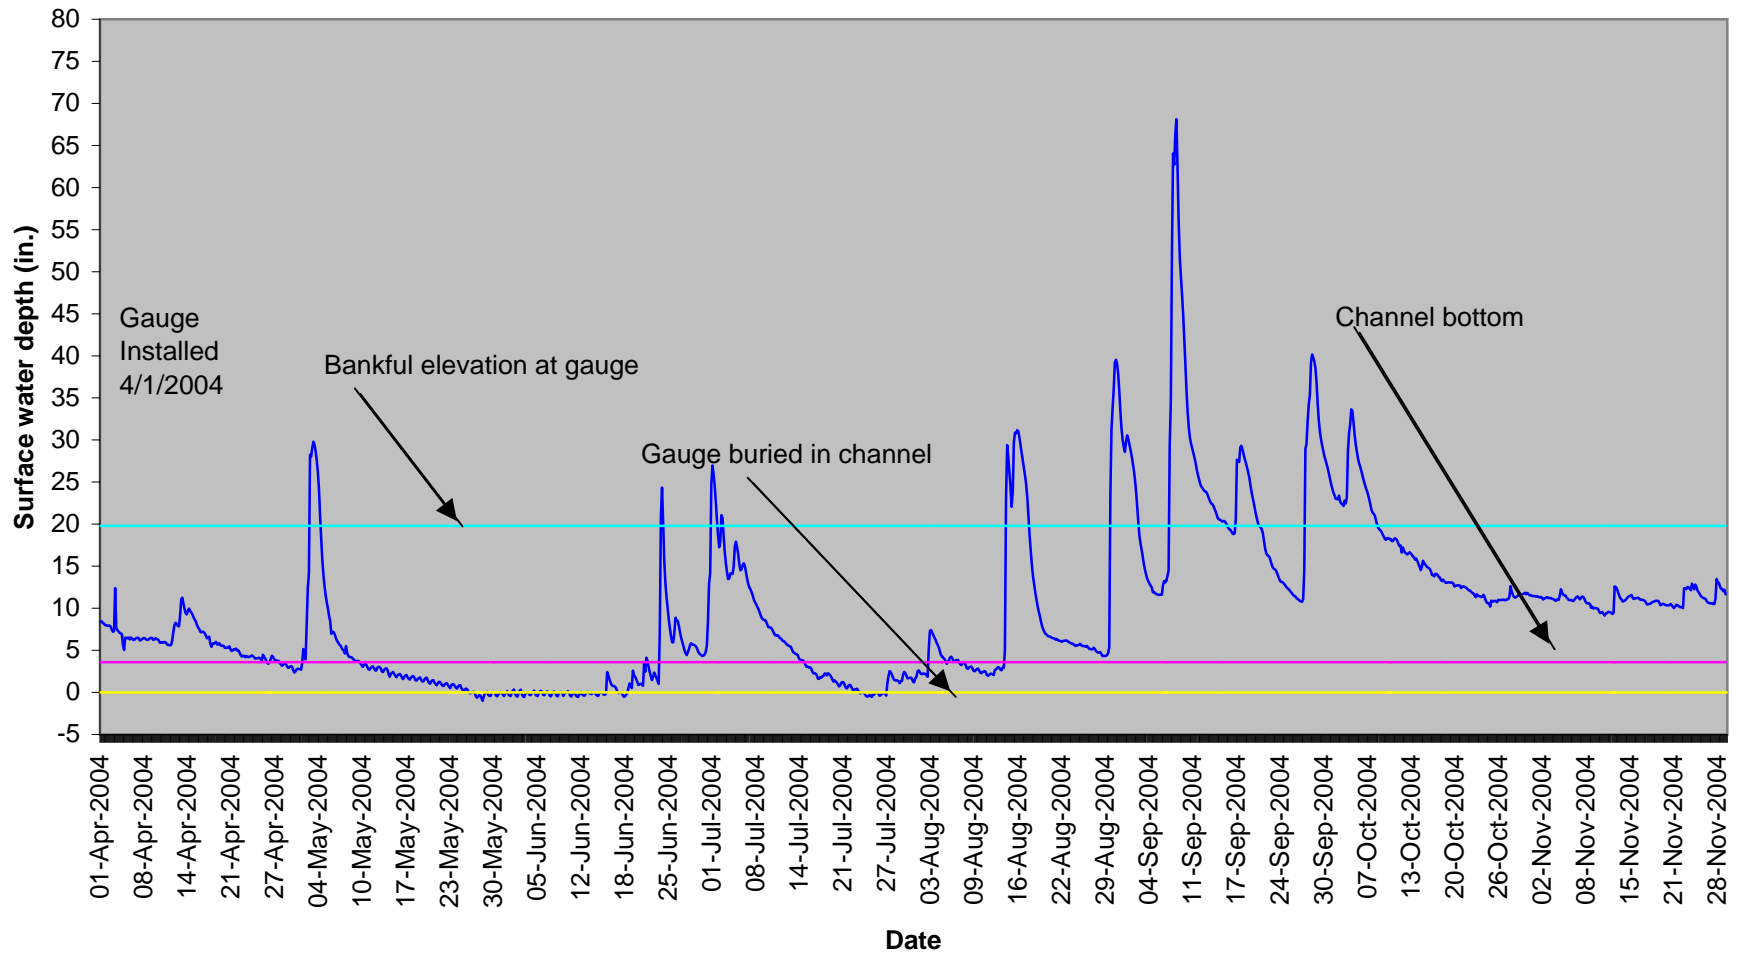
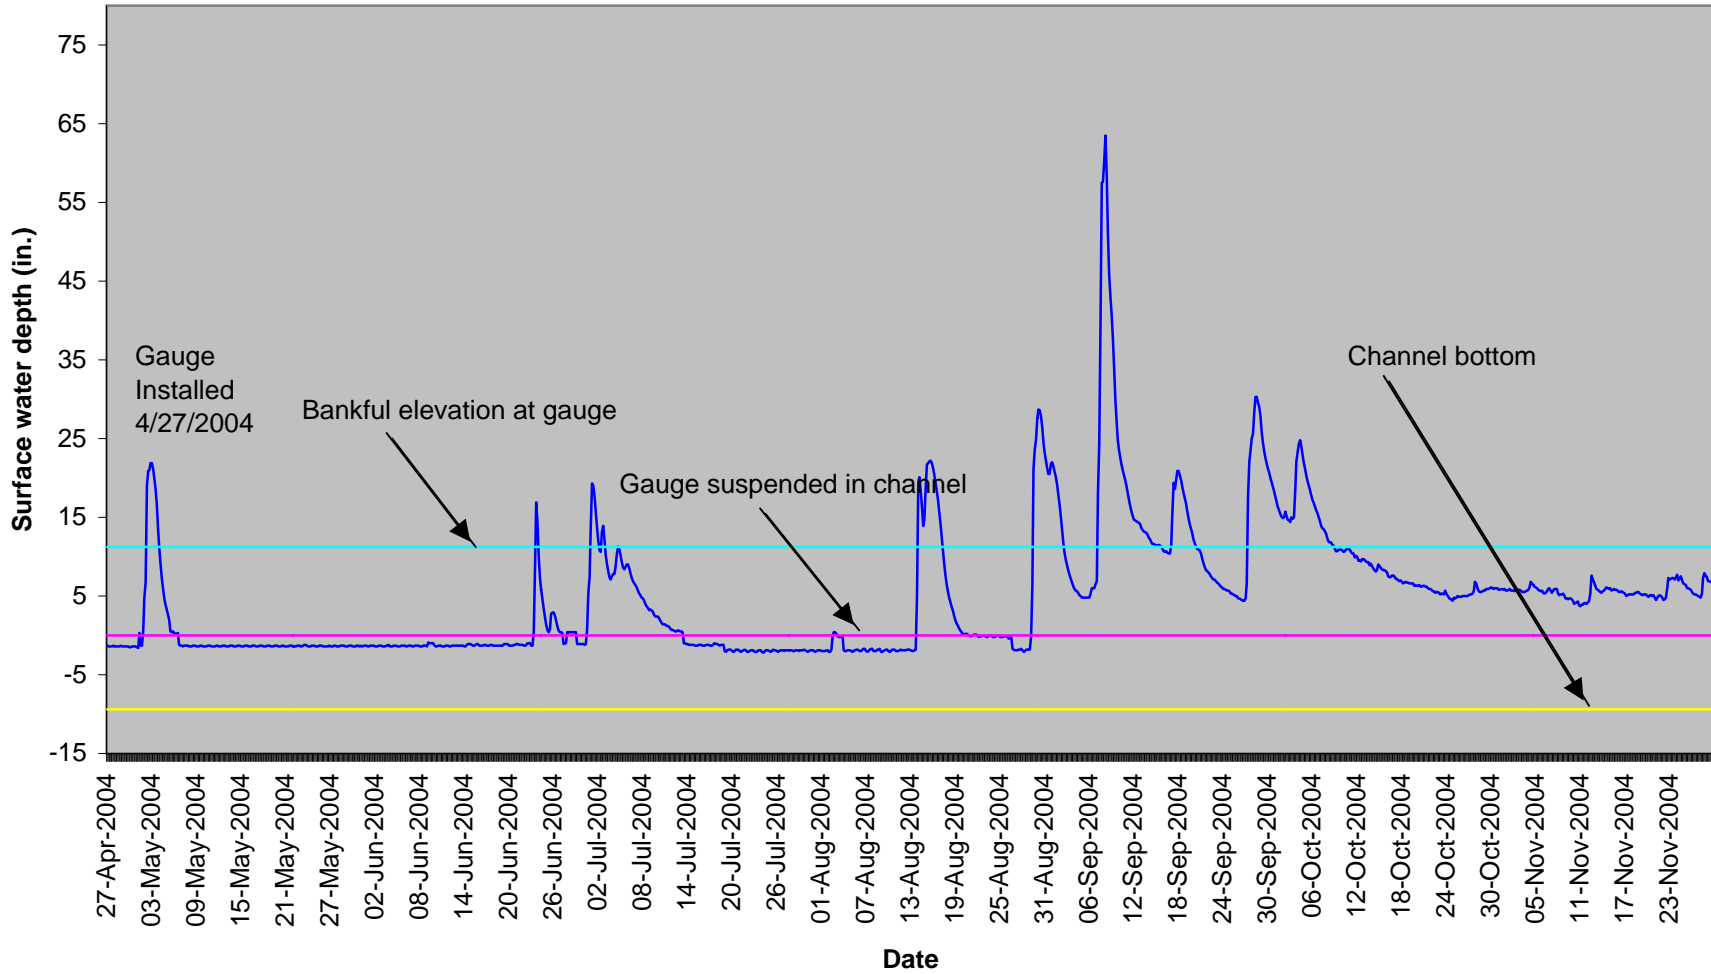
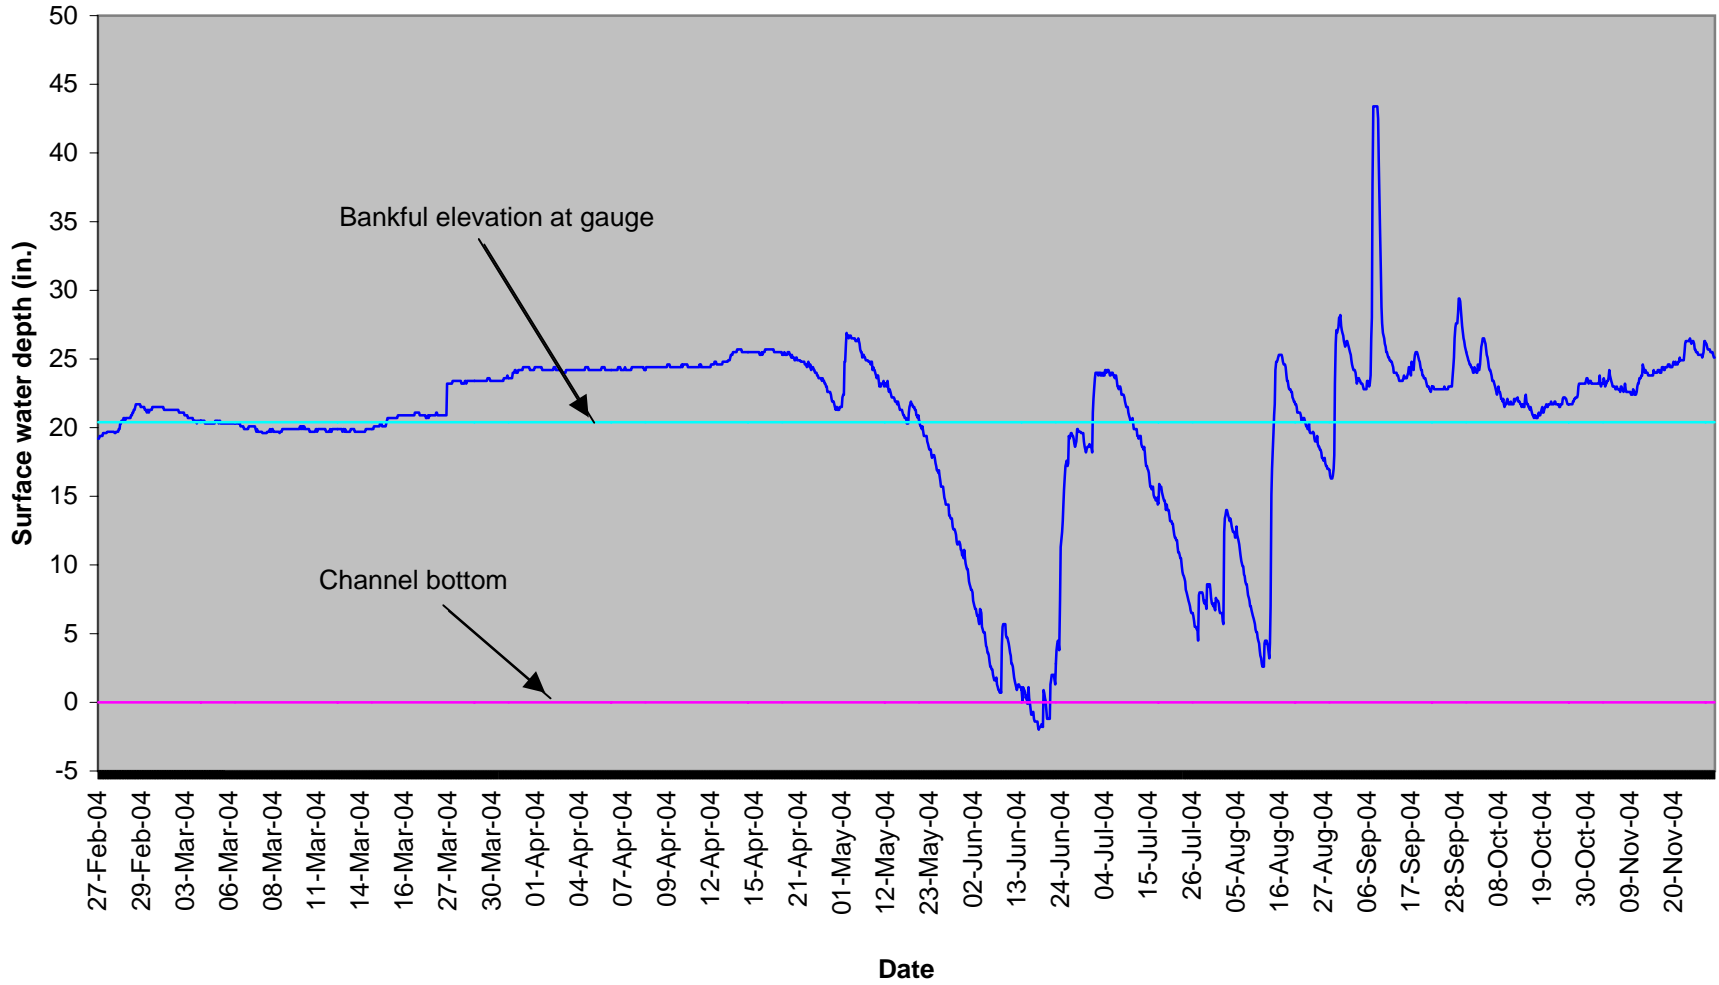
Appendix A contains charts of the water depth for each groundwater and surface gauge. Precipitation is shown on each graph as bars. These graphs show the reaction at each monitoring location of the groundwater level to specific rainfall events. The maximum number of consecutive days is noted on each graph.
