ANNUAL REPORT FOR 2007

Monitoring Year 4

Key Branch Mitigation Site
Anson County
WBS Element 34398.4.1
TIP No. R-2239WM

November 2007

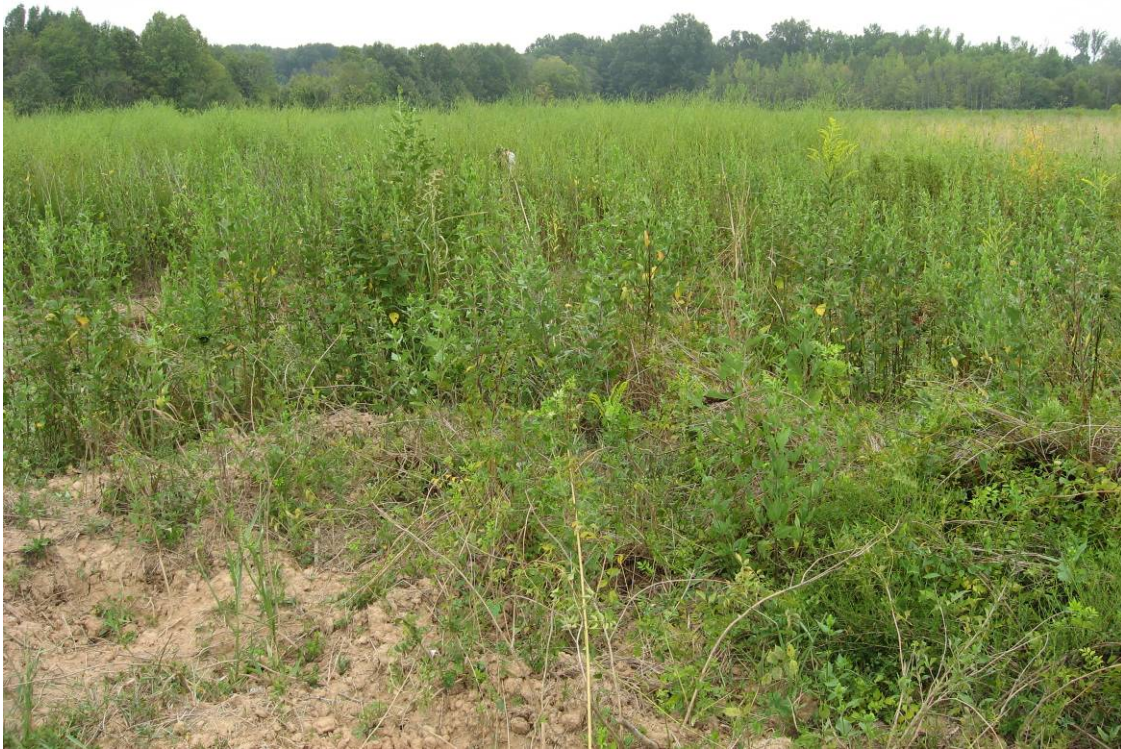
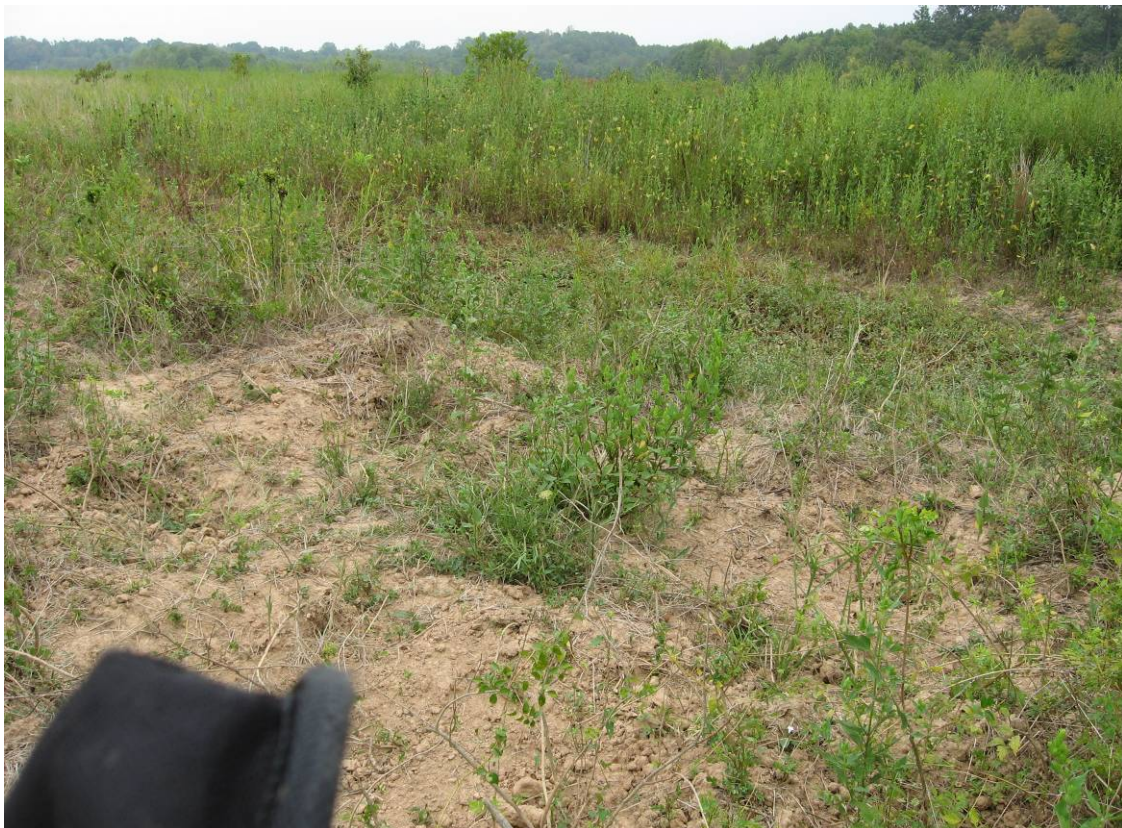
Streamside Boar Wallow Pits, Station 15+70-16+00 – 9/13/2007

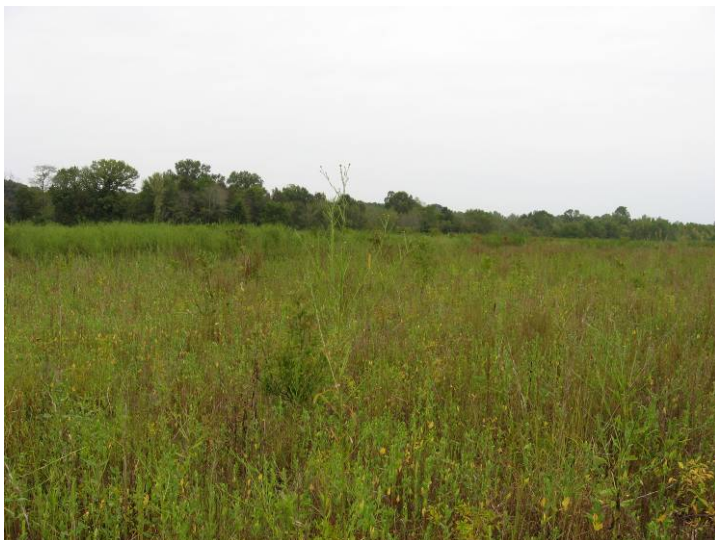
Plot 7 9/12/2007

Stem counts were low in plots 7, 8 and 12. Within the three plots, herbaceous cover was 100% and generally a monoculture existed with little to no diversity (plot photos are provided in Appendix B). There was no observed explanation the day of the survey for the low stem counts. In 2005 riparian plot placement was established through random selection; a comparison of these plots year on year revealed that both plots 7 and 8 had low stem counts from Monitoring Year 2 (2005) forward. Plot 12 had 8 silky dogwood (*Cornus amomum*) in Monitoring Year 2, but since then it appears many have been lost. Four-foot aster that appears to be taking over plot 12 has likely outcompeted them.
