Key Branch Wetland and Stream Restoration Site Year-5 Annual Monitoring Report (2008)

**Anson County, North Carolina
WBS Element 34398.4.1
TIP No. R-2239WM**

APRIL 2009

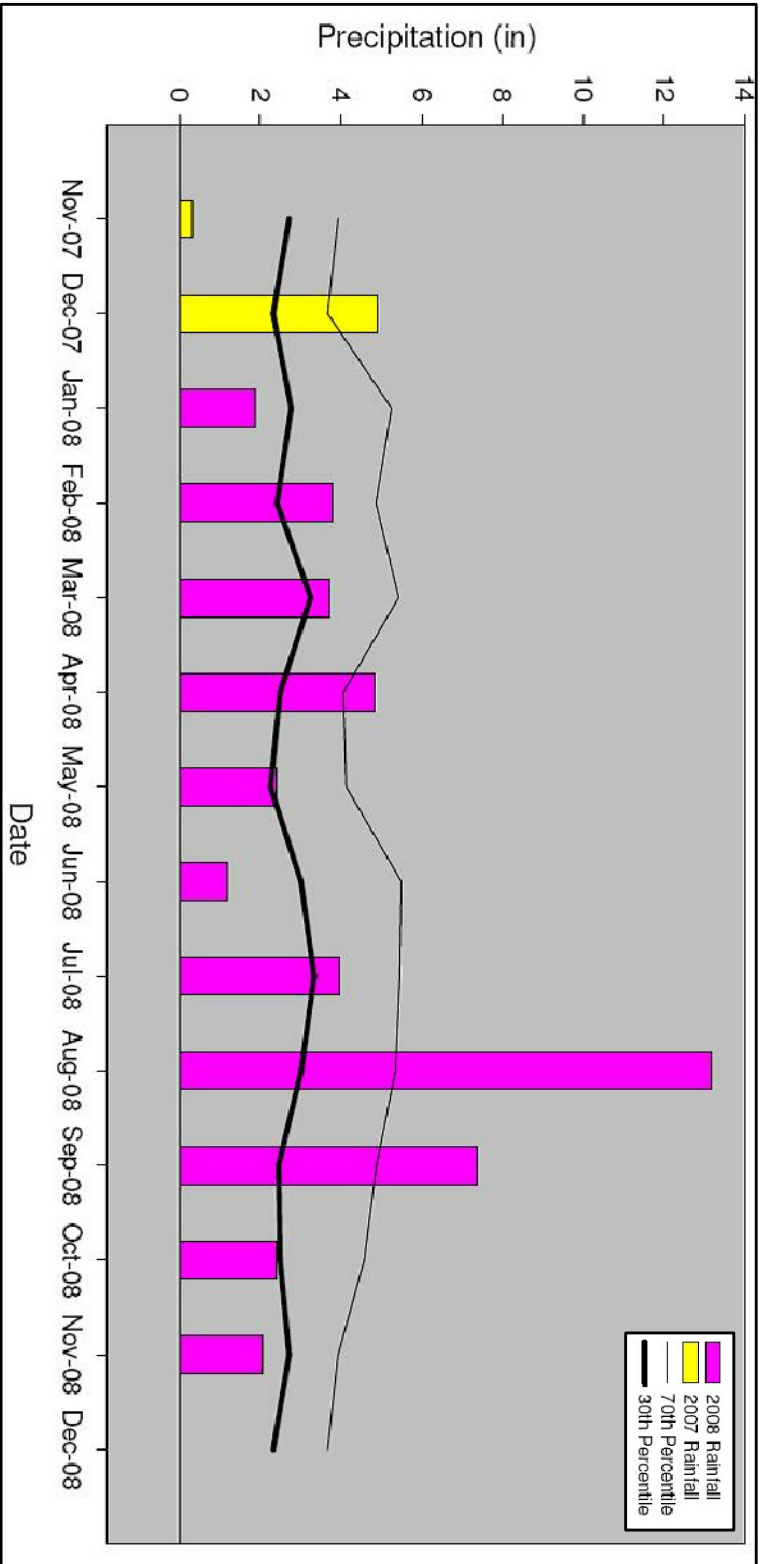
SHEET
 3

Figure 3 shows a comparison of 2008 monthly rainfall to historical precipitation for the area. This comparison indicates whether 2008 was “average” in terms of climate conditions by comparing the 2008 monthly rainfall to that of historical monthly rainfall. The figure averages all rainfall data collected between 1948 and 2008 and compares the monthly amounts below which 30 percent and 70 percent of all observations may be found with the actual 2007 monthly rainfall amount.

The Site experienced four months of above average rainfall: December 2007, and February, April, August, and September 2008. March 2008 was within one inch of the March average. The rest of the months experienced above-average rainfall ranging from 0.23 to 8.75 inches above normal. Overall, 2008 averaged 3.94 inches above average rainfall for the year.

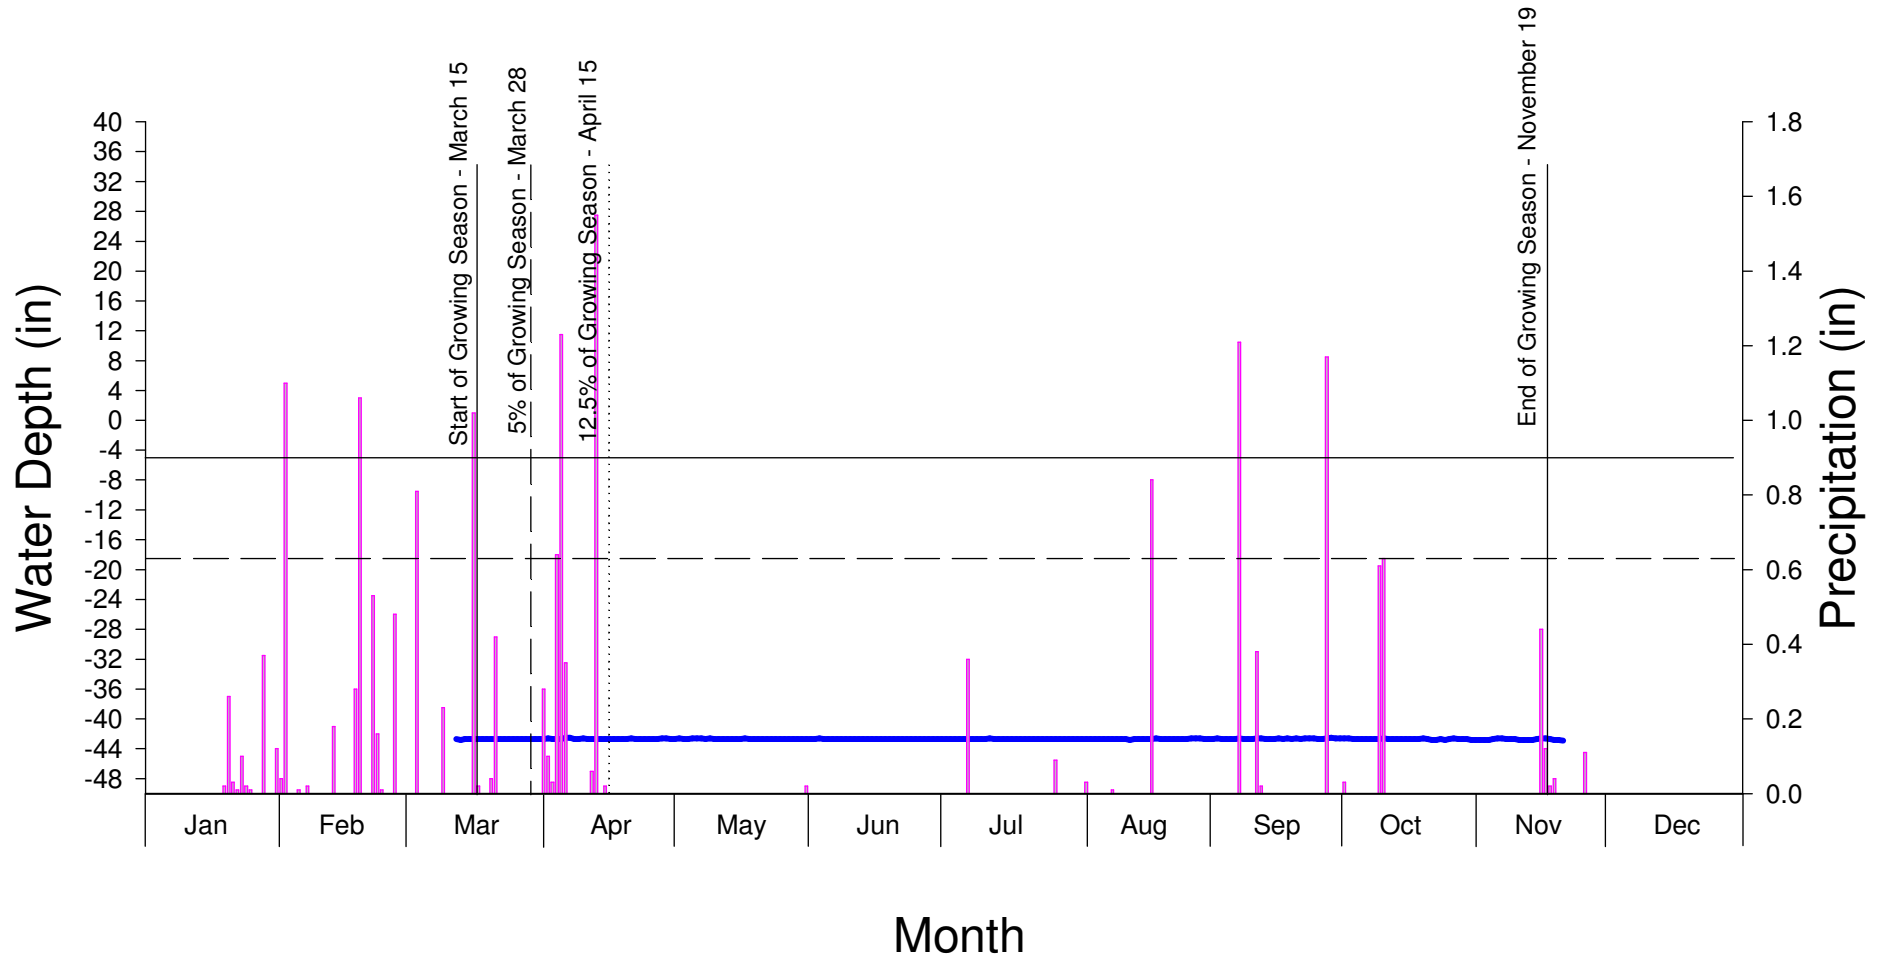
Key Branch 2008 Monitoring Gauge 9 - A28A3CC

Appendix B contains hydrographs of the water depth for each groundwater gauge. In general, groundwater levels show a typical pattern of flooding or high water table during the winter to early spring, followed by a summer and early fall drawdown period, punctuated by peaks of associated precipitation events. The hydrologic monitoring results of the groundwater gauges are illustrated in Figure 2.

Eight of the thirteen groundwater-gauges monitored in 2008 met the success criteria for jurisdictional hydrology (saturation within 12" of the surface for greater than 12.5 percent of the growing season). An additional four gauges measured saturation within 12" of the surface between 5 percent and 12.5 percent of the growing season. Only one gauge, KBMG9, never recorded surface saturation during the growing season.
