FINAL MITIGATION PLAN

KEY MILL MITIGATION SITE

Surry County, NC
NCDEQ Contract No. 7180
DMS ID No. 100025

Yadkin River Basin
HUC 03040101

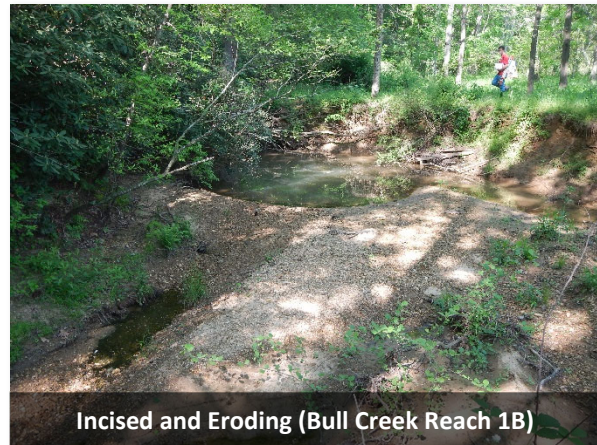
Reach 1A enters the Site from the west as a perennial stream. The valley at the upstream extent is confined but gently sloping, 1.0%. Bull Creek Reach 1B begins several hundred feet below the upstream extent of the project where the valley becomes wider, the stream becomes confined along the right valley toe, and the left floodplain land use transitions to open, actively grazed pasture. In this area, there is an old barbed wire fence that previously prohibited cattle access to the stream. The fence has not been maintained allowing cattle full access to Bull Creek as evidenced by a path along the left top of bank with regular trails down to Bull Creek. Valley slopes increase going downstream with a slope of 2.7% along Bull Creek Reach 2. Bank height ratios range from 3.7 to 4.1 with width to depth ratios of 14.1 to 16.8, indicating severe incision. Bull Creek has cut down to the bedrock layer and bedrock seams are exposed along the stream bed at regular intervals within these upper reaches. Riffles are present along the bedrock seams and pools are shallow and created by backwater as opposed to scour. Bedrock exposure is also common along the right toe of slope due to the location of the creek along the right valley toe. Bank erosion along these reaches consistently alternates between the left and right bank. Bed material along this reach consists of gravel, cobble, small boulders, and fines from bank erosion. Riffle cross-sections (XS1 and XS3) from these reaches classify the stream as a Rosgen F3.

Just upstream of Key Road, the concrete footers and stacked stone remnants of an old mill dam remain along the creek banks as well as timbers in the creek. The dam was hand stacked by a Key family ancestor. To avoid impacting this historical structure and to not restrict future activities associated with this structure, no restoration activities will occur within this reach. However, this area will be fenced to exclude livestock from accessing the stream except during times in which cattle are moved between pastures. The stream flows under Key Road crossing through two 60-inch corrugated metal pipes.

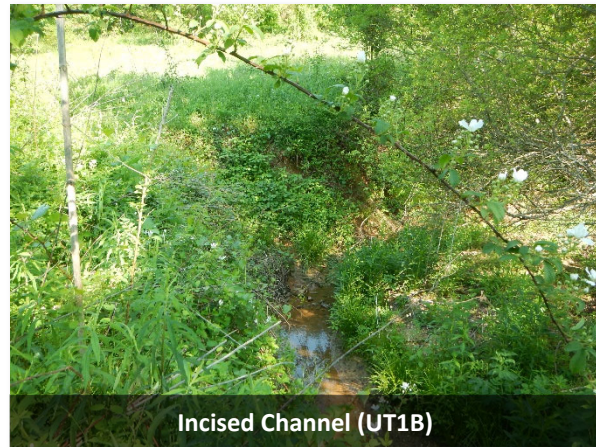
UT1A originates as a perennial stream outside of the conservation easement. Upstream of the Site, above Loblolly Lane, the stream is in good condition with stable banks, excellent pattern and bedform, and abundant habitat. UT1A enters the Site under a fence separating forest from cattle pasture. This reach contains limited riparian buffers, areas of bank erosion, and a grass road is present in the left floodplain. An existing 24" reinforced concrete pipe culvert crossing is present approximately 100 LF downstream of the Site boundary. A sediment bar upstream of the culvert crossing suggests that the culvert is clogged and serves as a sediment transport barrier in its current condition. Additionally, the culvert is perched downstream of the crossing. The grass farm road crosses the culvert and parallels UT1A on the right floodplain through the field before turning upslope.

Downstream of UT1A, the stream becomes incised as it transitions to reach UT1B and UT1C. The valley slope along UT1B is 2.4% and increases to 3.7% as it transitions to UT1C. Bank height ratios range from 5.0 to 7.9 with width depth ratios of 7.3 to 8.1. The right floodplain is wide and flat, but the channel follows the left valley toe. The stream's location in the valley and the presence of an old spoil berm along the right bank indicate historic relocation of the channel. Cattle have full access to the channel and the banks are trampled and unstable. An additional damaged culvert crossing is located within this lower reach. Riffle cross-sections (XS14 and XS15) from these reaches classify the stream as a Rosgen G4c and G4.

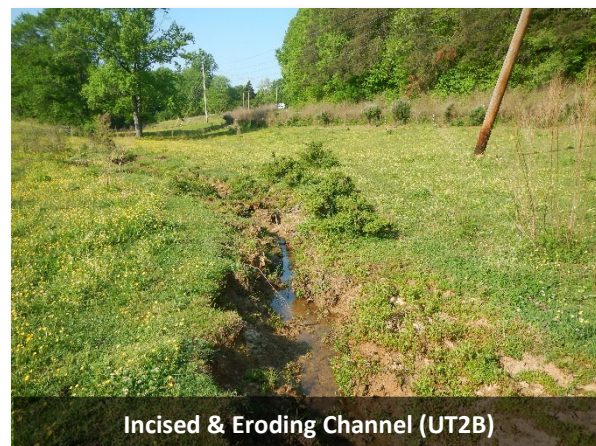
confluence with UT2A within the pasture. The valley along UT2 is confined and steeply sloping, 6.4%. UT2A begins at the property boundary and is a perennial system. As UT2A crosses into the pasture, the stream becomes incised and eroded. The valley is moderately confined with a slope of 2.9%. UT2B begins at a proposed stream culvert crossing location and has a valley slope similar to UT2A (3.1%). The valley widens as transitions downstream towards Bull Creek and the valley slope decreases to 1.9%. Riffle and pool morphology are limited and the bedform is impaired by fines generated from the bank erosion. Riffle cross-sections (XS12 and XS13) on reach UT2C classify the stream as a G5 stream type. Bank height ratios ranged from 1.4 to 1.9 with width to depth ratios ranging from 3.7 to 4.8.

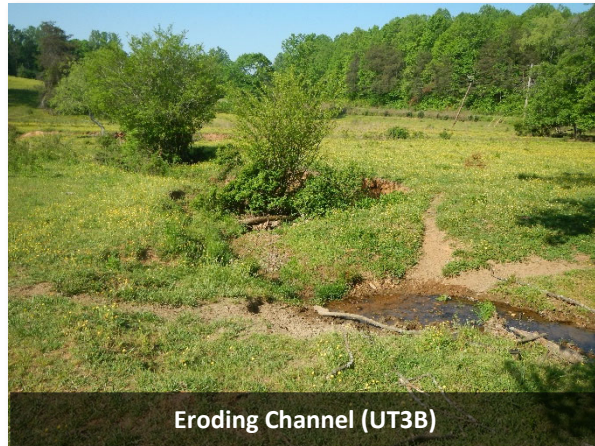
Eroding Channel (UT3B)

UT3 stream reaches originate just downstream from a farm pond which is fenced to prevent cattle access. UT3 and UT3A comprise two separate channels which flow from the pond. UT3 and UT3A are intermittent before transitioning to perennial flow on reach UT3A. The upstream reaches (UT3, UT3A, and UT3B) have a valley that is more V-shaped and steeper slopes (3.6%), before transitioning to UT3C (1.6% valley slope) within the wide, flat floodplain of Bull Creek. The V-shaped valley along UT3 and UT3A is partially wooded before transitioning to pasture within the downstream extent. Cattle have access throughout the entire stream reach. UT3 and UT3A exhibit normal pattern with some development of benches despite areas of bank erosion and extensive impacts from cattle access. Within the V-shaped valley, UT3B is deeply incised with extensive bank erosions resulting from vertical unstable banks. Within Bull Creek's floodplain, UT3C is deeply incised. As UT3C approaches Bull Creek, the existing incised channel is adjacent to an abandoned channel meander bend. Riffle cross-section (XS14 and XS15) data collected on this reach indicates bank height ratios of 2.7 to 3.8 and a width to depth ratios of 5.4 to 7.8. These reaches most closely classify as a Rosgen G5c and G5 stream types.

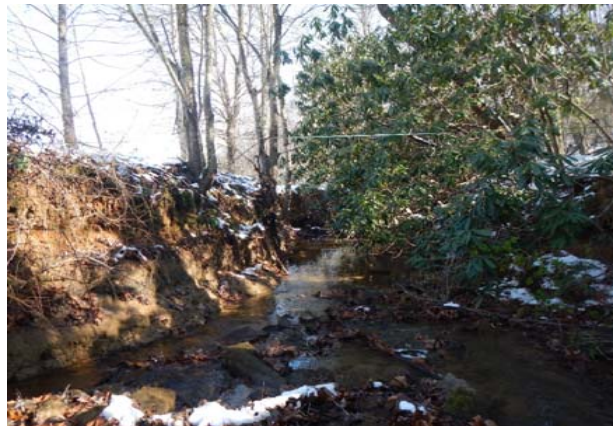
XS1 Riffle 1-Bull Creek Reach 1

18.7	x-section area (ft.sq.)
16.2	width (ft)
1.1	mean depth (ft)
2.1	max depth (ft)
17.6	wetted perimeter (ft)
1.1	hydraulic radius (ft)
14.1	width-depth ratio
20.8	W flood prone area (ft)
1.3	entrenchment ratio
3.7	low bank height ratio

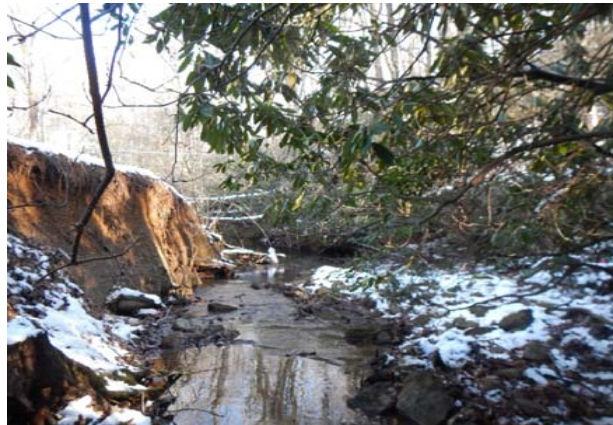
XS2 Riffle 2-Bull Creek Reach 1

21.6	x-section area (ft.sq.)
19.1	width (ft)
1.1	mean depth (ft)
1.8	max depth (ft)
20.4	wetted perimeter (ft)
1.1	hydraulic radius (ft)
16.8	width-depth ratio
25.1	W flood prone area (ft)
1.3	entrenchment ratio
4.1	low bank height ratio

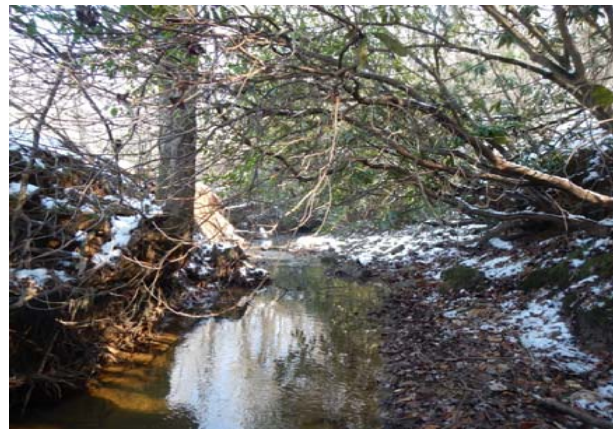
XS3 Pool-Bull Creek Reach 1

44.4	x-section area (ft.sq.)
14.6	width (ft)
3.0	mean depth (ft)
4.9	max depth (ft)
19.9	wetted perimeter (ft)
2.2	hydraulic radius (ft)
4.8	width-depth ratio

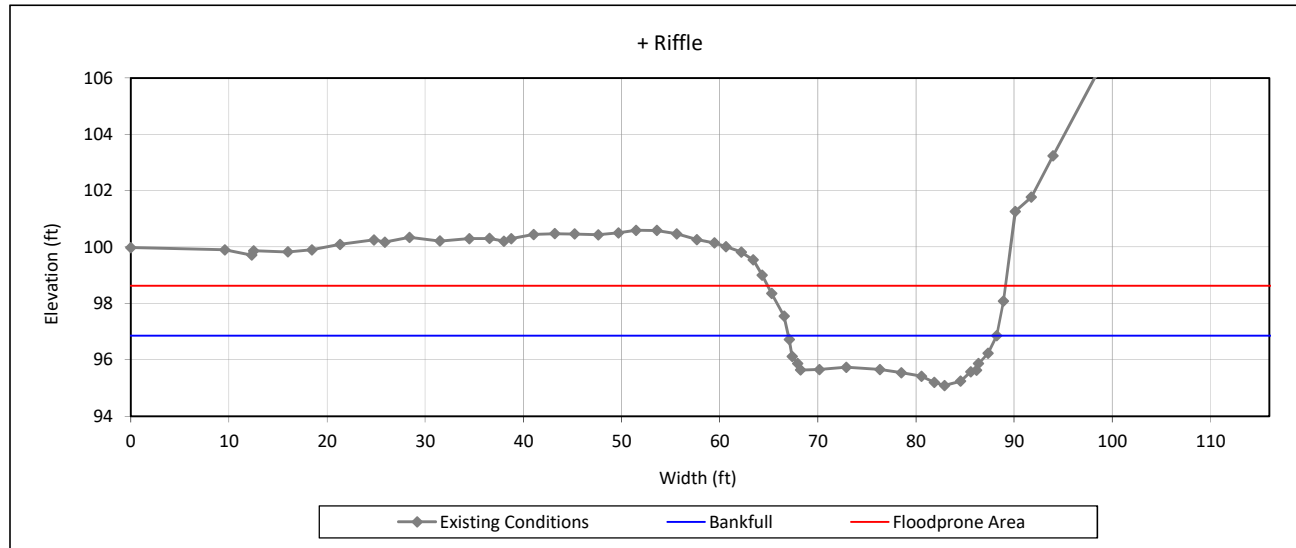
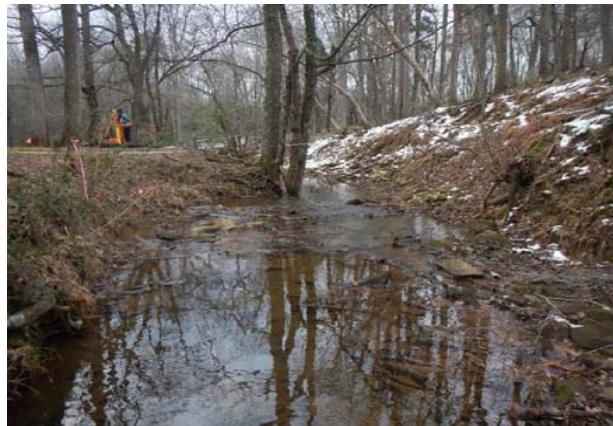
XS4 Riffle 1-Bull Creek Reach 3

26.2	x-section area (ft.sq.)
21.2	width (ft)
1.2	mean depth (ft)
1.8	max depth (ft)
22.3	wetted perimeter (ft)
1.2	hydraulic radius (ft)
17.2	width-depth ratio
49.0	W flood prone area (ft)
2.3	entrenchment ratio
2.8	low bank height ratio

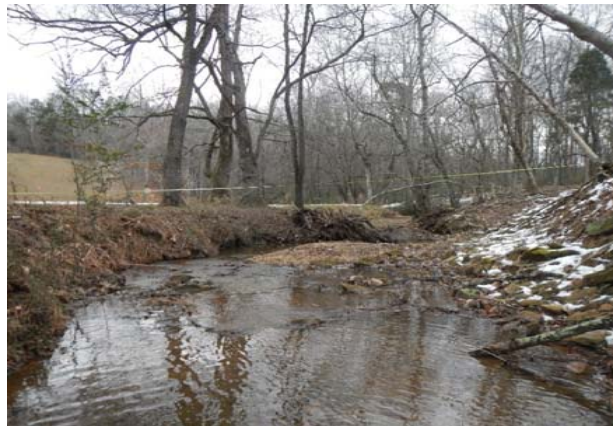
XS5 Riffle 2-Bull Creek Reach 3

28.7	x-section area (ft.sq.)
25.4	width (ft)
1.1	mean depth (ft)
1.6	max depth (ft)
26.8	wetted perimeter (ft)
1.1	hydraulic radius (ft)
22.5	width-depth ratio
32.6	W flood prone area (ft)
1.3	entrenchment ratio
3.0	low bank height ratio

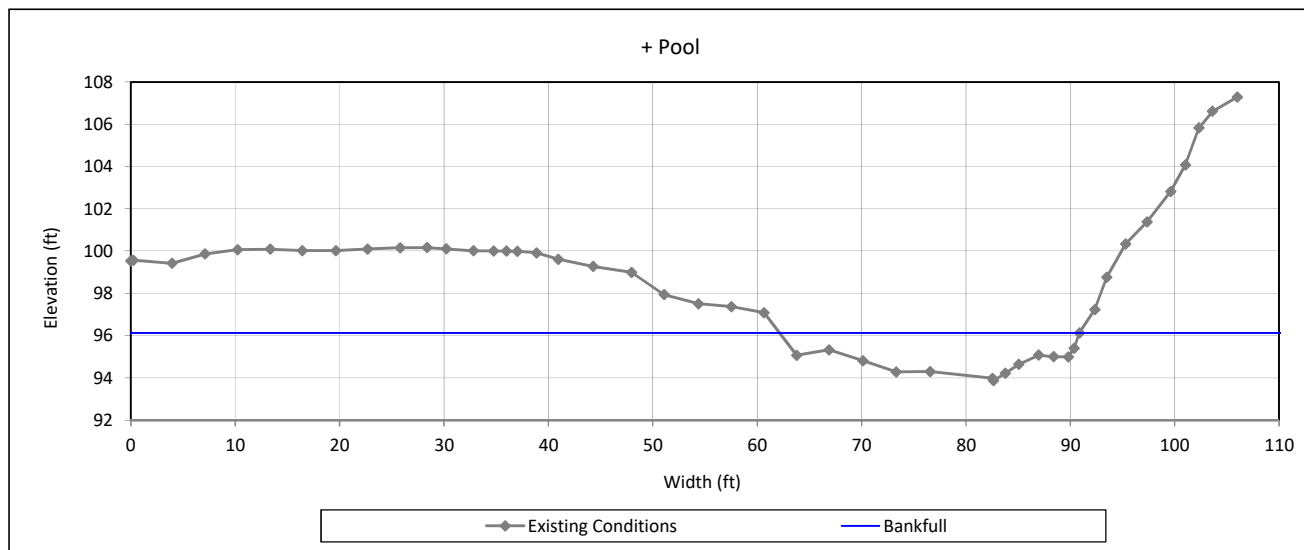
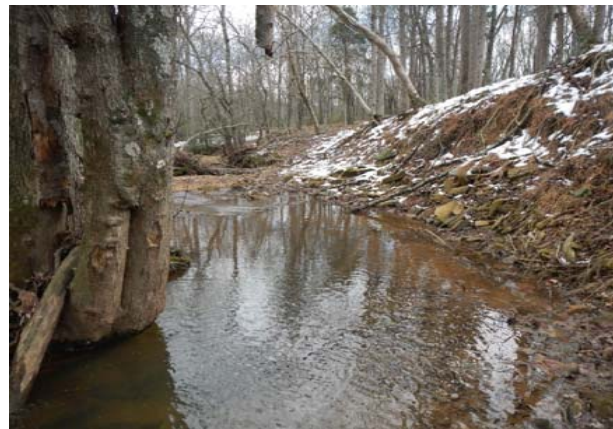
XS6 Pool-Bull Creek Reach 3

41.2	x-section area (ft.sq.)
28.7	width (ft)
1.4	mean depth (ft)
2.3	max depth (ft)
29.9	wetted perimeter (ft)
1.4	hydraulic radius (ft)
20.0	width-depth ratio

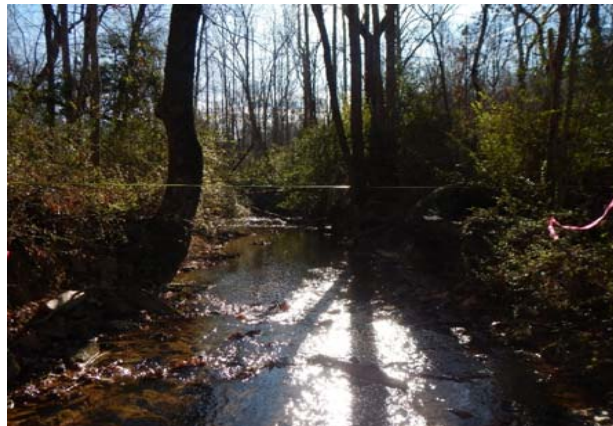
XS7 Riffle 3-Bull Creek Reach 3

37.8	x-section area (ft.sq.)
18.0	width (ft)
2.1	mean depth (ft)
2.7	max depth (ft)
19.9	wetted perimeter (ft)
1.9	hydraulic radius (ft)
8.5	width-depth ratio
52.9	W flood prone area (ft)
2.9	entrenchment ratio
1.9	low bank height ratio

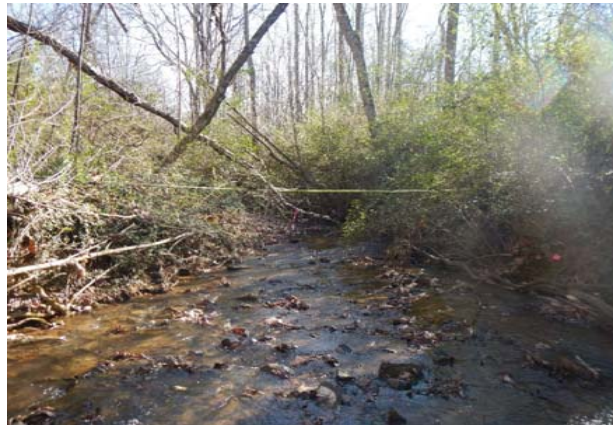
XS8 Riffle 4-Bull Creek Reach 3

39.5	x-section area (ft.sq.)
19.3	width (ft)
2.0	mean depth (ft)
2.5	max depth (ft)
22.2	wetted perimeter (ft)
1.8	hydraulic radius (ft)
9.4	width-depth ratio
27.0	W flood prone area (ft)
1.4	entrenchment ratio
2.3	low bank height ratio

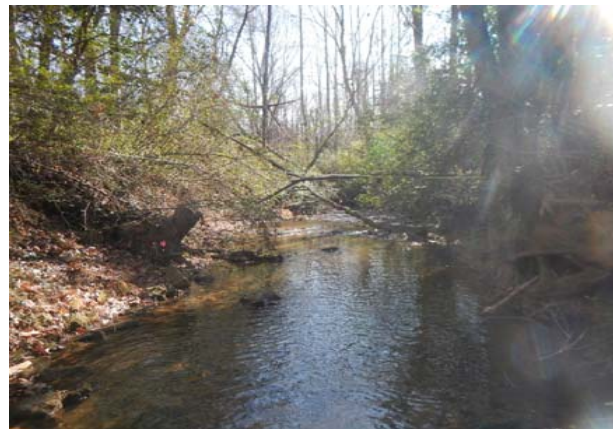
XS9 Pool-Bull Creek Reach 3

56.7	x-section area (ft.sq.)
46.2	width (ft)
1.2	mean depth (ft)
1.5	max depth (ft)
48.0	wetted perimeter (ft)
1.2	hydraulic radius (ft)
37.6	width-depth ratio

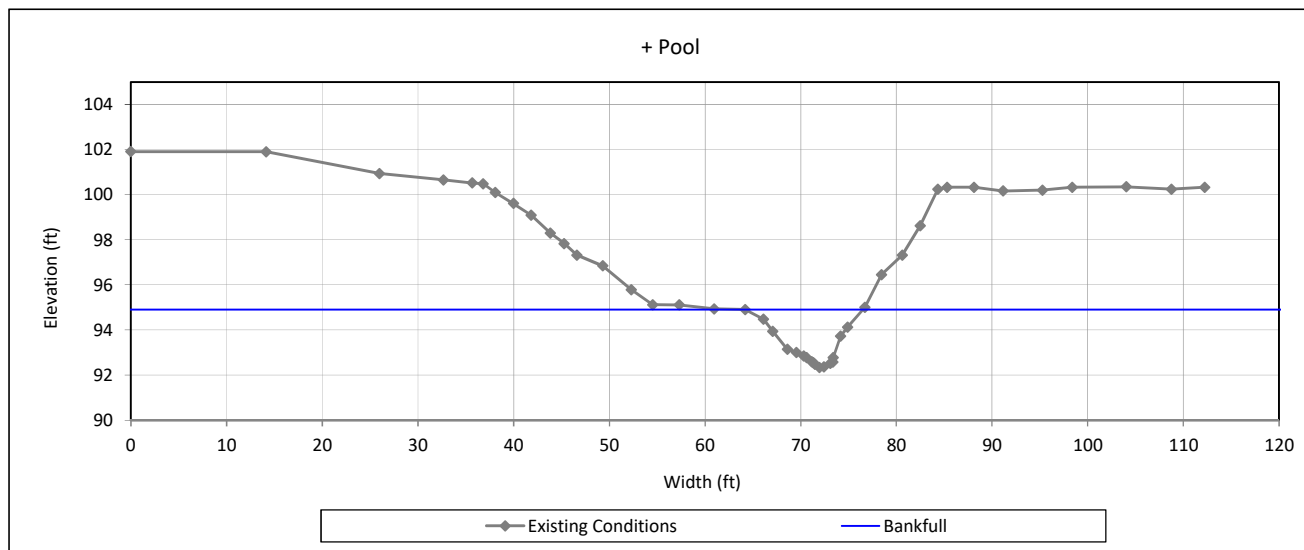
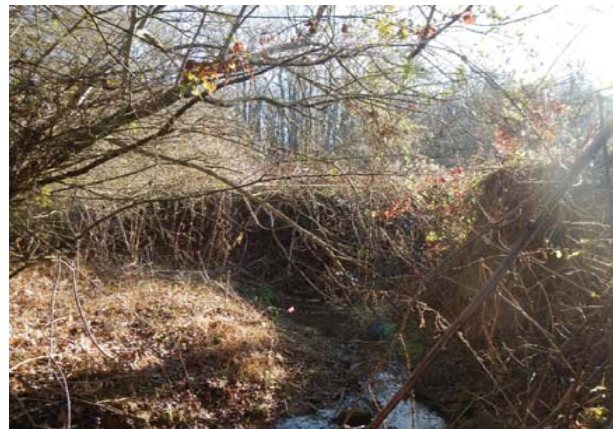
XS16 Pool-UT1

16.4	x-section area (ft.sq.)
12.8	width (ft)
1.3	mean depth (ft)
2.6	max depth (ft)
14.2	wetted perimeter (ft)
1.2	hydraulic radius (ft)
10.0	width-depth ratio

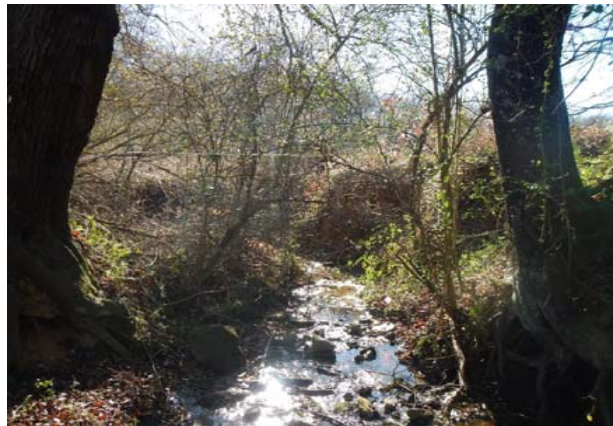
XS10 Riffle 1-UT1

3.9	x-section area (ft.sq.)
5.6	width (ft)
0.7	mean depth (ft)
1.0	max depth (ft)
7.8	wetted perimeter (ft)
0.5	hydraulic radius (ft)
8.1	width-depth ratio
14.0	W flood prone area (ft)
2.5	entrenchment ratio
7.9	low bank height ratio

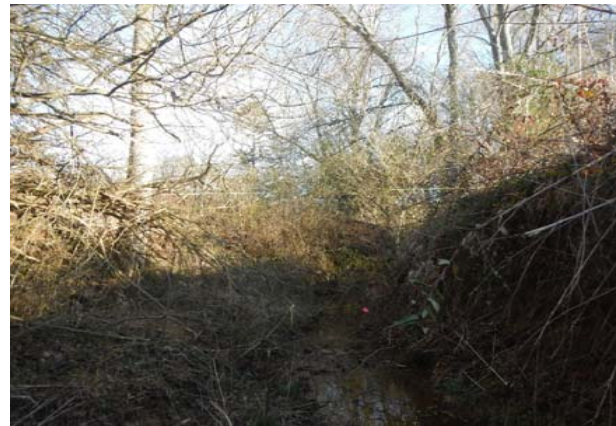
XS11 Riffle 2-UT1

6.8	x-section area (ft.sq.)
7.0	width (ft)
1.0	mean depth (ft)
1.5	max depth (ft)
8.1	wetted perimeter (ft)
0.8	hydraulic radius (ft)
7.3	width-depth ratio
17.1	W flood prone area (ft)
2.4	entrenchment ratio
5.0	low bank height ratio

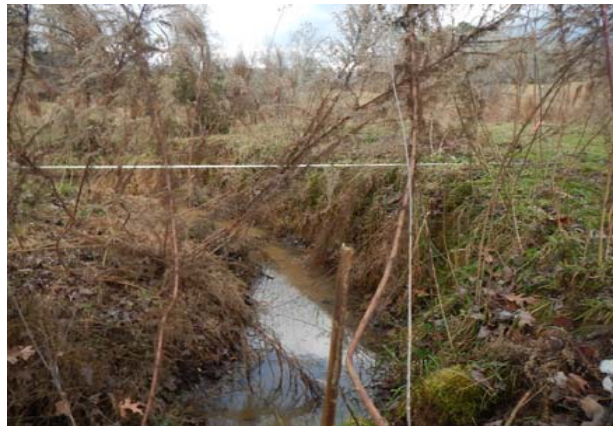
XS12 Riffle 1-UT2

5.7	x-section area (ft.sq.)
5.3	width (ft)
1.1	mean depth (ft)
2.0	max depth (ft)
6.9	wetted perimeter (ft)
0.8	hydraulic radius (ft)
4.8	width-depth ratio
84.1	W flood prone area (ft)
16.0	entrenchment ratio
1.4	low bank height ratio

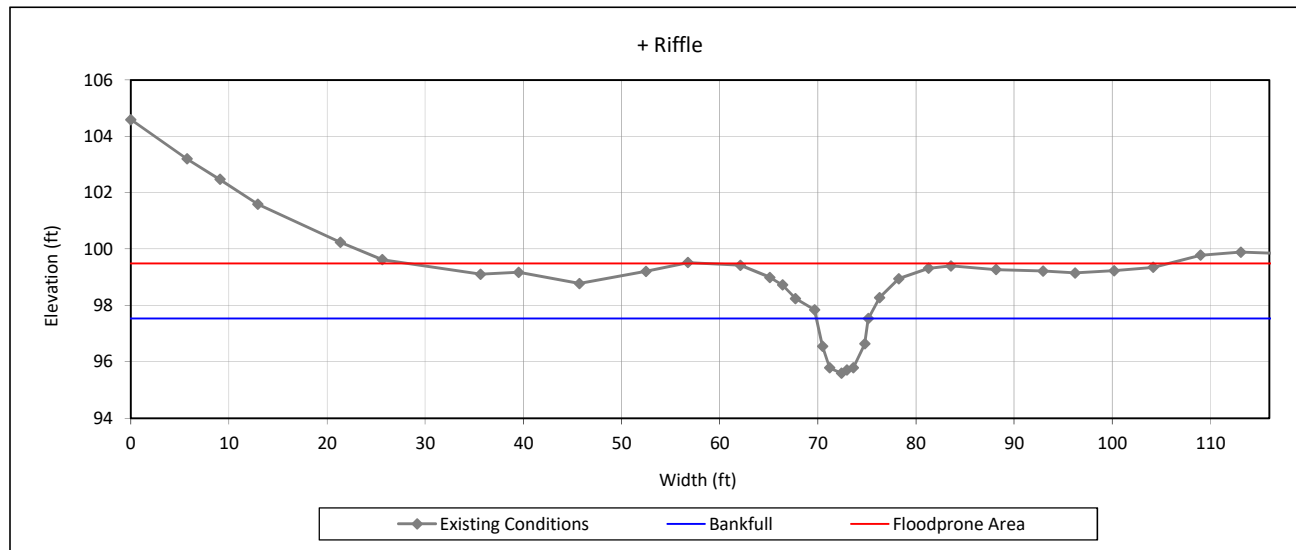
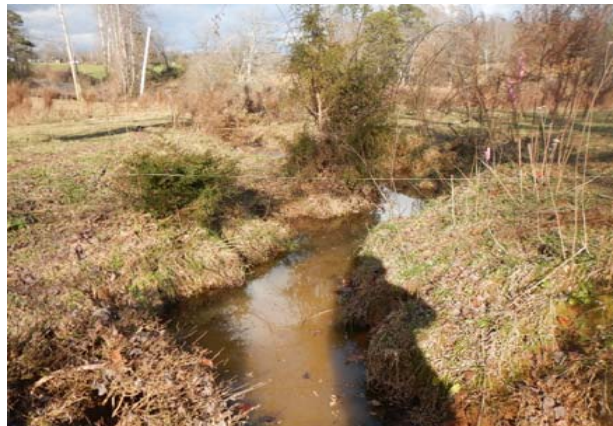
XS13 Riffle 2-UT2

7.4	x-section area (ft.sq.)
5.3	width (ft)
1.4	mean depth (ft)
1.9	max depth (ft)
7.1	wetted perimeter (ft)
1.1	hydraulic radius (ft)
3.7	width-depth ratio
111.5	W flood prone area (ft)
21.2	entrenchment ratio
1.9	low bank height ratio

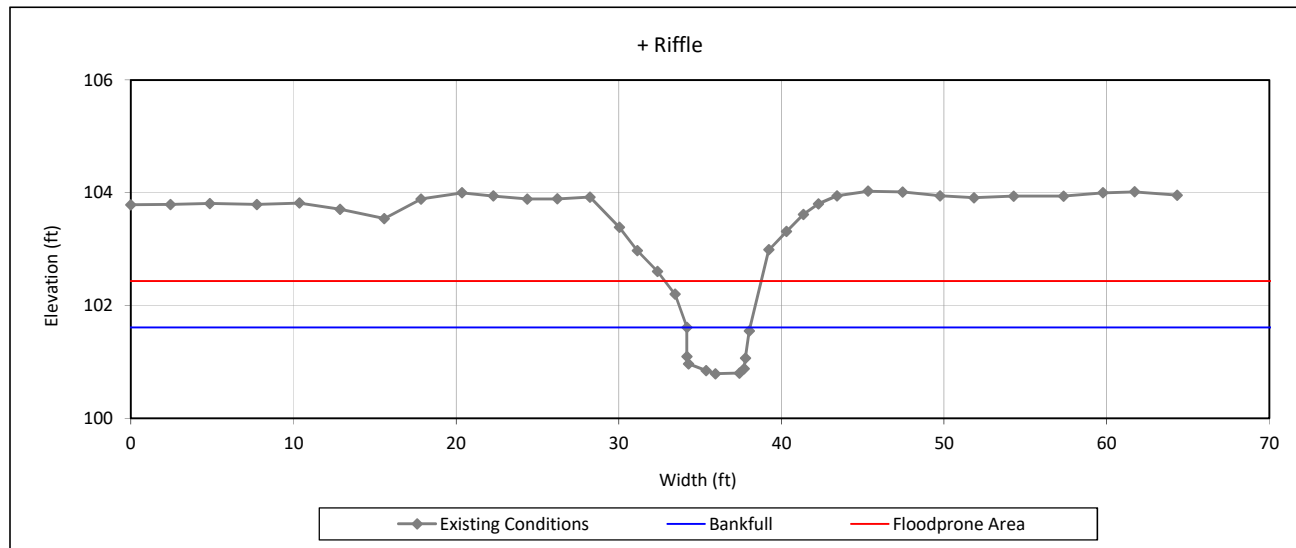
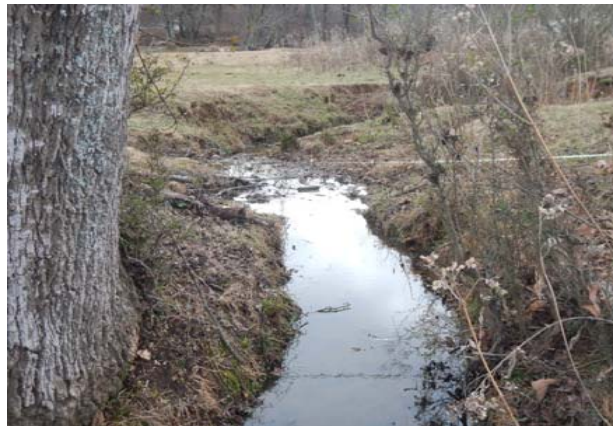
XS14 Riffle 1-UT3

2.8	x-section area (ft.sq.)
3.9	width (ft)
0.7	mean depth (ft)
0.8	max depth (ft)
4.9	wetted perimeter (ft)
0.6	hydraulic radius (ft)
5.4	width-depth ratio
13.7	W flood prone area (ft)
3.5	entrenchment ratio
3.8	low bank height ratio

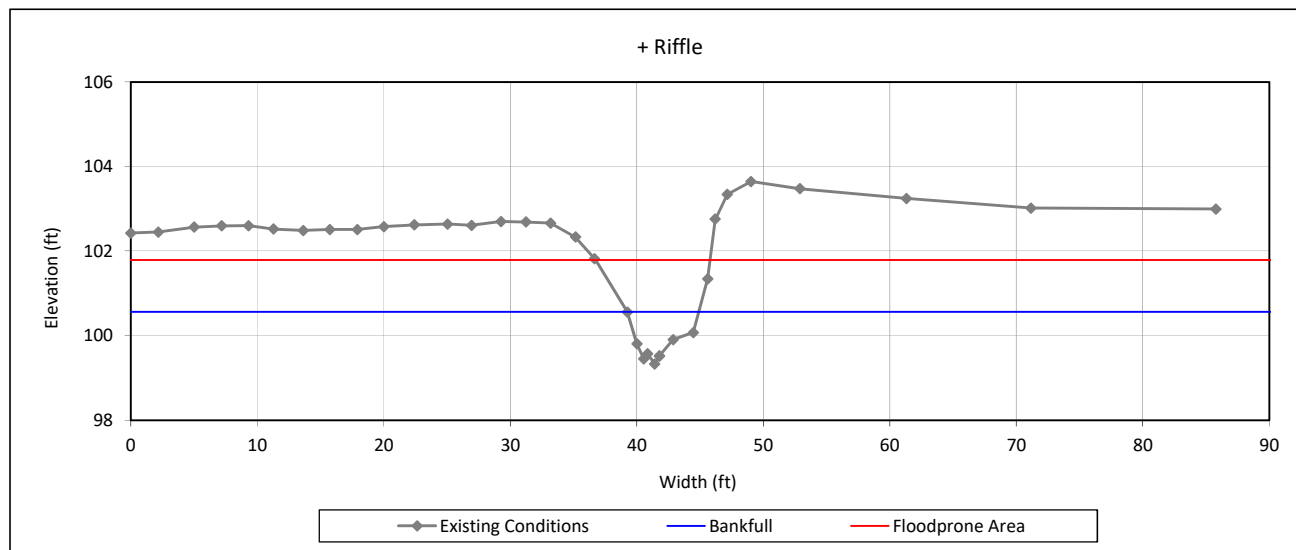
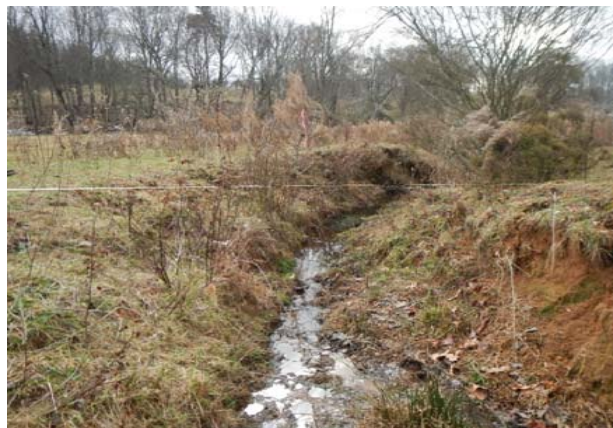
XS15 Riffle 2-UT3

4.1	x-section area (ft.sq.)
5.7	width (ft)
0.7	mean depth (ft)
1.2	max depth (ft)
6.5	wetted perimeter (ft)
0.6	hydraulic radius (ft)
7.8	width-depth ratio
9.1	W flood prone area (ft)
1.6	entrenchment ratio
2.7	low bank height ratio
