Mitigation Plan

Lake Wendell Mitigation Project

Johnston County, North Carolina

August 2017

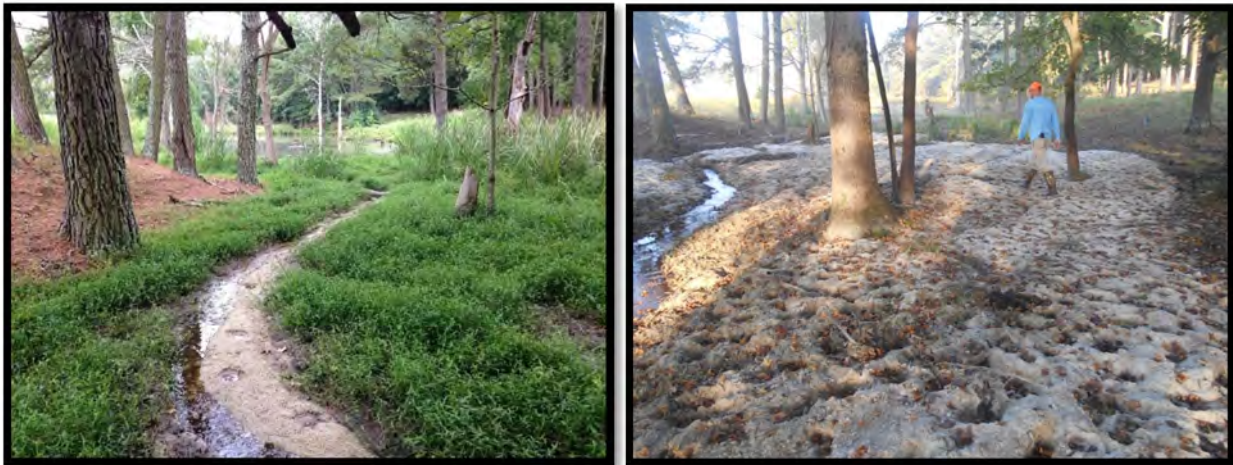
Before (left photo) of the stream reach leading down to the pond and after (right photo) of the same area after Hurricane Matthew 2016.

Hurricane Matthew Observations: On October 8th, 2016, Hurricane Matthew delivered over 10" of rain to the project site in less than 12 hours. Locally, the recurrence interval was estimated to be greater than a 500-year storm event (NOAA, NWS, 2016). After Hurricane Matthew and prior to subsequent rain events, WLS visited the site on October 20th, 2016 to measure sediment deposits in two distinct depositional areas or sinks, consisting of mostly fine sand material. The depositional areas were measured above and below the existing farm pond (upper Reach R3) to quantify the approximate sediment deposited by the storm event. For better accuracy, depositional areas were delineated using existing conditions survey basemap and grid areas/cross-sections were measured and compared with a cloth tape and hand-augured borings. The cubic footage was then converted to cubic yards to estimate tonnage. The total sediment yields were estimated to be approximately 52 tons upstream of the pond and 36 tons downstream of the pond, indicating the size of the pulse of sediment was mobilized through the system as a result of Hurricane Matthew.

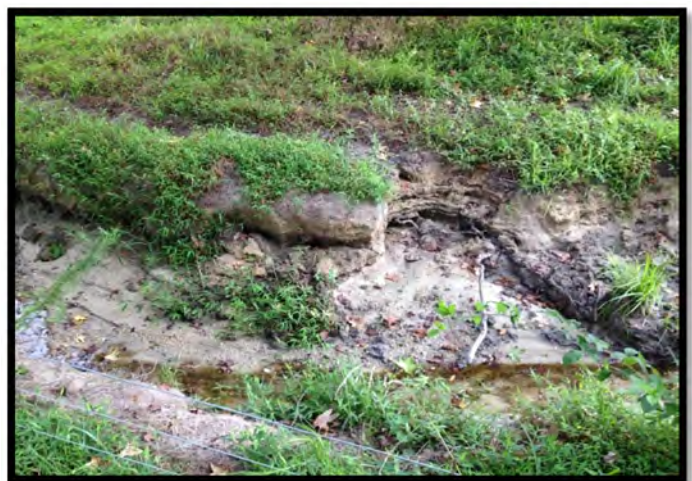
Looking at right bank erosion and sediment deposition along R2. Note the lack of deep rooted vegetation.

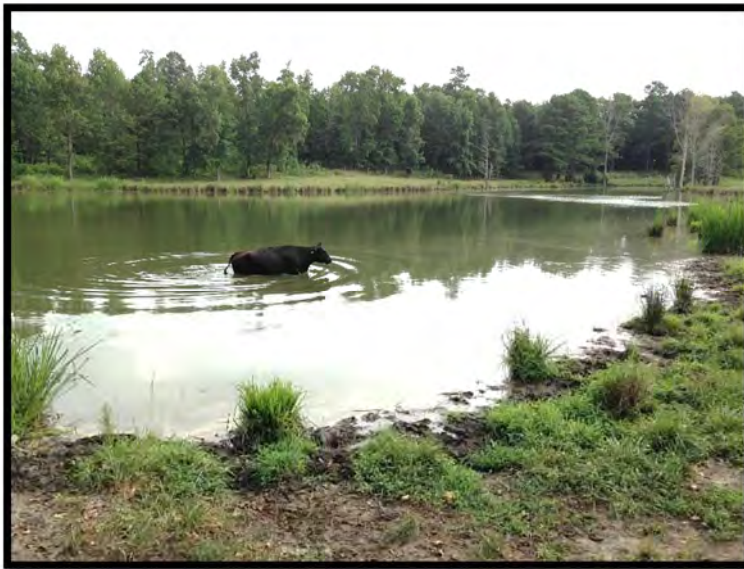
Looking up the valley at man-made farm pond along R3.

R3 begins downstream of R2 and flows west for approximately 150 feet before experiencing backwater effects from a man-made farm pond dam located 945 feet down valley before the stream flow exits at the outlet of a failing existing pond spillway system. Prior to the farm pond construction, the natural valley slope in this area was approximately 1.6 percent. The pond depth at the upstream base of the dam was measured at approximately 10 feet deep. The entire pond perimeter is subject to active water quality stressors, mainly resulting from hoof shear from unrestricted cattle access and riparian buffers less than 10 feet in width.

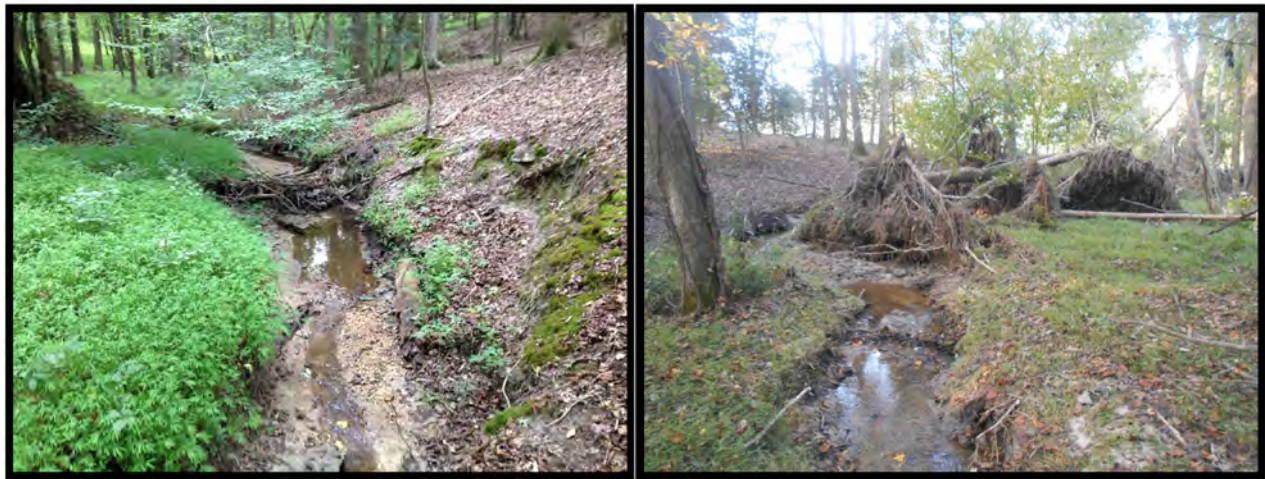
Photo on the left shows pre-Hurricane Matthew looking upstream along R4, photo on the right shows post-Hurricane Matthew looking downstream, the downed tree in the right photo can be seen in the top left corner of the photo on the left.

R4 begins at the farm pond spillway outfall near the base of the pond dam and continues for approximately 822 feet to the littoral zone of Lake Wendell. R4 has a drainage area of approximately 102 acres near Lake Wendell. The channel is mostly stable along the entire reach with native woody riparian buffer vegetation corridor greater than 50 feet on both sides of the channel, except for approximately 120 feet. In this location, the bank erosion and toe scour has increased significantly after Hurricane Matthew knocked down a few large canopy trees in the floodplain. These infrequent disturbances are localized and do not impact stability across the entire channel segment. The channel slope is 1.2 percent along this reach, bank erosion is low and most scour is localized along a few meander bends. The valley floor widens in this area and the stream has a connection to its floodplain. Relic channel features were observed along this reach and the channel sinuosity ($k=1.25$) is appropriate for the valley type. Cattle do not have access to this reach and historically this area has remained relatively undisturbed. The typical bank height ratio ranges from 1.0 to 1.2 and the channel is classified as an E5 stream type.

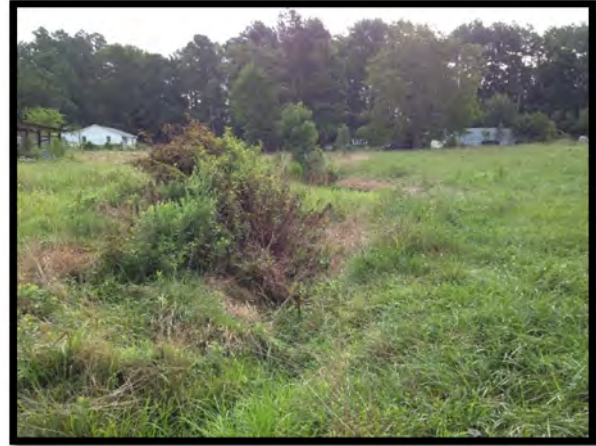
Reach R5, shows that buffer is limited to herbaceous vegetation.

The reach has experienced downcutting for approximately 50 percent of its length and the buffer is limited to herbaceous vegetation. R5 is actively subject to water quality stressors, mainly in the form of cattle access and minimal riparian buffer widths. R5

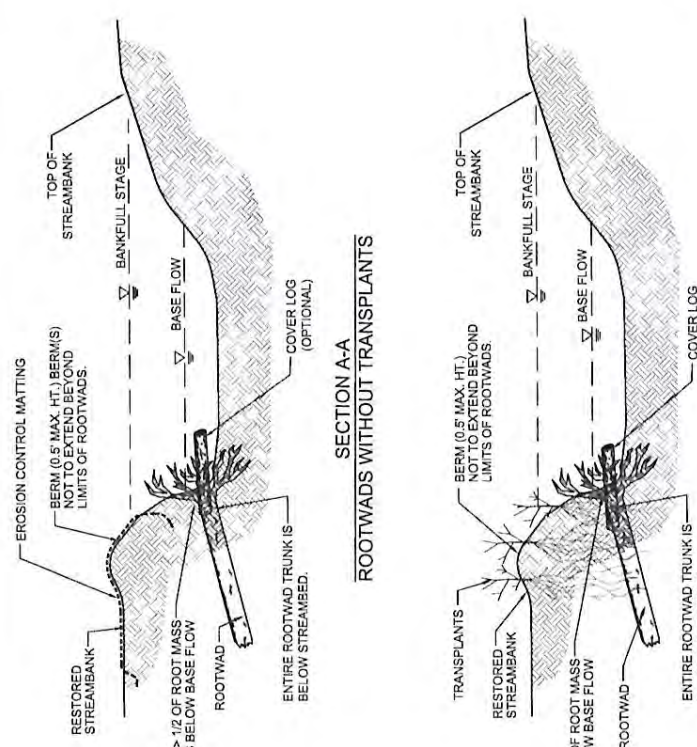
ROOTWADS
 NOT TO SCALE

NOTES:
 1. THE TRENCHING METHOD REQUIRES THAT A TRENCH BE EXCAVATED FOR THE LOG. PORTION OF THE ROOTWAD A COVER LOG SHOULD BE INSTALLED UNDERNEATH THE ROOTWAD IN A TRENCH EXCAVATED PERPENDICULAR TO THE BANK AND BELOW THE RESTORED STREAMBED. ONE-THIRD OF THE ROOTWAD SHOULD REMAIN BELOW NORMAL BASE FLOW CONDITIONS.

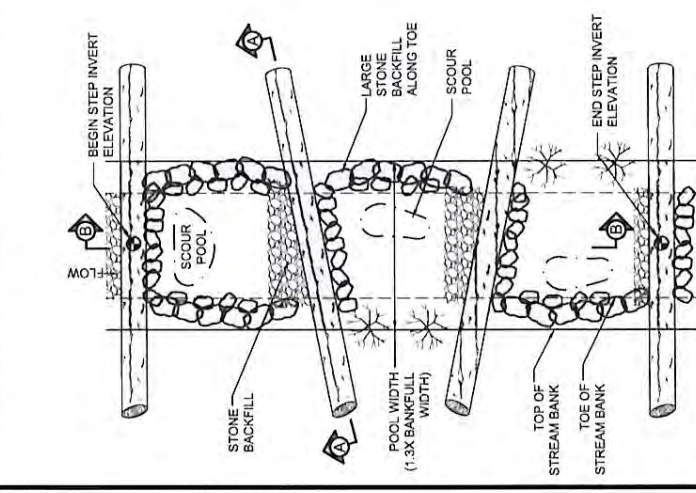
LOG WEIR
 NOT TO SCALE

8. TRANSPLANTS OR LIVE STAKES SUBSTITUTED IN AREAS WHERE EXISTING SLOPES EXCEED 10% AS DETERMINED BY THE ENGINEER.

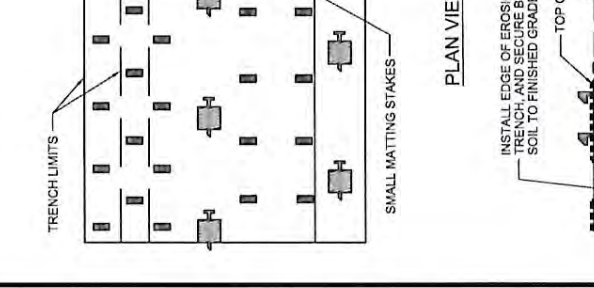
EROSION CONTROL MATTING
 NOT TO SCALE

- NOTES:
- RESTORED STREAM BANKS MUST BE SEEDED AND MULCHED PRIOR TO PLACEMENT OF EROSION CONTROL MATTING.
 - SEE TECHNICAL SPECIFICATIONS FOR MATTING STAKE SPACING REQUIREMENTS.
 - PLACE LARGE STAKES ALONG ALL MATTING SEAMS, IN THE CENTER OF STREAM BANK, AND TOE OF SLOPE.

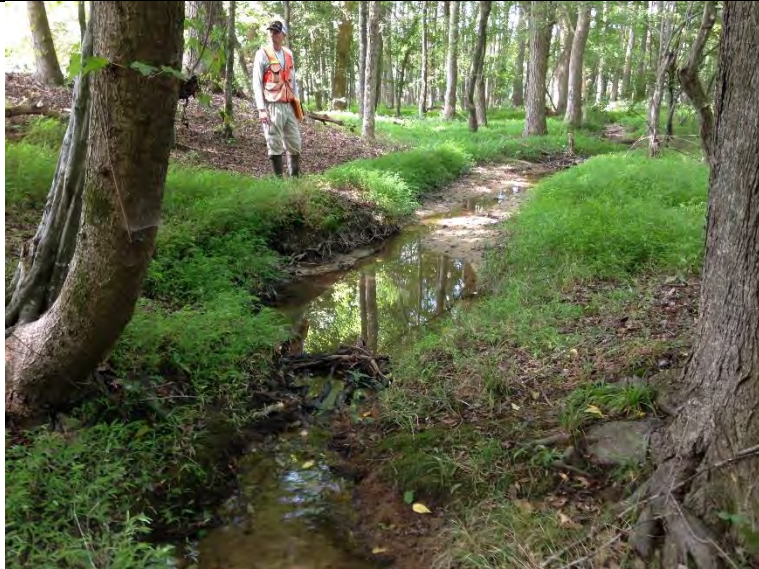
Reach 4- Showing stable stream channel (8/21/15)

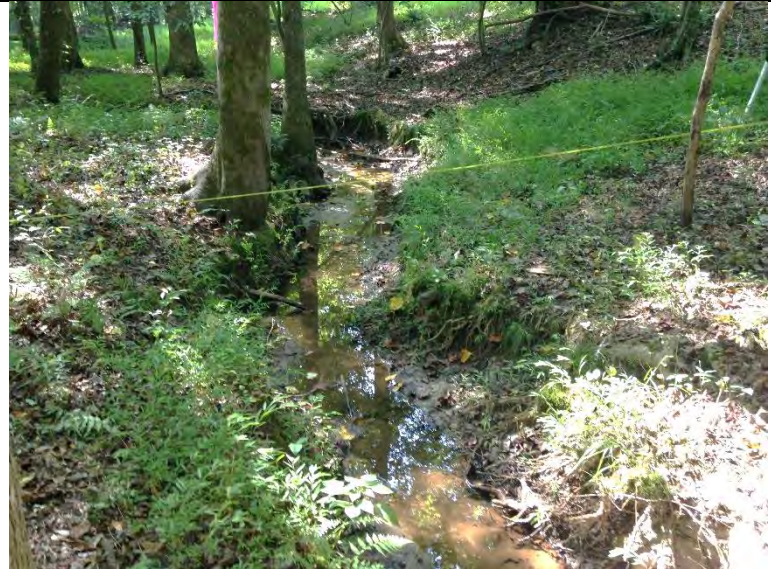
Reach 4 – Looking at stable conditions (8/21/15)

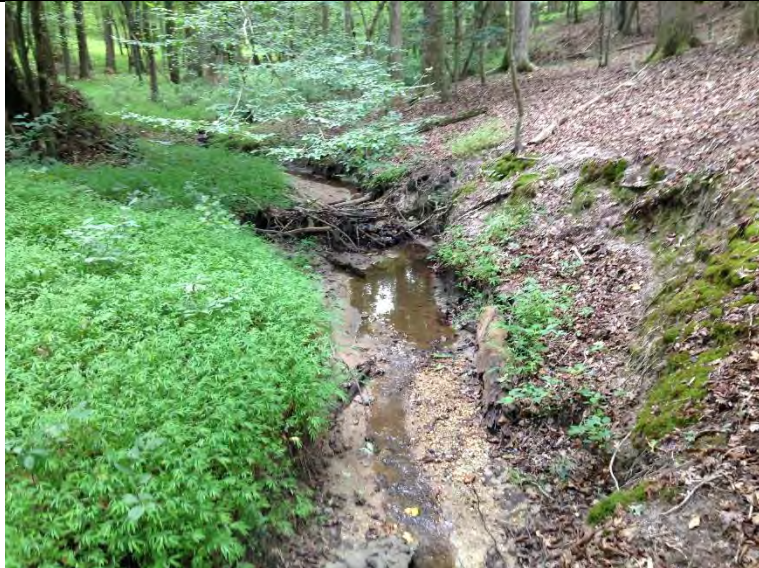
Reach 4 - Looking downstream at stable conditions (8/21/15)
