Monitoring Report – Year 4  
FINAL VERSION  
Lake Wendell Mitigation Project (Riparian Buffer Mitigation)  
Calendar Year of Data Collection: 2021

NCDEQ DMS Project Identification # 97081  
NCDEQ DMS Contract # 6826  
Neuse River Basin (Cataloging Unit 03020201)  
USACE Action ID Number: SAW-2016-00876  
NCDEQ DWR Project # 2016-0385  
Johnston County, NC  
Contracted Under RFP # 16-006477  
Data Collection Period: September 2021  
Submission Date: October 20<sup>th</sup>, 2021

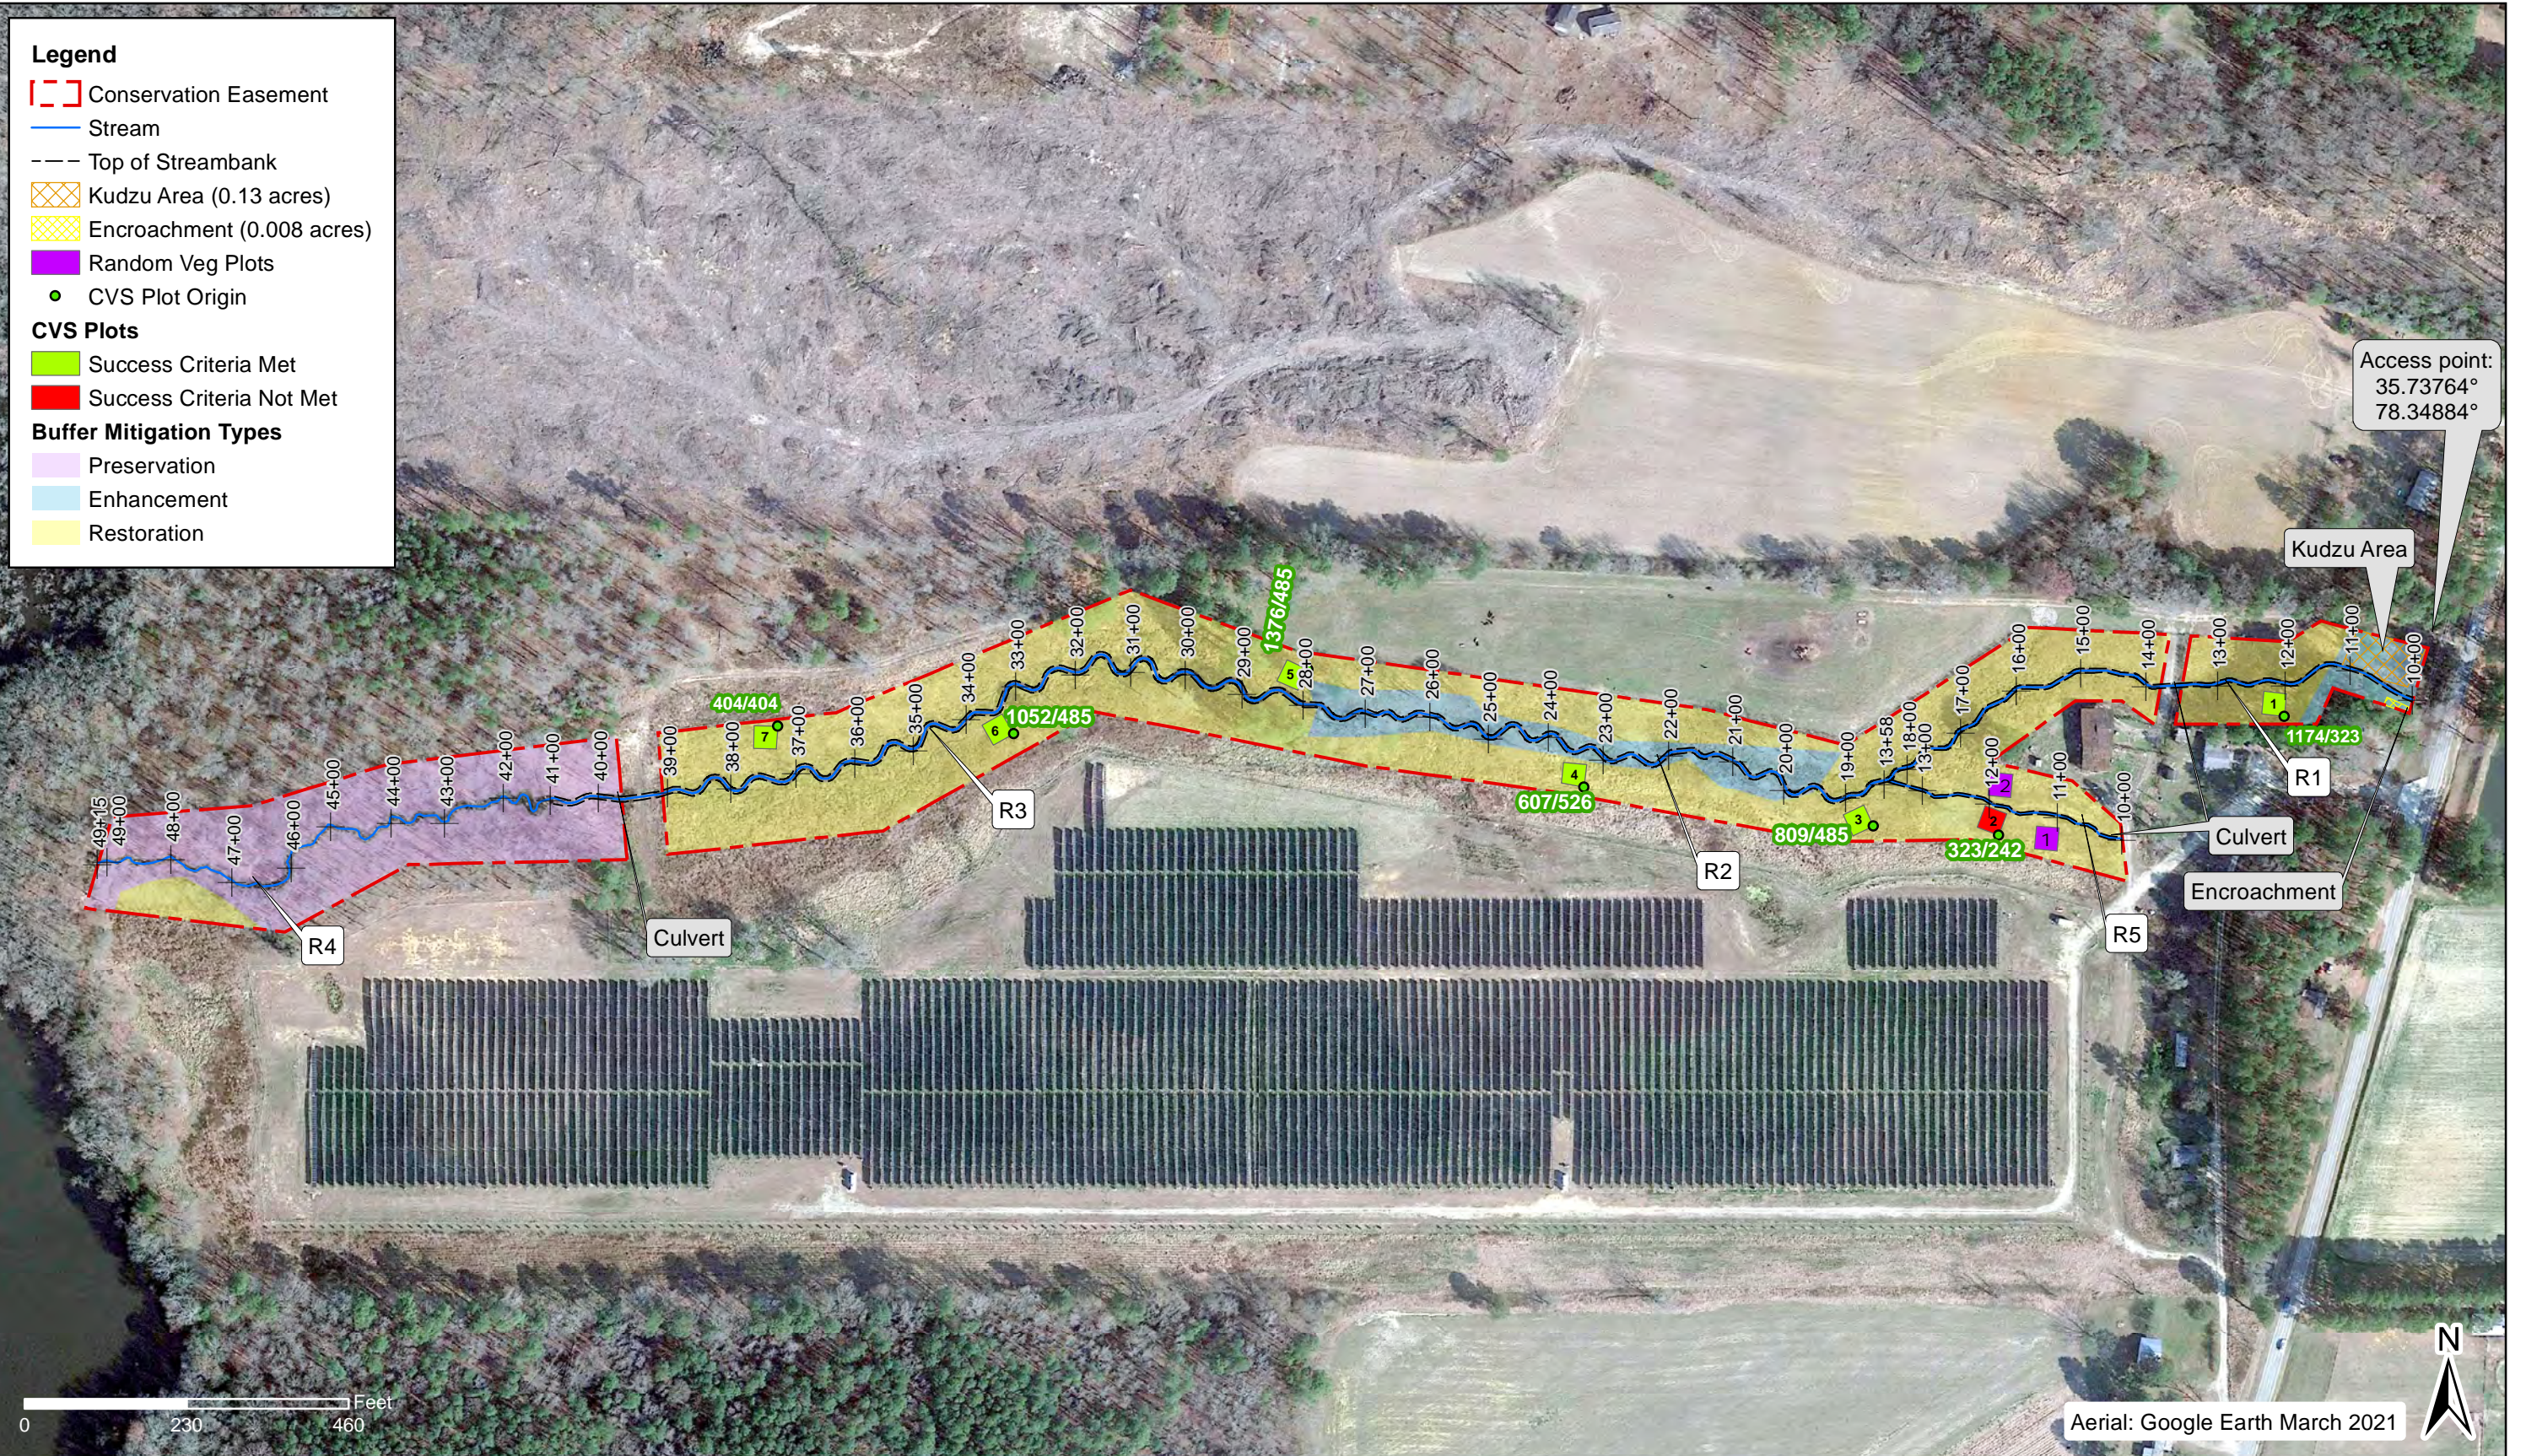
The project background and attribute summary are presented in Table 1. Refer to Figure 1 and Table 2 for the project areas and buffer asset information. Relevant project contact information is presented in Table 3.

Vegetation monitoring for MY4 was conducted utilizing the seven vegetation monitoring plots, with monitoring conducted in accordance with the CVS-EEP Level I & II Monitoring Protocol (CVS, 2008) and DMS Stream and Wetland Monitoring Guidelines (DMS, 2017). See Figure 1 in Appendix B for the vegetation monitoring plot locations. Plot 2 had an average stem density of 242 stems per acre which does not meet the year 5 minimum of 260 stems per acre. Plot 2 contains six stems total, one stem below the requirement to meet success criteria. Loss in stem density from MY4 to MY5 is due to thick herbaceous vegetation. To determine if there is a larger issue with vegetation in this area, two additional random veg plots were surveyed (10m x 10m). Both plots met success criteria (see table below). During MY5, Plot 2 will be monitored closely, and WLS will assess the need for supplemental planting in at this time. All other vegetation plots met MY4 interim success criteria. The surviving planted stems include a minimum of four native hardwood tree species or four native hardwood tree and native shrub species, where no one species is greater than 50 percent of the stems. Summary data and photographs of each plot can be found in Appendix B and C.

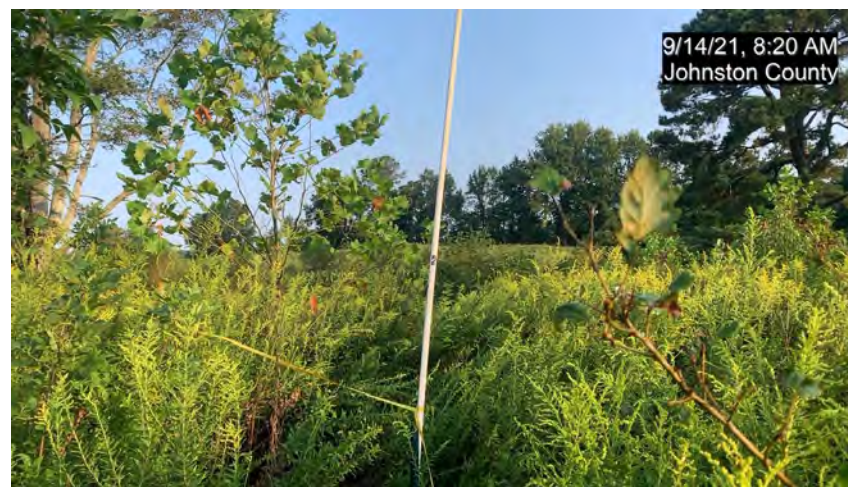
Veg Plot 2, September 14, 2021 (MY-04)

Annual monitoring was conducted during MY4 in accordance with the monitoring plan as described in the approved mitigation plan and was intended to document the site improvements based on restoration potential, catchment health, ecological stressors, and overall constraints. All the monitoring device locations are depicted on CCPV (Figure 1) and MY4 monitoring data results are listed in the appendices. The Project meets the MY4 success criteria for vegetation for all veg plots except plot 2.

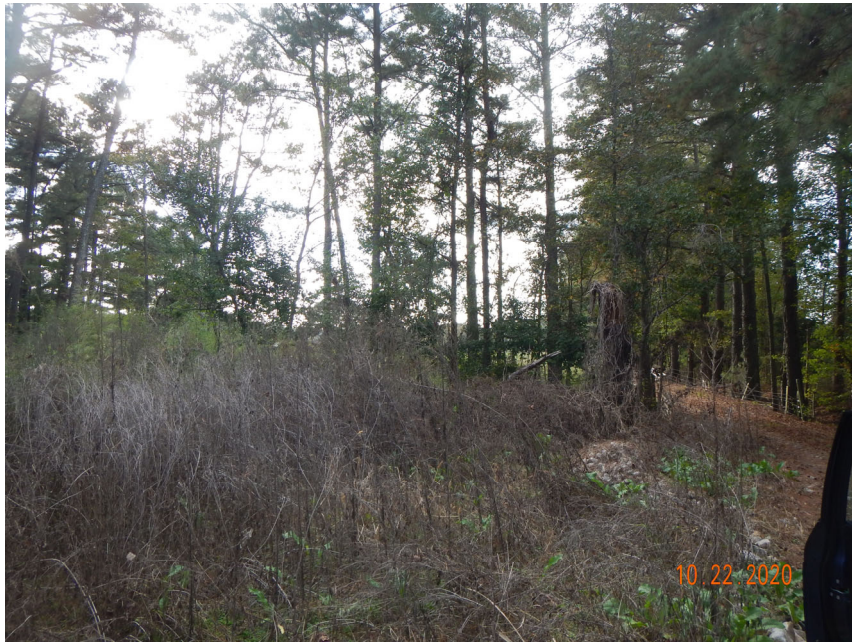
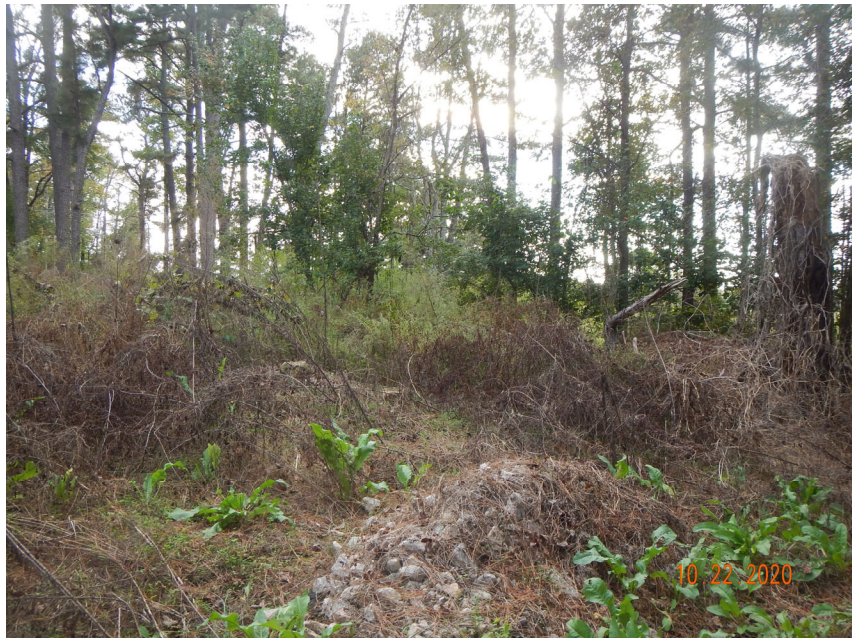
During MY1 an area of concern was observed along R1 buffer as shown on the Figure 1. This area was utilized as a temporary staging area during construction and contains invasive species vegetation (kudzu) along the right buffer. This area was managed once during MY4 using foliar spray of the limited remaining stems in July using a 3 percent solution of Garlon 3A (see table below for treatments). Following these treatments, the percent cover of kudzu was reduced to approximately 1%. This area was planted with species from the approved list in the mitigation plan on February 1st, 2021 (see planting table above). WLS will continue to monitor and treat the kudzu during MY5. Additionally, the visual monitoring confirmed that diffuse flow of runoff is being maintained in the riparian buffer areas.

Kudzu Problem Area, October 22, 2020 (MY-03)

Monitoring Year	Invasive Treatment	Date Treatment Conducted
2	Kudzu foliar spray and cut	August 15, 2019
	Kudzu foliar spray	September 24, 2019
3	Kudzu crown removal (hand-digging)	March 18, 2020
	Kudzu foliar spray	October 7, 2020
4	Kudzu foliar spray	July 1, 2021

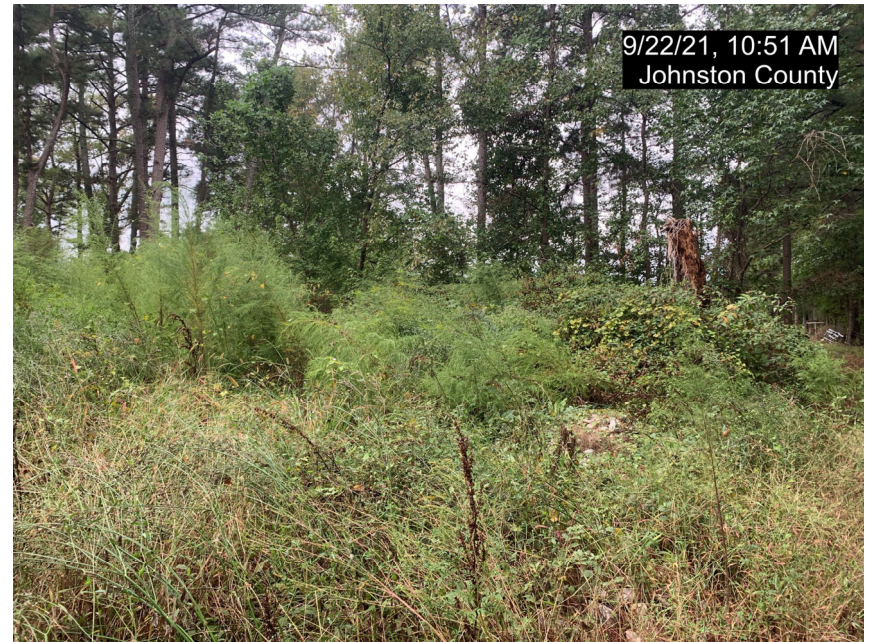
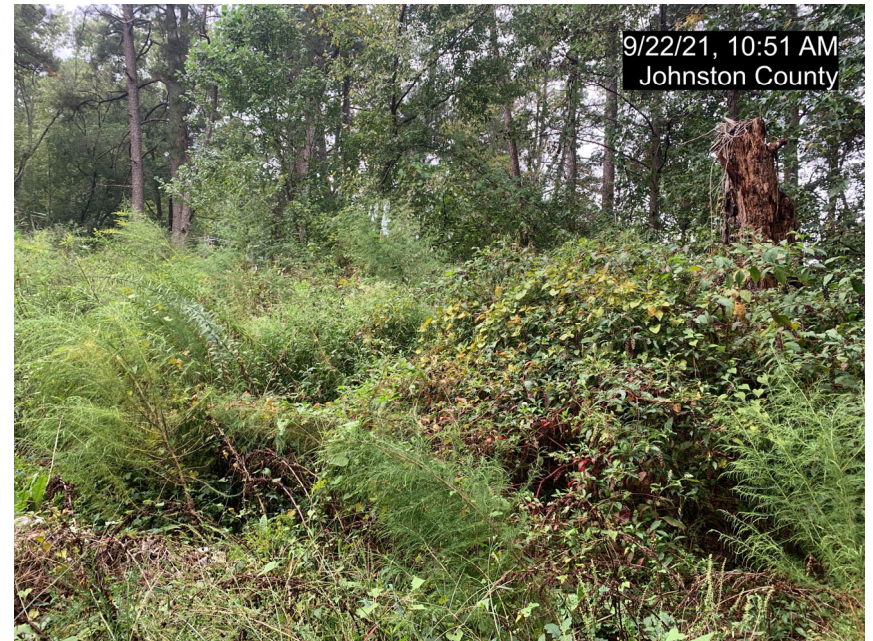
Kudzu Problem Area, September 22, 2021 (MY-04)

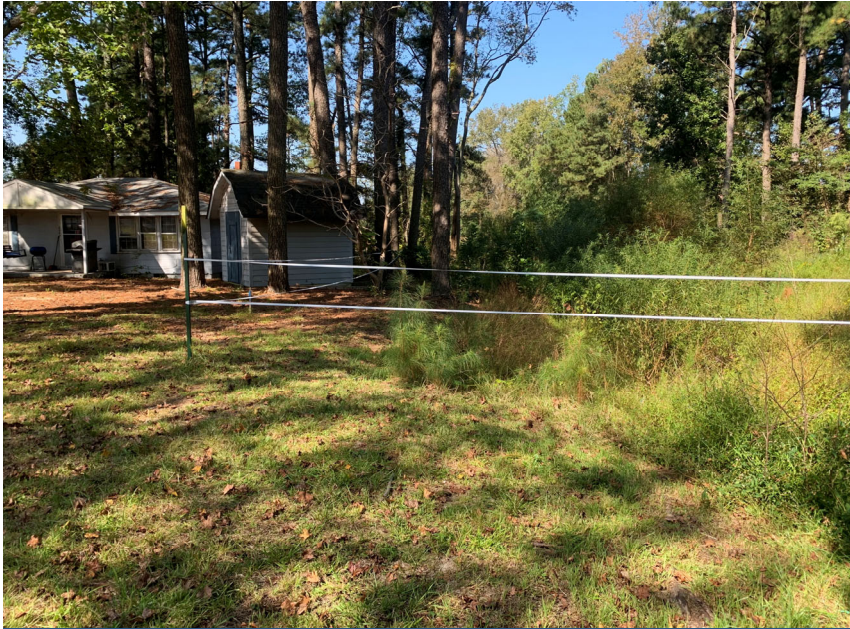
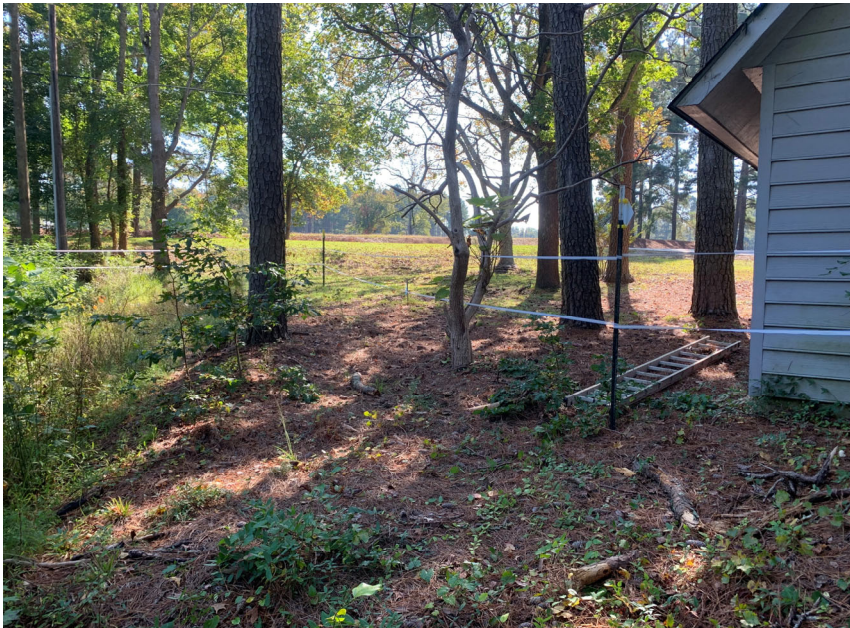
The MY4 vegetation monitoring was also conducted utilizing visual assessment along the Project stream reaches. The overall results of the visual assessment did not indicate any negative changes to the existing vegetation community. An area of encroachment approximately 0.008 acres was found along R1 in MY3, see Figure 1. This area was mowed by the adjacent homeowner and was vegetated with fescue. Management of this area began in January 2021 and included additional signage and a physical barrier (horse tape) to delineate the easement boundary and discourage further mowing. During MY4 trees were planted in this area to ensure tree cover is achieved (February 1st, 2021). Trees planted were from the approved list in the mitigation plan (see table below).

Encroachment Area, October 7, 2020 (MY-03)

Common Name	Scientific Name	# Planted
Tulip Poplar	<i>Liriodendron tulipifera</i>	10
Sycamore	<i>Platanus occidentalis</i>	10
River Birch	<i>Betula nigra</i>	5
	<b>TOTAL</b>	25

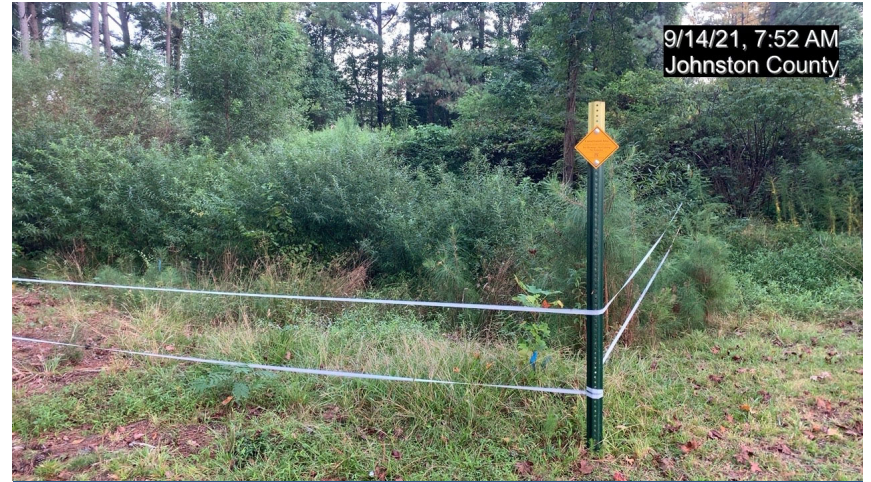
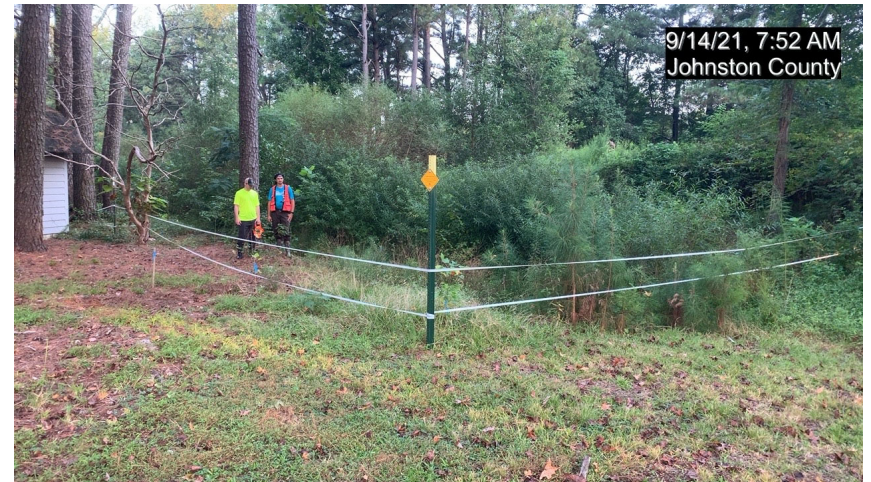
Encroachment Area, September 14, 2021 (MY-04)
