# **MYO FINAL MONITORING REPORT**

# LAUREL SPRINGS STREAM AND WETLAND MITIGATION SITE

Avery County, North Carolina French Broad River Basin Cataloging Unit 06010108

DMS Project No. 100122
Full Delivery Contract No. 7890
DMS RFP No. 16-007725 (issued 11/13/18)
USACE Action ID No. SAW-2019-00835
DWR Project No. 2019-0865

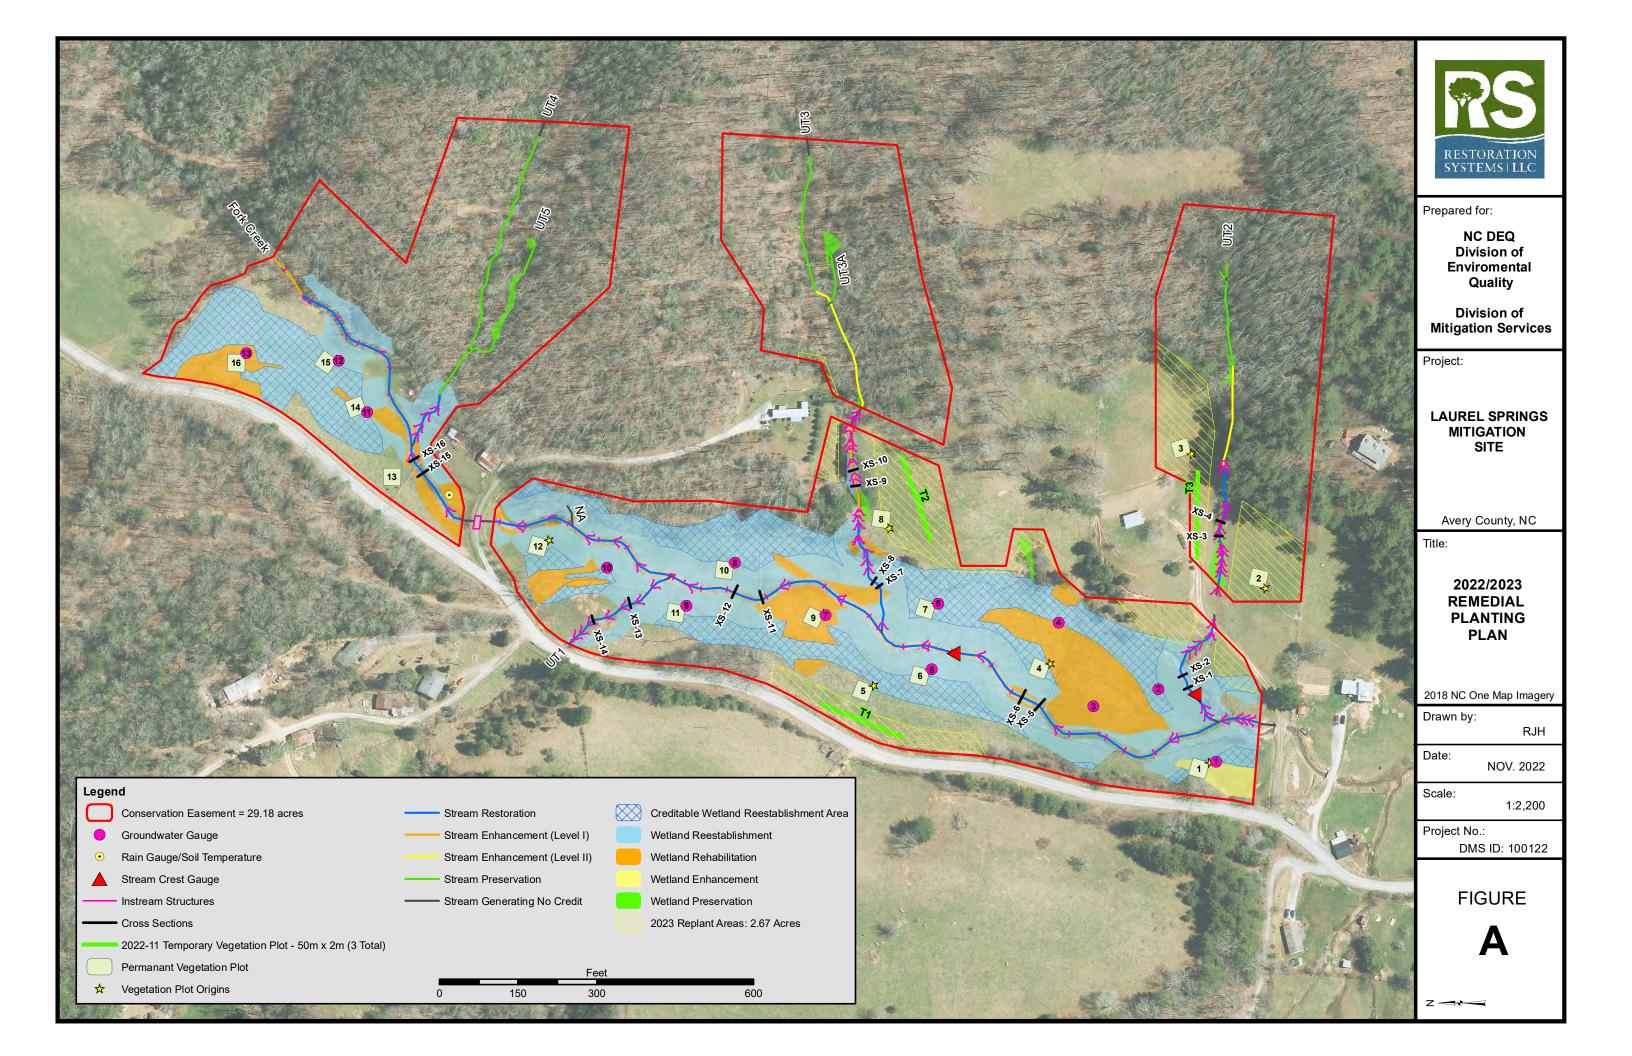
Attachment - Remedial Planting Plan Figure

During the 2022 growing season, Restoration Systems (RS) has observed areas of low stem densities at the Laurel Springs Mitigation Site (Site). Observed areas total 2.67 acres, which includes a 0.107-acre area of encroachment – see attached remedial planting figure. The encroachment area was partially due to a storage shed left within the easement used by the adjacent landowner. RS worked with the neighbor to remove the shed and cleared the area of all debris. Additionally, 6-inch treated fence posts were used to delineate the easement boundary in this area. A new shed was erected approximately 15 feet from the easement.

RS has ordered trees to replant 2.67 acres at a density of 670 stems per acre within observed low stem density areas, which includes the 0.107-acre area of encroachment. These areas are within the Acidic Cove Forest Association. The following species and quantities were secured for Q1-2023 planting.

These species were listed within the approved Mitigation Plan but were not planted within the Acidic Cove vegetation association during initial planting. These three species will add to the six species planted during initial planting for a total of nine species within the Acidic Cove vegetation association. A formal Remedial Planting Plan letter is provided after RS's Mitigation Plan Modification Request (request to count replacement tree species towards site success criteria) – immediately following these comment responses.

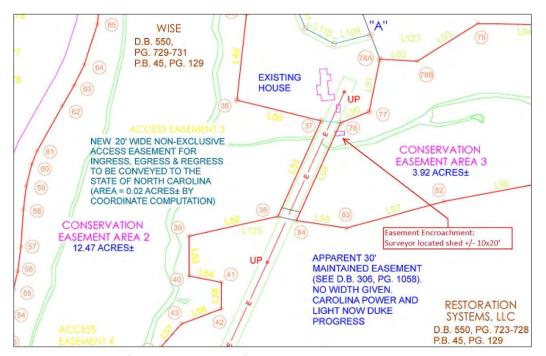
Figure 1 – Location of shed within the Site's conservation easement

During the MYO site visit with the NCDMS, it was noted that a small (approximately 10'x20') shed was located within the easement and UT3. Through discussions with DMS and the landowner, it was agreed

the best course of action was to decommission and remove the shed as opposed to modifying the conservation easement. RS has offered, and the landowner has agreed, to construct a new shed, outside of the easement boundary, and to remove the old shed and equipment from the easement. This work is being schedule and will be completed before the final Year 1 Monitoring Report.

15. Lastly, a residential shed and equipment were noted in the vicinity of UT3 near the mowing and lawn maintenance encroachment. Please confirm that the shed and equipment are not located within the conservation easement. Please complete the full boundary assessment during MY1 (2022) and report findings and completed survey monumentation and marking updates in the MY1 (2022) report. This boundary assessment and marking effort should be completed before requested payment for Task 6 (MY0).

Response: K2 Designs, our contracted surveyor, visited the Site on 9/22 to verify the integrity of the site boundary, locate rebar/stamped caps, and replace/add easement signage as needed. During this review, it was confirmed, that the small (approximately 10x20) shed identified by DMS during the site visit is currently located within the easement. RS has offered, and the landowner has agreed, to construct a new shed, outside of the easement boundary, and to remove the old shed and equipment from the easement. This work is being schedule and will be completed before the final Year 1 Monitoring Report.

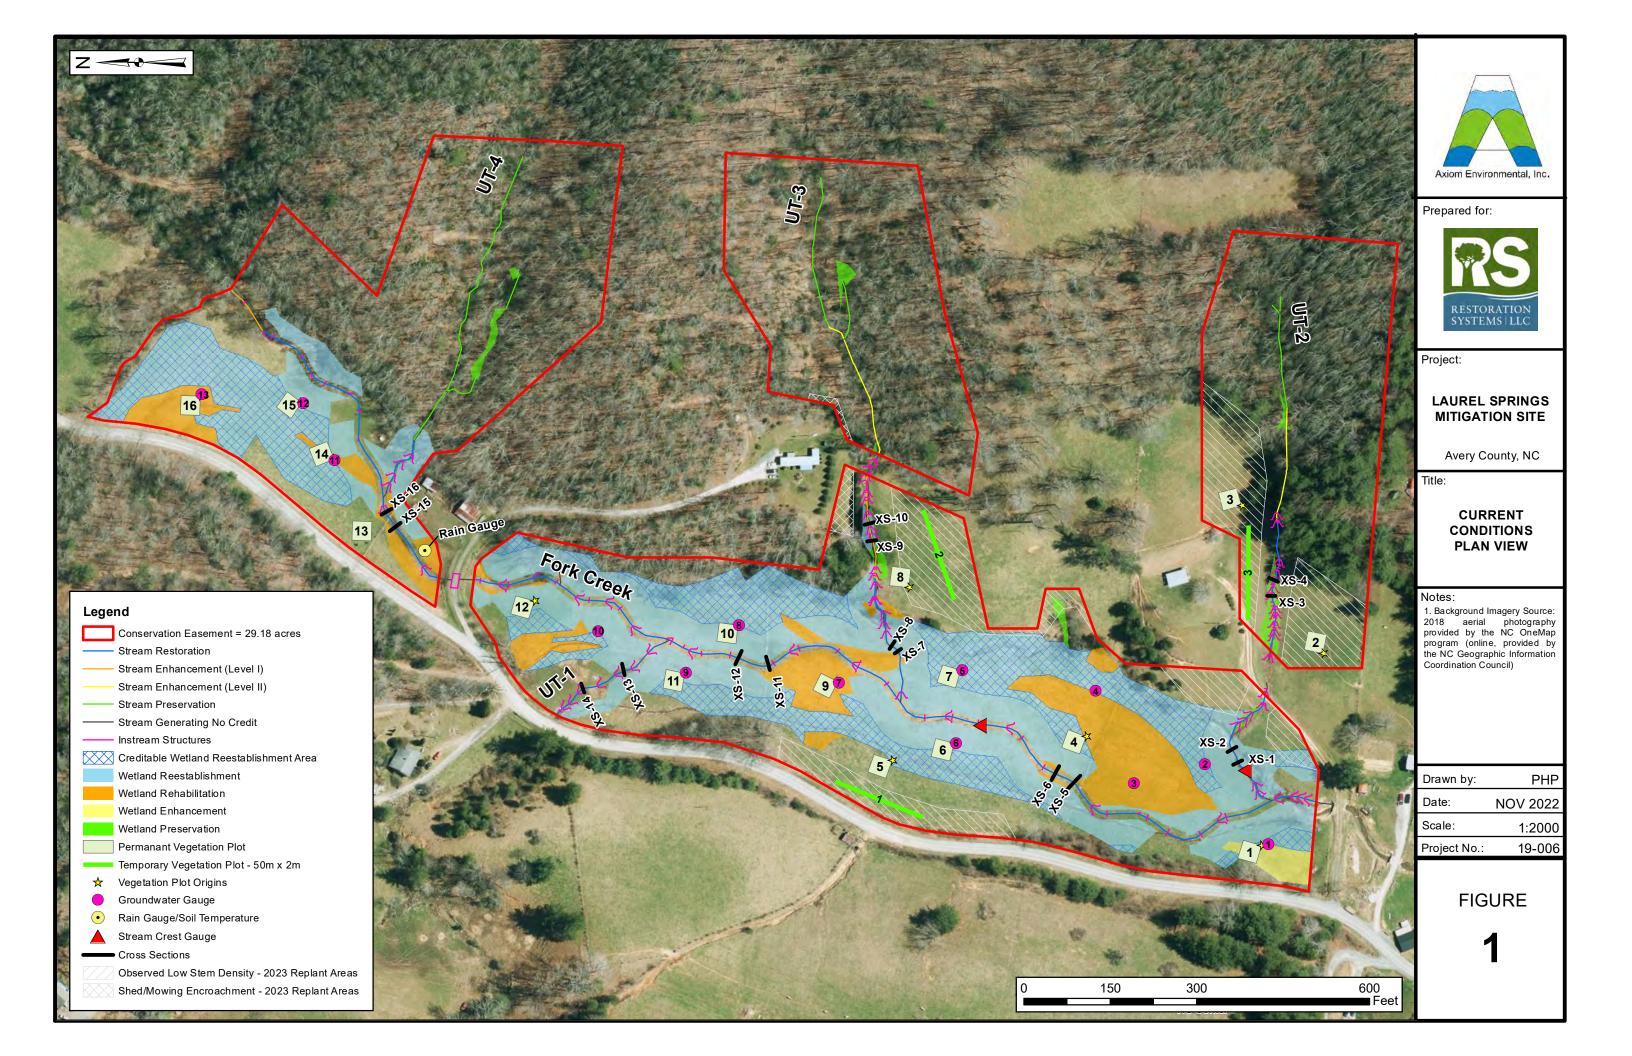
Figure 1. Current Conditions Plan View
Table 4A-E. Visual Stream Morphology Stability Assessment Table
Table 5. Vegetation Condition Assessment Table
Vegetation Plot Photographs
Photo Log
