MONITORING YEAR 0 ANNUAL REPORT FINAL

LAUREL VALLEY MITIGATION SITE

Burke County, NC
Catawba River Basin
HUC 03050101

DMS Project No. 100140

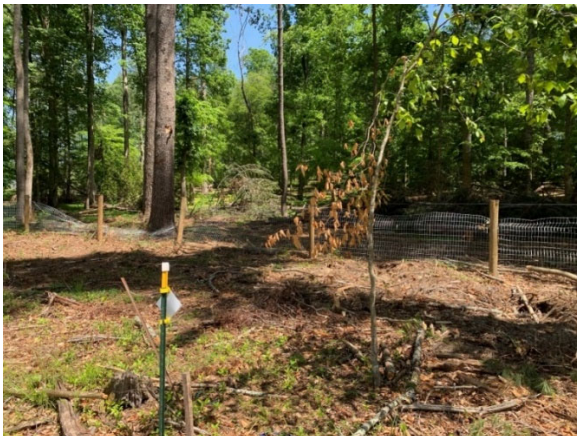
4. *Repair fence damaged by the fallen tree near corner #30.*

Wildlands Response: The fallen tree has been cleared from the fence. See the photo below. A fencing repair is scheduled to be completed by August 1. No livestock or animals are contained within the area where the fence is currently damaged. Wildlands will provide photos in the MY1 report of the completed fence repair.

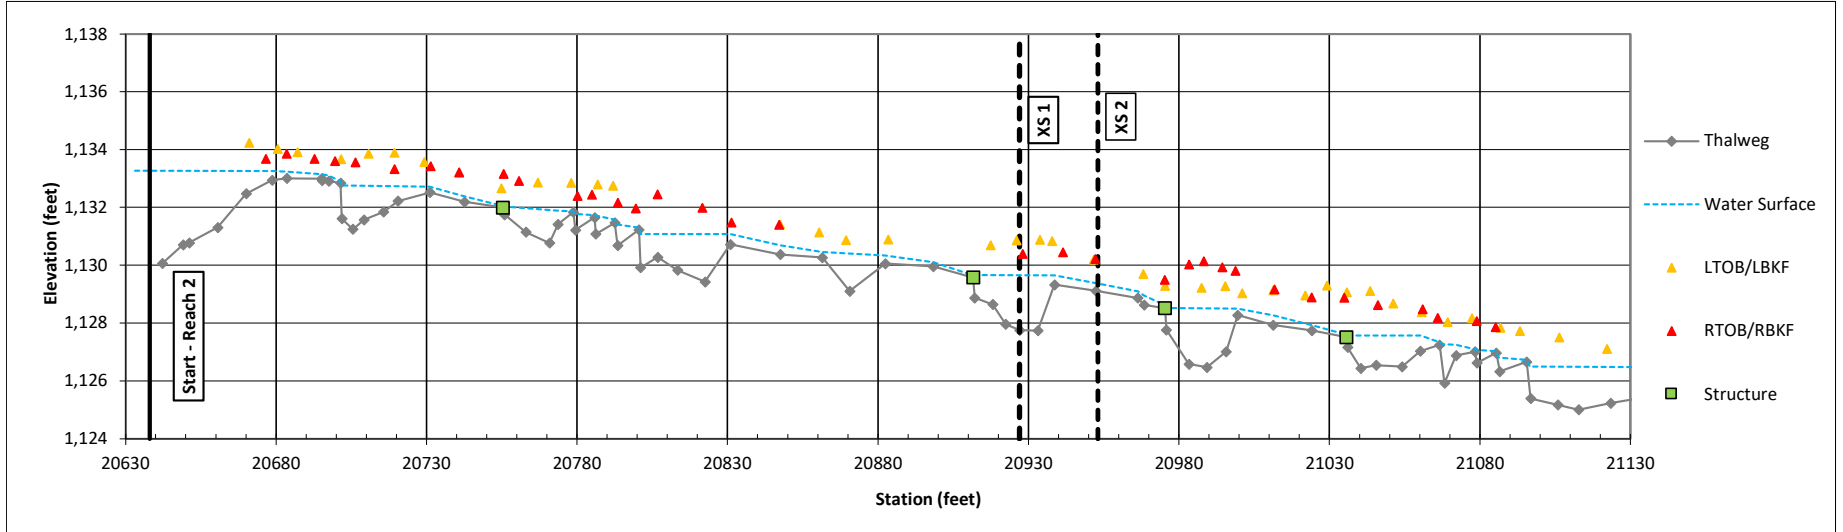
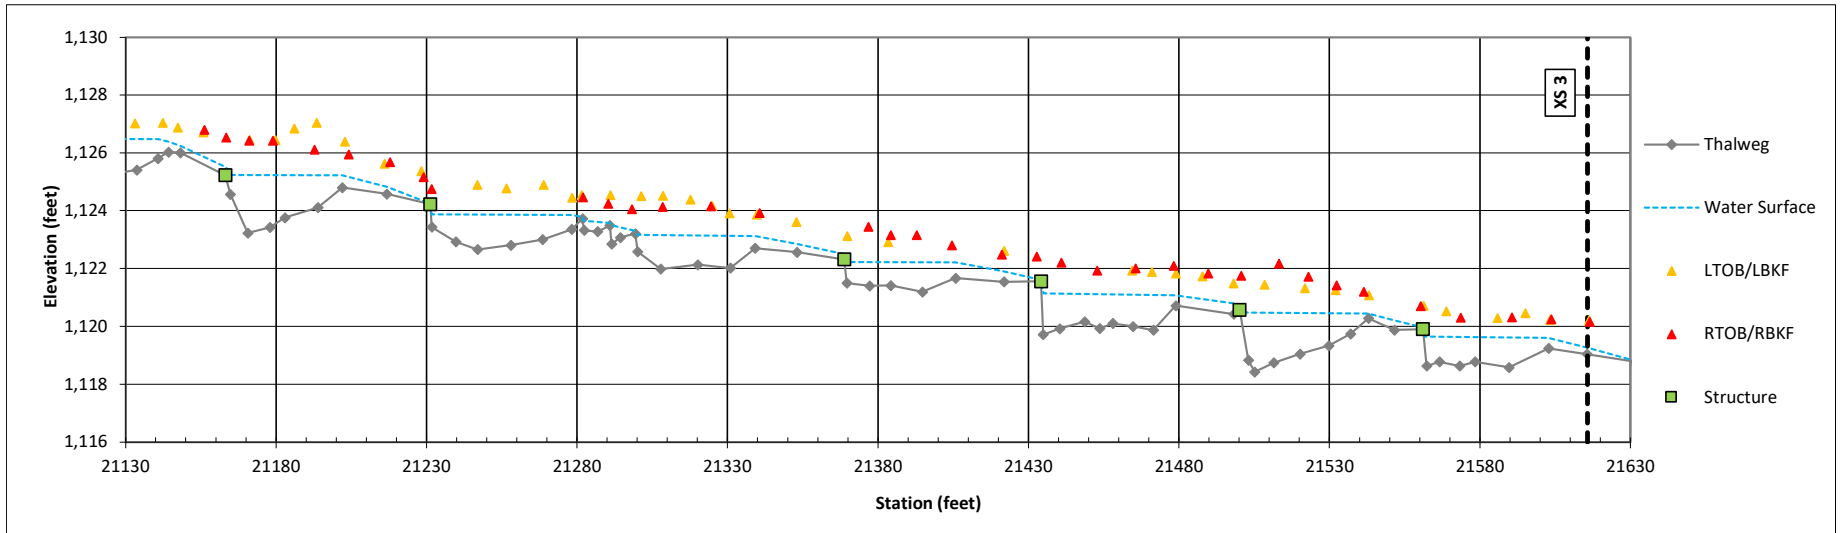
UT1 Reach 2 (STA 206+38 to 226+27)

Longitudinal Profile Plots

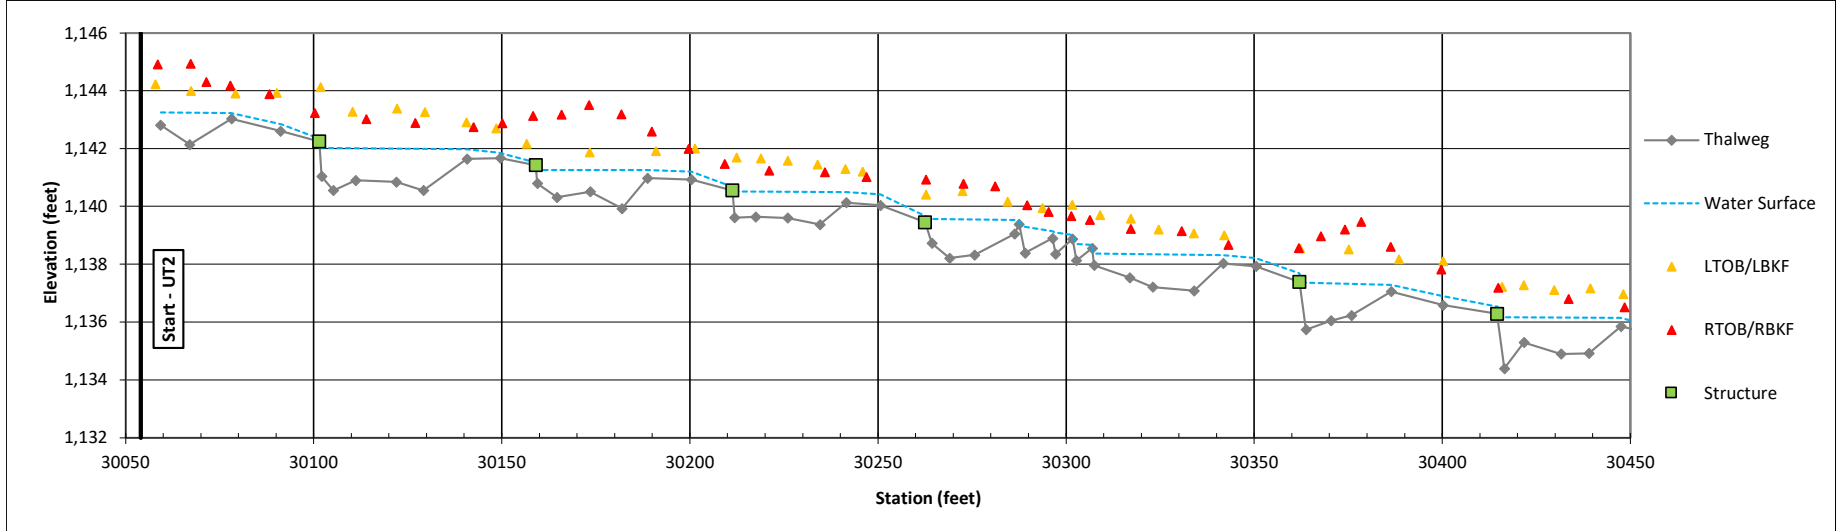
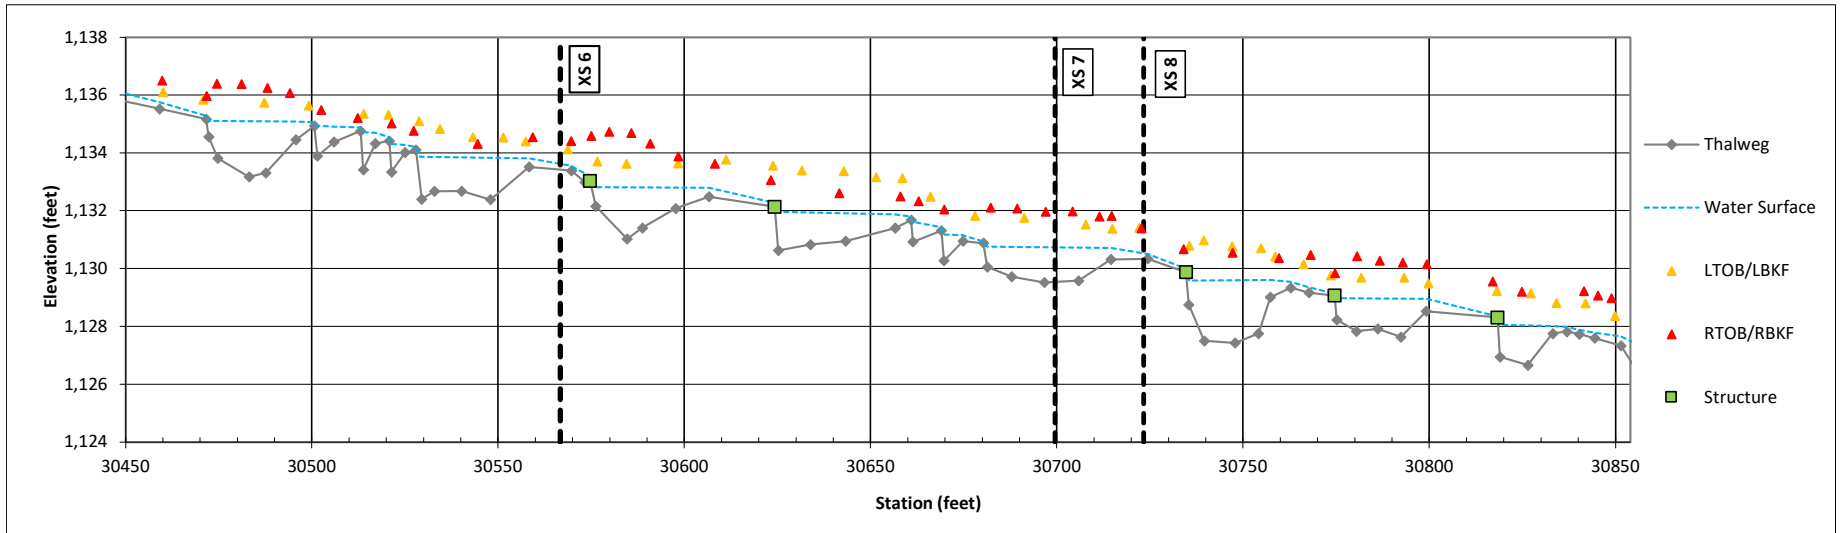
UT2 (STA 300+54 to 316+10)

Longitudinal Profile Plots

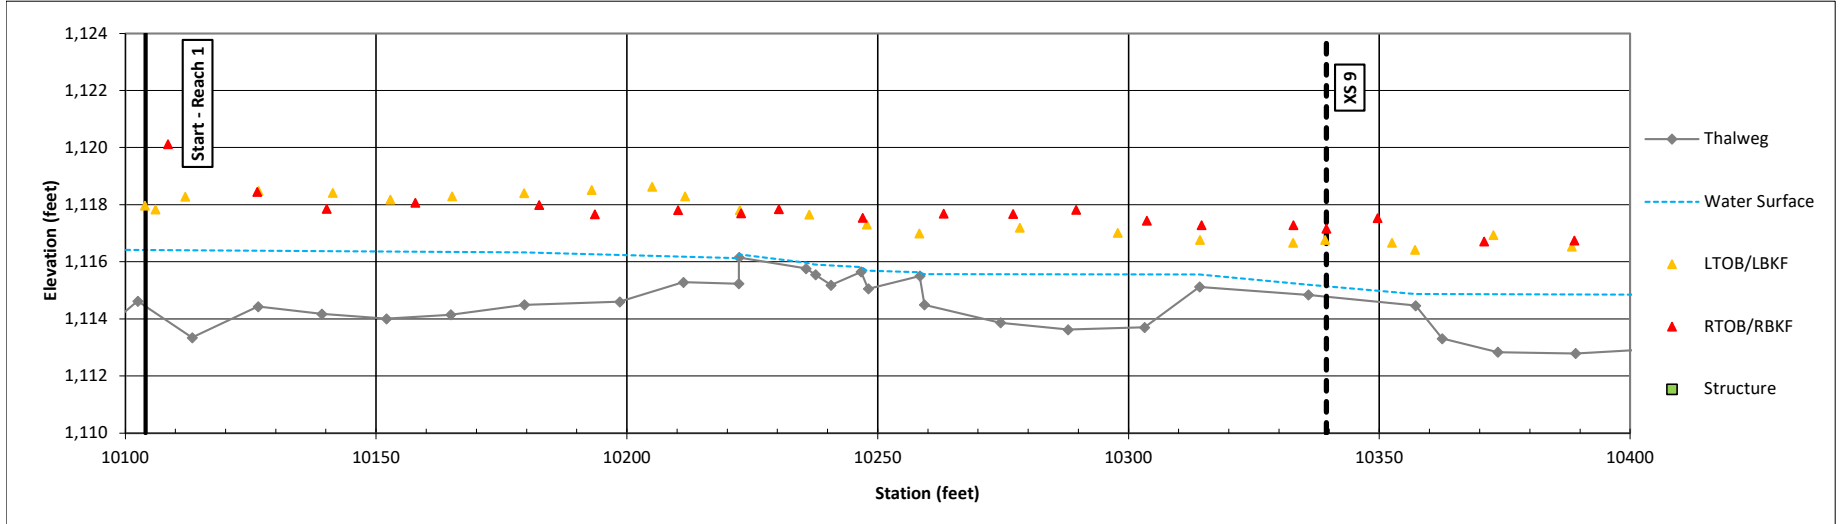
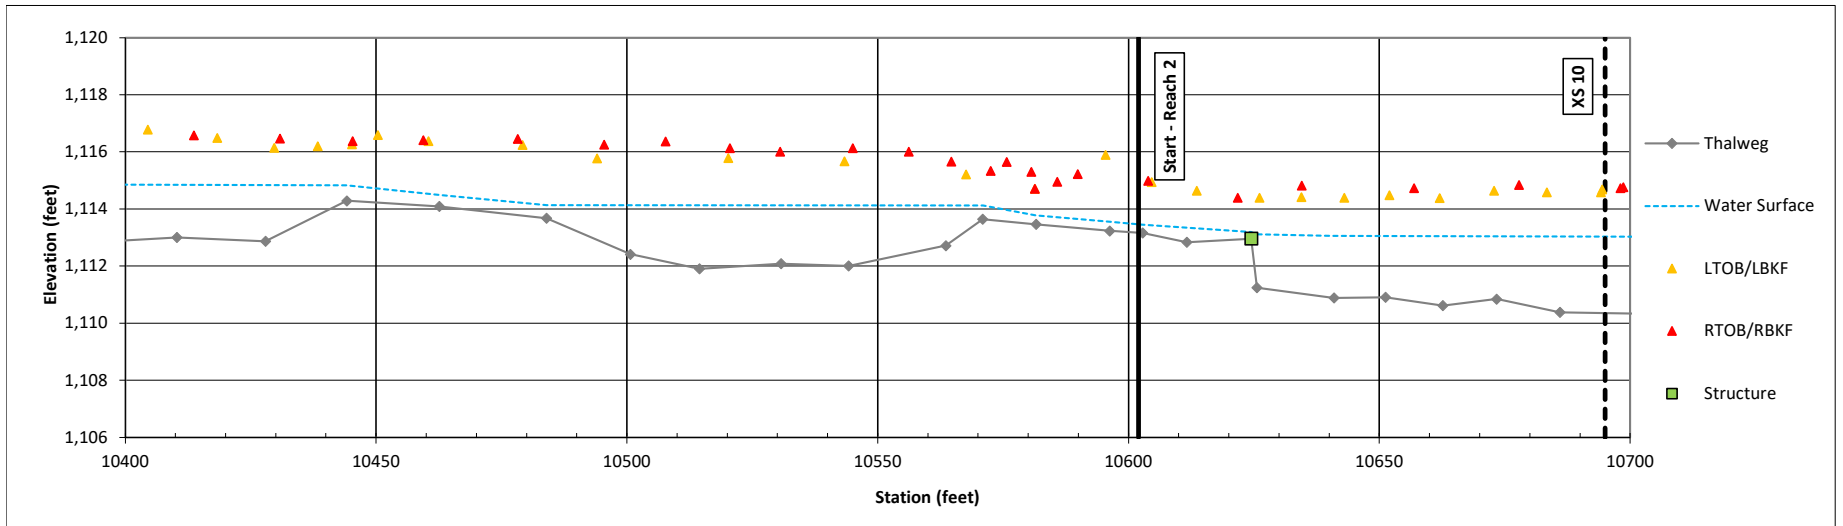
East Prong Hunting Creek (STA 101+04 to 112+88)

Longitudinal Profile Plots

- STA: 106+52 – STA: 106+73 – Cover log replaced brush toe for undercut bank, pool habitat.
- STA: 109+50 – STA: 109+76 – Cover log replaced brush toe for undercut bank, pool habitat.
- STA: 111+64 – As-built outlet ditch stabilized with rock sill and rock outlet stabilization for additional grade control.

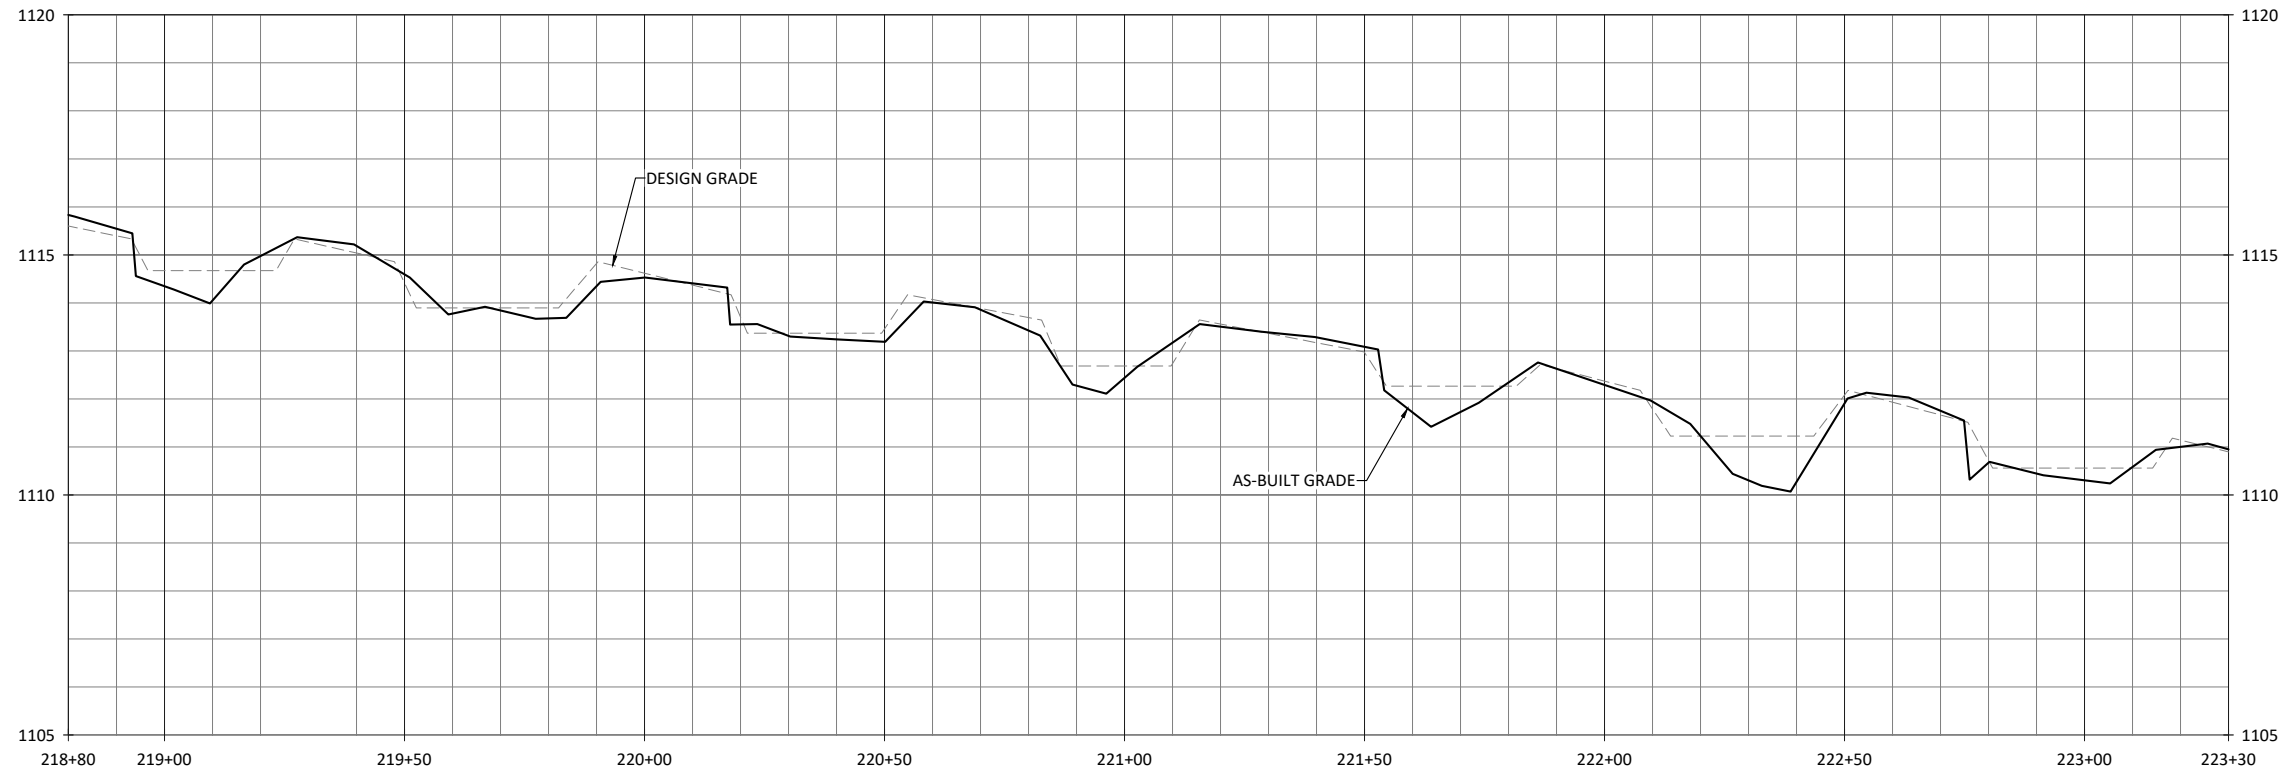
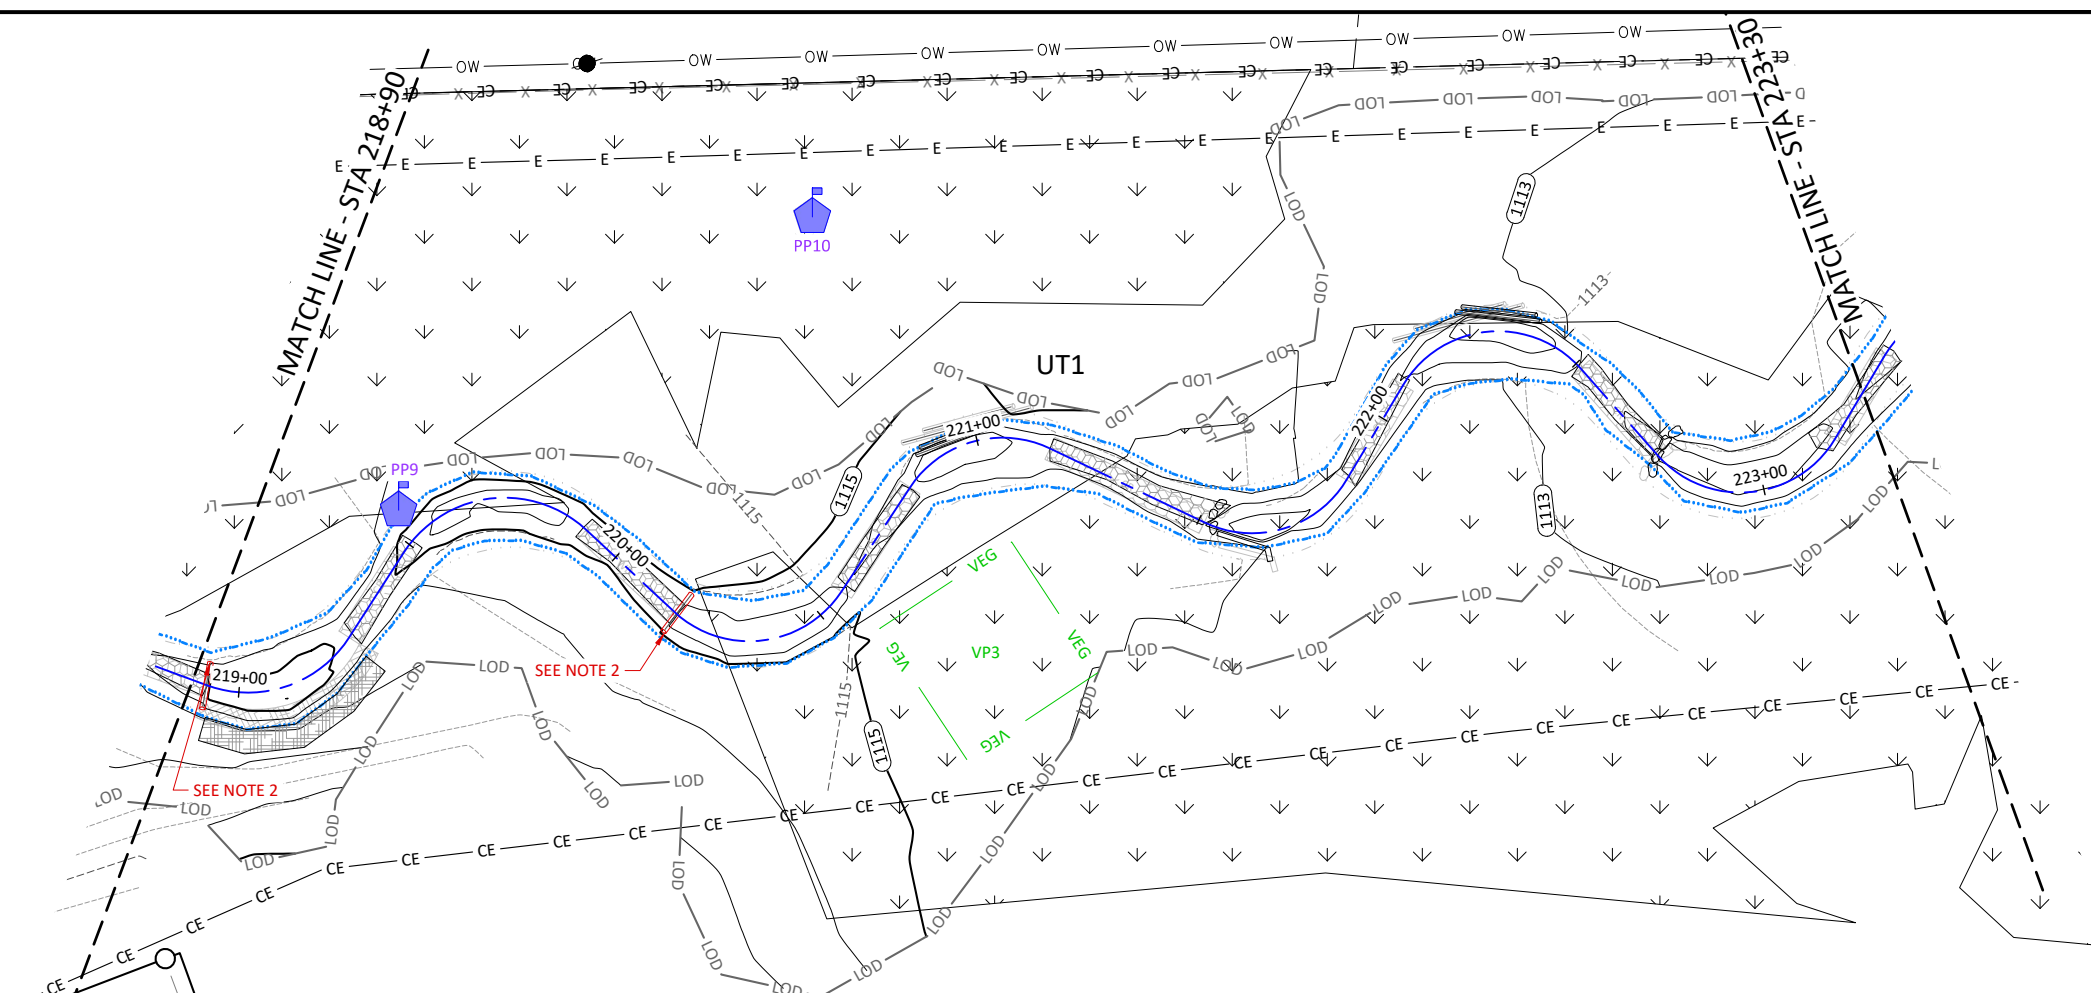
1.2.4
Sheet

- NOTES:
1. DEVIATIONS FROM THE DESIGN WILL BE SHOWN IN RED.
 2. STA 218+94 AND STA 220+17: LOG SILL ADDED FOR BED STABILITY

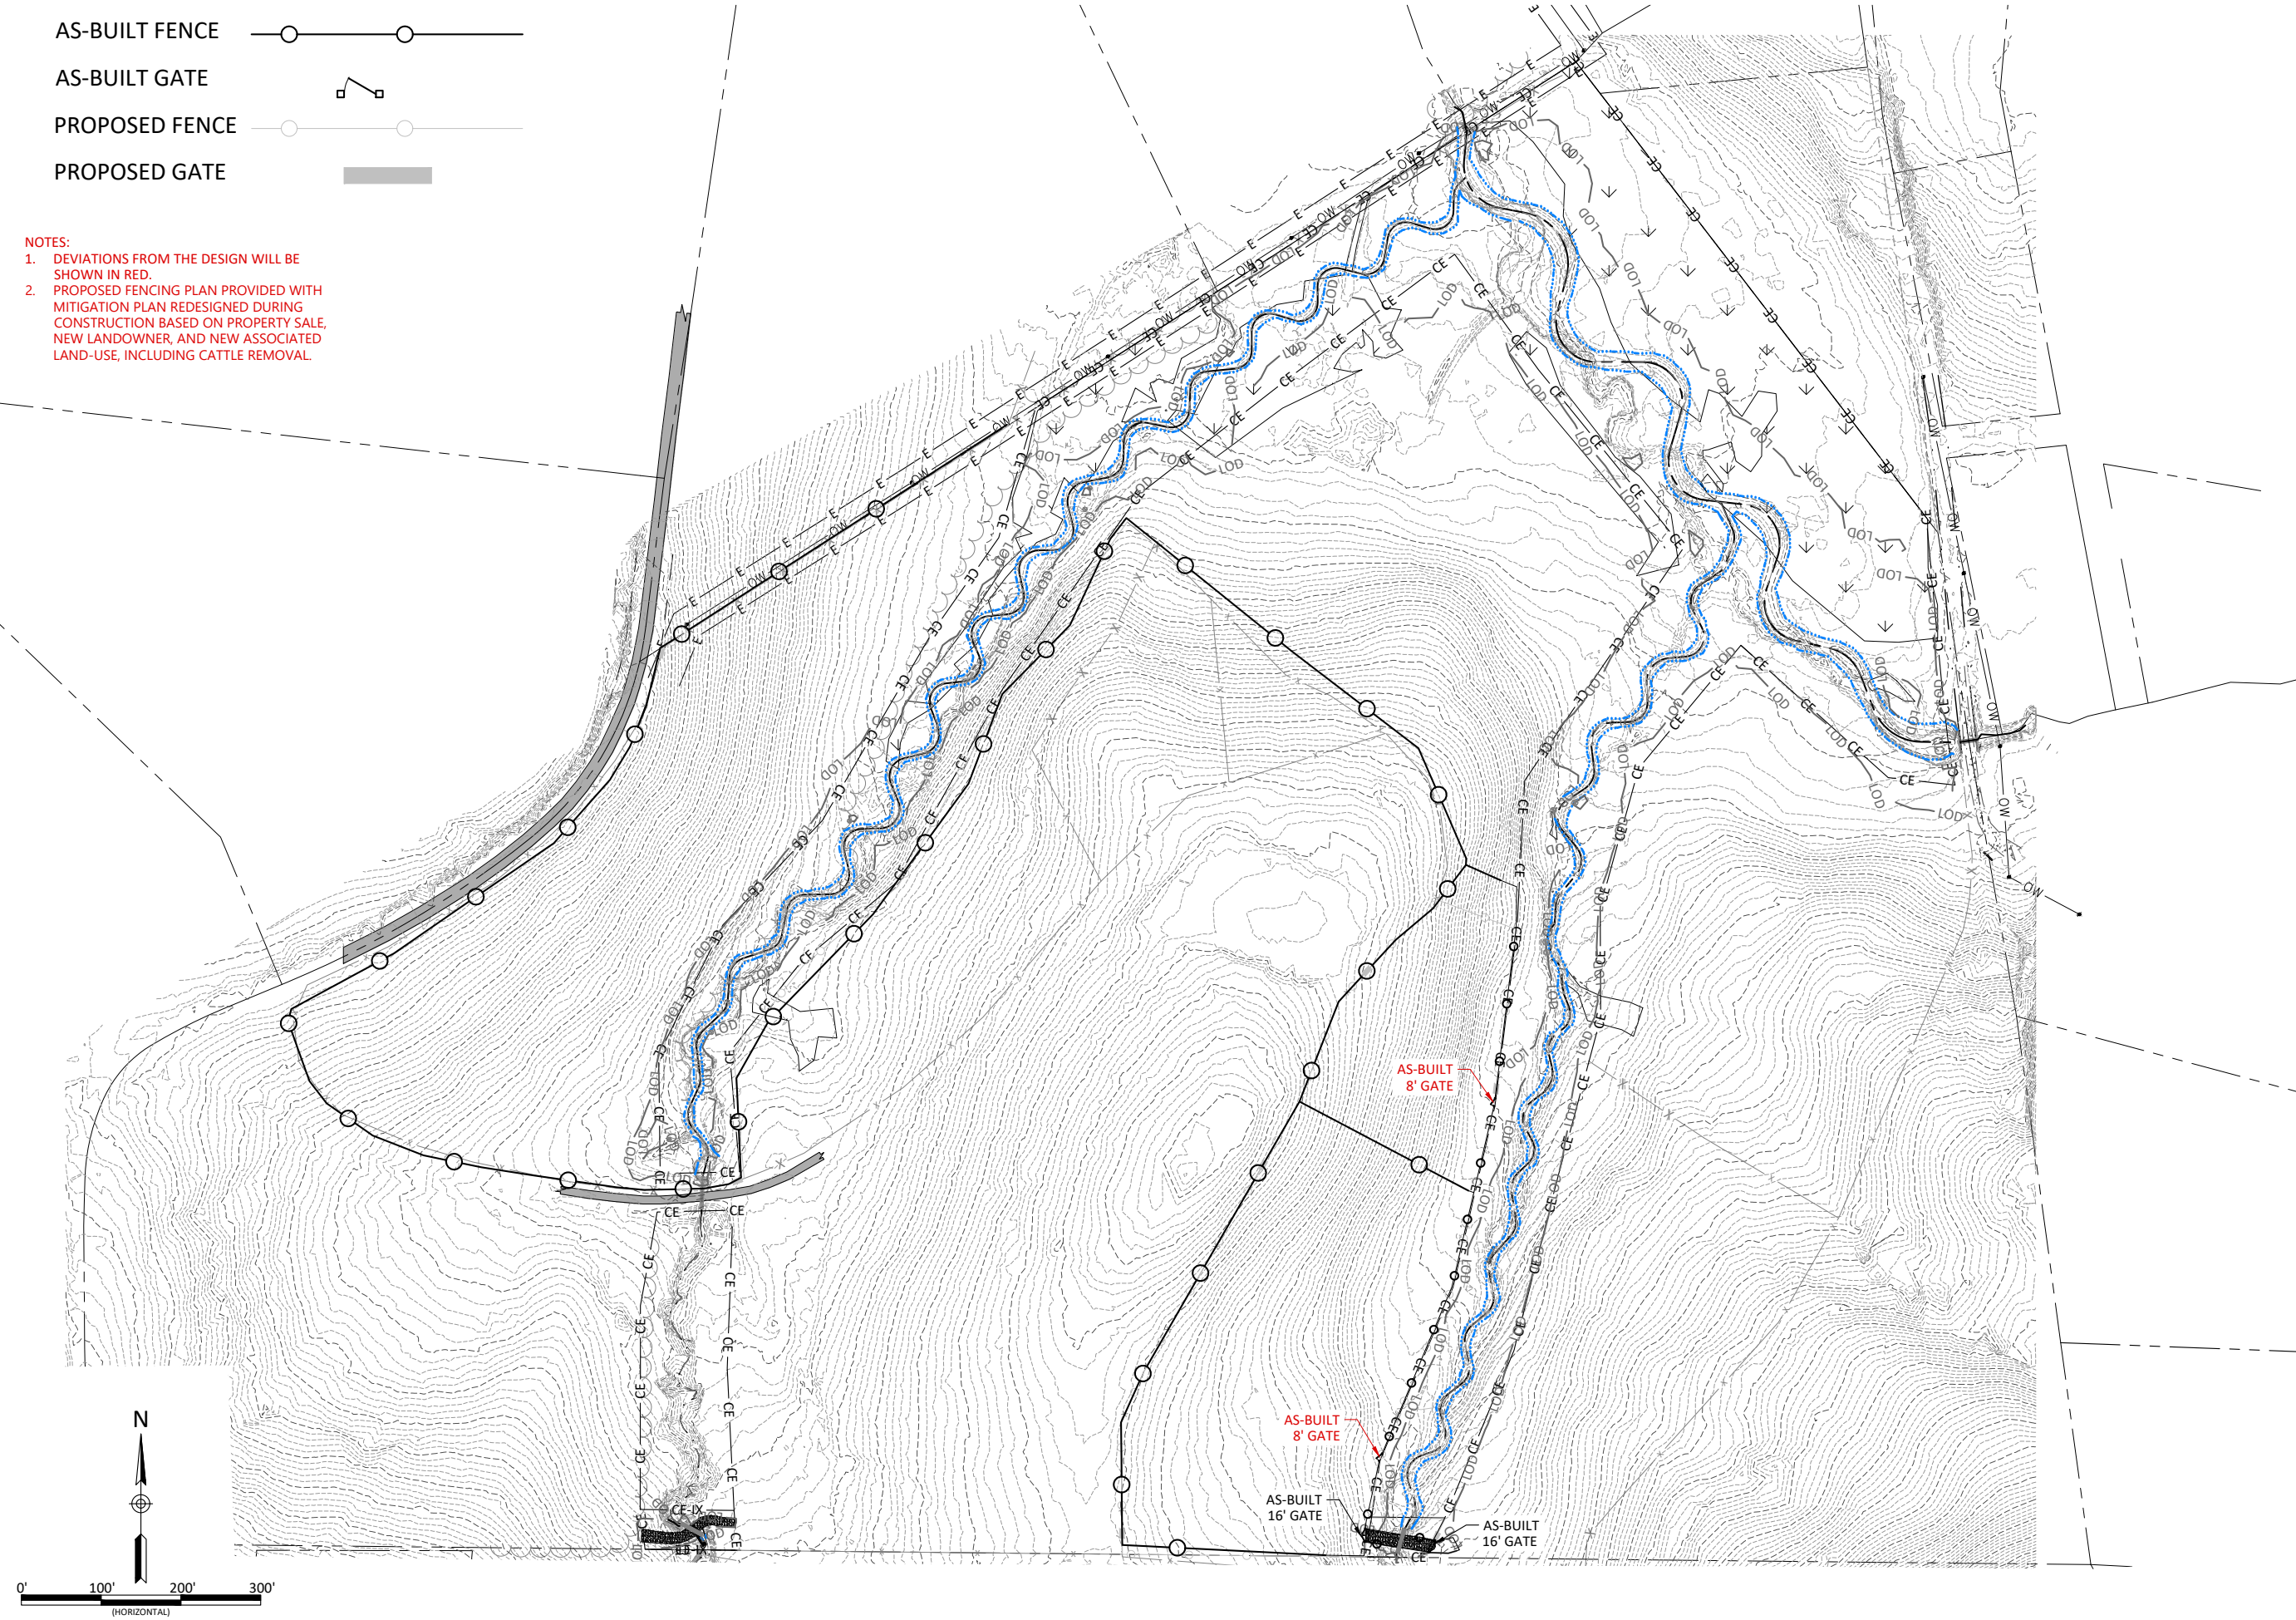
Fencing Plan
 Farm Plan

- NOTES:**
1. DEVIATIONS FROM THE DESIGN WILL BE SHOWN IN RED.
 2. PROPOSED FENCING PLAN PROVIDED WITH MITIGATION PLAN REDESIGNED DURING CONSTRUCTION BASED ON PROPERTY SALE, NEW LANDOWNER, AND NEW ASSOCIATED LAND-USE, INCLUDING CATTLE REMOVAL.

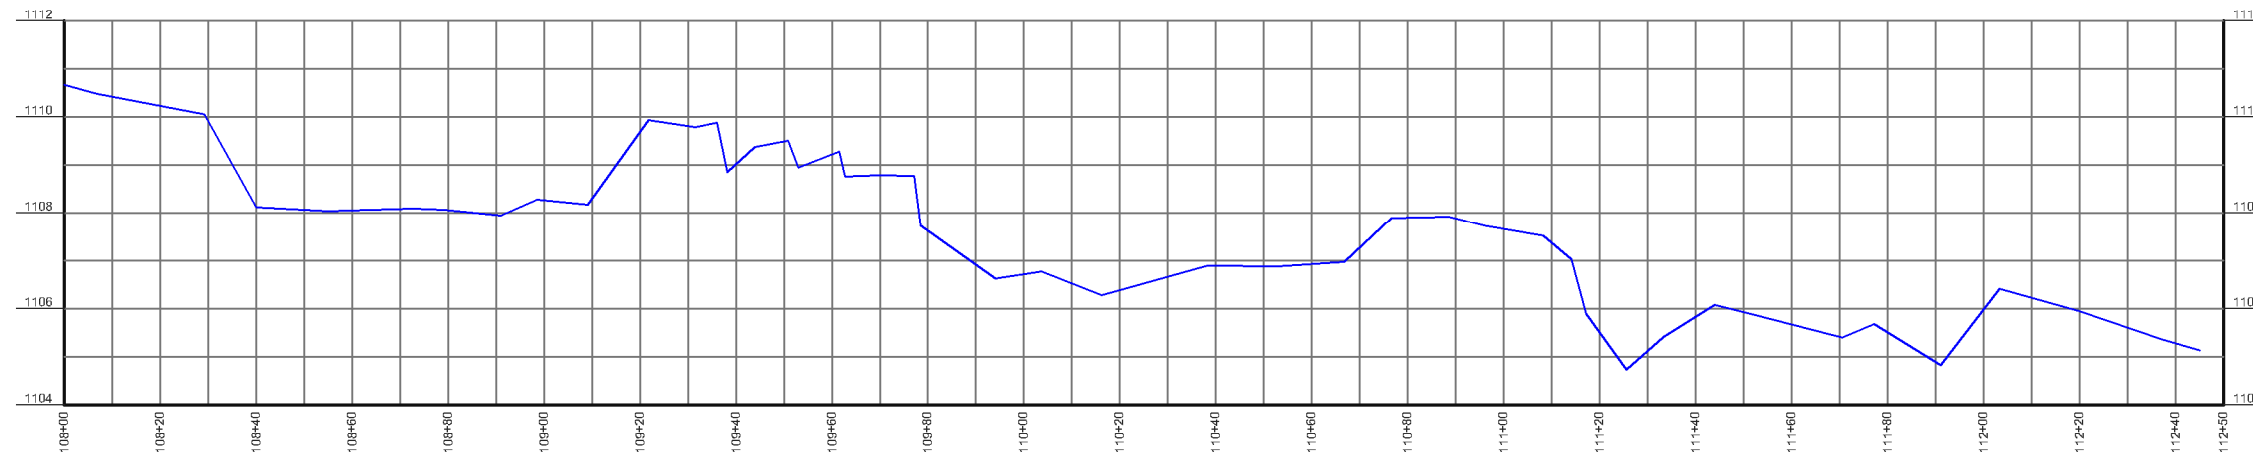
LONGITUDINAL PROFILE- EAST PRONG HUNTING CREEK (EPHC)

HORIZONTAL SCALE: 1" = 20' FULL SIZE, 1" = 40' HALF SIZE
 VERTICAL SCALE: 1" = 2' FULL SIZE, 1" = 4' HALF SIZE

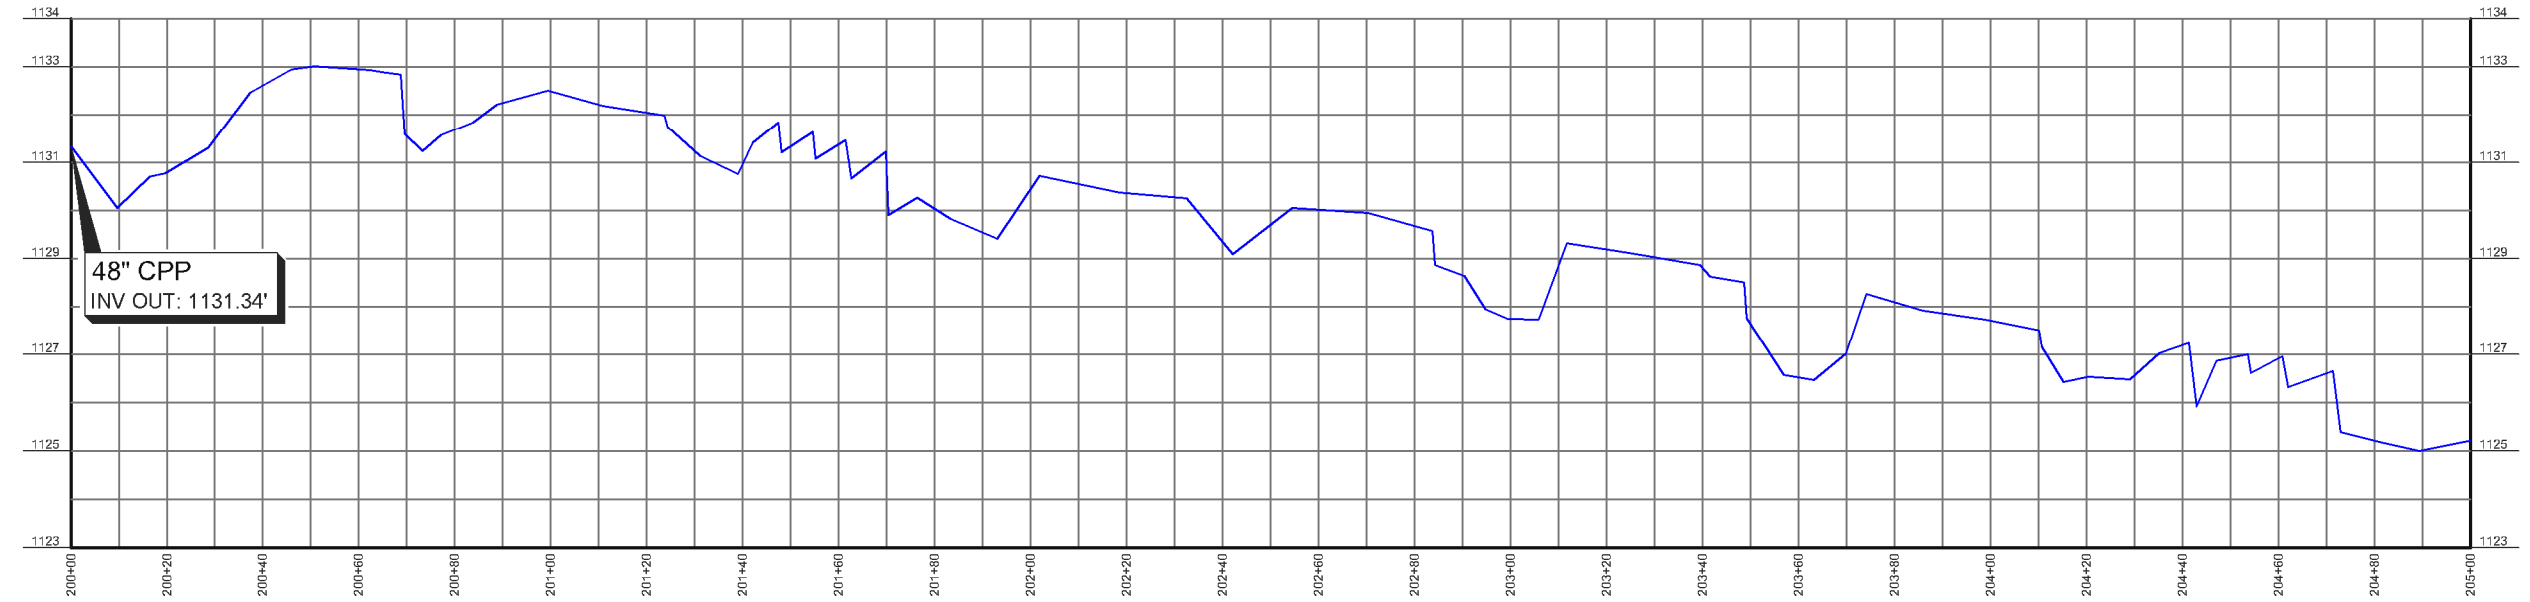
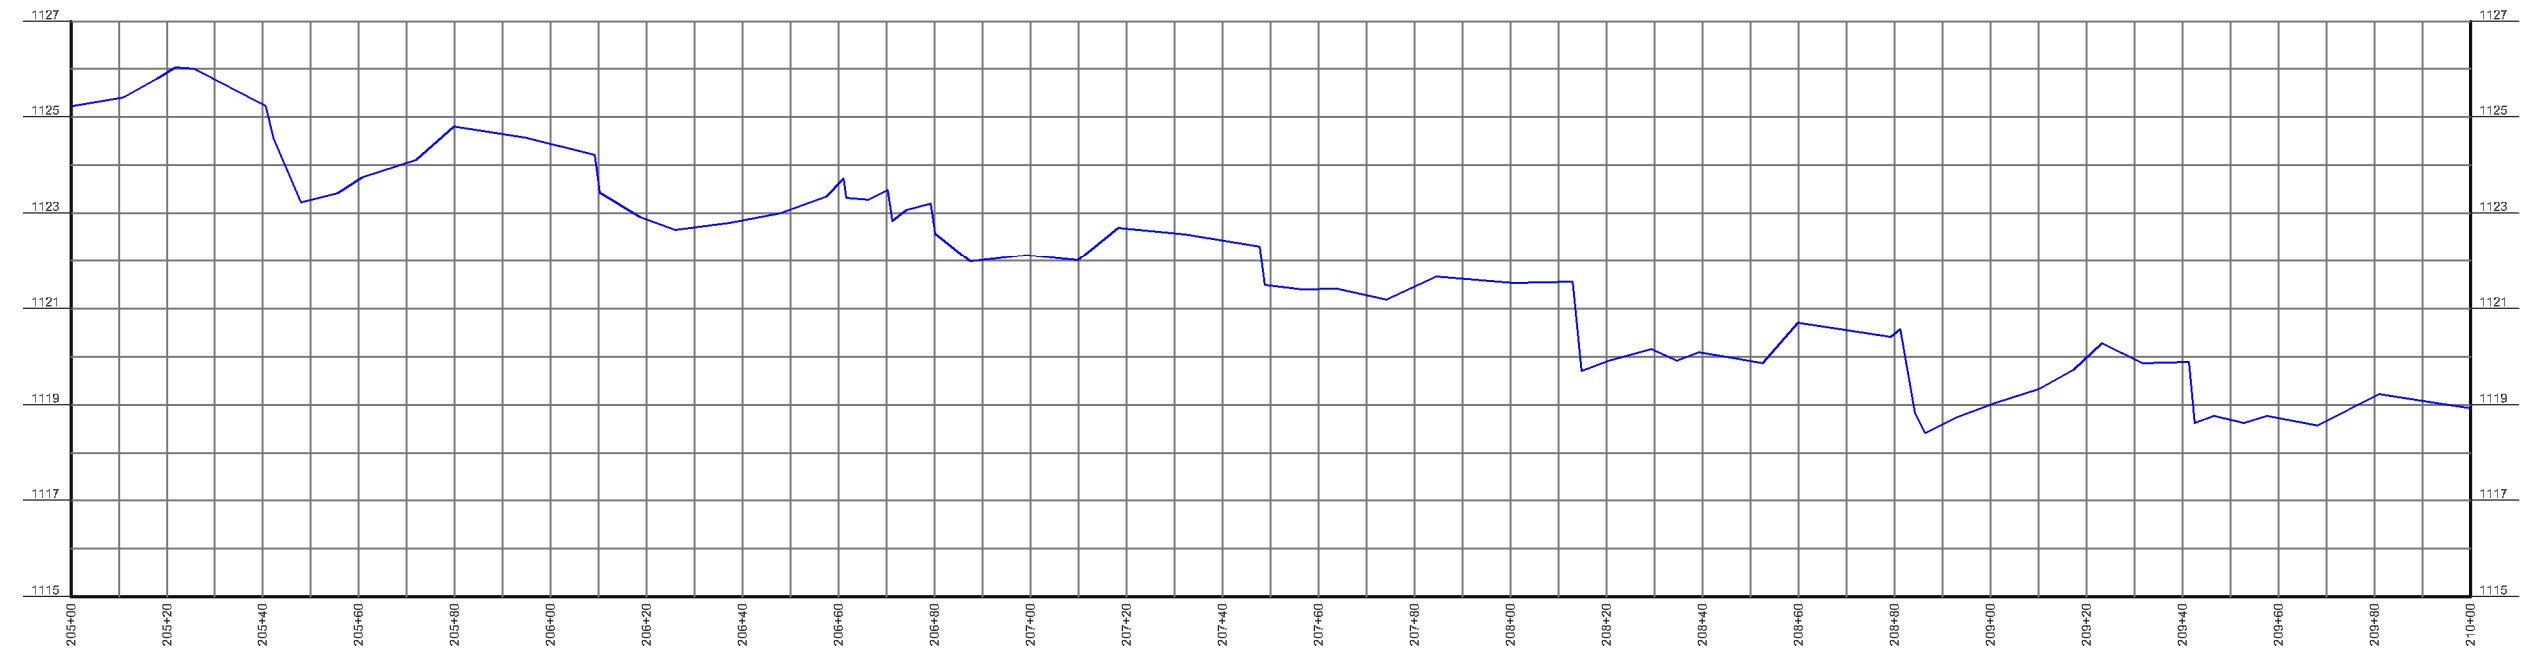
LONGITUDINAL PROFILE- UT1
HORIZONTAL SCALE: 1" = 20' FULL SIZE, 1" = 40' HALF SIZE
VERTICAL SCALE: 1" = 2' FULL SIZE, 1" = 4' HALF SIZE

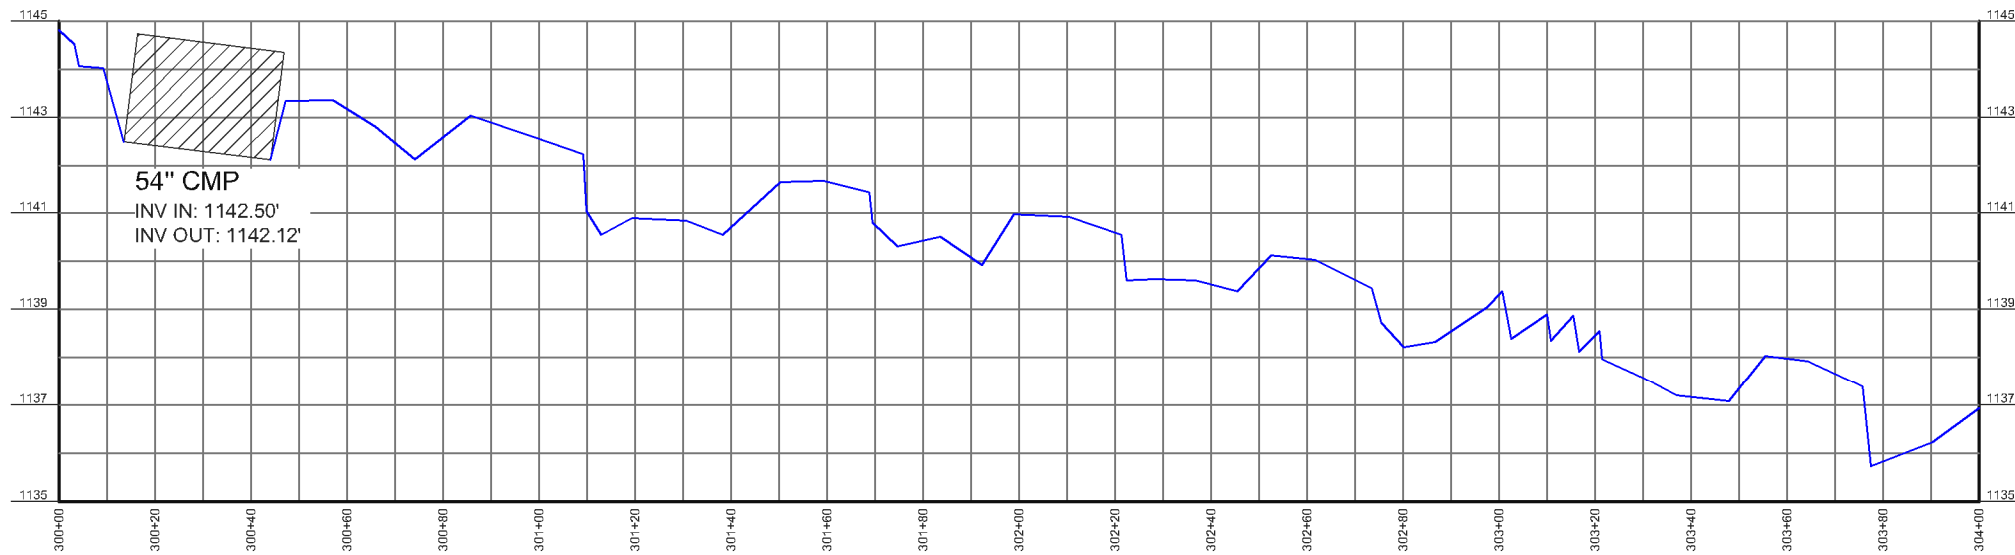
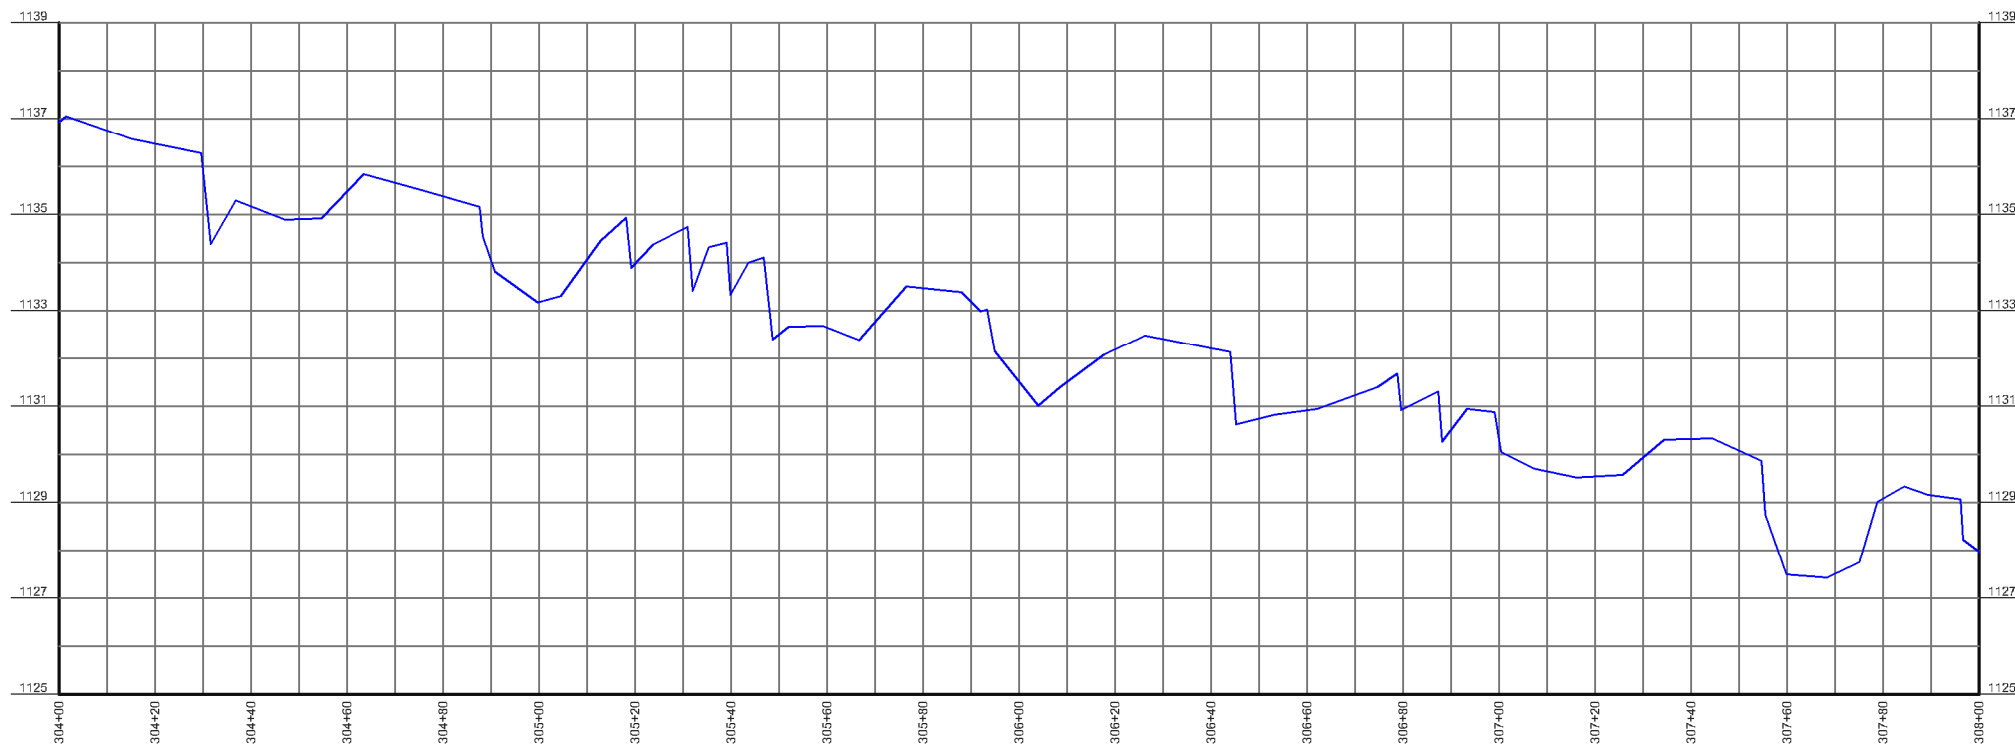
LONGITUDINAL PROFILE- UT2
 HORIZONTAL SCALE: 1" = 20' FULL SIZE, 1" = 40' HALF SIZE
 VERTICAL SCALE: 1" = 2' FULL SIZE, 1" = 4' HALF SIZE
