ANNUAL MONITORING REPORT

YEAR 2 (2007)

**LITTLE BUFFALO BUFFER MITIGATION SITE
JOHNSTON COUNTY, NORTH CAROLINA**

October 2007

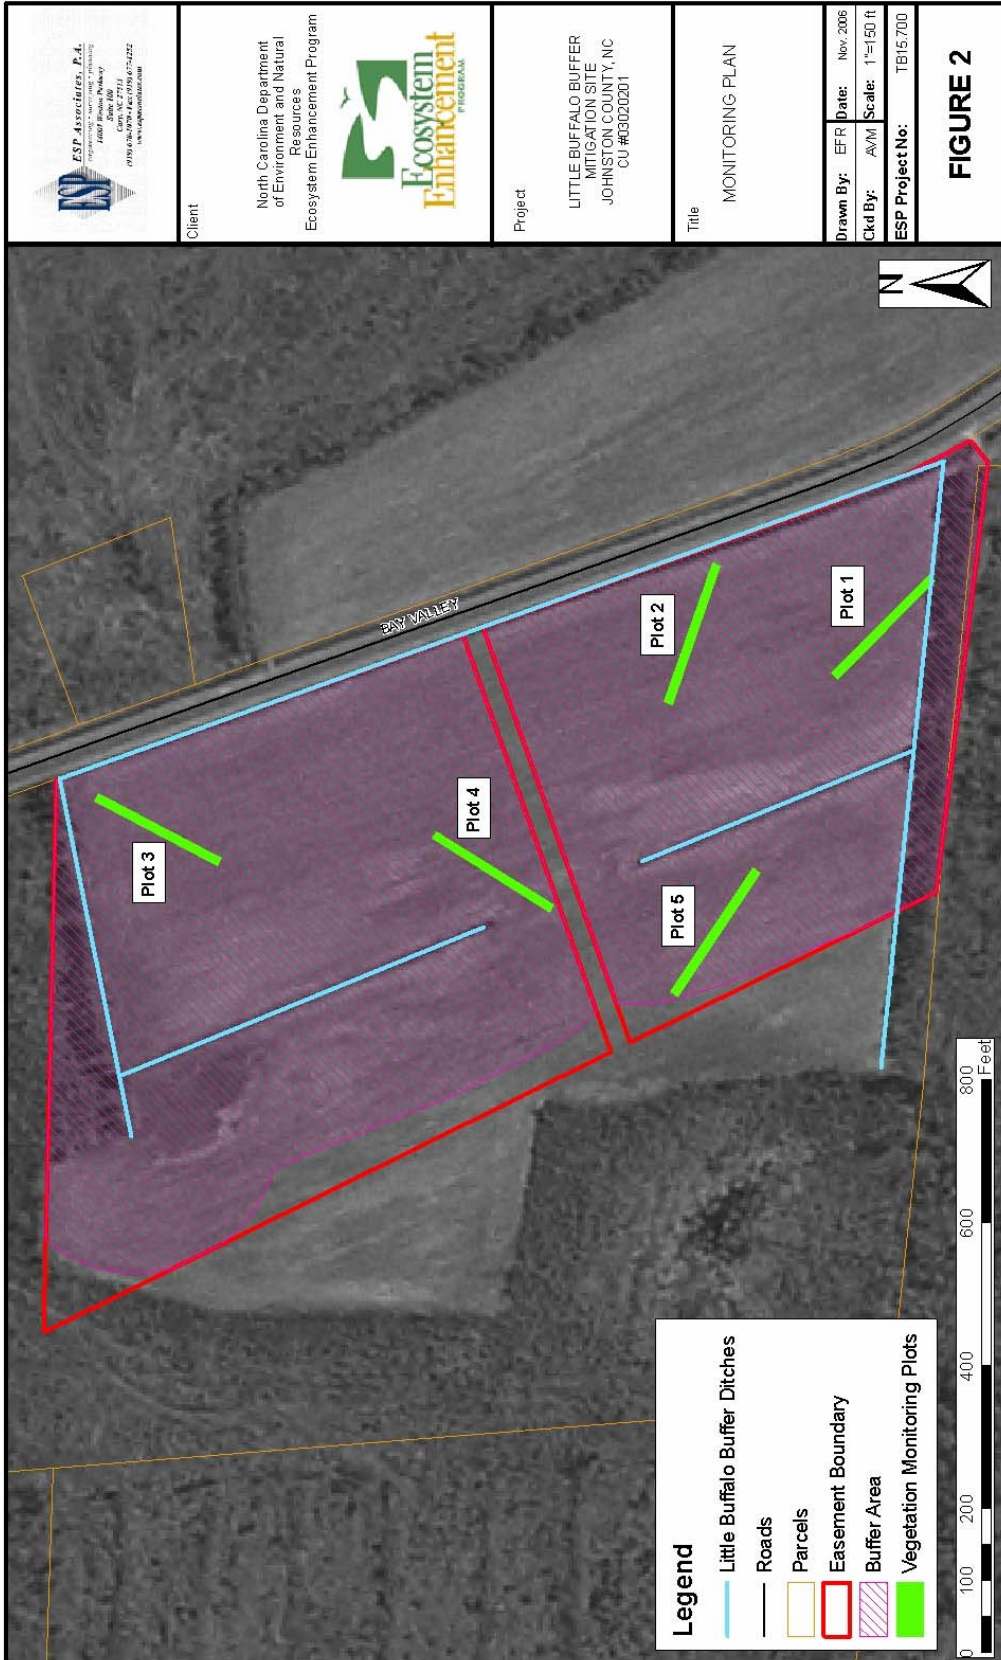
Monitoring procedures for vegetation were designed in accordance with *Stream Mitigation Guidelines* (USACE et al. 2003) and the *Draft Internal Guidance for Vegetation Monitoring Plans for NCWRP Riparian Buffer and Wetland Restoration Projects* (undated). A general discussion of the plant community restoration monitoring program is provided. Monitoring of restoration efforts will be performed for a minimum of 5 years or until success criteria are fulfilled. The locations of monitoring plots are shown in Figure 2.

Five sample transects were installed within planted areas of the Site shortly after replanting to equally represent the Site (Figure 2). Each transect is 200 feet in length and 12 feet in width (0.055 acre). In each sample plot, vegetation parameters that were monitored include species composition and species density. Photographs of the vegetation plots are included in Appendix A.
