ANNUAL MONITORING REPORT

YEAR 3 (2008)

**LITTLE BUFFALO BUFFER MITIGATION SITE
JOHNSTON COUNTY, NORTH CAROLINA**

September 2008

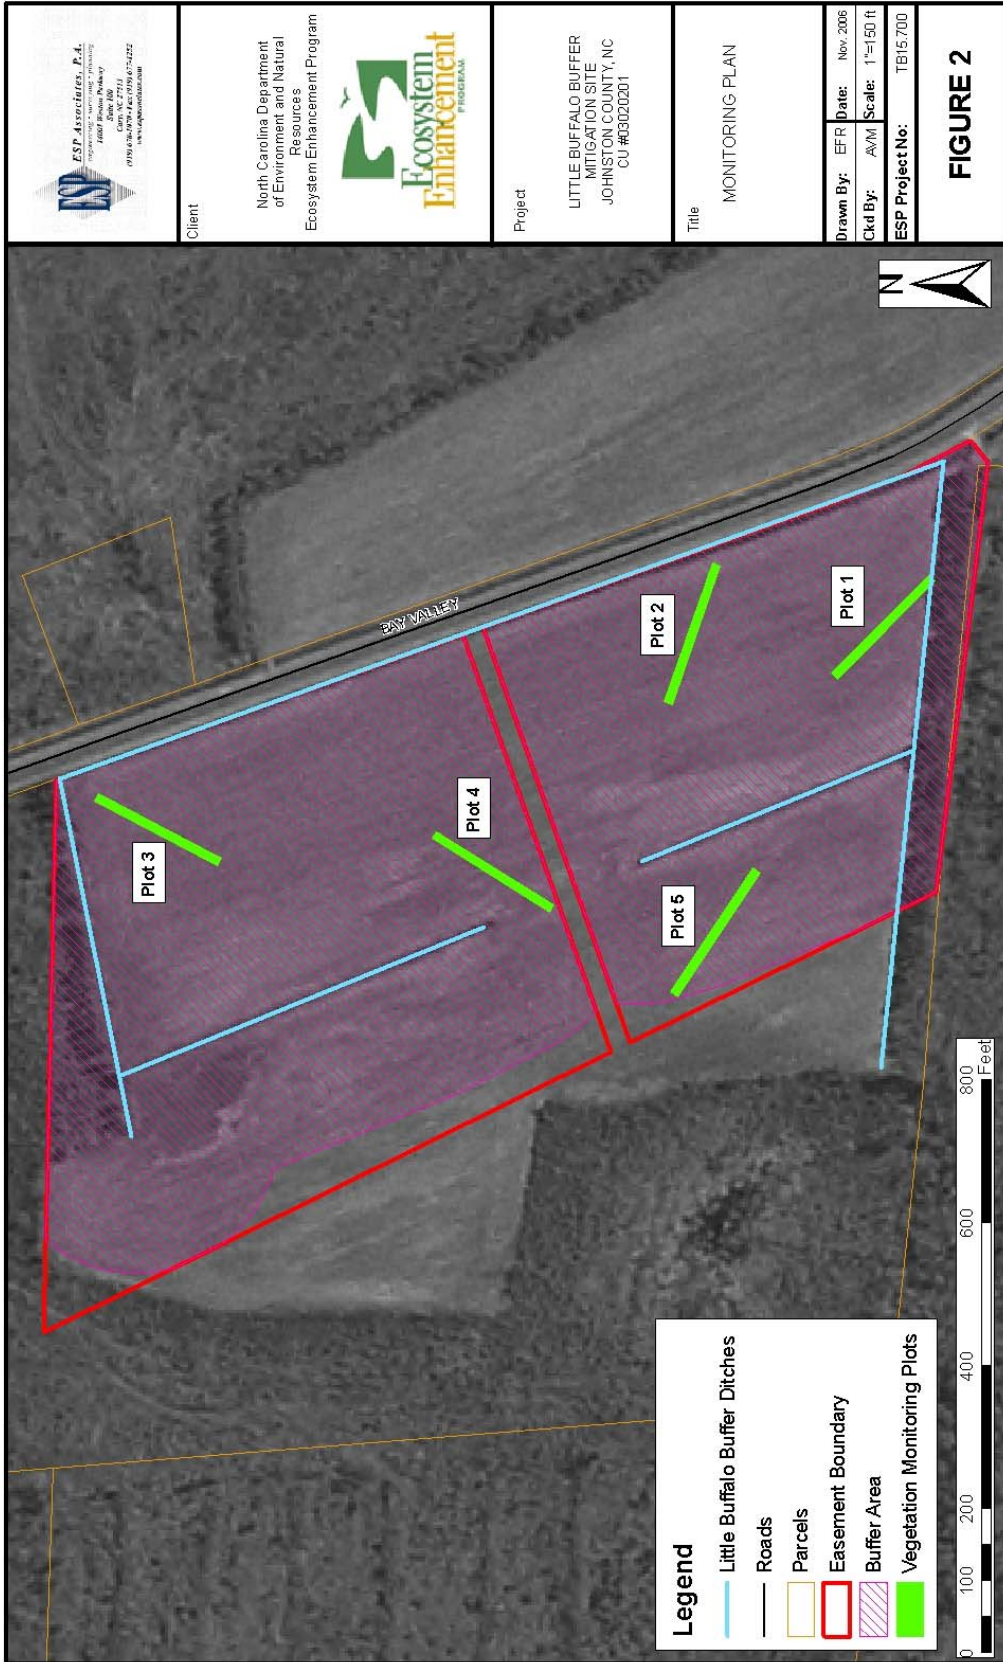
Monitoring procedures for vegetation were designed in accordance with *Stream Mitigation Guidelines* (USACE et al. 2003) and the *Draft Internal Guidance for Vegetation Monitoring Plans for NCWRP Riparian Buffer and Wetland Restoration Projects* (undated). A general discussion of the plant community restoration monitoring program is provided. Monitoring of restoration efforts will be performed for a minimum of 5 years or until success criteria are fulfilled. The locations of monitoring plots are shown in Figure 2.

Five sample transects were installed within planted areas of the Site shortly after replanting to equally represent the Site (Figure 2). Each transect is 200 feet in length and 12 feet in width (0.055 acre). In each sample plot, vegetation parameters that were monitored include species composition and species density. Photographs of the vegetation plots are included in Appendix A.
