**ANNUAL MONITORING REPORT**

**YEAR 4 (2009)**

**Contract D05015-1**

**LITTLE BUFFALO BUFFER MITIGATION SITE  
JOHNSTON COUNTY, NORTH CAROLINA**

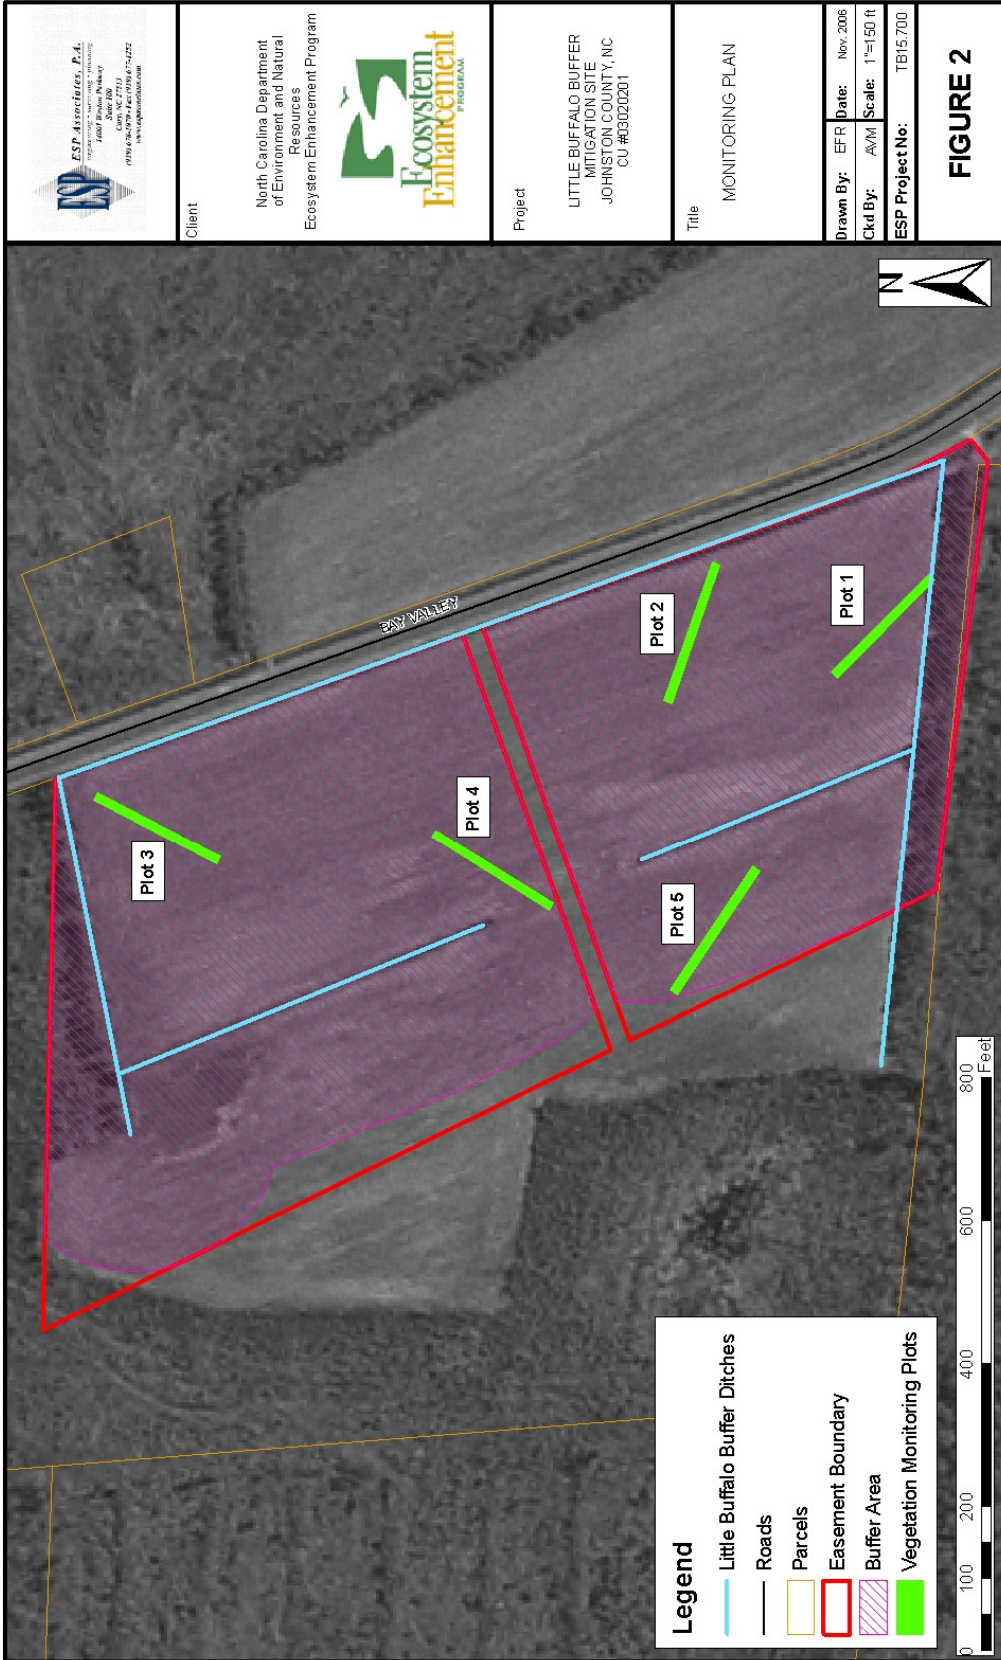
Monitoring procedures for vegetation were designed in accordance with *Stream Mitigation Guidelines* (USACE et al. 2003) and the *Draft Internal Guidance for Vegetation Monitoring Plans for NCWRP Riparian Buffer and Wetland Restoration Projects* (undated). A general discussion of the plant community restoration monitoring program is provided. Monitoring of restoration efforts will be performed for a minimum of 5 years or until success criteria are fulfilled. The locations of monitoring plots are shown in Figure 2.

Five sample transects were installed within planted areas of the Site shortly after replanting to equally represent the Site (Figure 2). Each transect is 200 feet in length and 12 feet in width (0.055 acre). In each sample plot, vegetation parameters that were monitored include species composition and species density. Photographs of the vegetation plots are included in Appendix A.
