ANNUAL MONITORING REPORT

YEAR 5 (2010)

**LITTLE BUFFALO BUFFER MITIGATION SITE
JOHNSTON COUNTY, NORTH CAROLINA**

October 2010

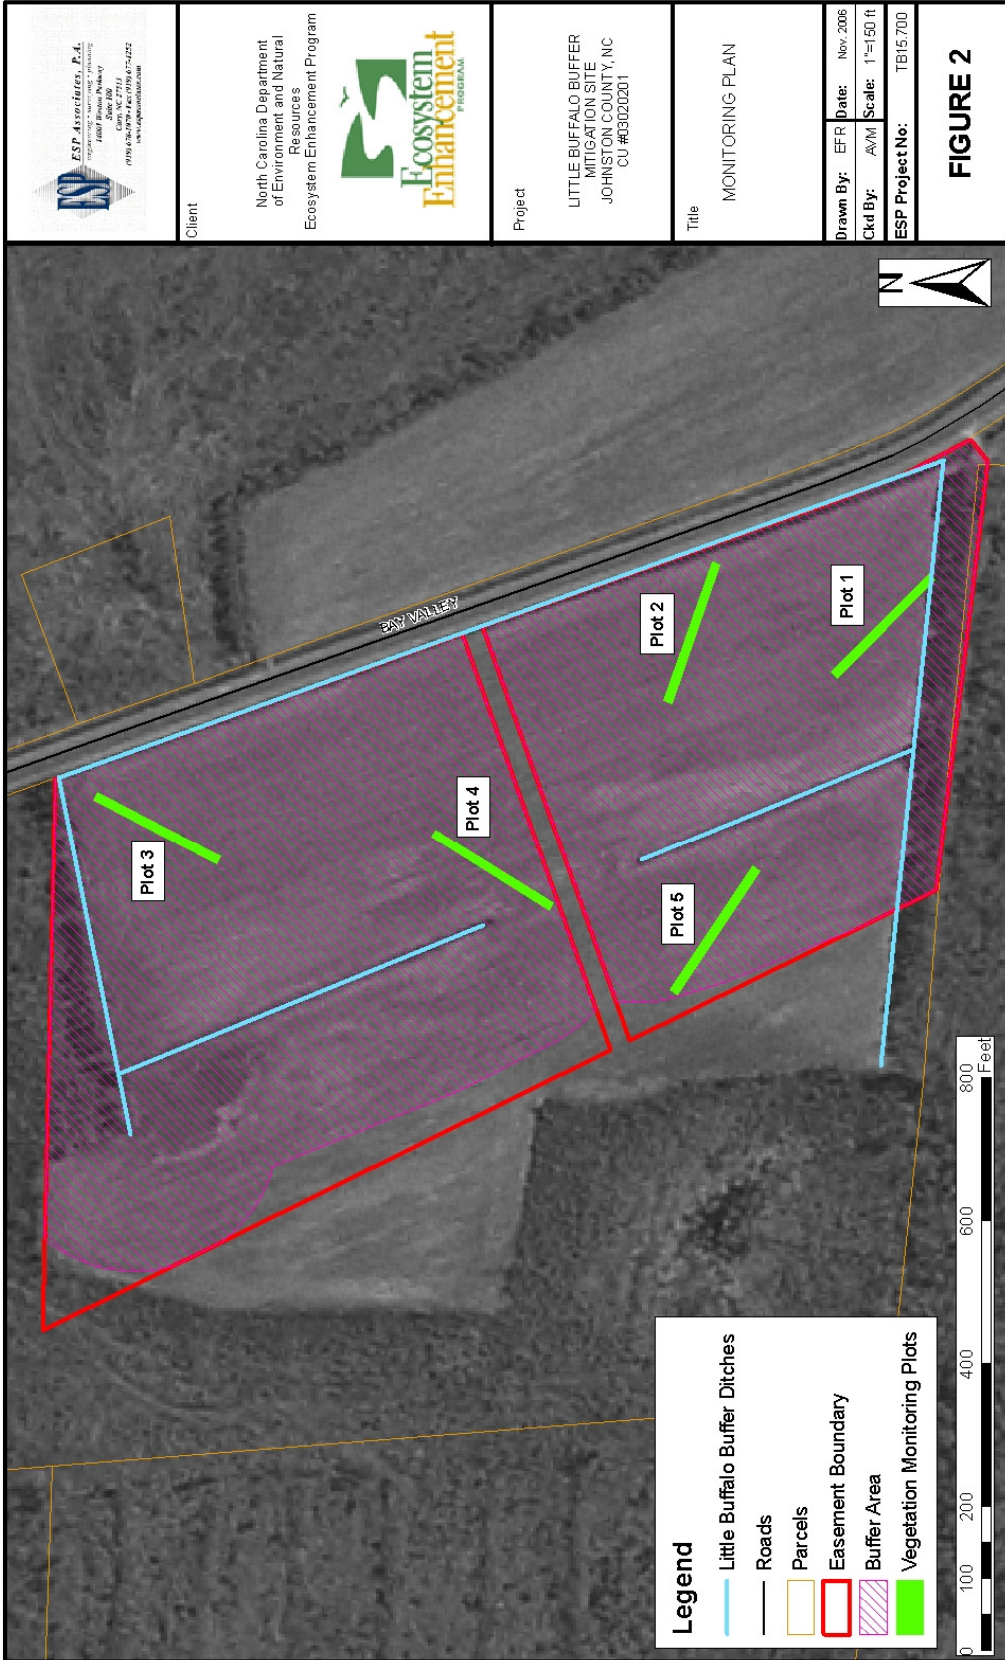
Monitoring procedures for vegetation were designed in accordance with *Stream Mitigation Guidelines* (USACE et al. 2003) and the *Draft Internal Guidance for Vegetation Monitoring Plans for NCWRP Riparian Buffer and Wetland Restoration Projects* (undated). A general discussion of the plant community restoration monitoring program is provided. Monitoring of restoration efforts have been performed for 5 years to ensure success criteria are fulfilled. The locations of monitoring plots are shown in Figure 2.

Five sample transects were installed within planted areas of the Site shortly after planting. Efforts were made to ensure that locations of sample plots would not unfairly favor any portion of the buffer site (Figure 2). Each transect is 200 feet in length and 12 feet in width (0.055 acre). Vegetation parameters that were monitored include species composition and species density. Photographs of the vegetation plots are included in Appendix A.
