Little Grassy Creek Project

Mitigation Plan Report

Granville County, North Carolina

Monitoring Firm: Baker Engineering
Monitoring Firm POC: Kevin Tweedy
Monitoring Firm Project Manager: Joshua White
NCEEP Project Manager: Robin Dolin
SCO #: 0501661501
Prepared for: NCDENR - Ecosystem Enhancement Program
2728 Capital Blvd, Suite 1H 1032728
Raleigh, NC 27604
Date Submitted: March 2008

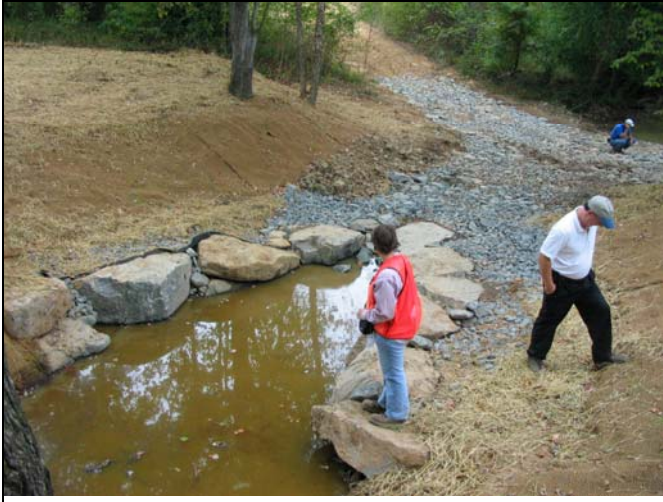
Cross vane Photo Point on Little Grassy Creek

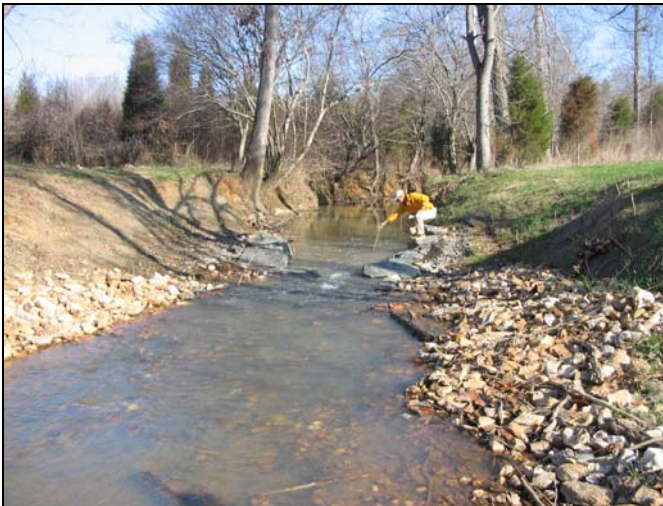
Cross vane on Little Grassy Creek during final walk-through

Construction of the in-stream structure (cross vane) for enhancement portion of Little Grassy Creek began at approximately 126+00, downstream of a failed concrete ford crossing. Upon completion of the cross vane structure, the banks were seeded, mulched, matted, and livestaked. The concrete ford crossing was removed and replaced with a stone ford crossing. The as-built cross-section and longitudinal profile are shown in Appendix B. Further upstream along Little Grassy Creek, near station 88+00, an existing ford crossing and its sideslopes were reconstructed for stability and an adjacent culvert (outside the conservation easement) was repaired and stabilized on-site as a landowner's requirement.

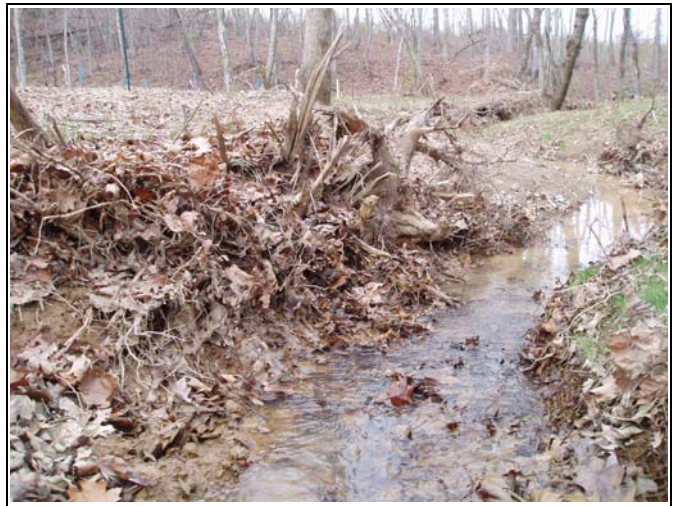
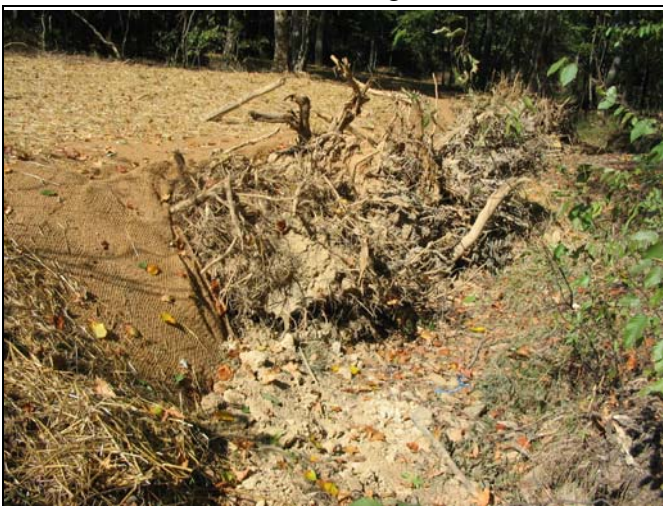
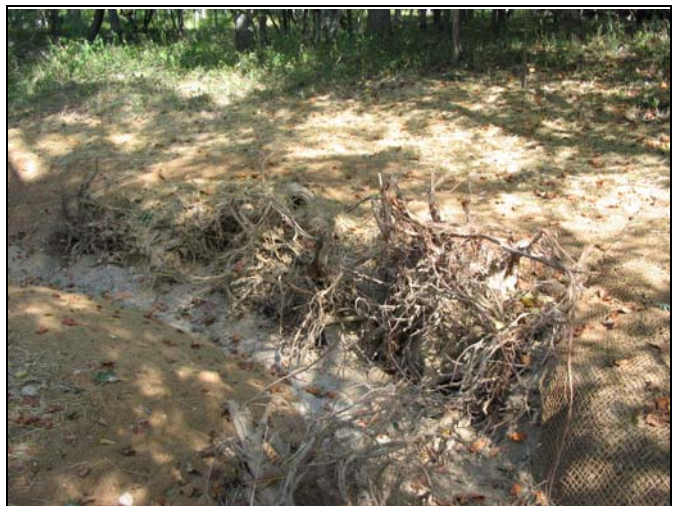
Rootwads along UT1

UT1 construction consisted of fence removal, invasive species removal, riparian buffer planting, bank sloping, and installation of root wads to add bank protection and help stabilize meander bends. The final as-built enhancement stream length for the UT1 project was broken into two areas separated by 164 feet of preservation. The downstream construction consisted of 270 feet of bank sloping, root wad installation, and riparian buffer planting. The as-built cross-sections and longitudinal profile are shown in Appendix B. The upstream construction consisted of 2,464 feet of invasive species removal and riparian buffer planting. The lengths of preservation and enhancement are indicated in Table 2.

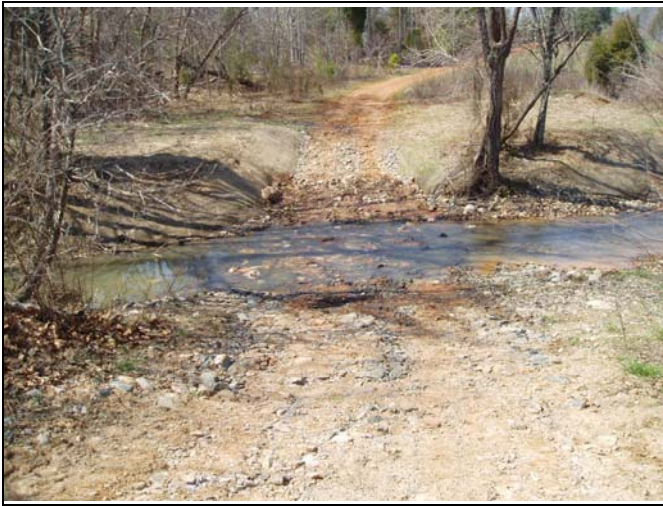
Ford crossing above cross vane on Little Grassy Creek

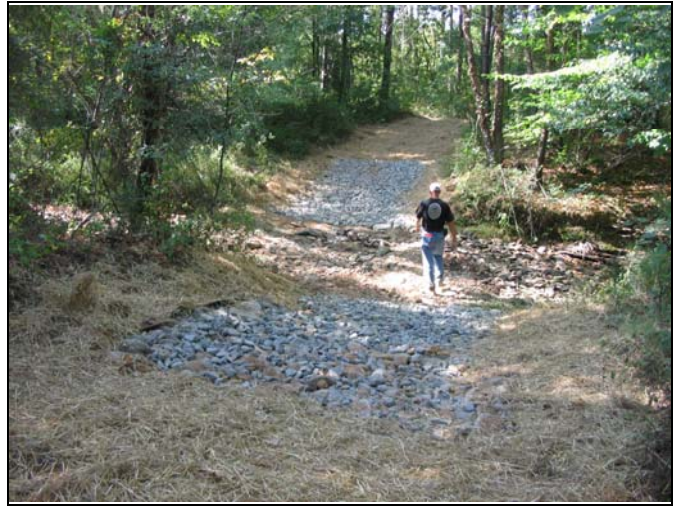
Ford crossing near the mill on Little Grassy Creek

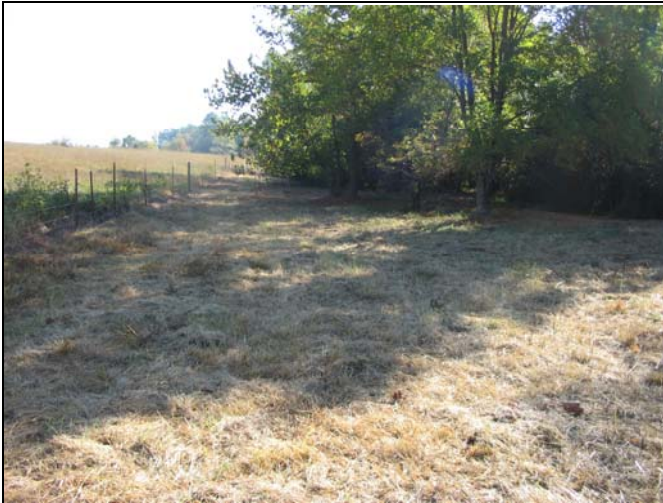
Invasive species removal – cut and spray

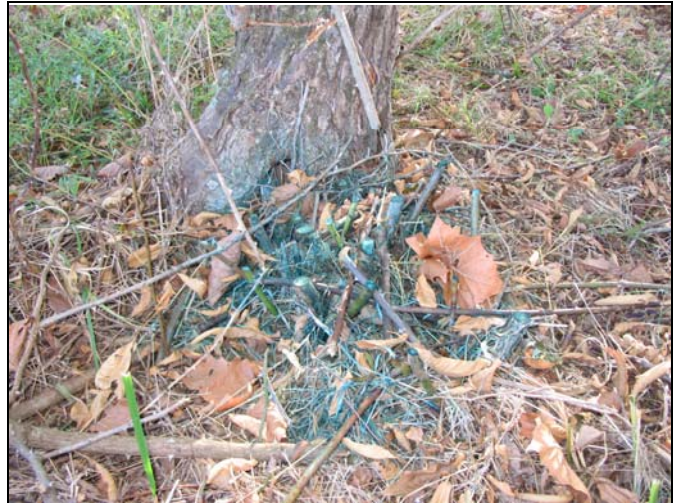
Invasive species removal – Mutliflora Rose cut and sprayed

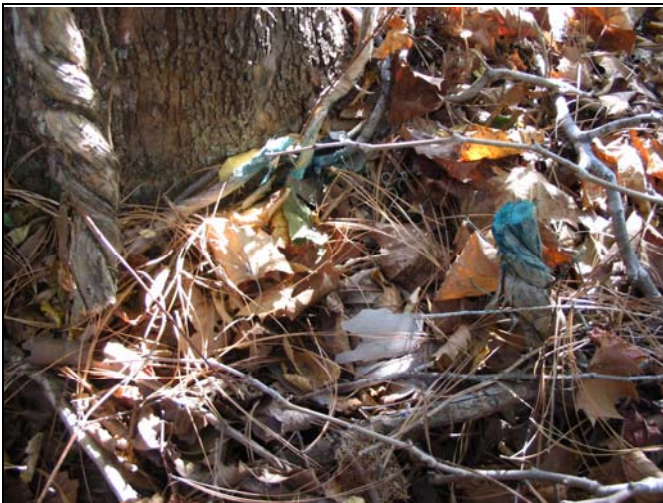
Invasive species removal – vine cut and painted

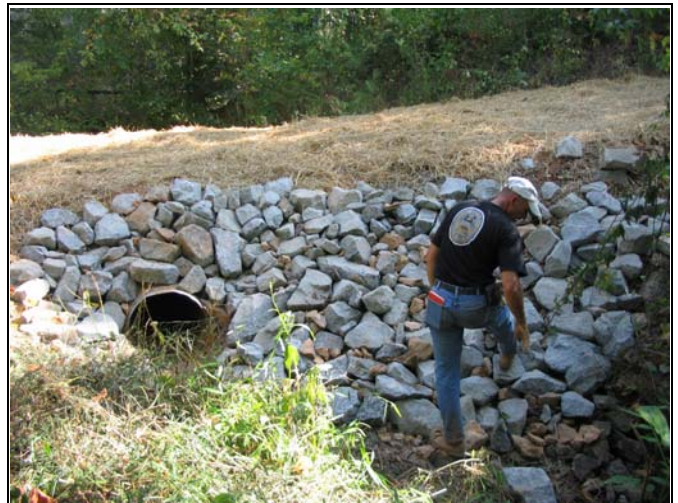
Culvert crossing stabilization
