FINAL
YEAR 2 (2015) ANNUAL MONITORING REPORT
LITTLE LICK CREEK BUFFER RESTORATION

Durham County, North Carolina
DMS Project No. 92542, Contract No. D13010S

Data Collection - October 2015

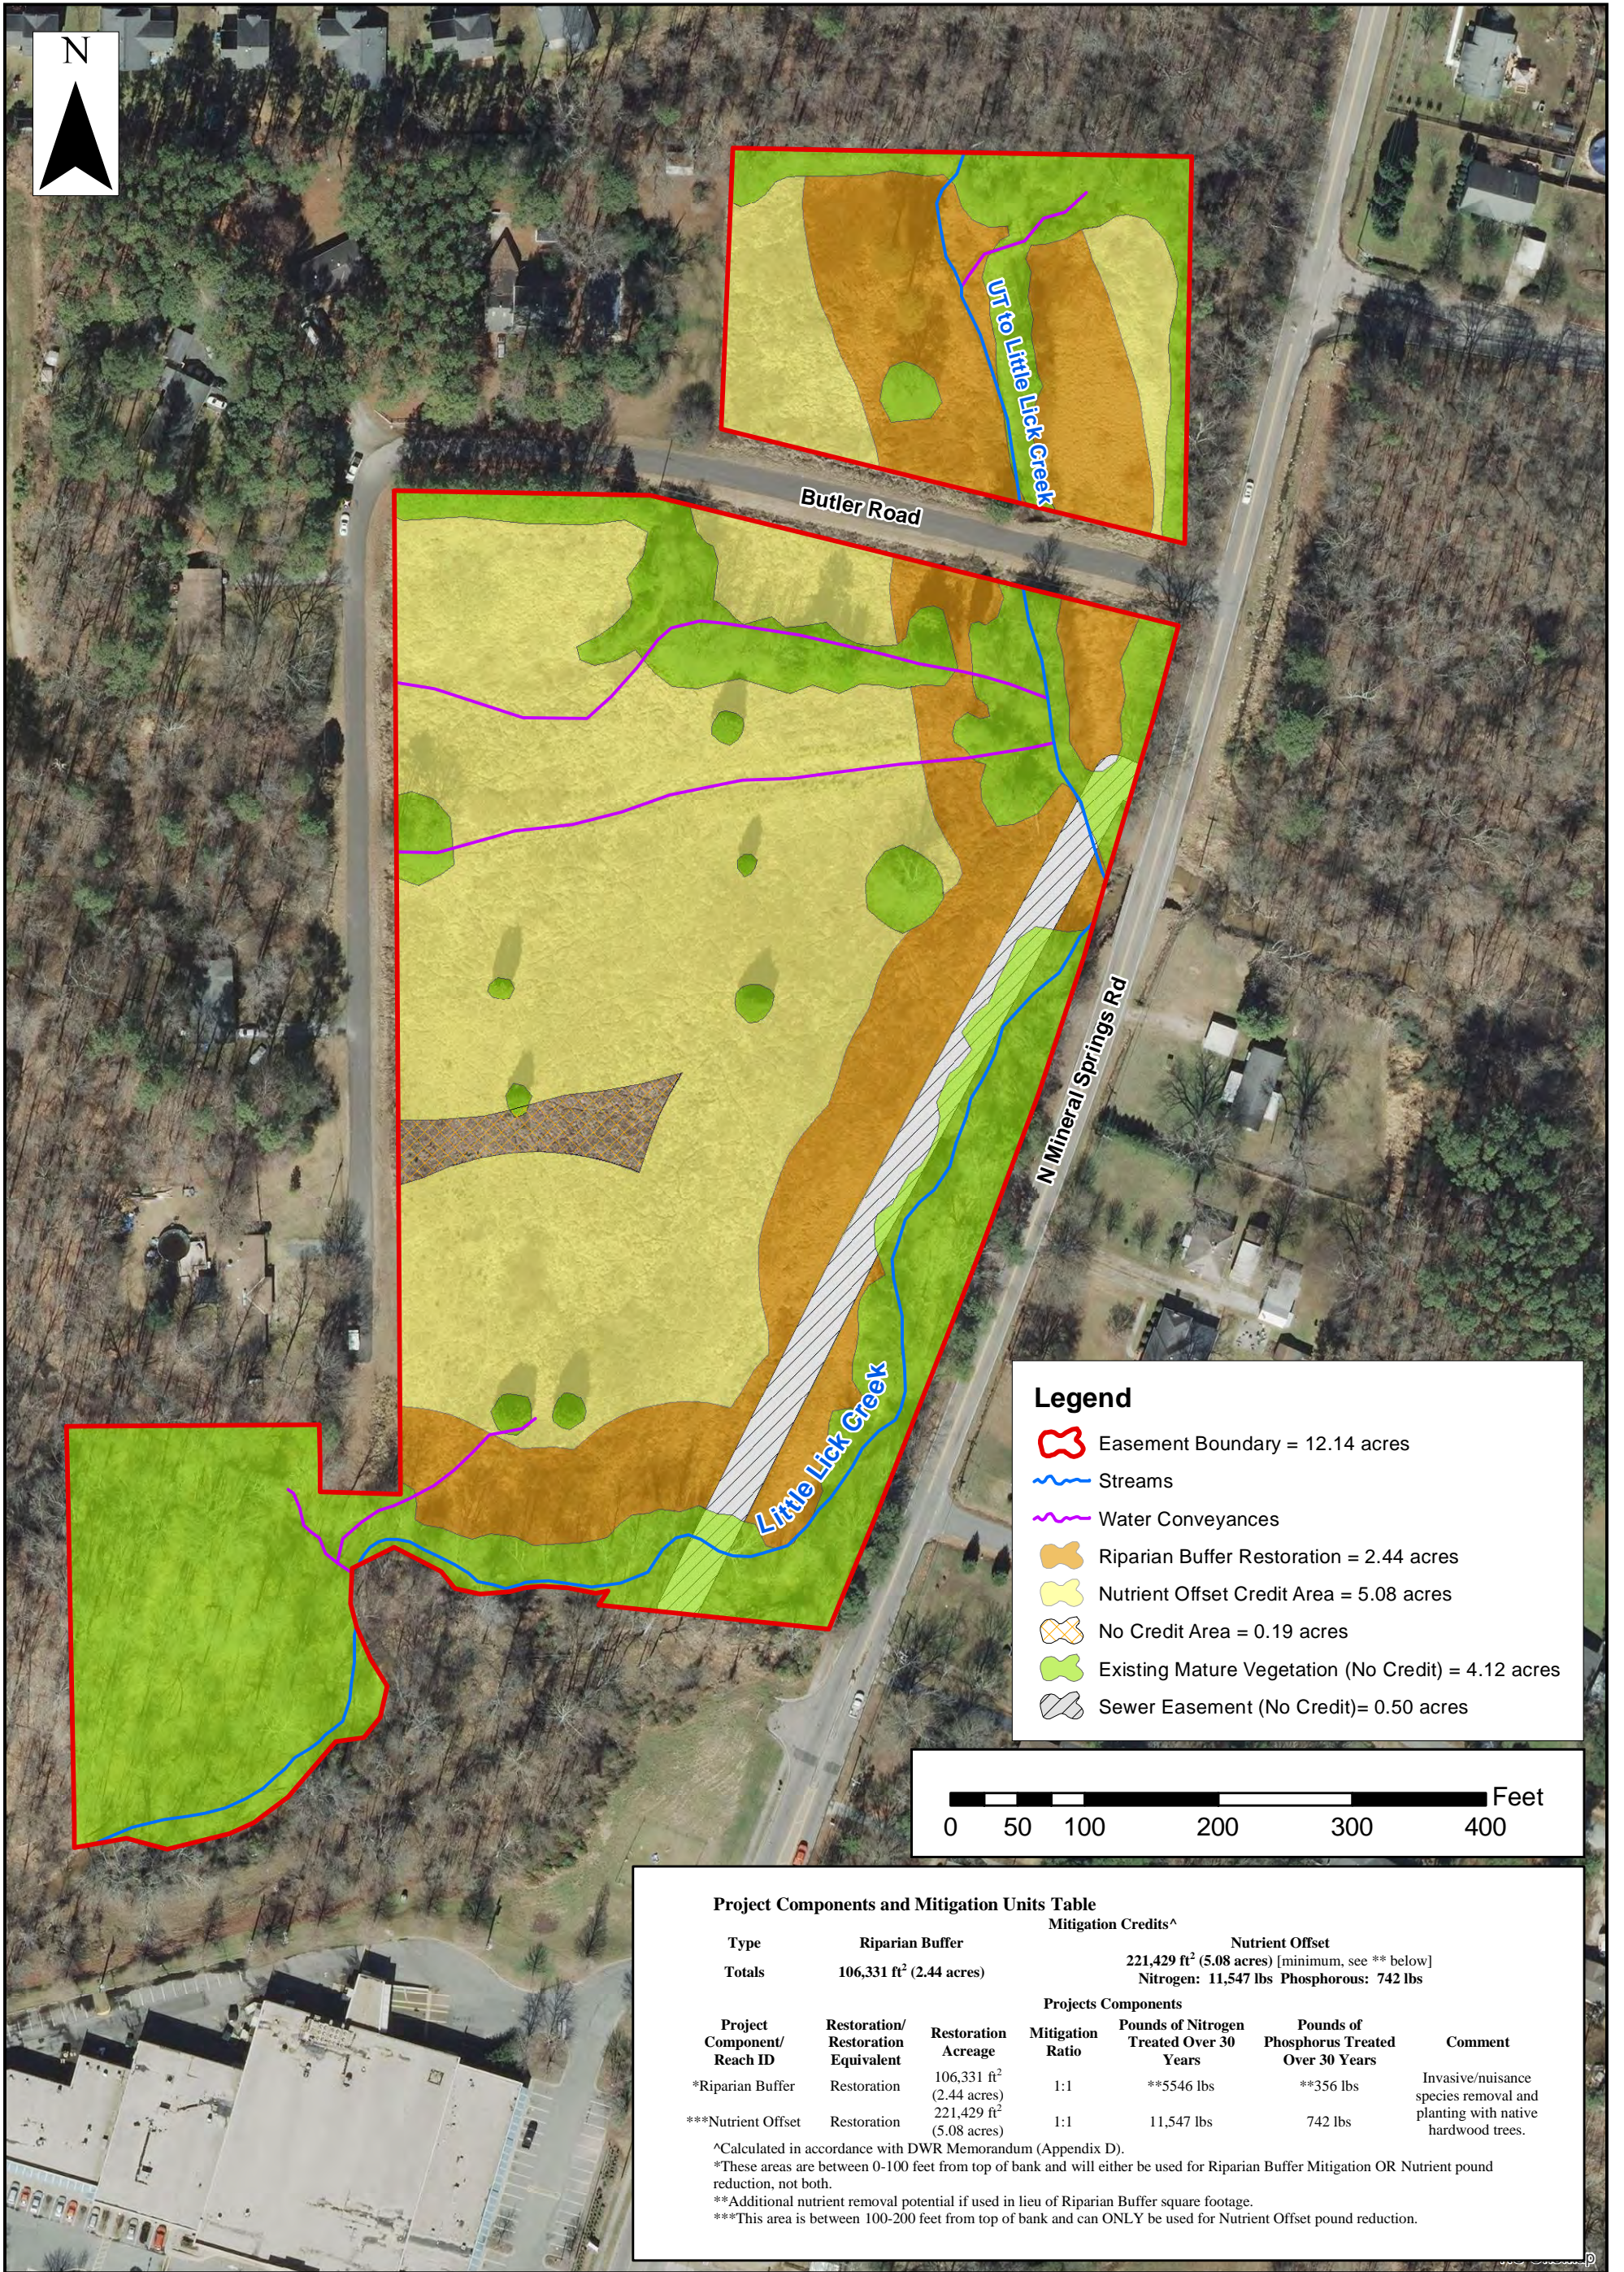
FIGURE
2

- Easement Boundary = 12.14 acres
- Streams
- Water Conveyances
- Riparian Buffer Restoration = 2.44 acres
- Nutrient Offset Credit Area = 5.08 acres
- No Credit Area = 0.19 acres
- Existing Mature Vegetation (No Credit) = 4.12 acres
- Sewer Easement (No Credit) = 0.50 acres

**PROJECT ASSETS
 LITTLE LICK CREEK SITE
 DMS PROJECT NUMBER 92542
 Durham County, North Carolina**

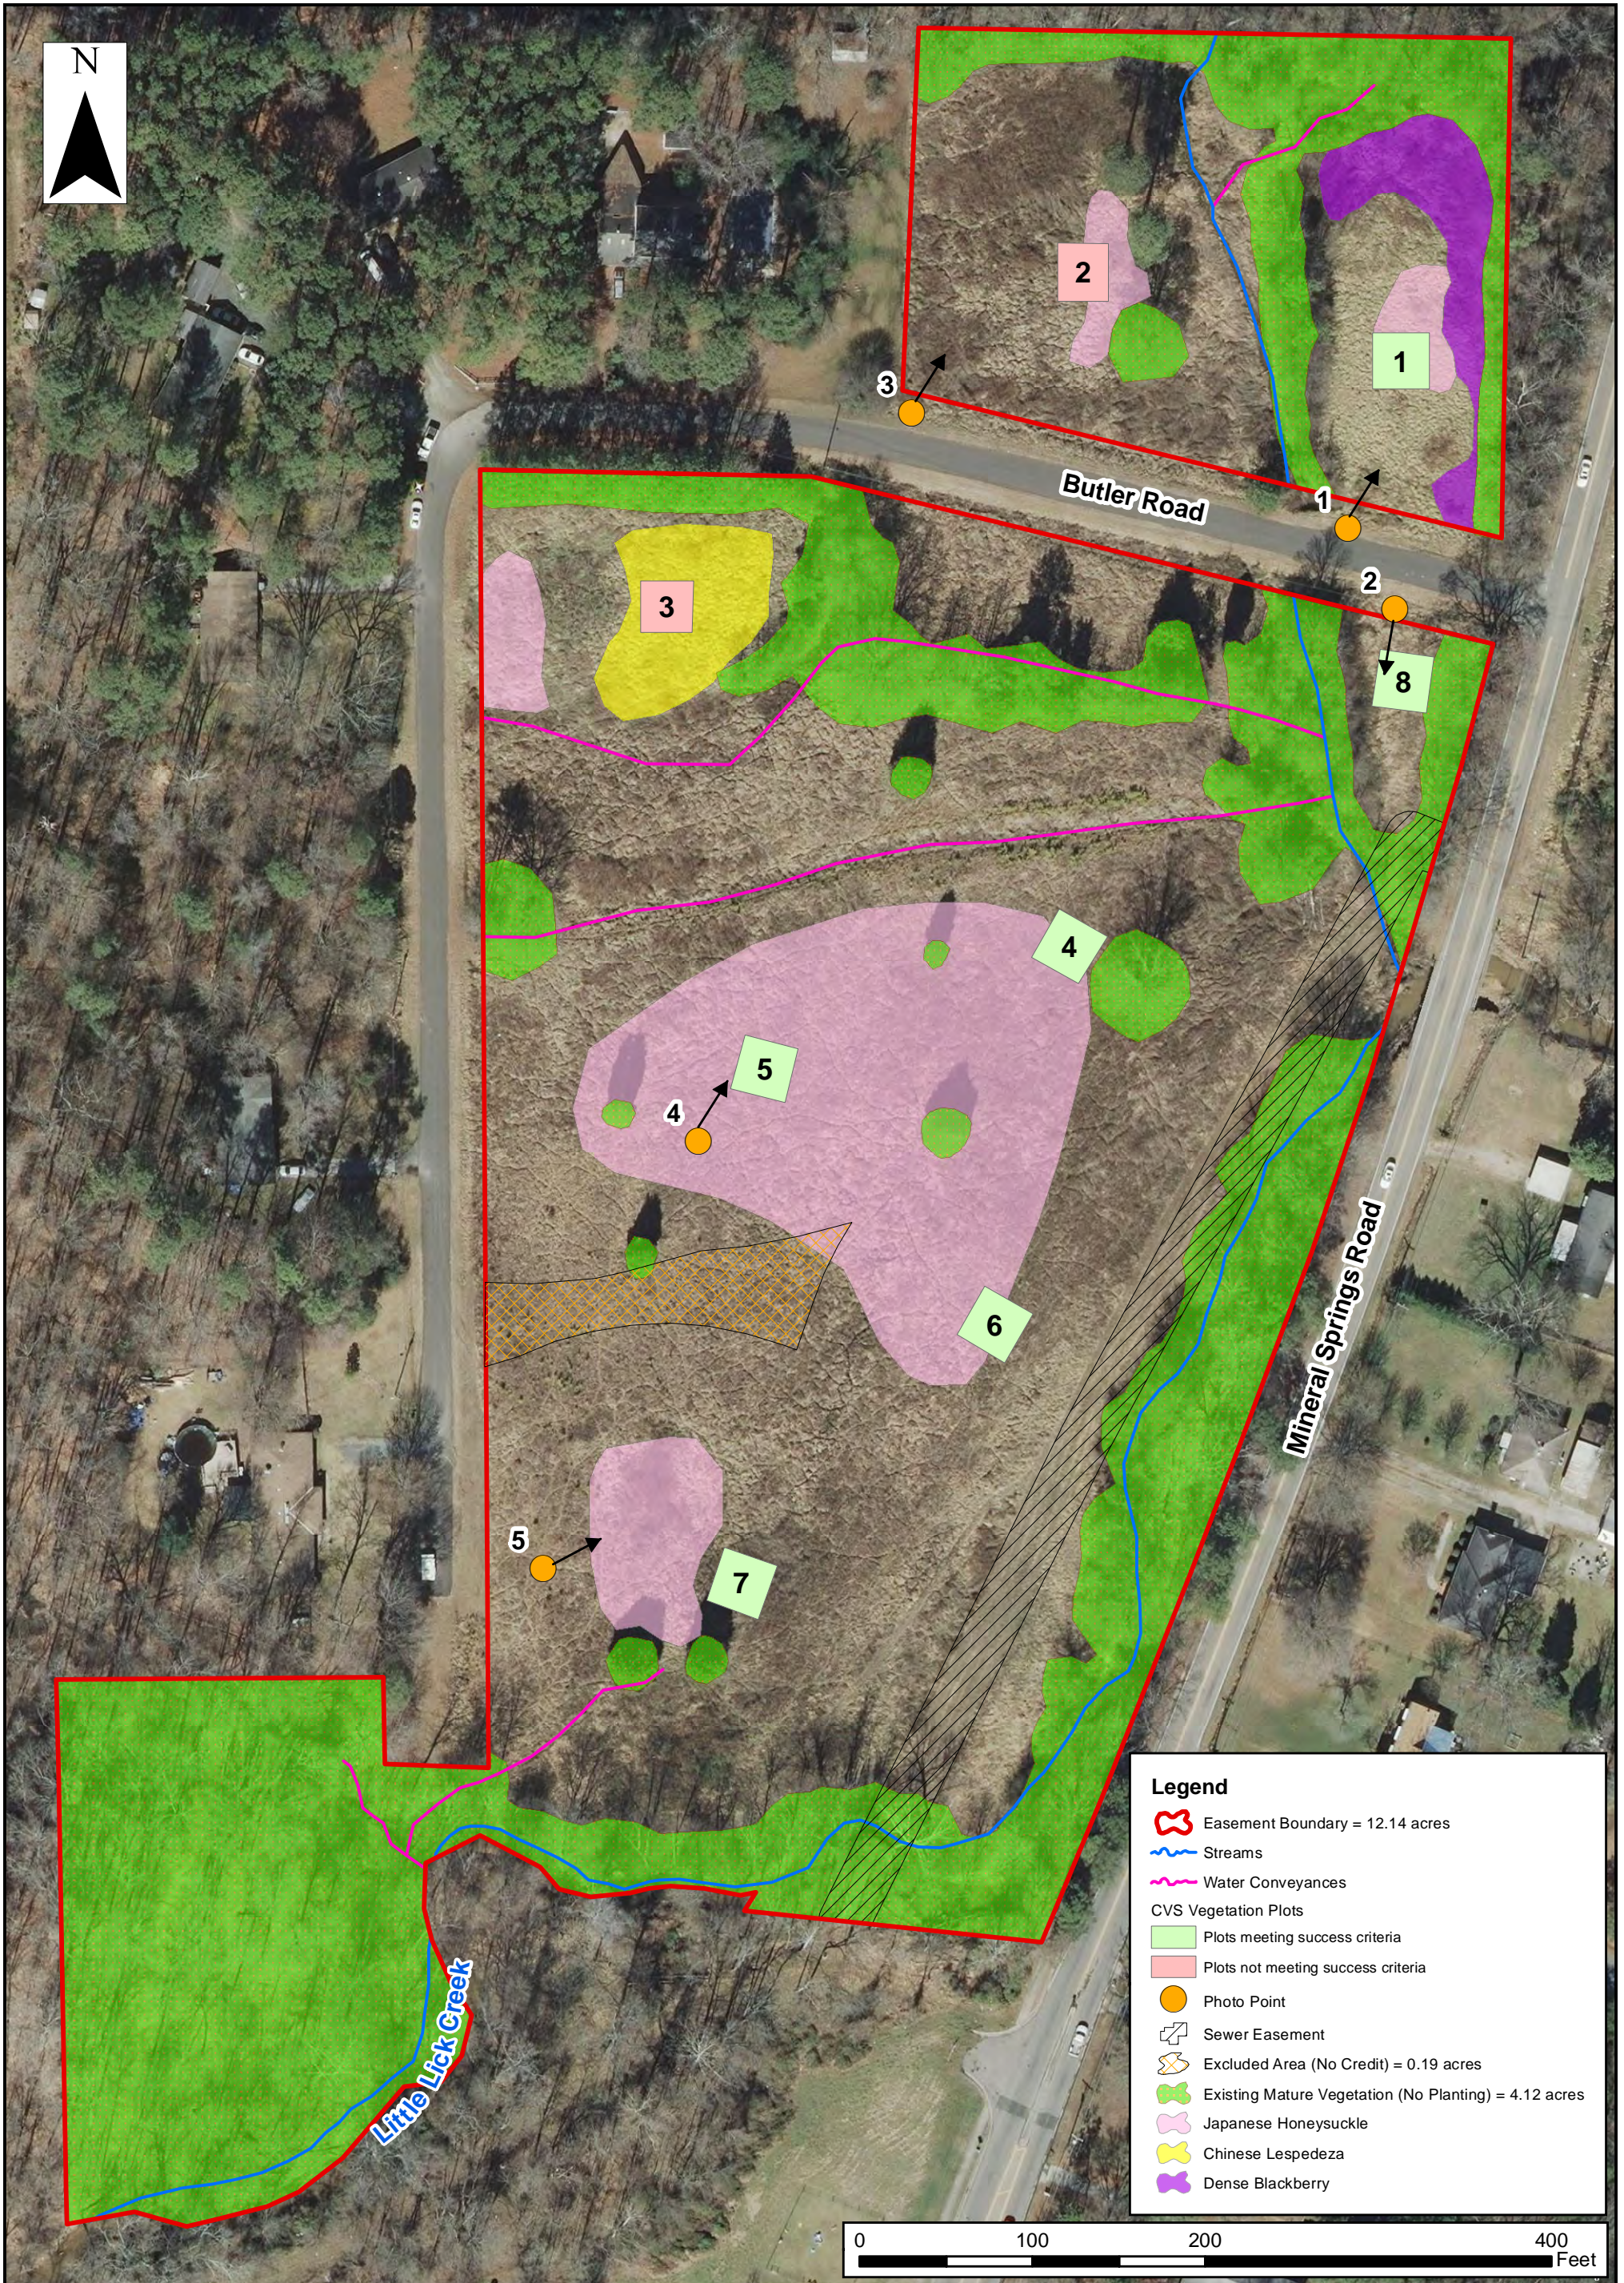
Vegetation Category	Definitions	Mapping Threshold	CCPV Depiction	Number of Polygons	Combined Acreage	% of Easement Acreage
4. Invasive Areas of Concern ⁴	Dense Japanese honeysuckle and Chinese lespedeza competing with planted woody vegetation.	1000 SF	pink and yellow polygons	6	1.74	14.3%
5. Easement Encroachment Areas ³	None	none	none	0	0.00	0.0%

Planted stem mortality can be attributed to competition from the dense herbaceous layer. Several large, dense patches of Japanese honeysuckle (*Lonicera japonica*) was observed throughout the Site. The vines are affecting the vigor of planted woody stems; therefore, treatment is recommended. Additionally, a small patch of Chinese lespedeza (*Lespedeza cuneata*) was observed in the vicinity of Plot 3, which is attributing to low planted stem counts in this plot. Furthermore, a large patch of blackberry was observed in the northeast portion of the site, near plot 1. The blackberry is dense and appears to be outcompeting several planted stems in this area (Figure 3, Appendix B).
