FINAL
YEAR 4 (2017) ANNUAL MONITORING REPORT
LITTLE LICK CREEK BUFFER RESTORATION

Durham County, North Carolina
DMS Project No. 92542, Contract No. 5908

RE: Little Lick Creek Monitoring (DMS Project # 92542, Contract #5908)
Final MY4 (2017) Annual Monitoring Report

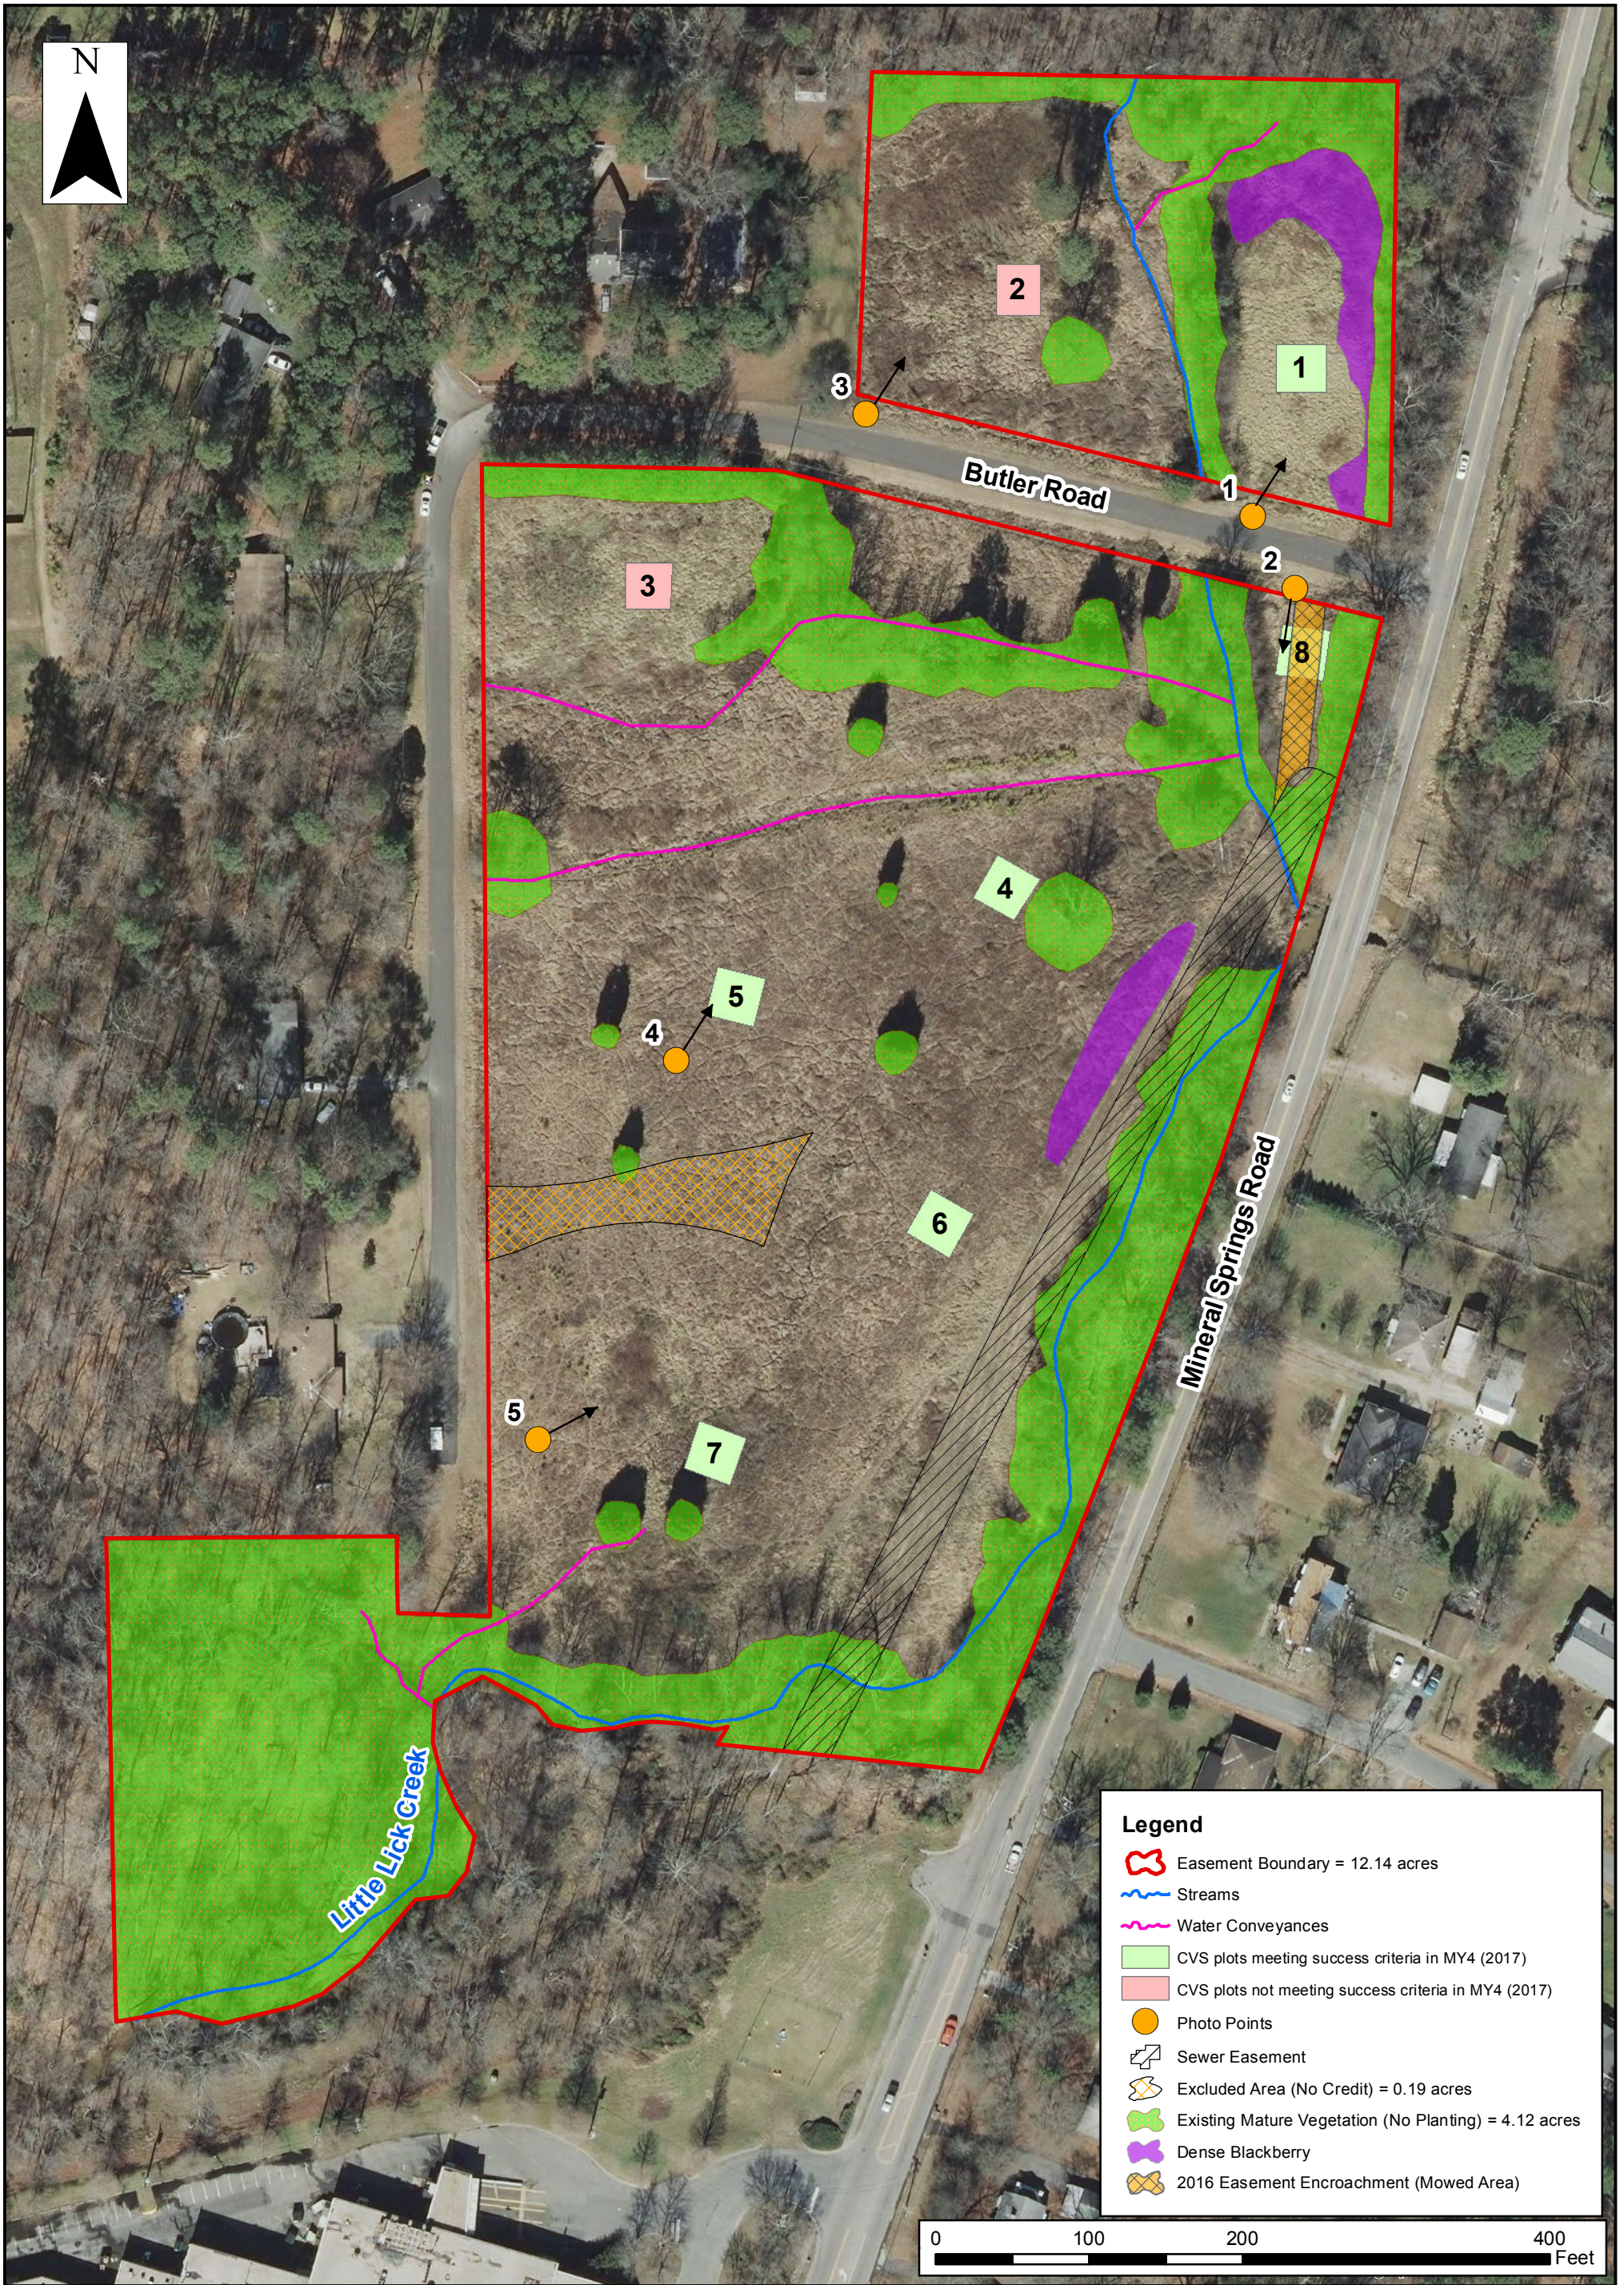
Vegetation Category	Definitions	Mapping Threshold	CCPV Depiction	Number of Polygons	Combined Acreage	% of Easement Acreage
4. Invasive Areas of Concern ⁴	None	1000 SF	N/A	0	0.00	0.0%
5. Easement Encroachment Areas ³	Mowed area	none	Black crosshatch with orange background	1	0.05	0.4%

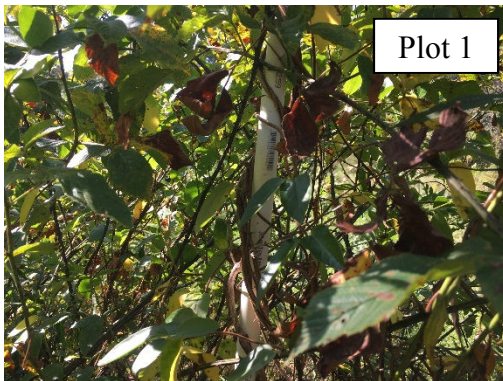
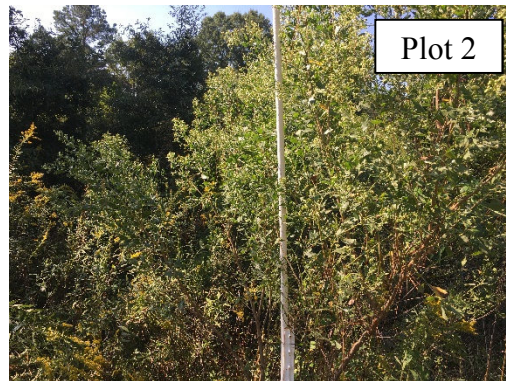
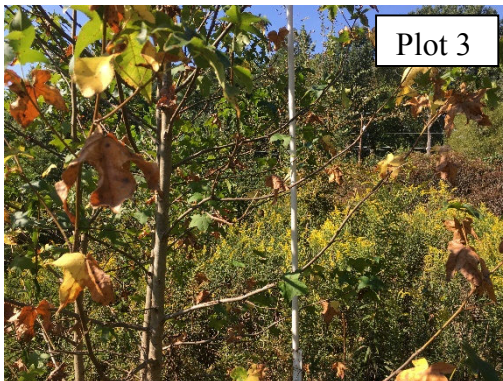
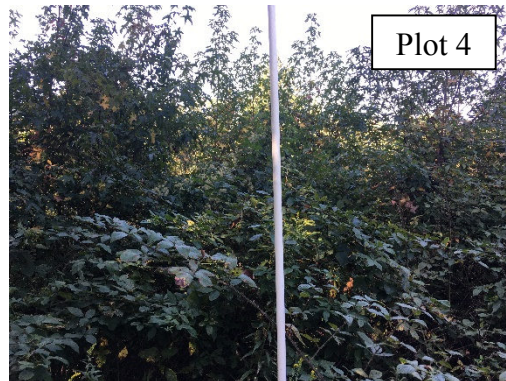
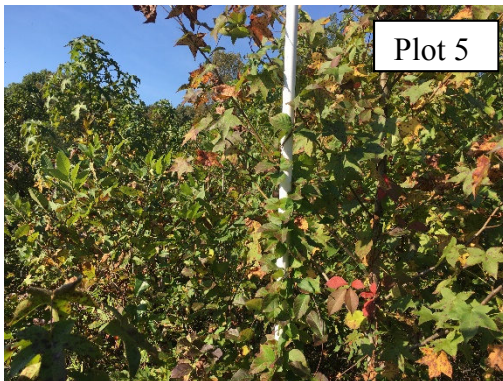
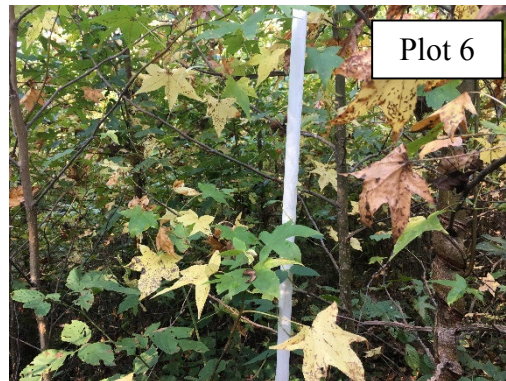
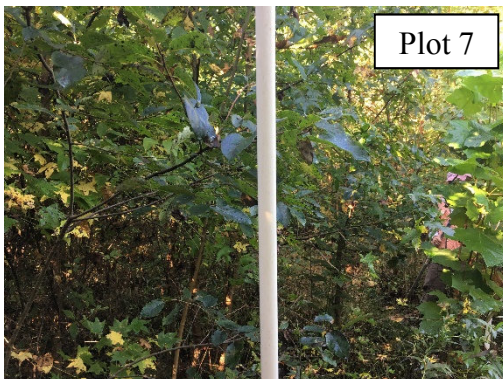
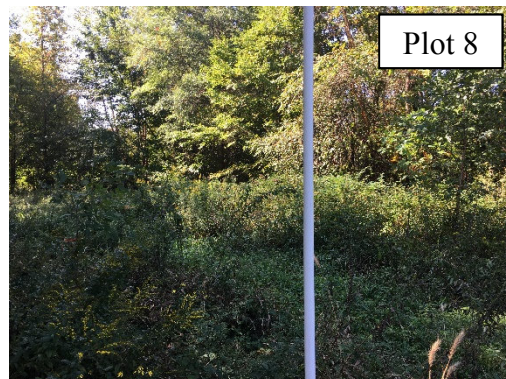
**Little Lick Creek (Butler Road)
Vegetation Monitoring Photographs
Taken October 2017**

After planting was completed, an initial evaluation was performed to verify planting methods were successful and to determine initial species composition and density. Eight sample vegetation plots (10-meter by 10-meter) were installed and measured within the Site as per guidelines established in *CVS-DMS Protocol for Recording Vegetation, Version 4.2* (Lee et al. 2008) (Figure 3, Appendix B). Vegetation plots are permanently monumented with 6-foot metal T-posts at each corner, and a ten foot tall pvc at the origin. In each sample plot, vegetation parameters to be monitored include species composition and species density. Visual observations of the percent cover of shrub and herbaceous species will be documented by photograph. Vegetation plot information for MY4 (2017) was collected in October 2017 and can be found in Appendix C. Stem count measurements for MY4 (2017) indicate an average of 369 planted stems per acre (excluding livestakes) across the Project. Six out of eight vegetation plots met success criteria for MY4 (2017) monitoring based on planted stems. Plots 2 and 3 were both 3 stems shy of meeting success criteria based on planted stems alone; however, when including natural recruits of green ash (*Fraxinus pennsylvanica*) and willow oak (*Quercus phellos*) in Plot 2 and winged elm (*Ulmus alata*) in Plot 3, these plots were above success criteria.

Planted stem mortality can be attributed to competition from the dense herbaceous layer and a dense shrub layer consisting of naturally recruited woody stems. Several dense patches of Japanese honeysuckle (*Lonicera japonica*) were observed throughout the Project during MY2 (2015). These areas have consistently reduced in size since originally observed, and in MY4 (2017) it was determined that the vines are no longer significantly affecting the vigor of planted woody stems; therefore, the areas are no longer considered areas of concern. Additionally, a small patch of Chinese lespedeza (*Lespedeza cuneata*) was observed in the vicinity of Plot 3 during previous monitoring years, which had contributed to low planted stem counts in this plot. This population was significantly smaller during MY4 (2017) and is therefore no longer considered an area of concern. Furthermore, two patches of blackberry were observed; one in the northeast portion of the site, near plot 1 and one on the eastern portion of the Project along the sewer easement. The blackberry remains dense during MY4 (2017) and appears to be outcompeting several planted stems in these areas. Also, a small area of easement encroachment was observed in and around CVS plot 8. An approximately 5 meter wide strip was mowed from Butler Road to the existing maintained sewer easement (Figure 3, Appendix B). This area was originally observed during MY3 (2016) and it appears to have been continuously maintained throughout MY4 (2017) as well.
