# FINAL MITIGATION PLAN

Little Pine Creek III Stream & Wetland Restoration Project  
Alleghany County, North Carolina  
DENR Contract No. D12010S  
SCO No. 07-07088-03  
EEP ID No. 94903

Wildlands Engineering, Inc.  
1430 South Mint Street, Suite 104  
Charlotte, NC 28203  
Phone – 704-332-7754

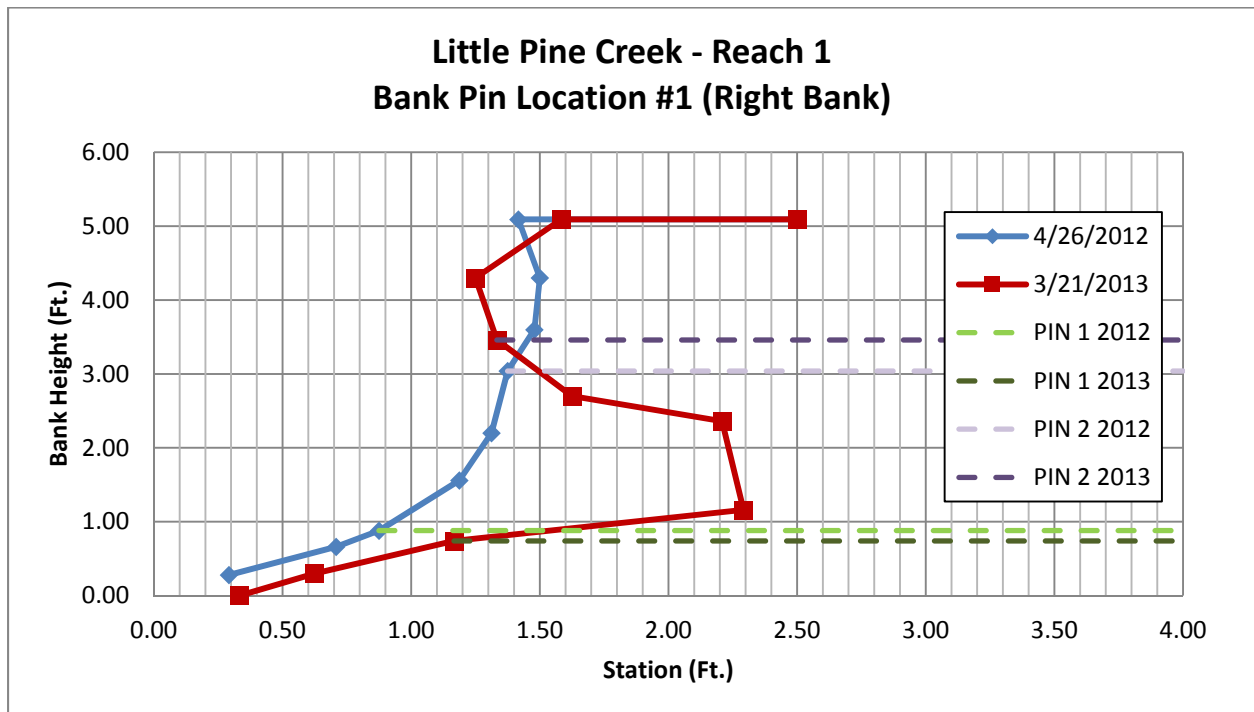
Bank pin data measured at both the left and right banks of Little Pine Creek Reach 1 showed severe lateral migration and changes in channel dimensions, with the left bank retreating at 1.81 ft/yr and the right bank retreating at 0.14 ft/yr. Bank profiles show sediment loss of up to 8.66 ft<sup>3</sup> per linear foot of stream bank per year (ft<sup>3</sup>/LF/yr) on the left bank, and 2.12 ft<sup>3</sup>/LF/yr on the right bank. The bank profile on the right bank shows this area becoming extremely undercut, so sediment losses of greater proportions could be expected at this location.

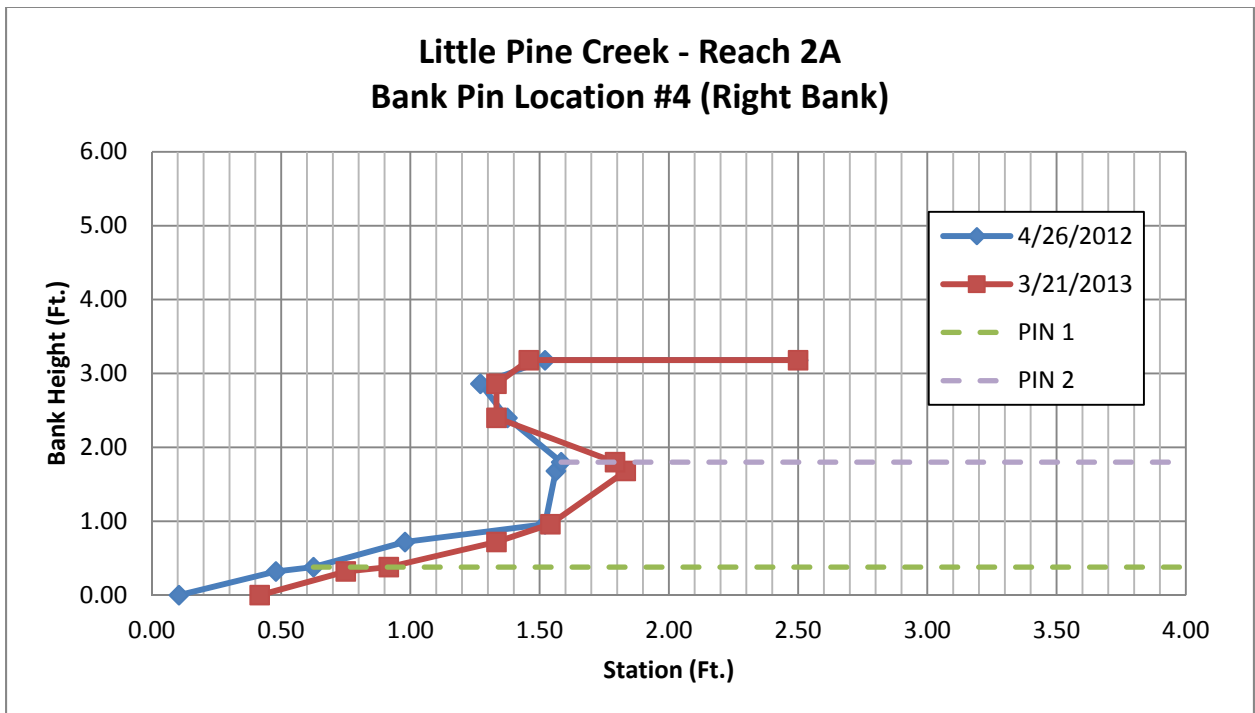
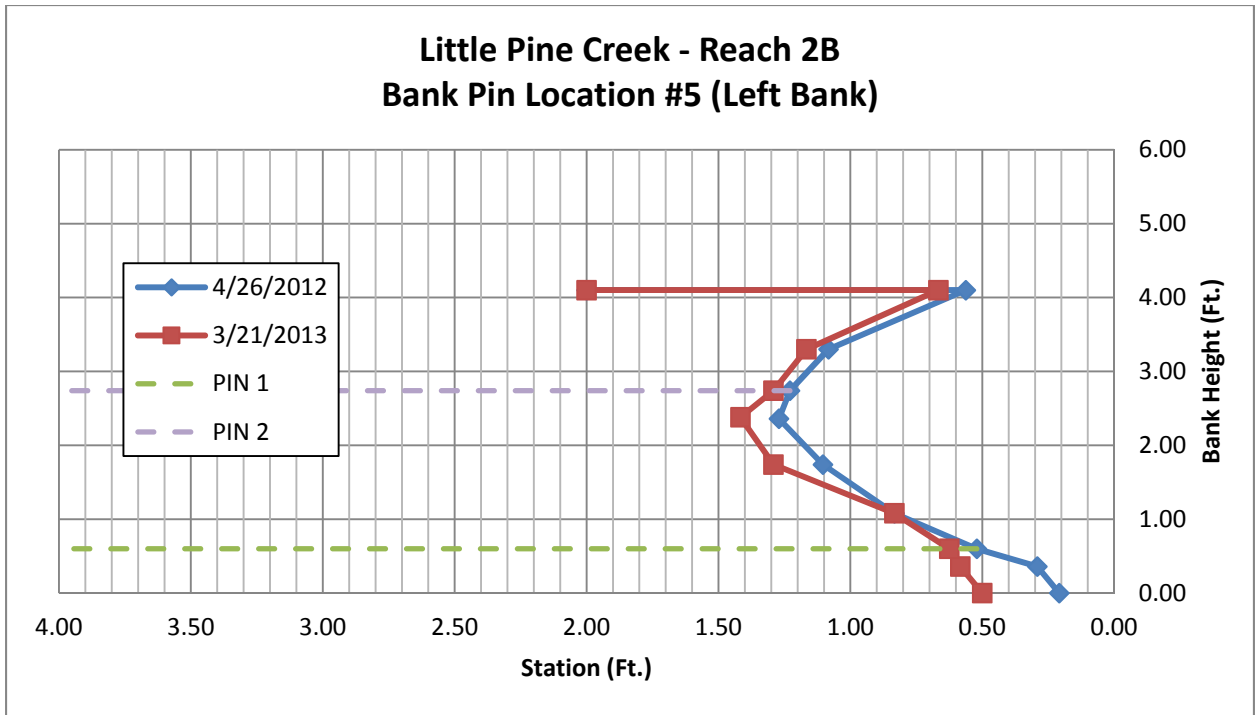
Little Pine Creek Reach 2A shows lateral migration on the right bank of 0.28 ft/yr. The bank profile shows 0.5 ft<sup>3</sup>/LF/yr of lost sediment. Similar results were found at Little Pine Creek Reach 2B, with bank profile showing 0.55 ft<sup>3</sup>/ft/yr of lost sediment, but bank pins showing only 0.09 ft/yr retreat on average. This is because a greater amount of erosion occurred between bank pins than at pin measurement locations.

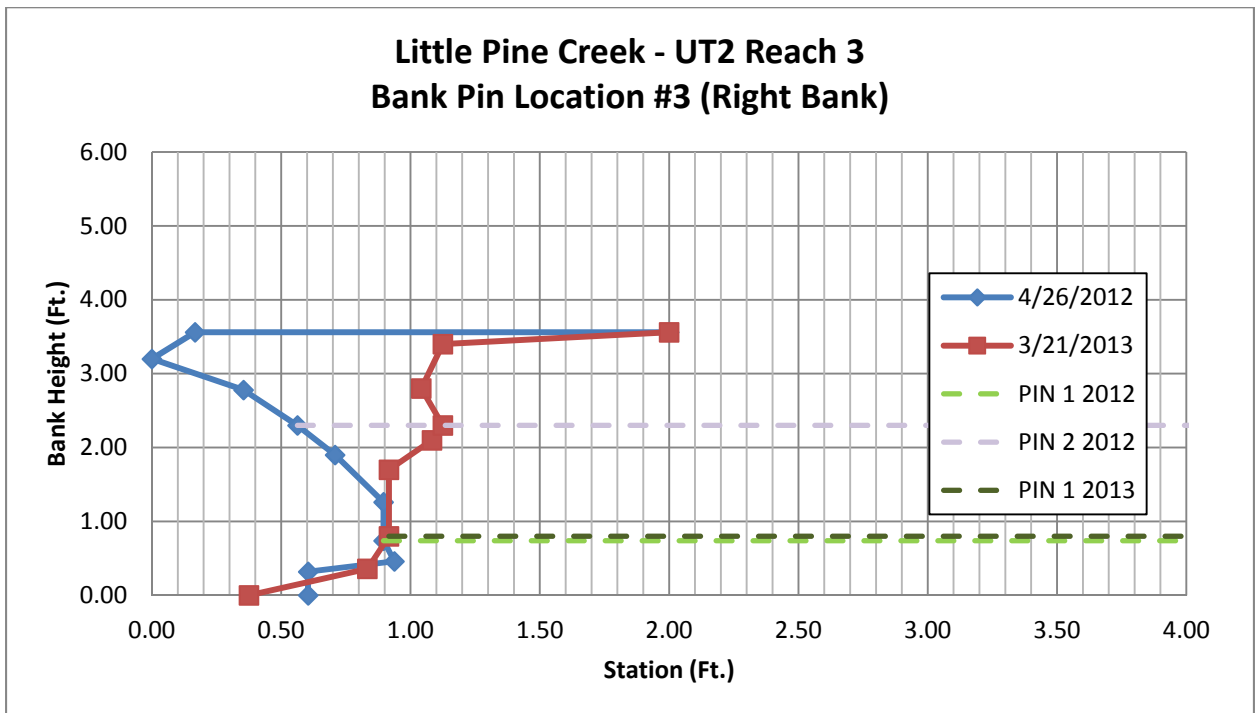
UT2 Reach 3 has bank pin and profile data from the right bank, showing a major change in channel dimensions, where sediment from severely undercut banks is lost between 2012 and 2013. This is reflected by the linear retreat at PIN 1 (the upper pin) but not at PIN 2 (the lower pin). Average linear retreat at this location was 0.29 ft/yr, with bank profile data showing 1.37 ft<sup>3</sup>/LF/yr of lost sediment.
