# LITTLE TROUBLESOME CREEK MITIGATION SITE

*Rockingham County, NC*

## Mitigation Plan

June 2011

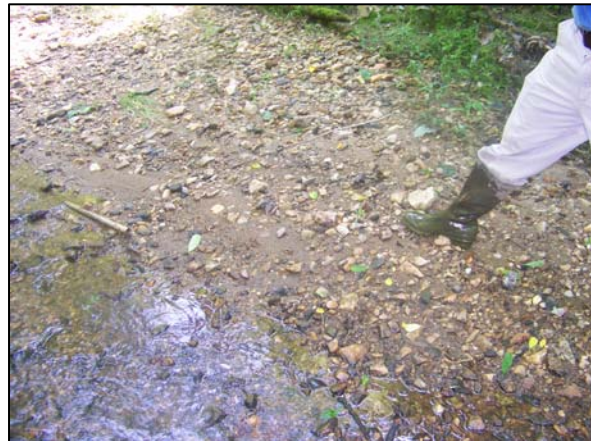
Gravel and sand substrate common throughout Irvin Creek

Irvin Creek Reach 2 is approximately 1,533 LF and includes the area downstream of the bedrock grade control point of Reach 1 to the confluence with Little Troublesome Creek. Reach 2 continues to be classified as a Rosgen G4c stream type with an increased watershed size of 0.91 square mile. Reach 2 is also highly incised with a comparable entrenchment ratio to Reach 1 of 1.2. This reach is deeper than Reach 1 with similar bankfull widths, resulting in a much lower width-to-depth ratio ranging from 8.0 to 8.6. As with Reach 1, Reach 2 is known to have been historically straightened and heavily managed, particularly in the area adjacent to natural gas line, so sinuosity cannot be used for classification. Substrate throughout this reach transitions from a coarse gravel and cobble upstream to a gravel and coarse sand downstream.

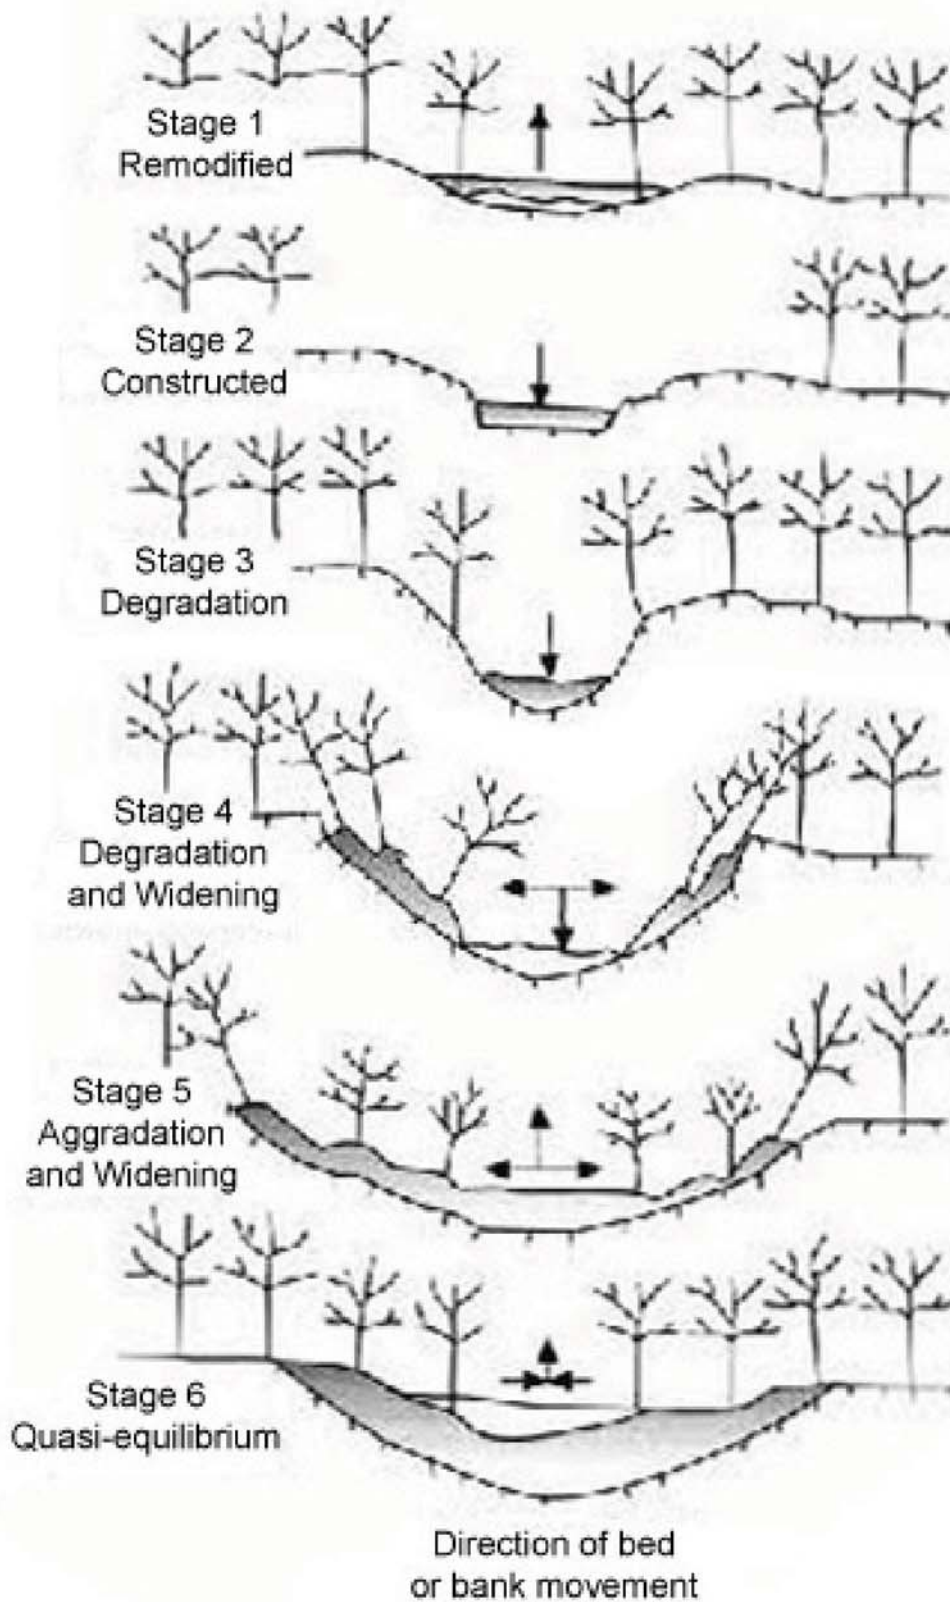
Figure 8. Channel Evolution Model - Six Stages  
 Little Troublesome Creek Mitigation Site  
 Cape Fear River Basin (03030002)

\*Simon & Hupp, 1986

The project stream reaches are all currently laterally unstable. According to the Simon channel evolution model (Simon, 1986), the project reaches of Irvin Creek, Little Troublesome Creek, and UT1 appear to be at *Stage 4 – Channel Widening* (Figure 8). They have passed *Stage 3 – Incision*; the down-cutting has been arrested by grade control or incision to local base level. In most areas bank erosion is actively widening the channels. In some locations bank erosion causes substantial widening and some transient deposition is beginning.

For Irvin Creek and UT1 this is evident by the classification of G according to the Rosgen system and related channel evolution models. According to the Rosgen channel type succession model, these streams have progressed from C or E streams (the likely natural condition of the streams given regional physiography) to G streams and appear to be moving towards the wider incised F-type streams. Little Troublesome Creek is moving from a C to an F channel through lateral erosion having never incised to a G stream type.

Once this stage of mass wasting is completed, the project streams would likely begin to experience increased sediment deposition caused by decreased depth of flow and shear stress in the wider channels. This depositional trend, known as *Stage 5* according to Simon's model, will eventually create a new floodplain within the over-widened channels and a small C type or E type channel will be formed (*Stage 6 – Quasi-Equilibrium*).

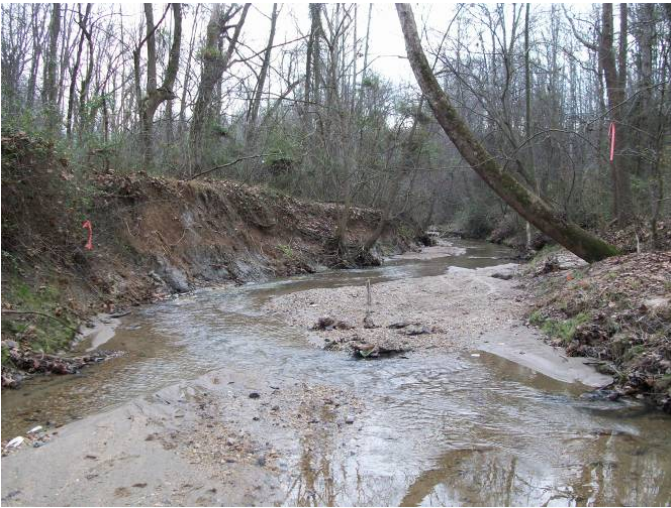
Little Troublesome Creek, facing downstream - Stream Mitigation Site

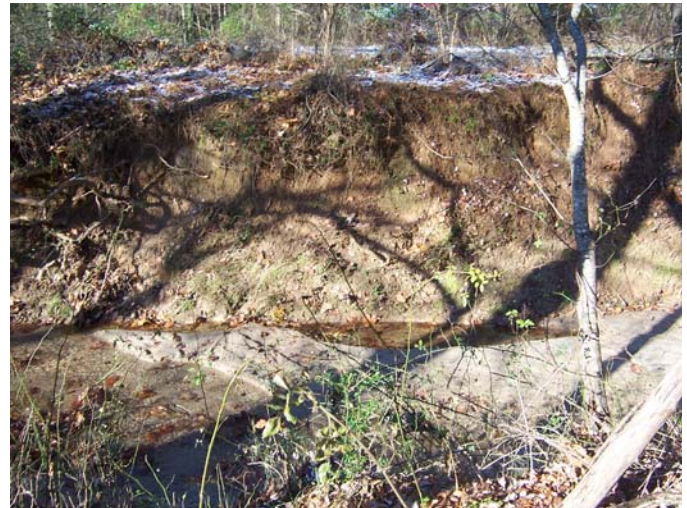
Irvin Creek, lower portion of project – Stream Mitigation Site

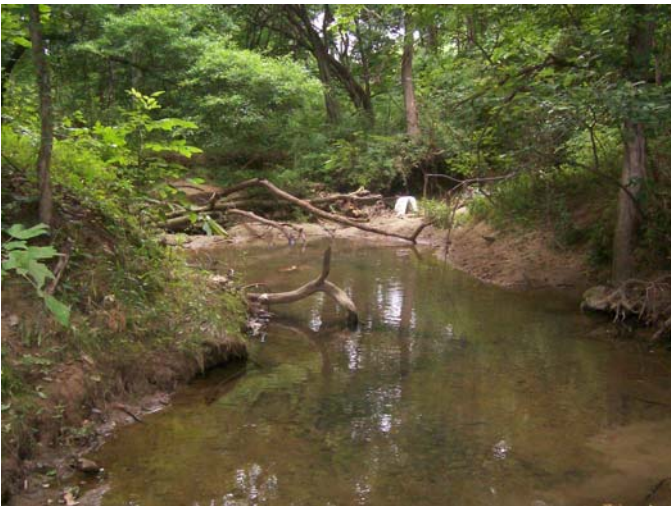
Irvin Creek, facing downstream at upper portion of project – Stream Mitigation Site

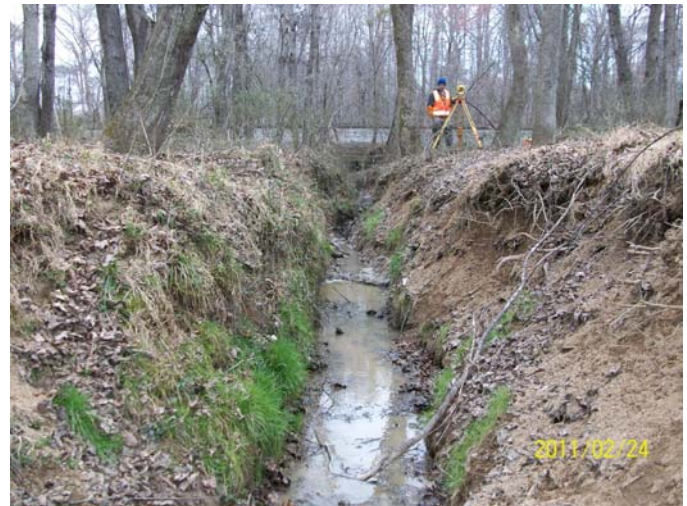
UT1, facing upstream to culvert crossing – Stream Mitigation Site

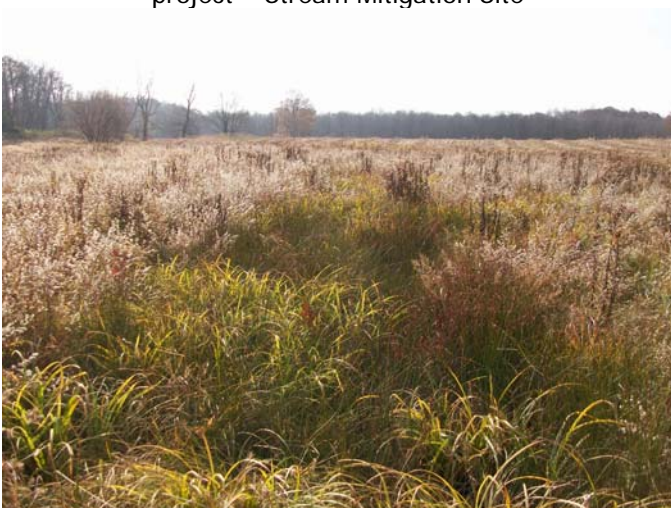
Wetland (WL-1) and adjacent agricultural field, facing south - Wetland Mitigation Site

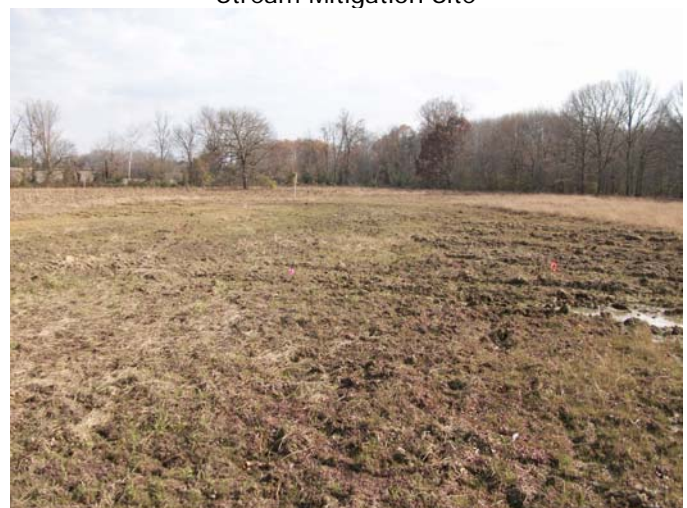
Southern agricultural field, mapped as non-wetlands by NRCS – Wetland Mitigation Site

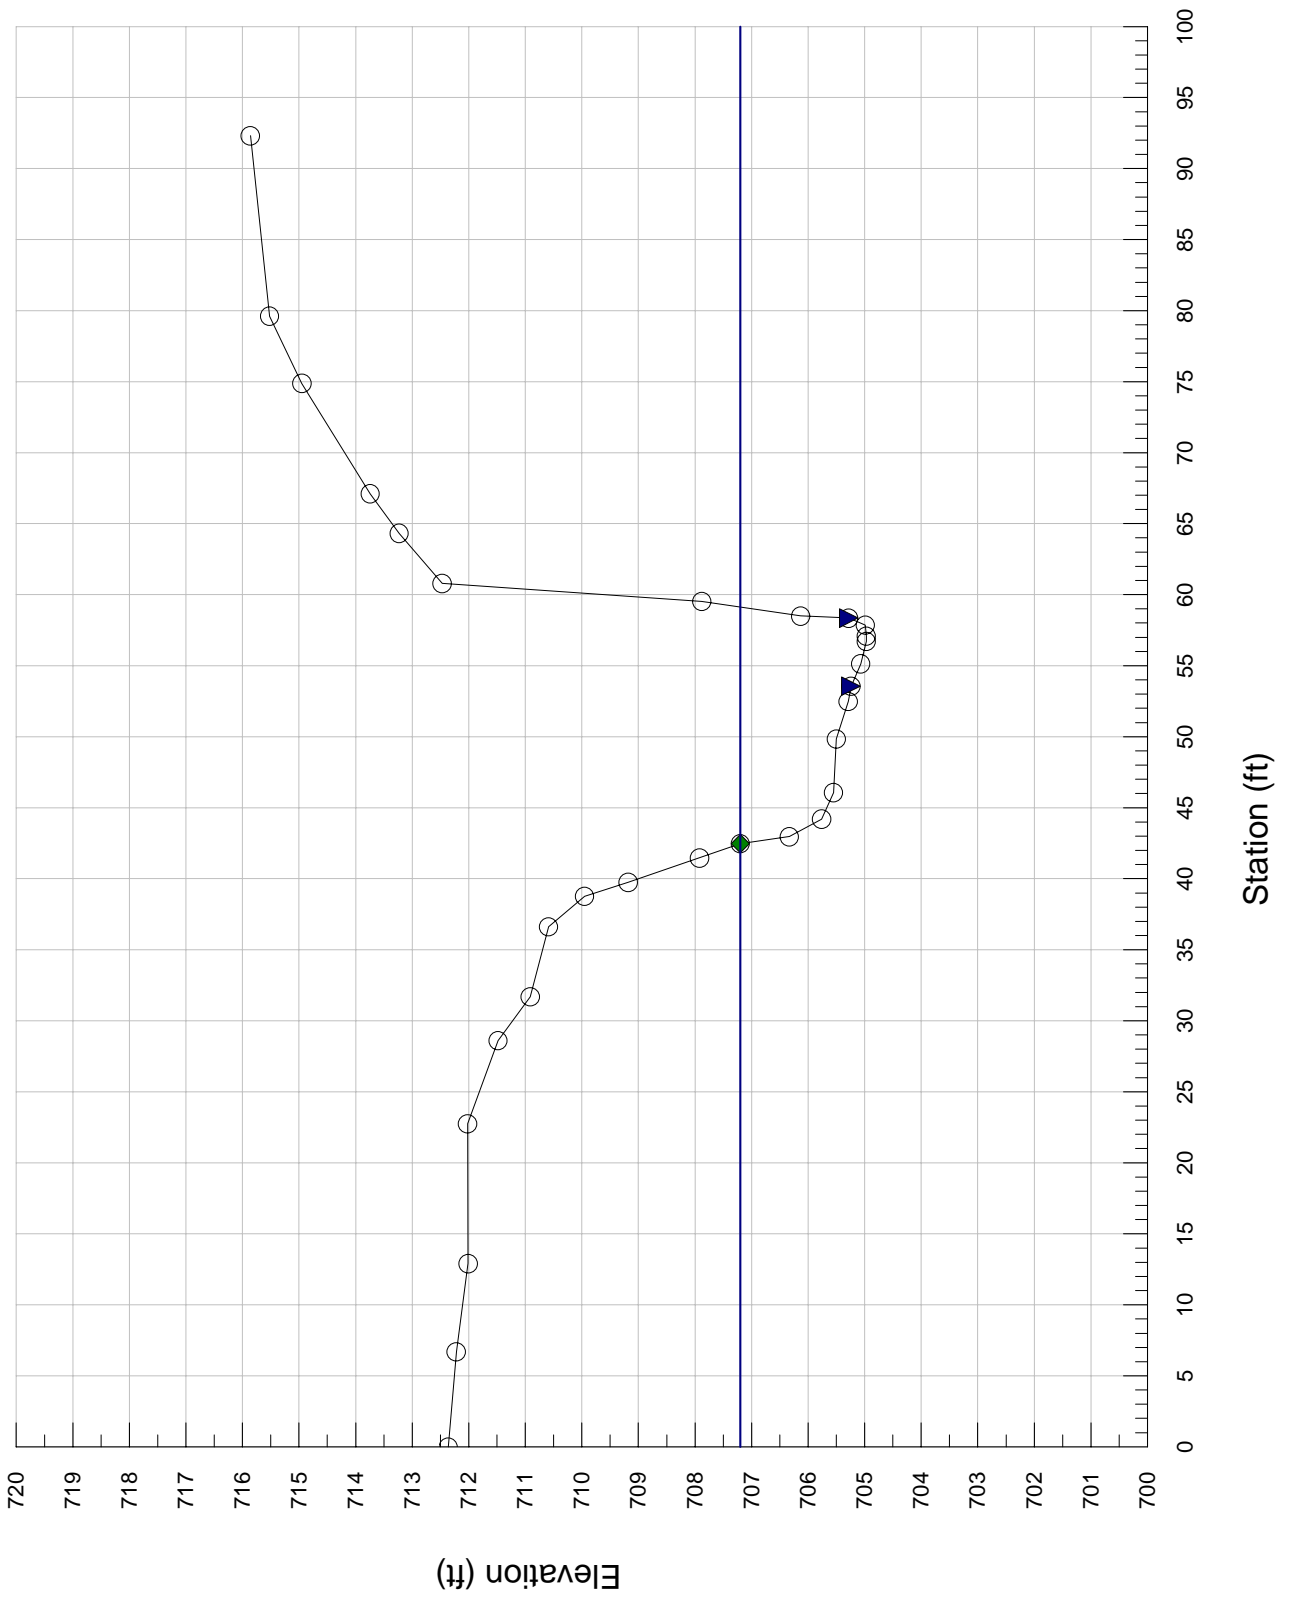
XS6 Pool  
RIVERMORPH CROSS SECTION SUMMARY

○ Ground Points      ◆ Bankfull Indicators      ▼ Water Surface Points  
Wbkf = 16.6      Dbkf = 1.7      Abkf = 28.5

River Name: Little Troublesome  
 Reach Name: Reach 2  
 Cross Section Name: XS6 Pool - Little Troublesome Creek  
 Survey Date: 12/08/09
