MITIGATION PLAN

Loflin Dairy Buffer
Mitigation Site
Randolph County, North Carolina
DENR Contract 003995

Randleman Lake Watershed
Cape Fear River Basin
HUC 03030003

February 2012

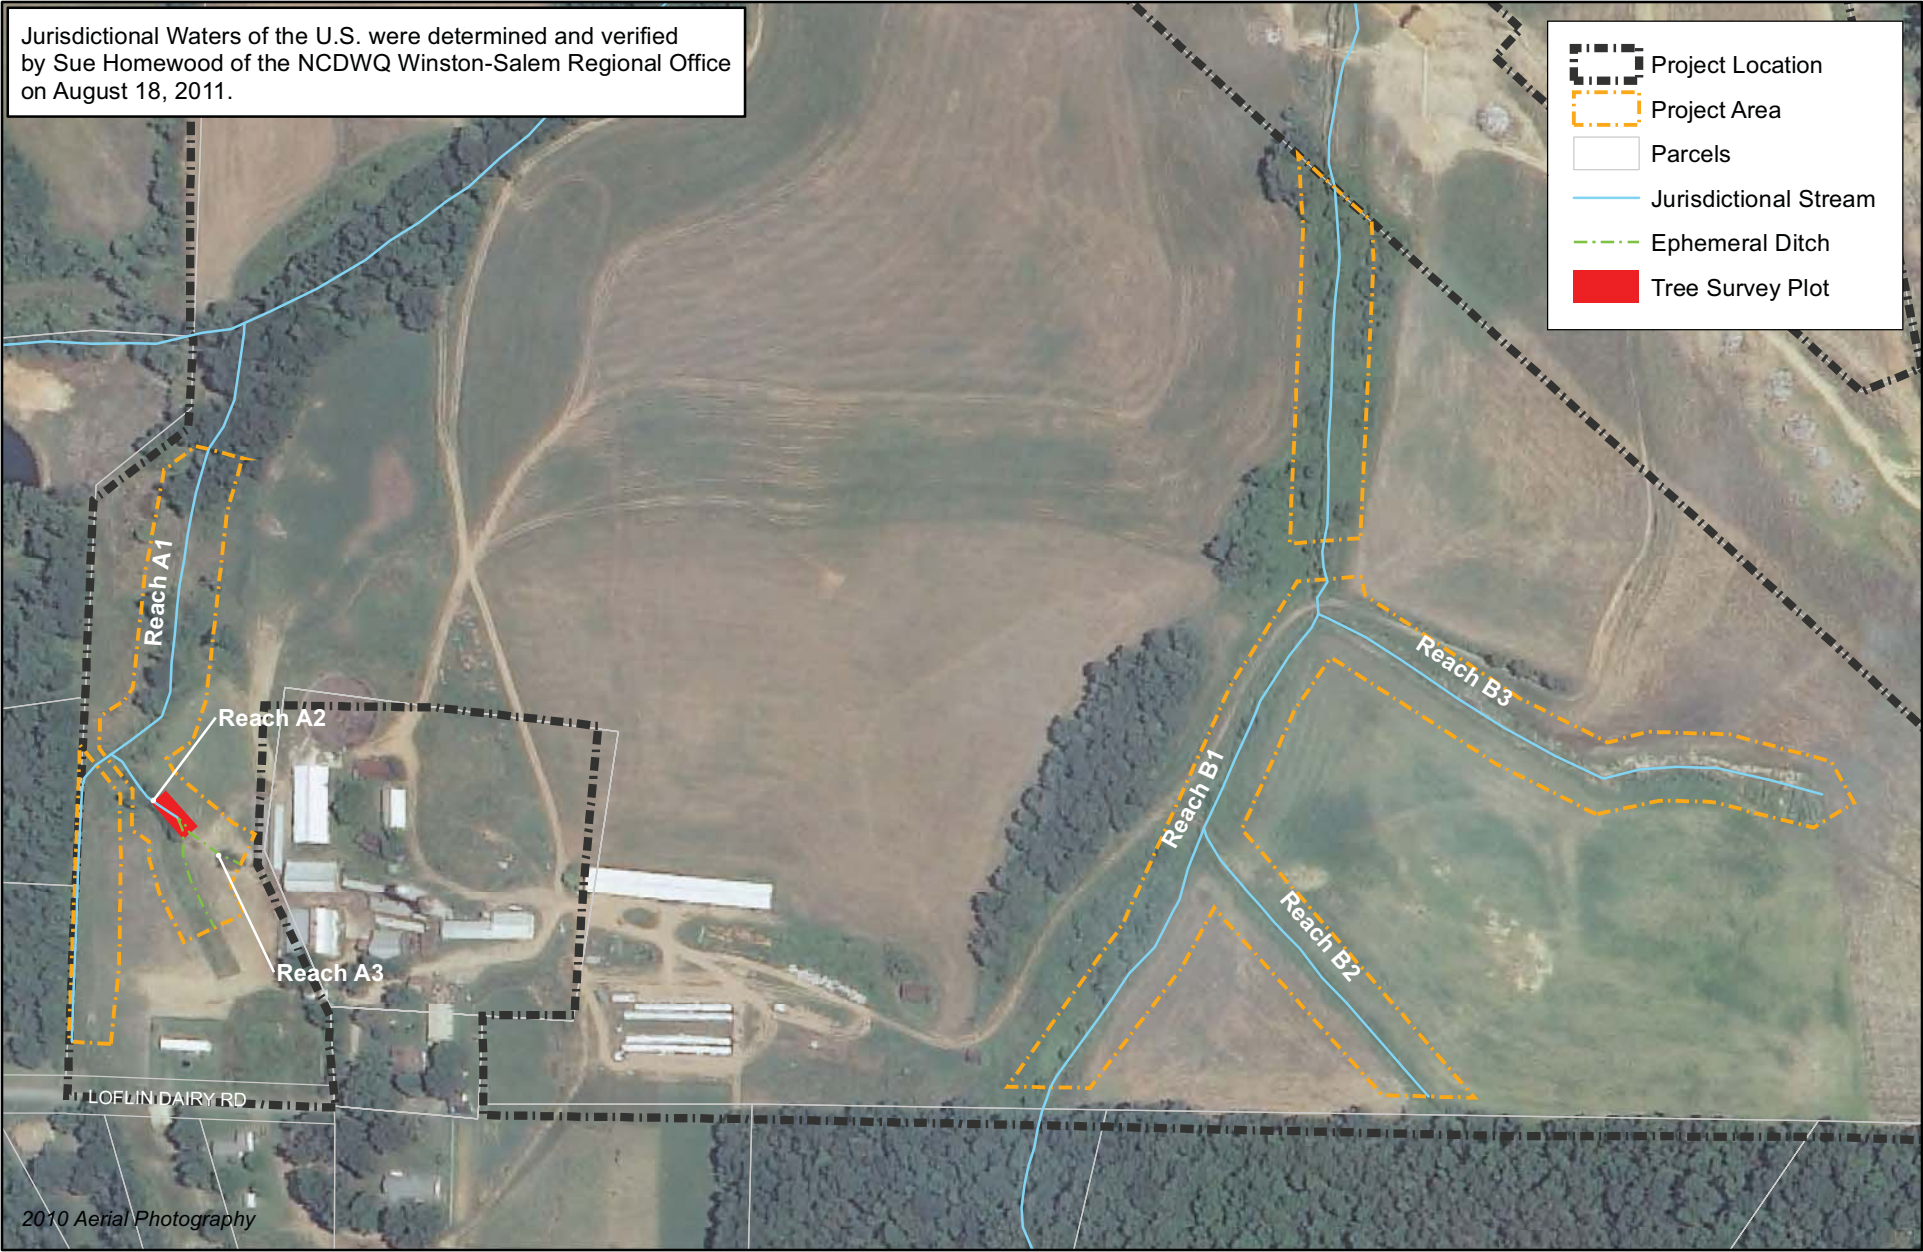
Figure 4 Hydrologic Features Map
Loflin Dairy Buffer Mitigation Site
Cape Fear Basin (03030003)

The results of the on-site field investigation indicate that there are five jurisdictional stream channels located within the proposed project area: Reaches A1, A2, B1, B2 and B3 (Figure 4). No jurisdictional wetland areas were identified within the proposed project area. There are also two ephemeral ditches located in Area A: a portion of Reach A2 and Reach A3. The NCDWQ has approved all seven project reaches as appropriate for buffer mitigation as related to the rules set forth in the Randleman Lake Water Supply Watershed: Mitigation Program for Protection and Maintenance of Existing Riparian Buffers (15ANCAC02B.0252). The approval letter from NCDWQ is included in Appendix B as are all NCDWQ Stream Classification Forms.

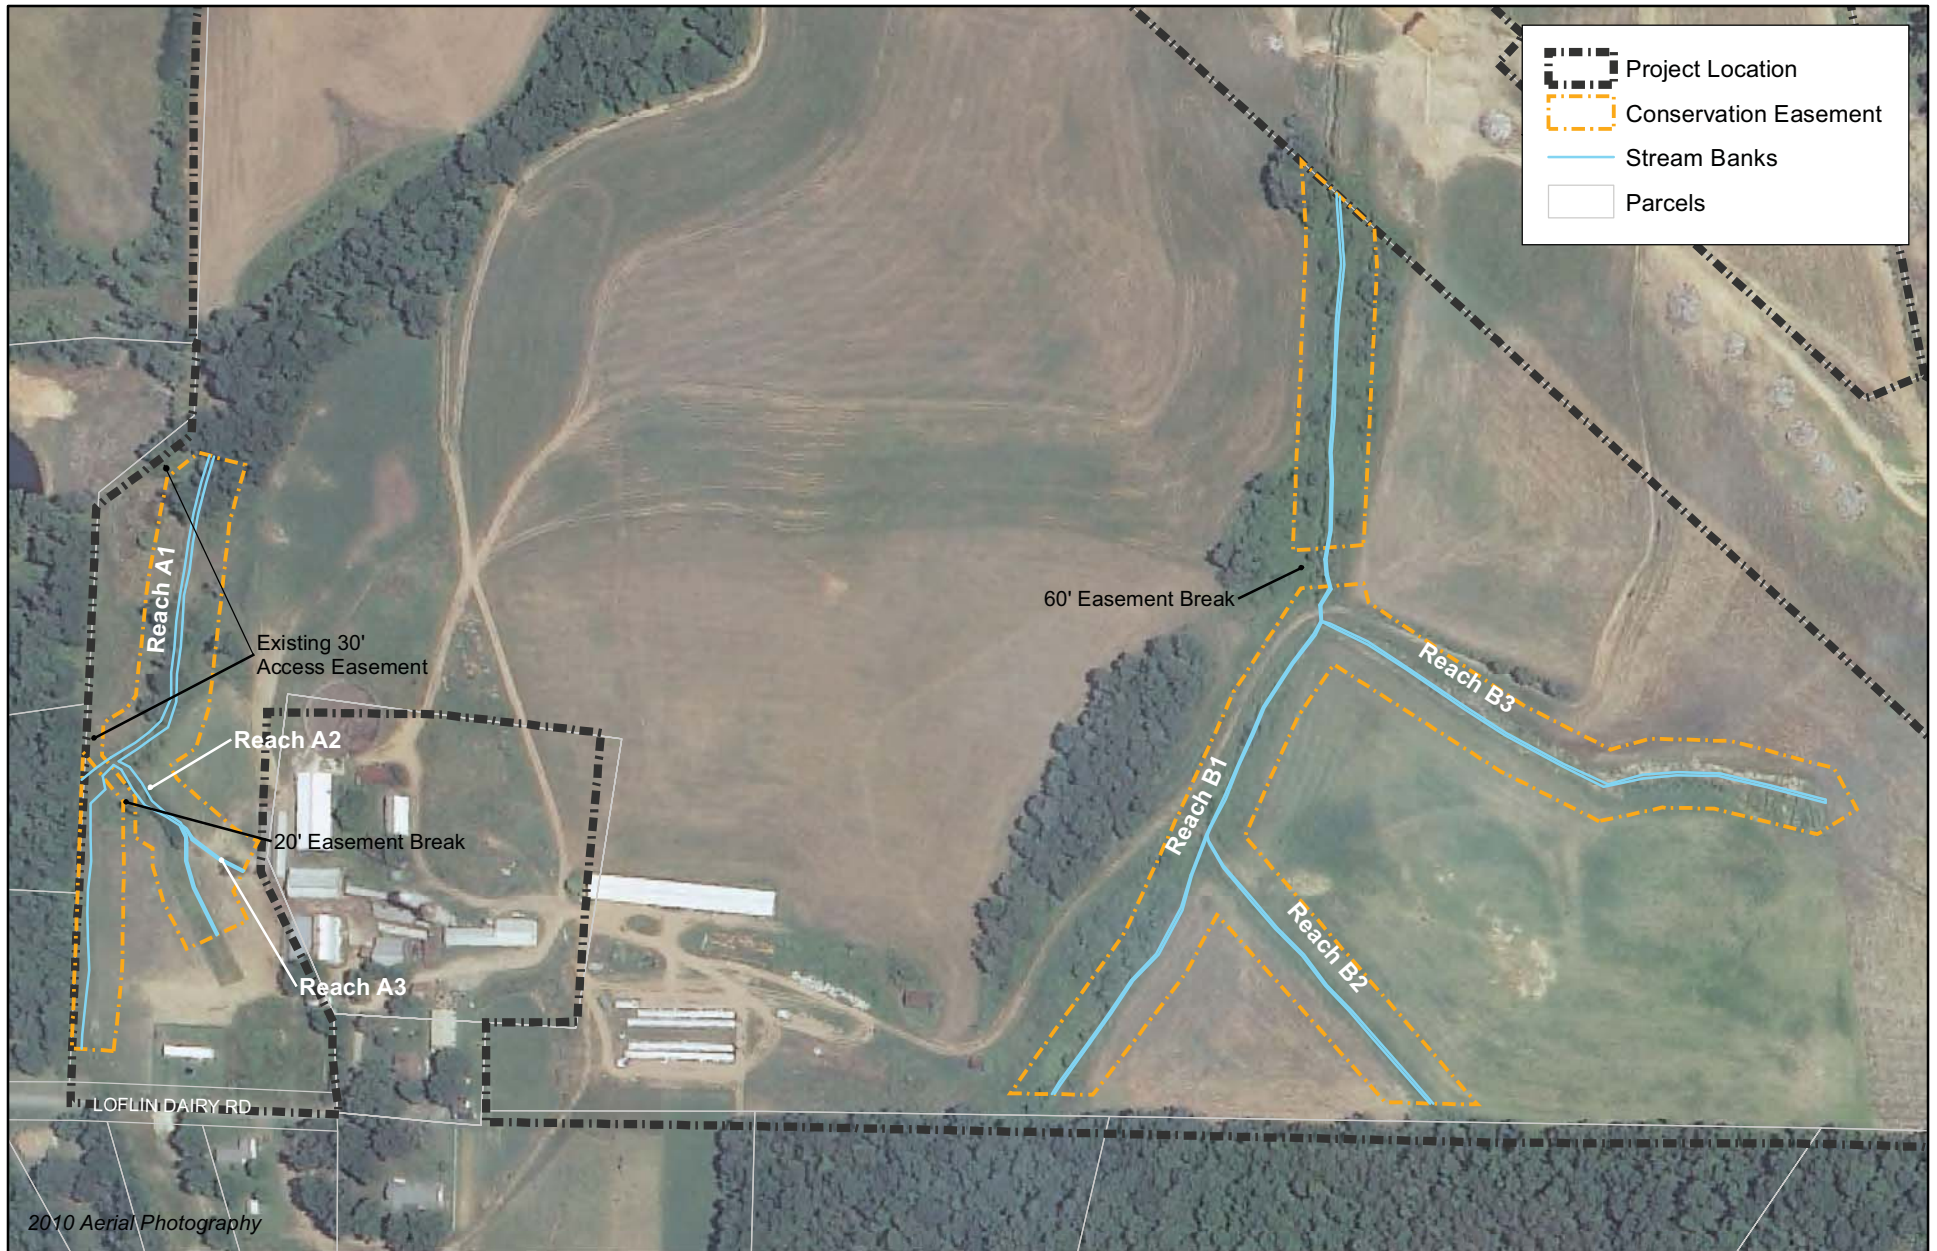
Figure 5 Site Protection Instrument
 Loflin Dairy Buffer Mitigation Site
 Cape Fear Basin (03030003)

The land required for construction, management, and stewardship of the mitigation project includes portions of the parcel listed in Table 3. The proposed conservation easement on this property has not yet been recorded. A copy of the draft land protection instrument is included in the Appendix A.

See Figure 5 for the Site Protection Instrument Figure for the Loflin Dairy Buffer Mitigation Site.

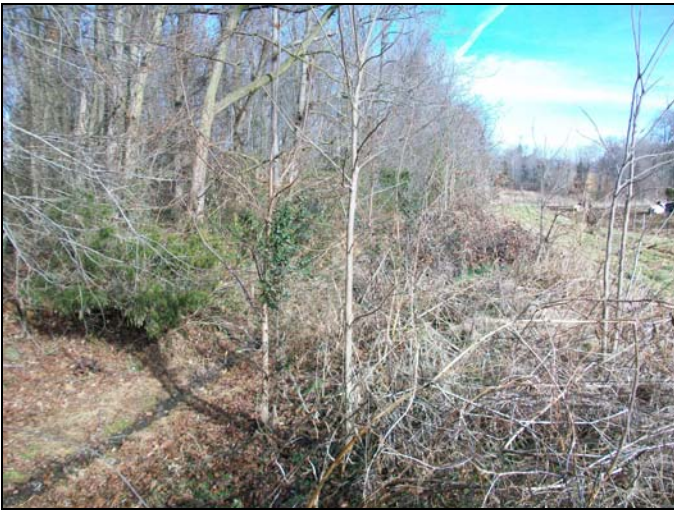
Photo 1- Intermittent Reach A1, facing downstream

Reach A1 – As there was only a single line of four trees found along the top-of-bank of this reach with DBH greater than or equal to five inches, the conservation easement area along this entire reach will be riparian buffer restoration.

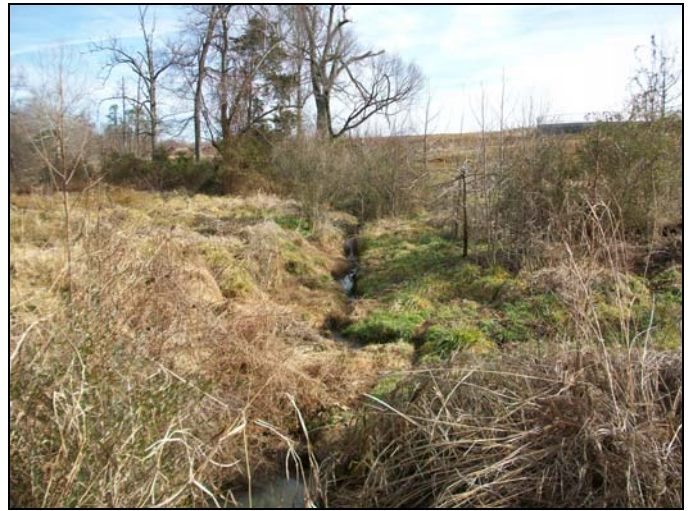
Photo 2- Perennial Reach A1, facing downstream

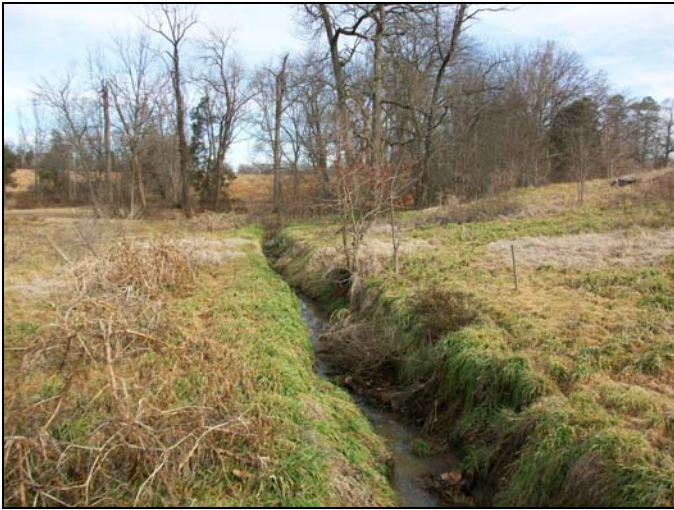
Photo 3- Perennial Reach A1, facing downstream

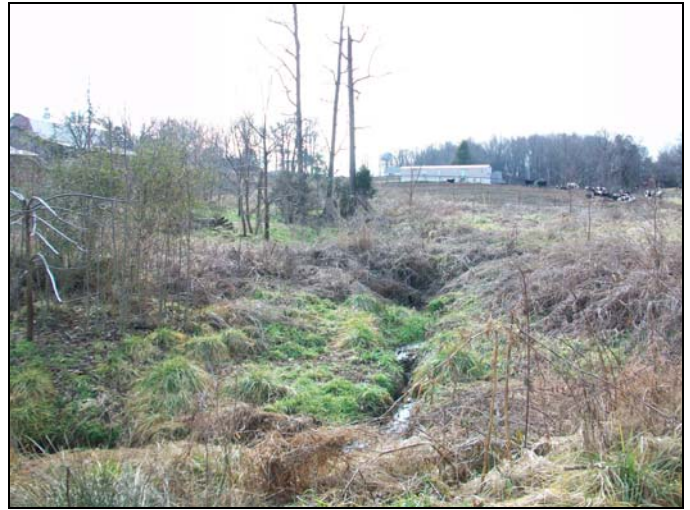
Photo 4- Intermittent Reach A2, facing upstream

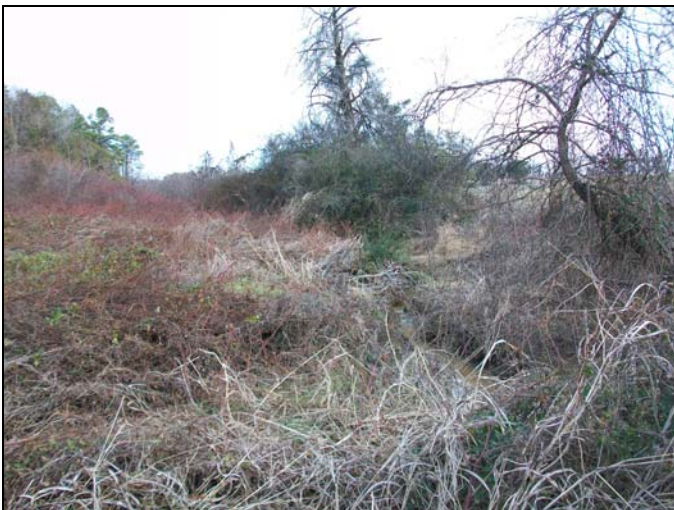
Photo 5- Intermittent Reach B1, facing downstream

Reach B1 flows on-site from an adjacent forested area and transitions from an intermittent channel to a perennial channel approximately midway through the project area. This reach exhibits stable channel conditions and shows no signs of active bank erosion or channel incision. The riparian buffer zone along Reach B1 is immediately adjacent to active row crop fields and receives direct runoff from sediment and fertilizer applications. The buffer zone exhibits no mature canopy trees, sporadic understory trees, and an abundance of shrub and vine species including Chinese privet (*Ligustrum sinense*) and Japanese honeysuckle (*Lonicera japonica*).

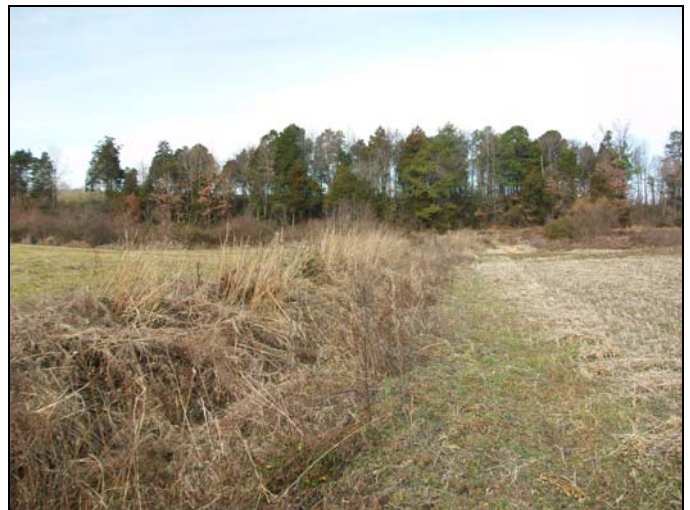
Photo 6- Intermittent Reach B2, facing downstream

Reaches B2 and B3 are small intermittent tributaries to Reach B1. These channels have been heavily ditched and maintained in the past; however, they exhibit stable channel conditions with no evidence of active bank erosion or channel incision. The riparian zones have been actively mowed and sprayed due to their locations in an active row crop field and exhibit an abundance of herbaceous vegetation with no mature trees.

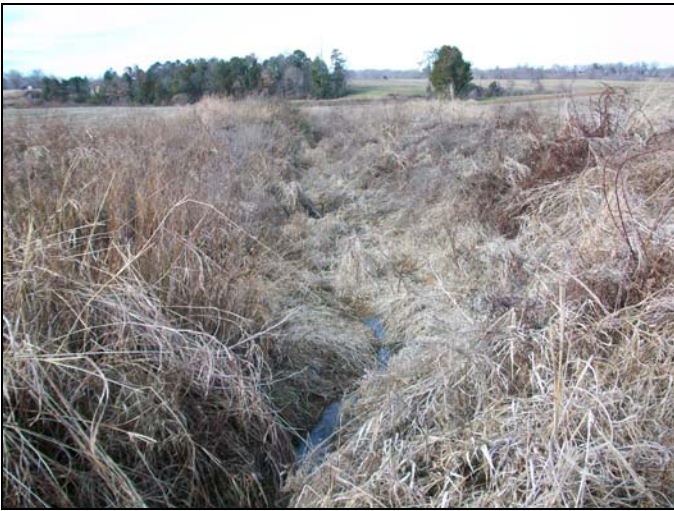
Photo 7- Intermittent Reach B2, facing downstream

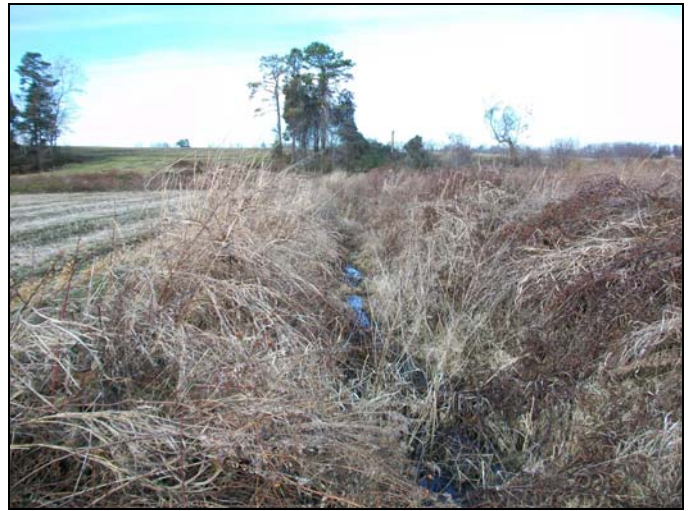
Photo 8- Intermittent Reach B3, facing downstream

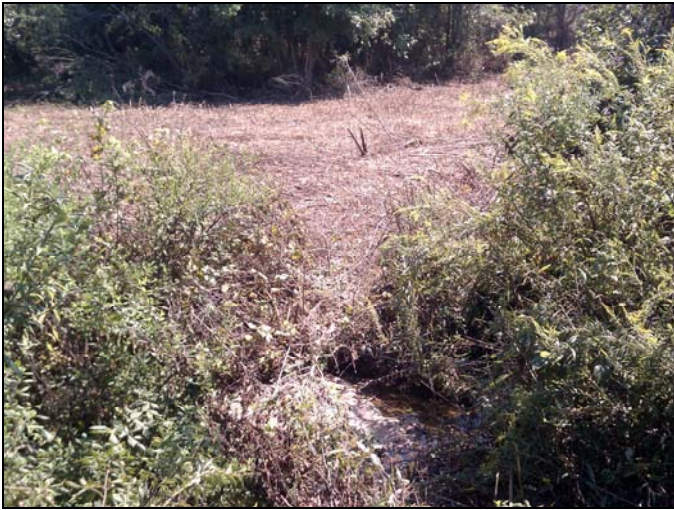
Photo 9- Lack of buffer on Perennial Reach B1

Reach B1 – As there were no trees found with DBH greater than or equal to five inches, the conservation easement area along this entire reach will be riparian buffer restoration.

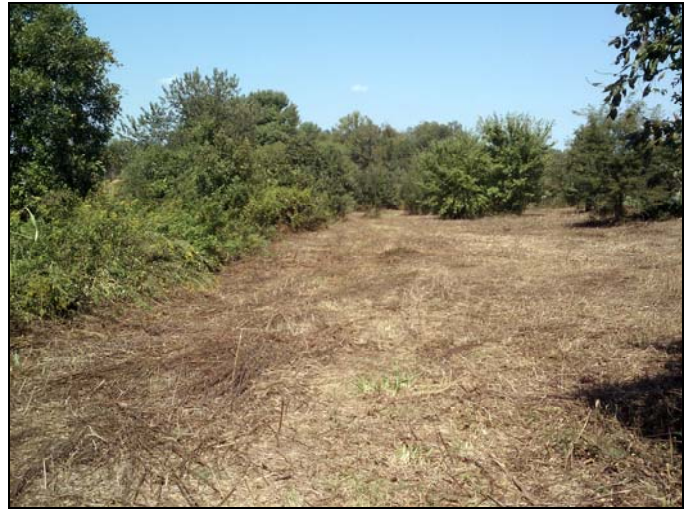
Photo 10- Maintained riparian zone along Reach B1

The riparian zones surrounding Reaches B1, B2, and B3 include maintained herbaceous areas adjacent to active row crop fields and dense streamside thickets. Typical herbaceous vegetation within these areas includes: Canada goldenrod, ragweed (*Ambrosia artemisiifolia*), Nepalese browntop (*Microstegium vimineum*), and various grasses (*Festuca* spp.). No mature canopy trees exist within the streamside thickets and shrub species are dominated by common blackberry and Chinese privet interspersed with Japanese honeysuckle.
