LOFLIN DAIRY BUFFER MITIGATION SITE

DENR Contract 003995

NCEEP Project Number 95008

Monitoring Year 1 Annual Report FINAL

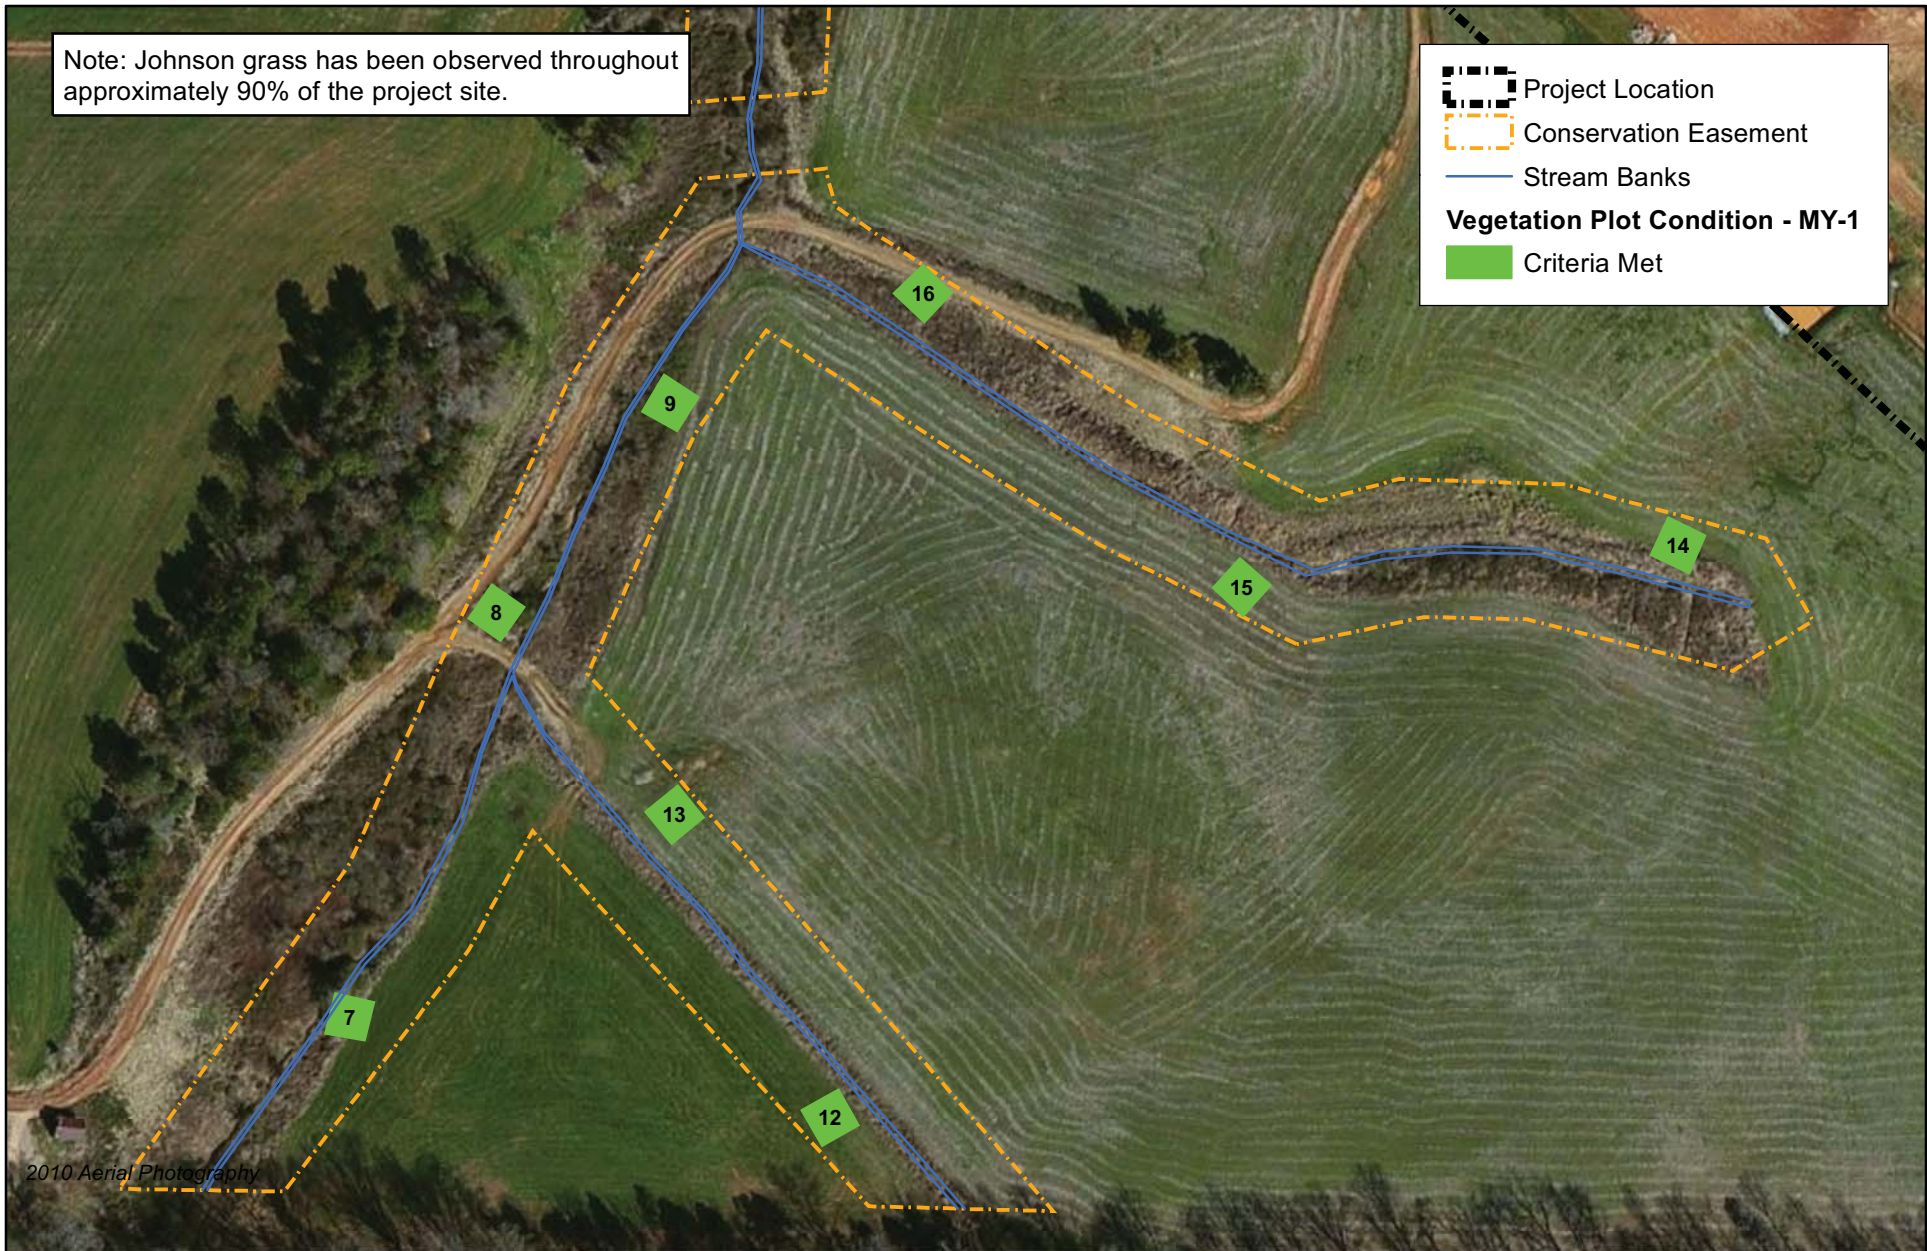
Figure 3.2 Integrated Current Condition Plan View
 (Sheet 2 of 3)
 Loflin Dairy Buffer Mitigation Site
 NCEEP Project Number 95008
 Monitoring Year 1 of 5
 Randolph County, NC

Note: Johnson grass has been observed throughout approximately 90% of the project site.

Project Location
 Conservation Easement
 Stream Banks
Vegetation Plot Condition - MY-1
 Criteria Met

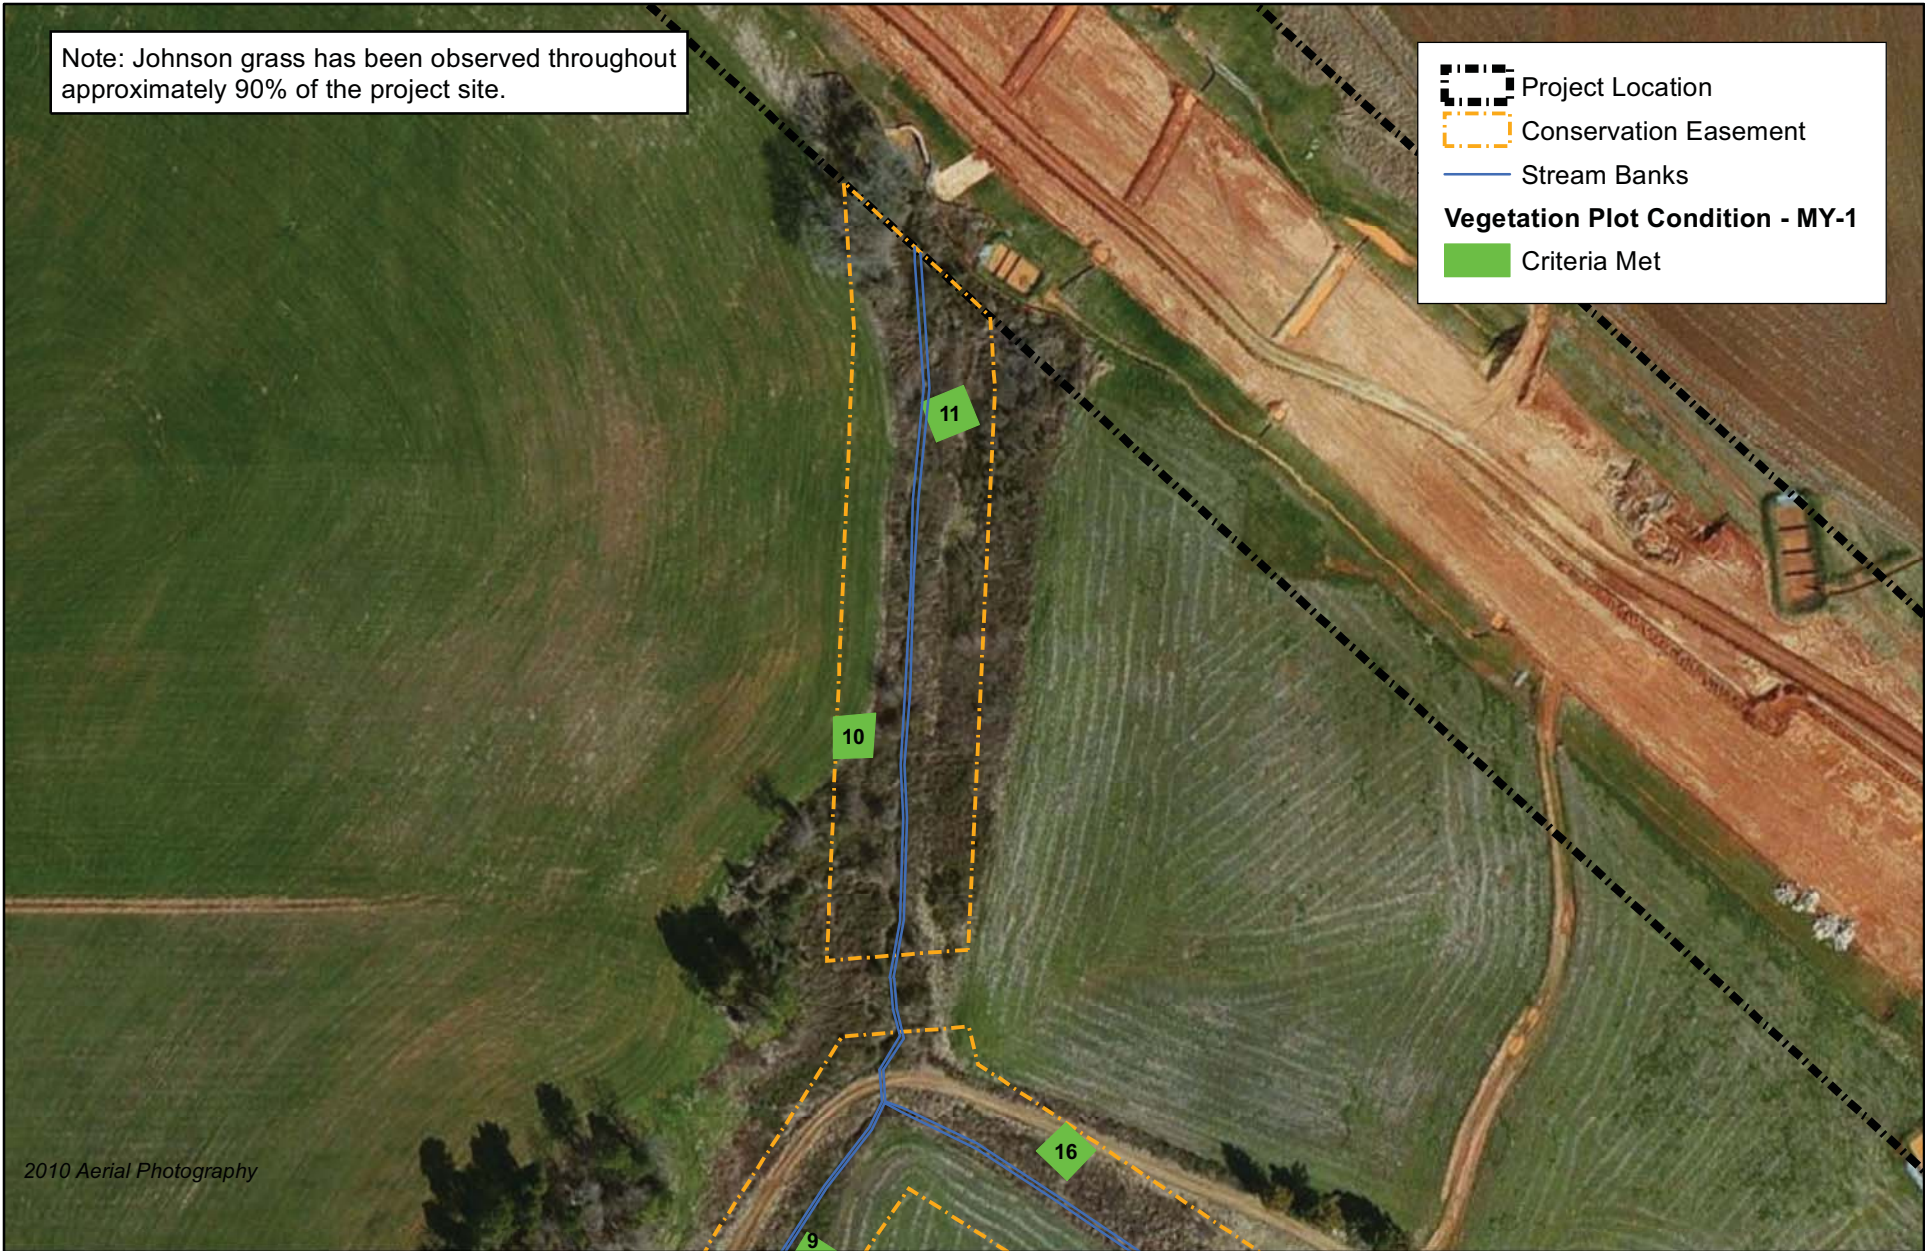
Figure 3.3 Integrated Current Condition Plan View
(Sheet 3 of 3)
Loflin Dairy Buffer Mitigation Site
NCEEP Project Number 95008
Monitoring Year 1 of 5
Randolph County, NC

Note: Johnson grass has been observed throughout approximately 90% of the project site.

- Project Location (dashed black line)
- Conservation Easement (dashed orange line)
- Stream Banks (solid blue line)
- Vegetation Plot Condition - MY-1
 - Criteria Met (green square)
