LOFLIN DAIRY BUFFER MITIGATION SITE

Randolph County, NC
DENR Contract 003995
NCEEP Project Number 95008

Monitoring Year 2 Annual Report FINAL

Monitoring Year 2 Annual Report

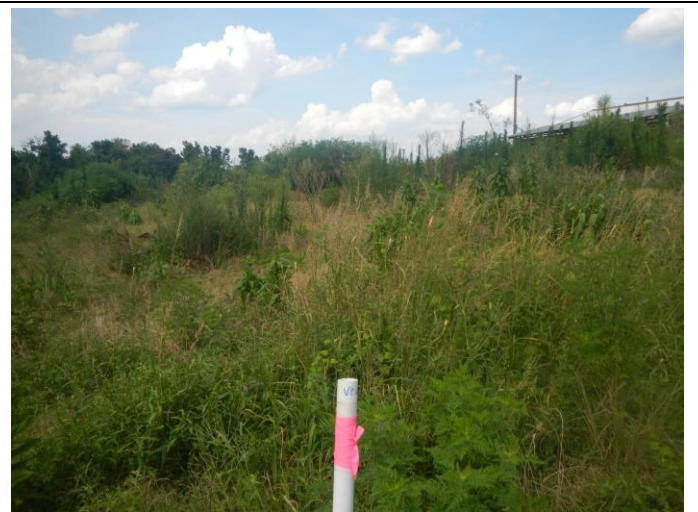
Vegetation Plot 6 (07/25/2013)

| Plot | MY2 Success Criteria Met (Y/N) | Tract Mean |
|---|---|---|
| 6 | N | |

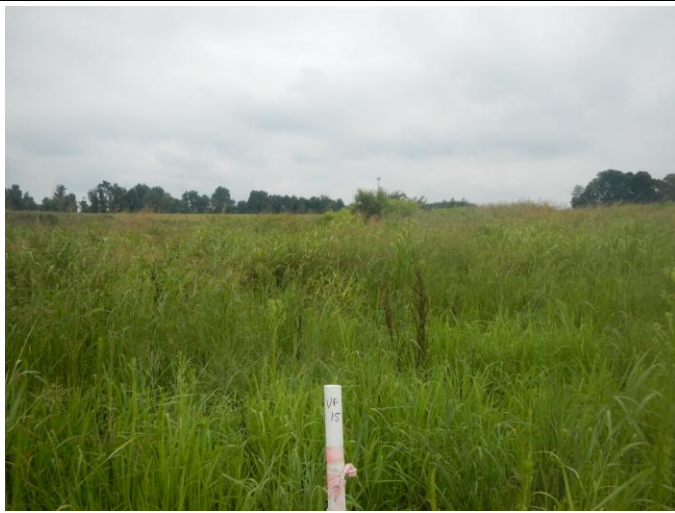
Vegetation Plot 15 (07/25/2013)

| Plot | MY2 Success Criteria Met (Y/N) | Tract Mean |
|---|---|---|
| 15 | N | |
