**MONITORING YEAR 5
ANNUAL REPORT**
Final

LOFLIN DAIRY BUFFER MITIGATION SITE

Randolph County, NC
NCDEQ Contract No. 003995
DMS ID No. 95008

Data Collection Period: July 2016
Final Submission Date: September 30, 2016

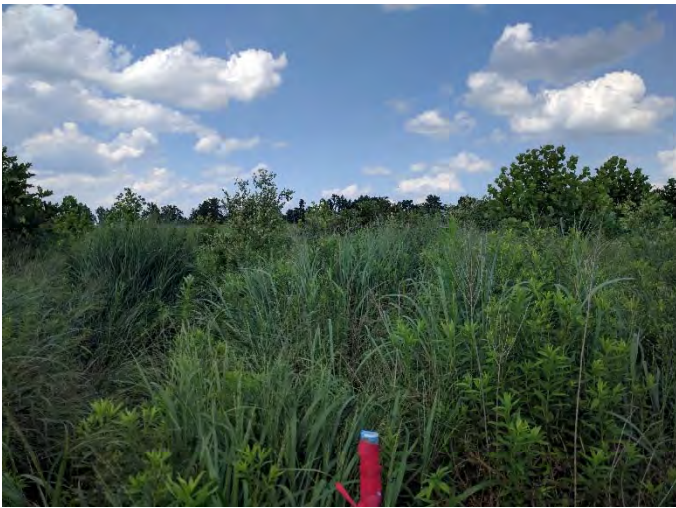
Vegetation Plot 15 – (07/05/2016)

Plot	MY5 Success Criteria Met (Y/N)	Tract Mean
1	Y	94%
2	Y	
3	Y	
4	Y	
5	Y	
6	Y	
7	Y	
8	Y	
9	Y	
10	Y	
11	Y	
12	Y	
13	Y	
14	Y	
15	N	
16	Y
