# MITIGATION PLAN

## LONE HICKORY MITIGATION SITE

Yadkin County, NC  
NCDEQ Contract No. 6897  
DMS ID No. 97135

Yadkin River Basin  
HUC 03040101

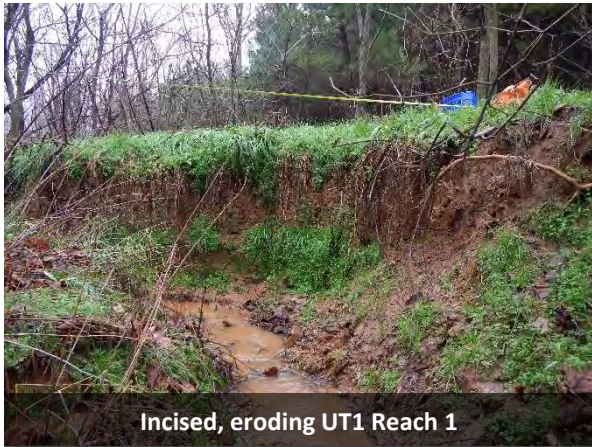
**Incised, eroding UT1 Reach 1**

**UT1 Reach 1**

Below the headcut, UT1 is deeply incised, with steep banks, mass wasting, and moderate bank erosion on alternating banks. UT1 is characterized here by moderate pattern and coarse gravels, and cross sections 1 and 2 were taken here which classify the channel as an incised (bank height ratio of 3.8), unstable Rosgen E5b-type stream. Approximately 300 feet downstream of the headcut, UT1 reaches a 30-foot tall embankment undergoing mass wasting with series of small headcuts leading to a steep boulder cascade. This embankment is clearly visible on the 1993 historical aerial as an old farm road. Beyond the boulder cascade, UT1 enters Wetland G, which has formed within the accumulated sediments in Pond 1.

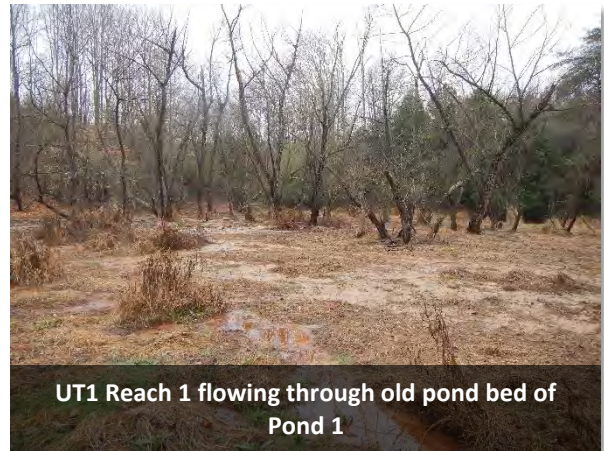
**UT1 Reach 1 flowing through old pond bed of Pond 1**

Within the old pond bed UT1 has weakly defined bed and banks and is braided with several concurrent flowpaths. The top of the accumulated sediment of Pond 1 has a longitudinal slope of 1.7%. Flow continues for 250 feet through the old pond bed before the weakly defined channel begins to follow a ditch. Several headcuts occur along this ditch and the stream becomes incised. This slightly meandering, incised section continues for 150 feet until reaching another breaching dam with an active, 10-foot headcut. Banks around the base of this headcut are 12-20 feet above the streambed, and are mass-wasting with several visible root masses undermined by erosion. Over the course of 18

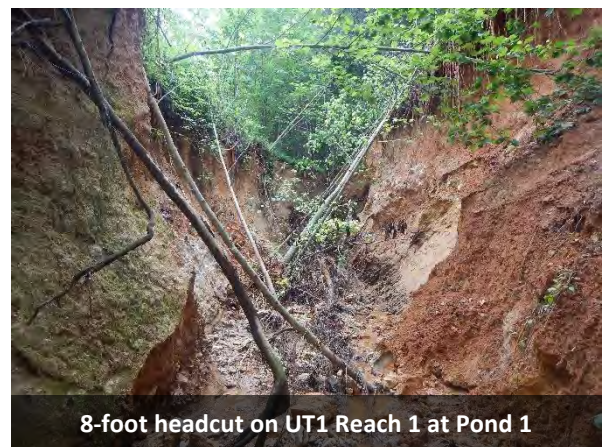
**8-foot headcut on UT1 Reach 1 at Pond 1**

months of site investigations, the headcut has rapidly progressed, advancing an average of 1 foot per month. A photo log of the headcut progression is included in Appendix 4.

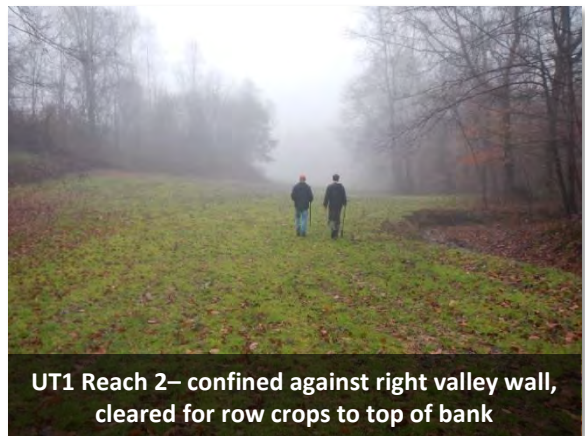
UT1 Reach 2 begins where UT1 takes a sharp turn back to the north approximately 100 feet below the 10 foot headcut at Pond 1 and immediately downstream from Wetland H. Reach 2 is confined against the right valley wall and is perched above the lowest point in the valley, suggesting historic relocation. A review of historic aerials shows that UT1 has occupied near the same alignment since 1963. Wetland H is hydrologically connected to Pond 1 through a drainage pipe that contributes to the hydrology of this wetland and may be the remnant UT1 channel prior to its impoundment. A series of bedrock outcrops also begin to appear in Reach 2, and continue to influence the streambed throughout the reach.

**UT1 Reach 2– confined against right valley wall, cleared for row crops to top of bank**

Approximately 100 feet downstream from the northward turn, the entire valley bottom is cleared for row crops with UT1 occupying the right valley toe. The Reaves family recount that their grandfather ditched UT1 along the valley wall to open the field for farming (Reaves, 2015). Moderate to mild bank erosion occurs throughout this length of UT1 due to the confinement of the channel and the lack of stabilizing vegetation. The reach is predominantly incised, but regains some floodplain connection in areas where bedrock outcrops are present in the channel and in isolated areas where bankfull benches have developed within the incised channel. Due to confinement against the right valley wall, the stream has very little pattern. Long riffles and short, shallow pools dominate the streambed. Due to the steepness of the right valley wall, mass wasting is present in areas where the stream has eroded into it. Cross sections 3 and 4 were taken here and classify the stream as a Rosgen G4-type stream channel. The valley slope of UT1 Reach 2 varies down its length, but is approximately 3% on average.

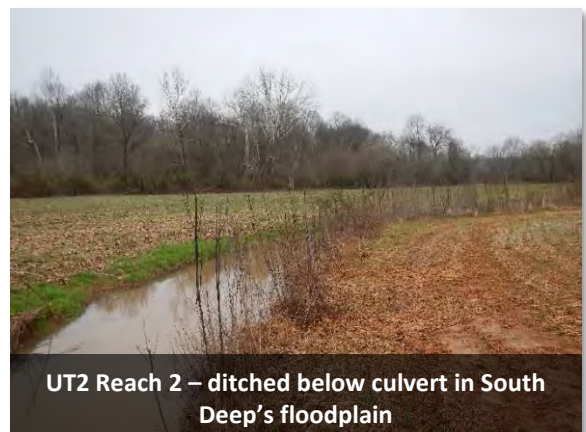
UT2 Reach 2 begins at an existing culvert outlet where UT2 leaves its valley and enters the broad, flat floodplain of South Deep Creek. Reach 2 follows a straight trajectory until just downstream of its confluence with UT2A and UT2B, where it curves gradually northeast, terminating at the wood-line. At its confluence of UT2A, inner berms vegetated with annual species are a consistent channel feature. Throughout its entire length, UT2 Reach 2 is ditched, incised with low entrenchment ratios and high bank height ratios, and straightened. Bedform diversity is poor with only low sloped runs and shallow pools for habitat. Cross sections 3 and 4 classify the stream as a Rosgen G5-type stream.

**UT2 Reach 2 – ditched below culvert in South Deep's floodplain**

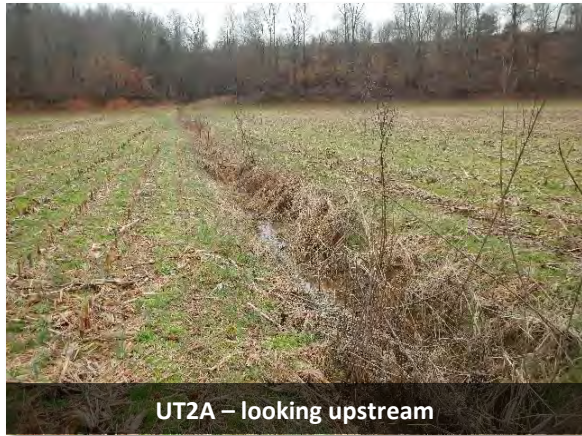
UT2A – looking upstream

UT2A to South Deep Creek enters the Site flowing north through a failing concrete culvert. Upstream of the culvert, an ephemeral channel drains a steeply sloping hardwood forest. Just downstream from the culvert, UT2A becomes intermittent. UT2A here is ditched, deeply incised, and straightened. Approximately 100 LF upstream of UT2A's confluence with Open Water A (a field ditch), the stream becomes perennial. The perennial stream takes a sharp right turn to the east at its confluence with Open Water A, and flows straight until its perpendicular confluence with UT2. UT2A is joined

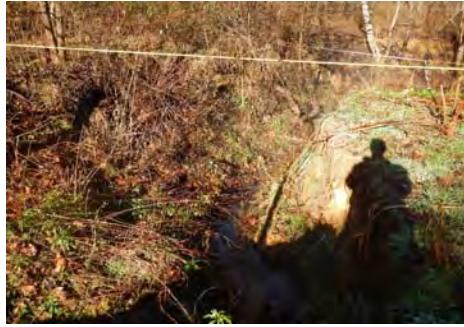
View Downstream

- 4.4 x-section area (ft.sq.)
- 5.3 width (ft)
- 0.8 mean depth (ft)
- 1.4 max depth (ft)
- 6.4 wetted perimeter (ft)
- 0.7 hyd radi (ft)
- 6.4 width-depth ratio
- W flood prone area (ft)
- entrenchment ratio
- 4.1 low bank height ratio

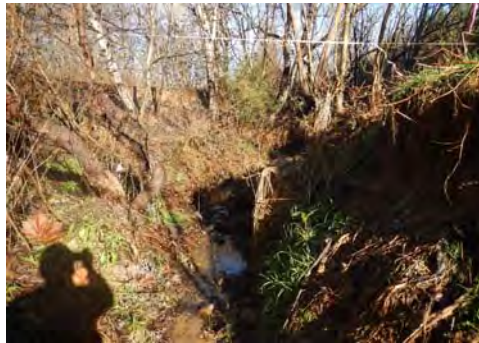
View Downstream

- 3.8 x-section area (ft.sq.)
- 4.8 width (ft)
- 0.8 mean depth (ft)
- 1.4 max depth (ft)
- 5.9 wetted perimeter (ft)
- 0.6 hyd radi (ft)
- 6.2 width-depth ratio
- 13.1 W flood prone area (ft)
- 2.7 entrenchment ratio
- 3.8 low bank height ratio

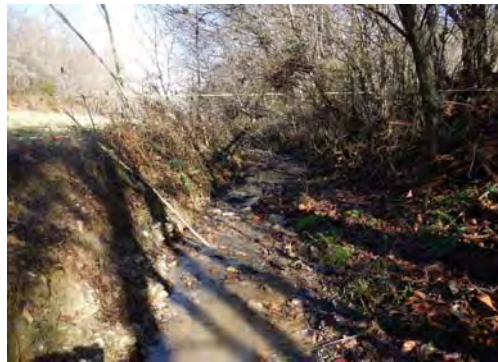
View Downstream

- 7.2 x-section area (ft.sq.)
- 8.9 width (ft)
- 0.8 mean depth (ft)
- 1.3 max depth (ft)
- 10.0 wetted perimeter (ft)
- 0.7 hyd radi (ft)
- 11.0 width-depth ratio
- 13.2 W flood prone area (ft)
- 1.5 entrenchment ratio
- 2.6 low bank height ratio

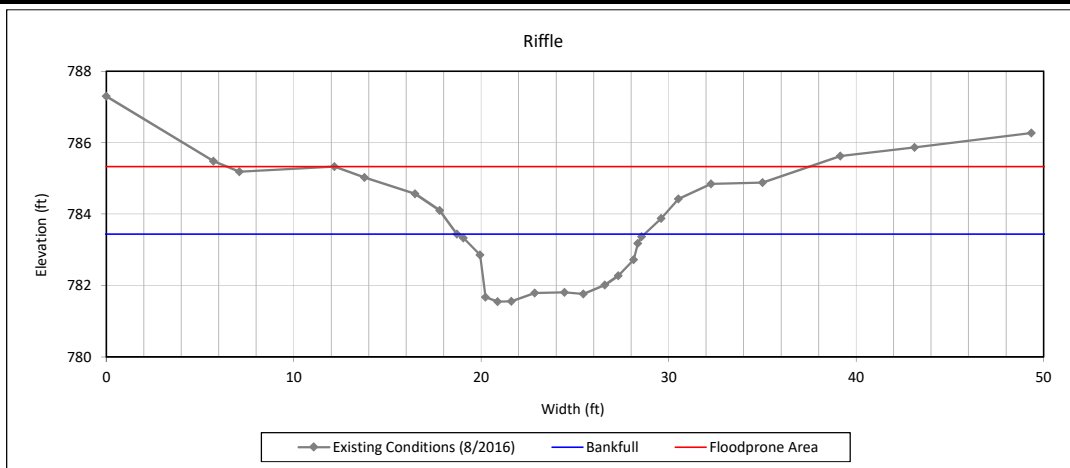
Cross Section 5, UT1 Reach3

- 13.4 x-section area (ft.sq.)
- 10.0 width (ft)
- 1.3 mean depth (ft)
- 1.9 max depth (ft)
- 11.7 wetted perimeter (ft)
- 1.1 hyd radi (ft)
- 7.5 width-depth ratio
- 31.1 W flood prone area (ft)
- 3.1 entrenchment ratio
- 1.7 low bank height ratio

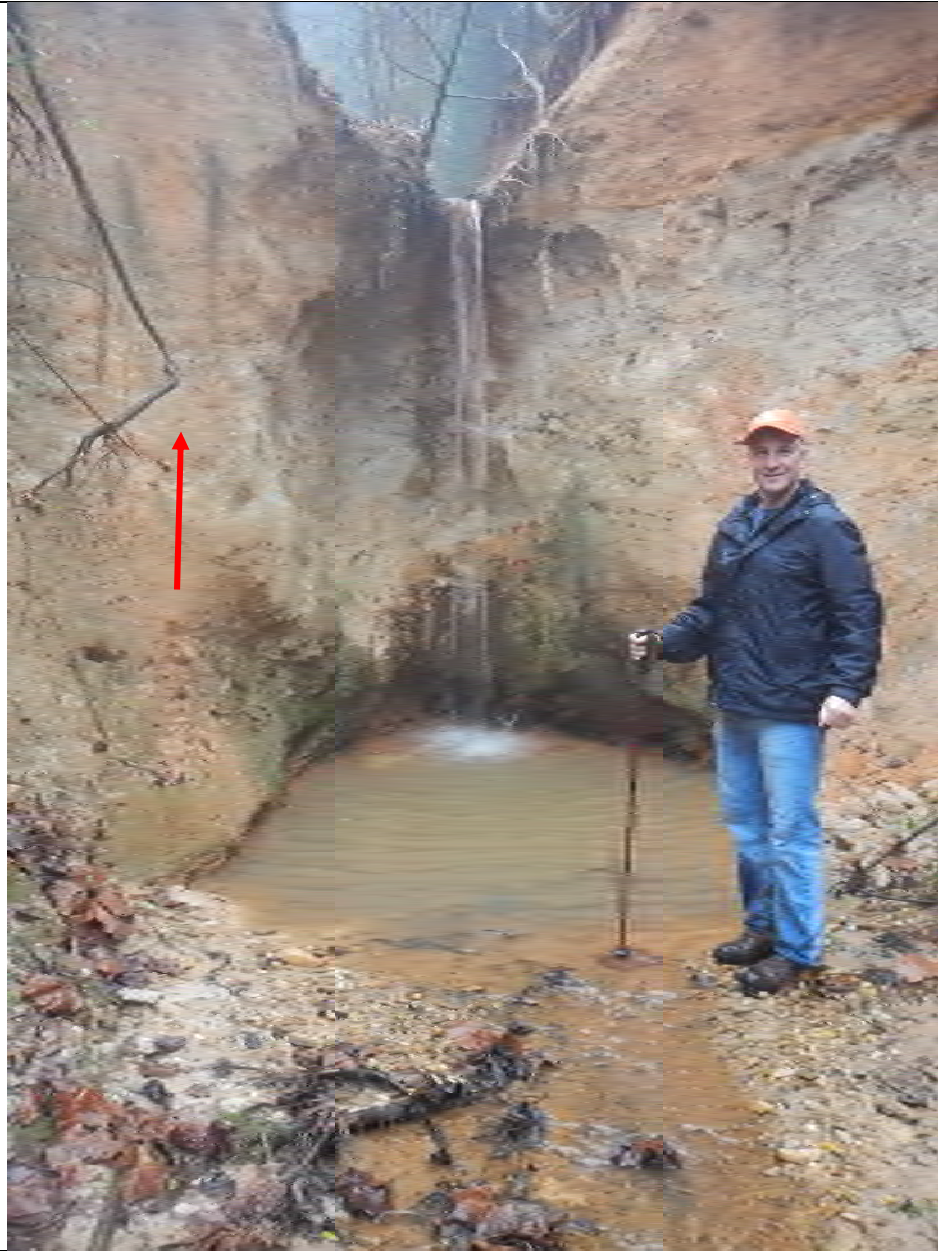
12/22/2015; UT1 Pond 1 Headcut on initial site visit

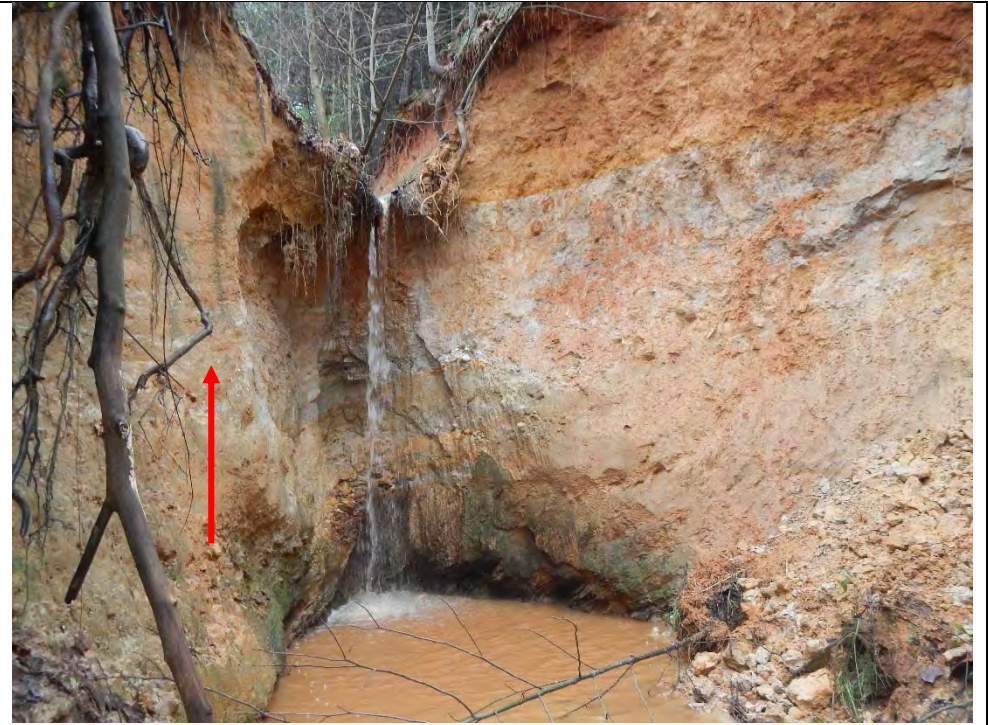
12/29/2015; UT1 Pond 1 Headcut (1 wk)

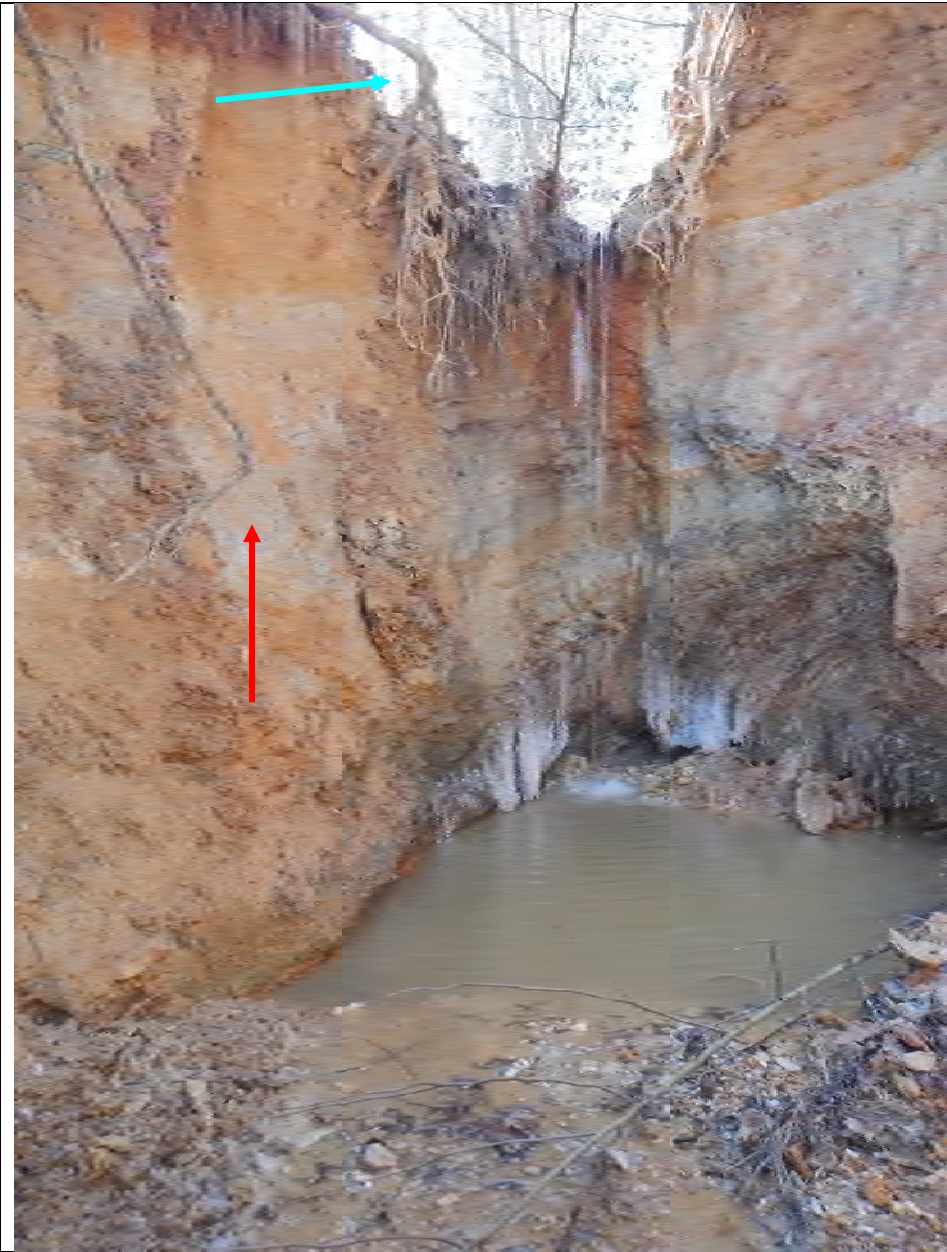
1/7/2016; UT1 Pond 1 Headcut (2 wk)

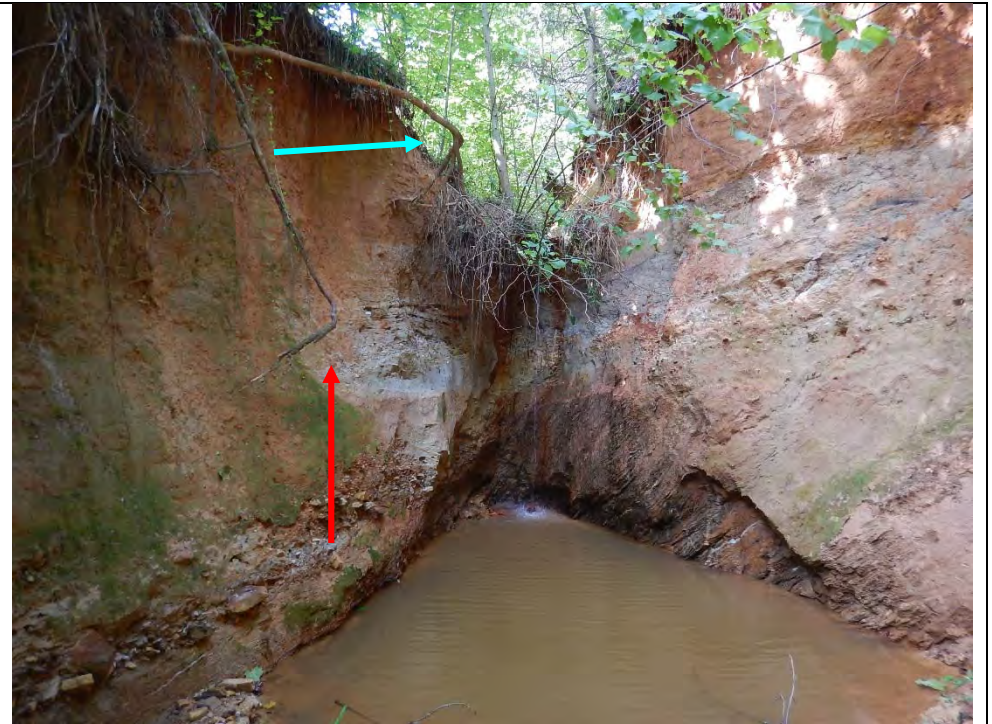
7/15/2016; UT1 Pond 1 Headcut (7 months)

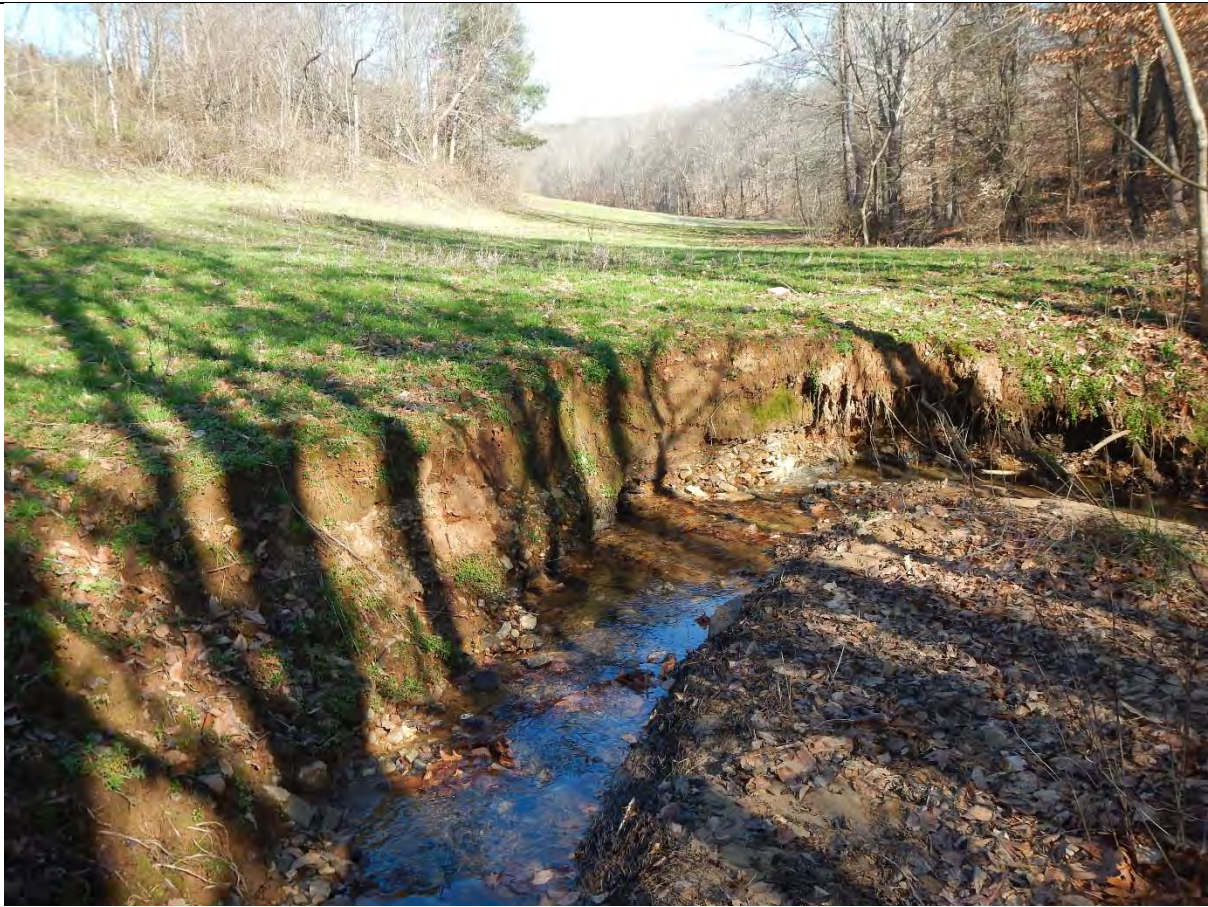
UT1 – Reach 2A. Incision, bank erosion, and instream deposition of fines

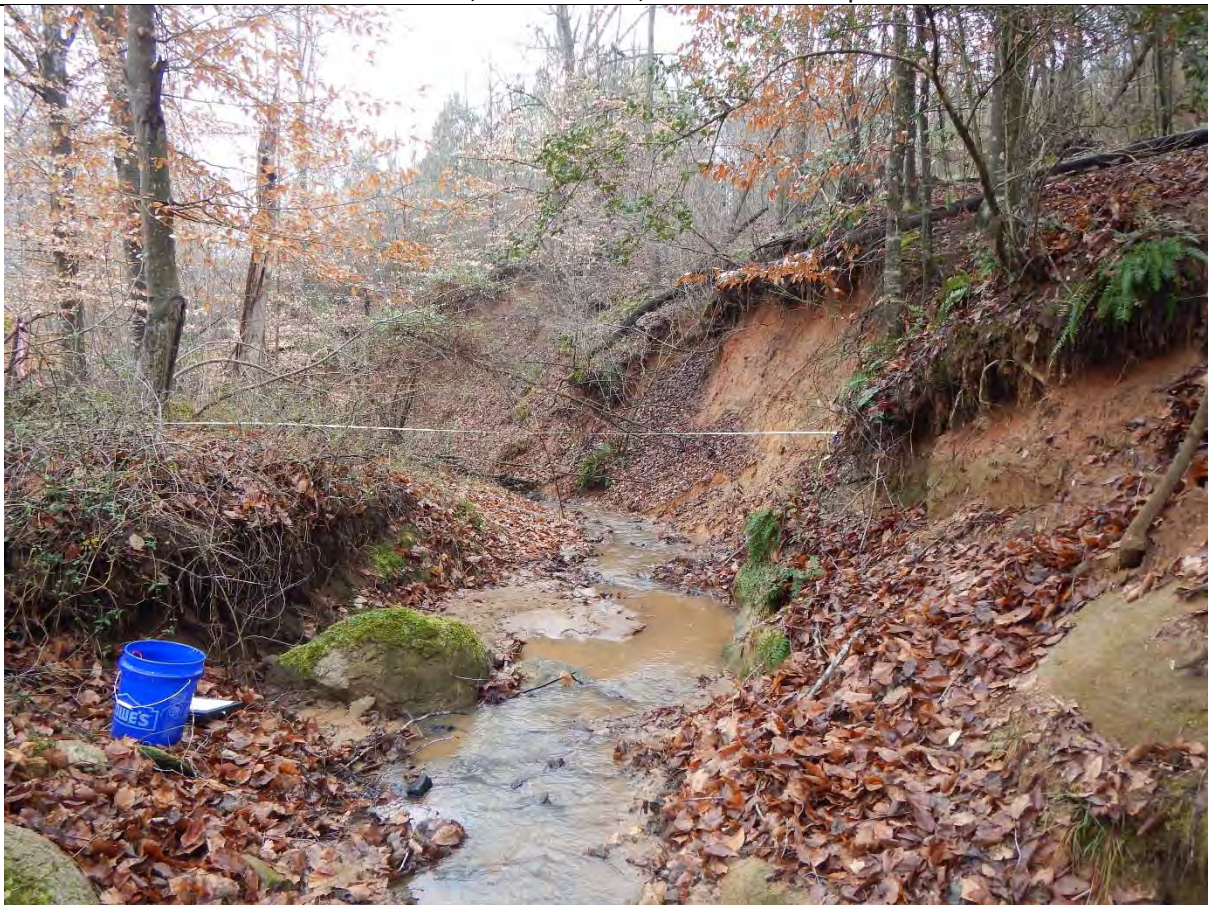
UT1 – Reach 2A. Heavy sediment load, valley wall and bank erosion near bedrock outcrop

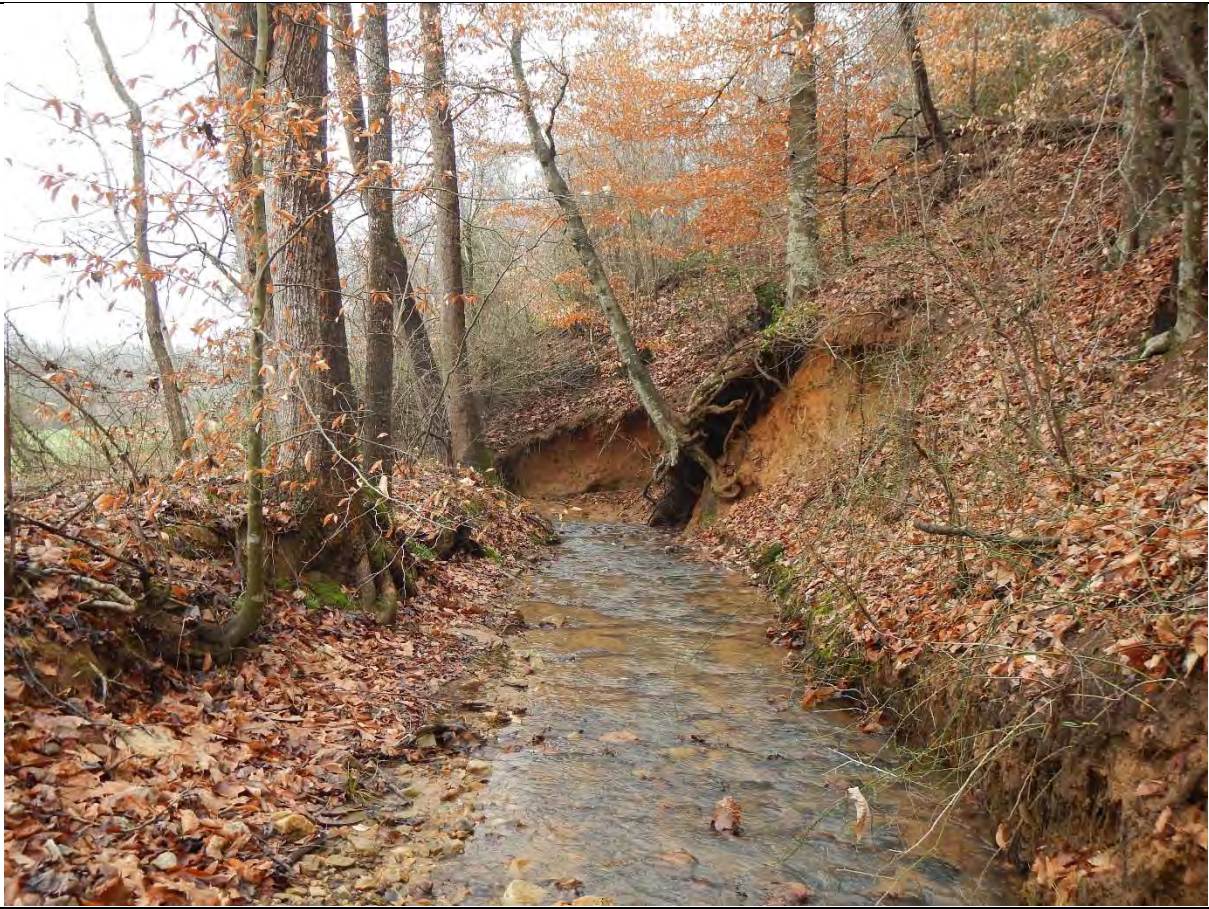
UT1 – Reach 2B, Consistent bank erosion, mass wasting of valley wall, and embedded riffle substrate.

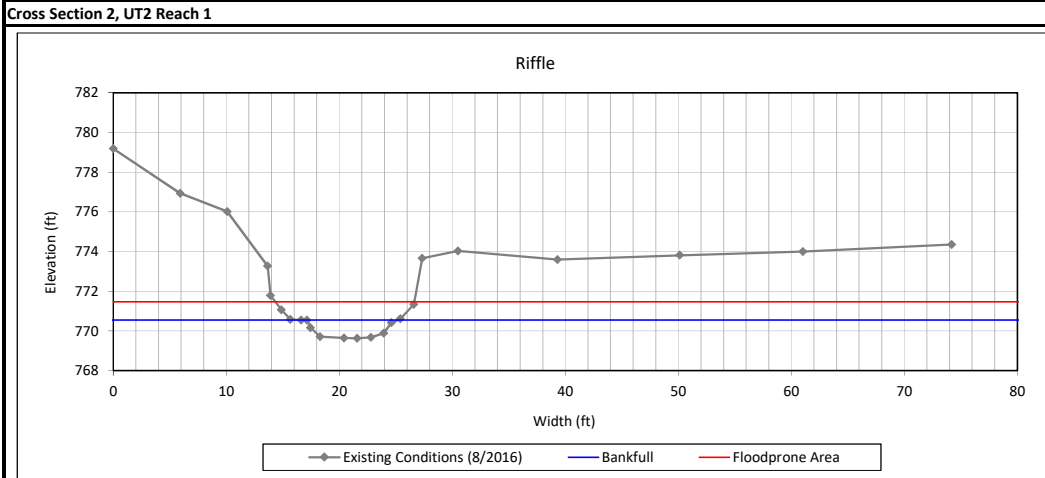
Cross Section Plots  
 Lone Hickory Mitigation Site (DMS Project No. 97135)  
 Existing Conditions

- Bankfull Dimensions**
- 5.7 x-section area (ft.sq.)
  - 8.7 width (ft)
  - 0.7 mean depth (ft)
  - 0.9 max depth (ft)
  - 9.2 wetted parimeter (ft)
  - 0.6 hyd radi (ft)
  - 13.1 width-depth ratio
  - 12.3 W flood prone area (ft)
  - 1.4 entrenchment ratio
  - 4.4 low bank height ratio

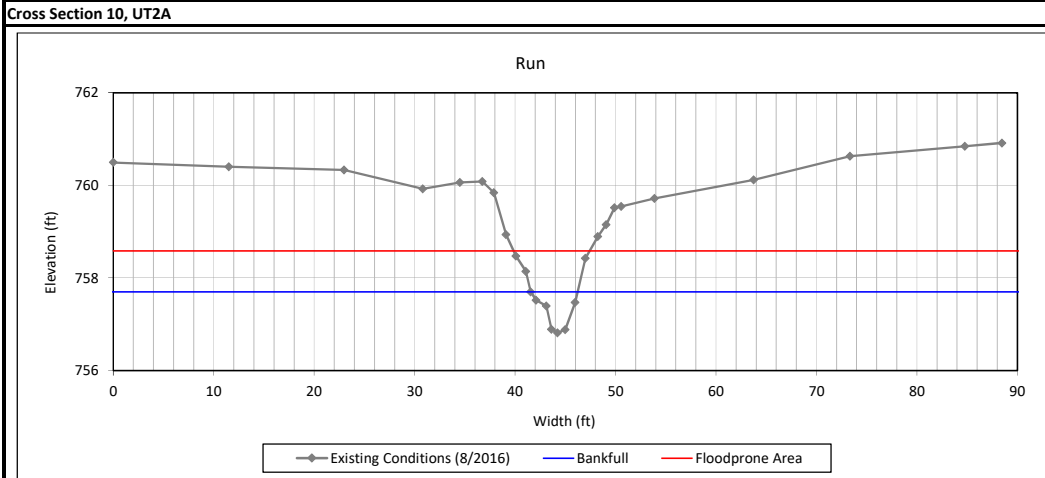
Cross Section Plots  
 Lone Hickory Mitigation Site (DMS Project No. 97135)  
 Existing Conditions

- Bankfull Dimensions**
- 2.3 x-section area (ft.sq.)
  - 4.7 width (ft)
  - 0.5 mean depth (ft)
  - 0.9 max depth (ft)
  - 5.2 wetted perimeter (ft)
  - 0.4 hyd radi (ft)
  - 9.5 width-depth ratio
  - 11.4 W flood prone area (ft)
  - 2.4 entrenchment ratio
  - 3.1 low bank height ratio

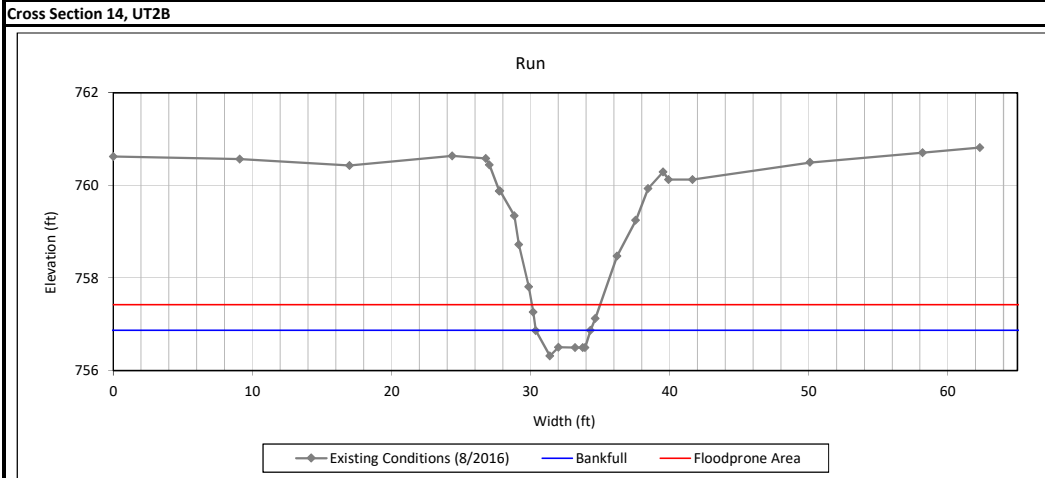
Cross Section Plots  
 Lone Hickory Mitigation Site (DMS Project No. 97135)  
 Existing Conditions

- Bankfull Dimensions**
- 1.4 x-section area (ft.sq.)
  - 3.9 width (ft)
  - 0.3 mean depth (ft)
  - 0.6 max depth (ft)
  - 4.3 wetted perimeter (ft)
  - 0.3 hyd radi (ft)
  - 11.4 width-depth ratio
  - 6.4 W flood prone area (ft)
  - 1.6 entrenchment ratio
  - 7.2 low bank height ratio

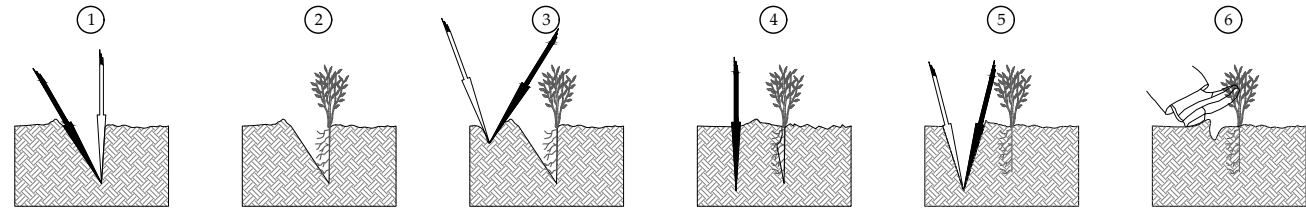
1. ALL SOILS WITHIN THE BUFFER PLANTING AREA SHALL BE DISKED, AS REQUIRED, PRIOR TO PLANTING.
2. ALL PLANTS SHALL BE PROPERLY HANDLED PRIOR TO INSTALLATION TO INSURE SURVIVAL.

1. INSERT THE DIBBLE, OR SHOVEL, STRAIGHT DOWN INTO THE SOIL TO THE FULL DEPTH OF THE BLADE AND PULL BACK ON THE HANDLE TO OPEN THE PLANTING HOLE. (DO NOT ROCK THE SHOVEL BACK AND FORTH AS THIS CAUSES SOIL IN THE PLANTING HOLE TO BE COMPACTED, INHIBITING ROOT GROWTH.)

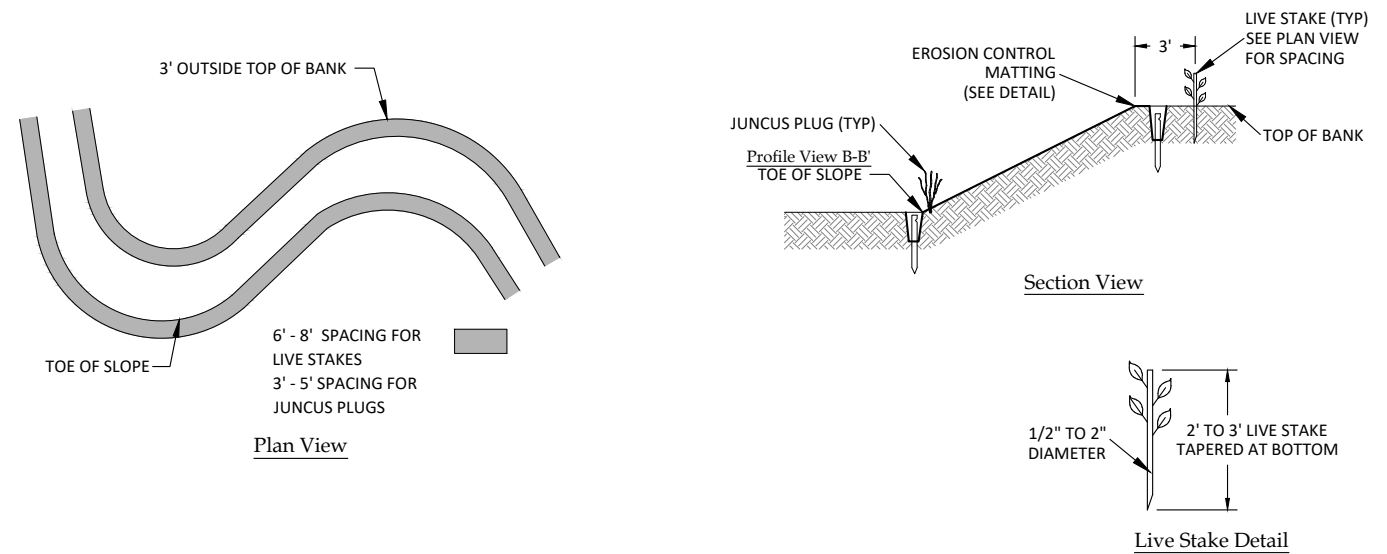
- NOTE:**
1. ROOTED/LEAFED CONDITION OF THE LIVING PLANT MATERIAL IS NOT REPRESENTATIVE OF THE TIME OF INSTALLATION.
  2. BOTTOM OF FIRST COMPACTED EARTH LIFT TO BE PLACED 6" ABOVE NORMAL BASEFLOW.
  3. NUMBER OF COMPACTED EARTH LIFTS TO VARY DEPENDING ON DESIGN TOP OF BANK HEIGHT.

- NOTE:**
1. LIVE STAKES TO BE PLANTED IN AREAS AS SHOWN ON PLANS AND DIRECTED BY THE ENGINEER.
