MY02 Monitoring Report

Longhorn Riparian Buffer Mitigation Site

Randolph County, NC

DMS Project No. 100114

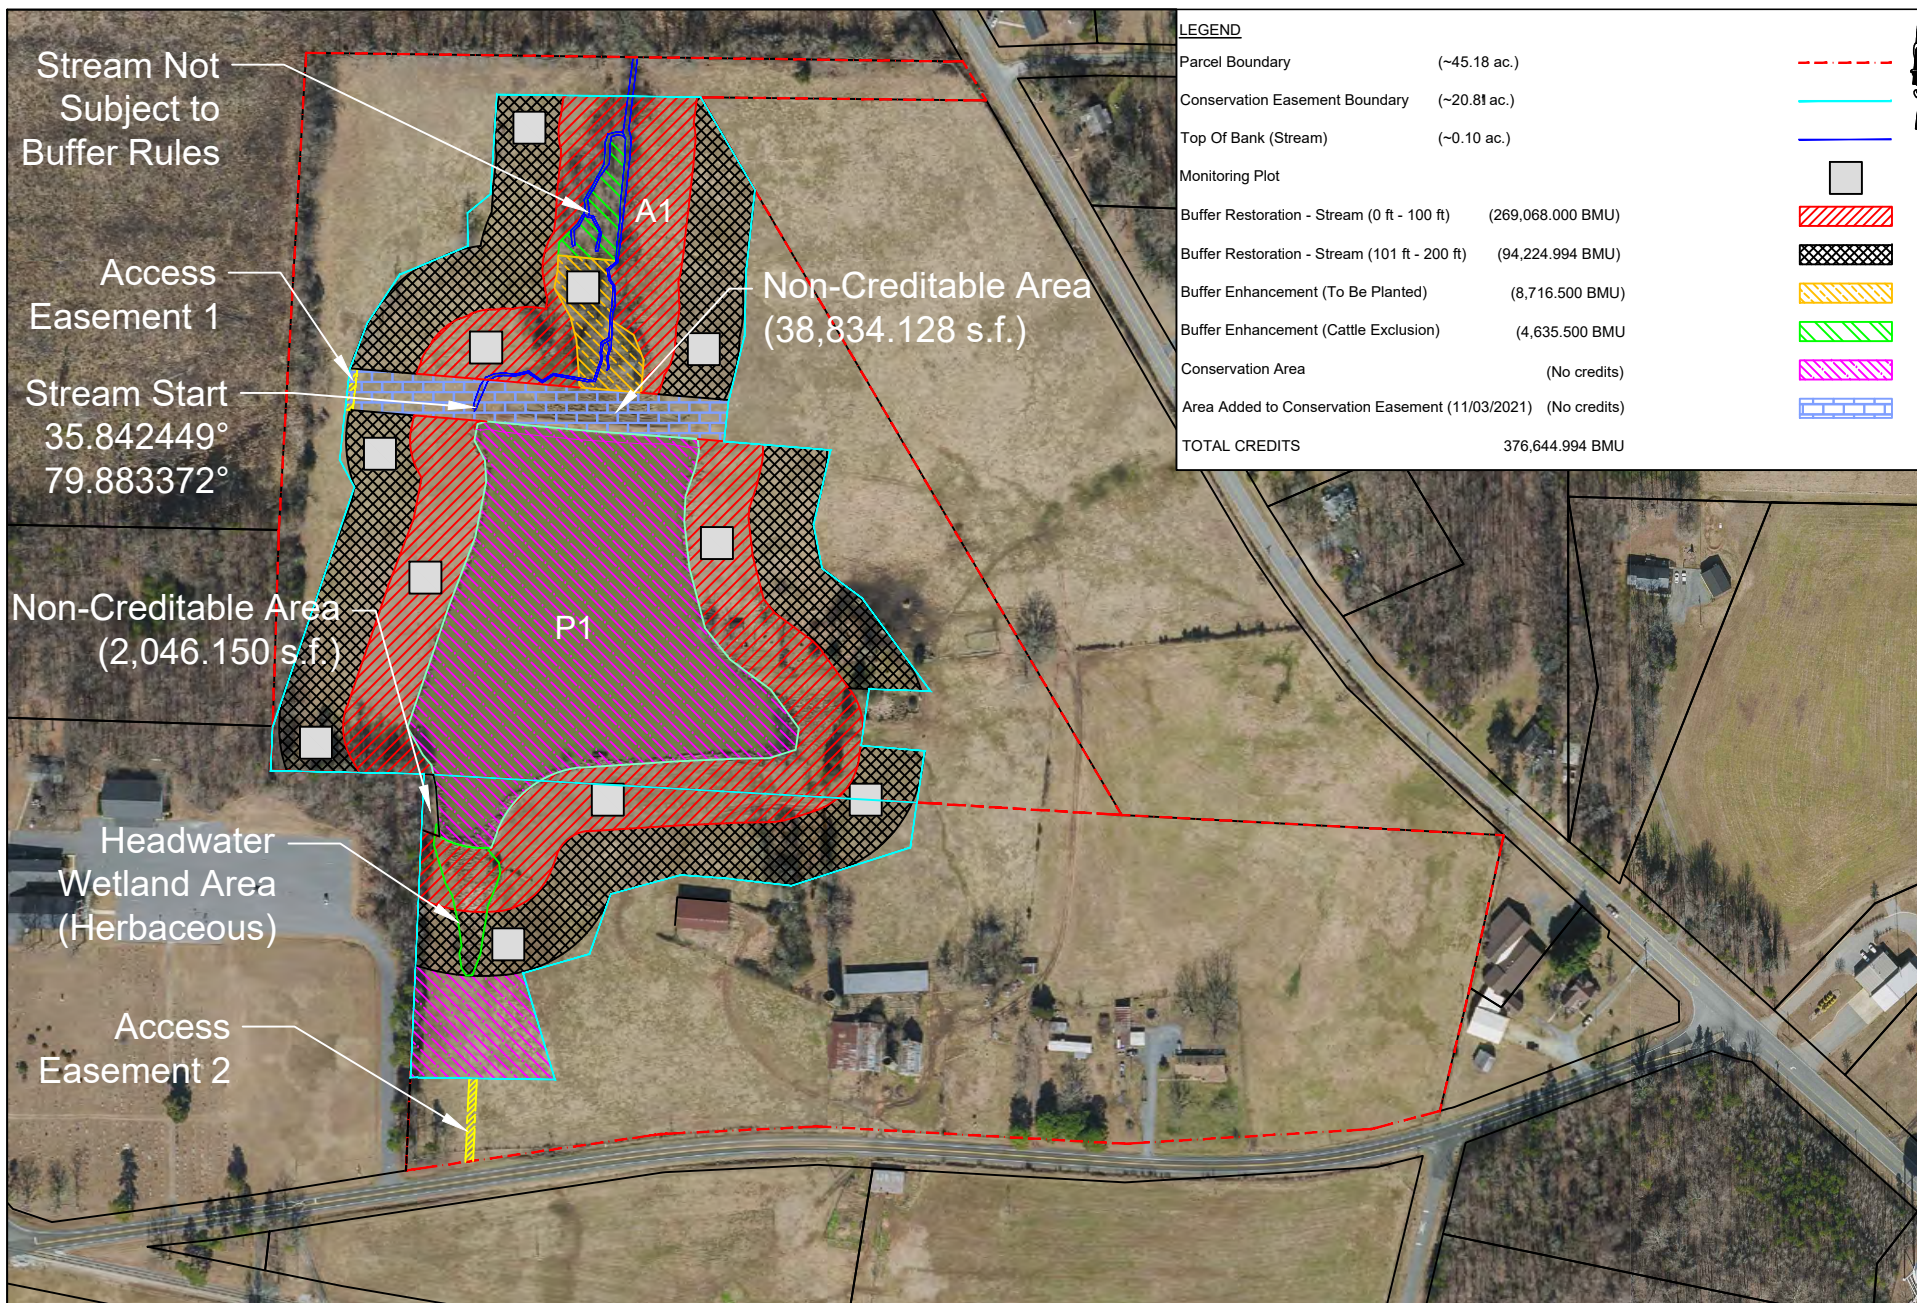
Project: Longhorn Riparian Buffer Mitigation Site Catalog Unit 03030003 Title: Mitigation Plan	Date: November 2019	Revision Date: 2/26/2020
	Scale: 1"=300'	Job Number: LMG19.249
	Drawn By: GSF	Figure: 8

The buffer mitigation site consists of one stream reach (A1) and an in-line pond (P1) as illustrated in Figure 8. Reach A1 is a perennial stream that flows from the in-line pond (P1) to the north and into Bob Branch. There is approximately 625 lf of stream associated with Reach A1 within the proposed buffer easement area. Pond (P1) is an in-line pond that is approximately 5.3-acres and lies entirely within the proposed conservation easement area.

Mitigation credits are presented in Table 2 and Figure 8 in Appendix A and are based upon the conservation easement survey.

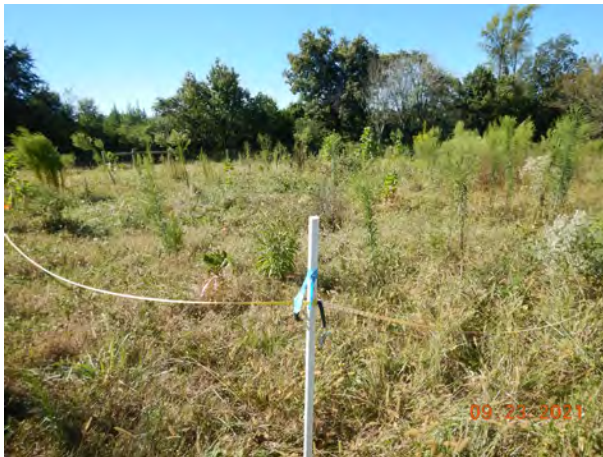
(5) Plot 5

Plot 5 mortality was likely caused by dry conditions post-planting and the subsequent overtopping by dense grasses. The area around Plot 5 appears to have been affected by dry conditions and exhibits higher mortality. Supplemental planting will occur in this area in the Winter of 2022 (January – February). The proposed supplemental planting area equates to approximately 0.75-acres. Supplemental planting densities and species will be coordinated with NC DMS prior to execution. The vegetation visual assessment table is included in Appendix B.

Overall, the Site appears to be progressing well towards the target success criteria. However, based upon the documentation of reduced survivorship around Plot 5, supplemental planting will be performed in the Winter of 2022. The specific planting plan and species mix will be coordinated with NC DMS prior to execution. The site will continue to be monitored for problem areas. In addition, invasive treatment areas will continue to be monitored, and invasive vegetation management will continue to be implemented if additional exotic species volunteer into the site. If it is determined that the Site's ability to achieve the performance standards are jeopardized, staff members of NCDMS/NCDWR will be notified, and an adaptive management plan will be developed to address these issues.

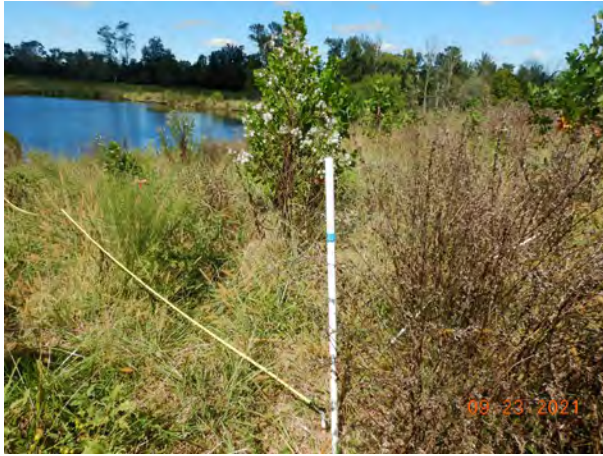
(7) Plot 7

In addition, it should be noted that Plots 7, 9, and 10 all exhibited relatively higher stem mortality and lower vigor during MY01. It is believed that these areas experienced mortality due to dry conditions following site planting and competition from fescue grass. Although these three plots were exceeding the final stem success criteria during MY01, supplemental planting was proposed to occur in these areas in the Winter of 2021 (January – February). However, a selective, broad spectrum, postemergence herbicide (Poast) was used for control of fescue grass and mortality has ceased in these areas. Most of the stem mortality occurred between MY0 and MY01. During MY02 these areas are on track to meet the final stem density success criteria. Refer to Figure 9 (Current Condition Plan View) and Table 4 in Appendix B for additional information and proposed supplemental planting areas.
