MY04 Monitoring Report

Longhorn Riparian Buffer Mitigation Site

Randolph County, NC

DMS Project No. 100114

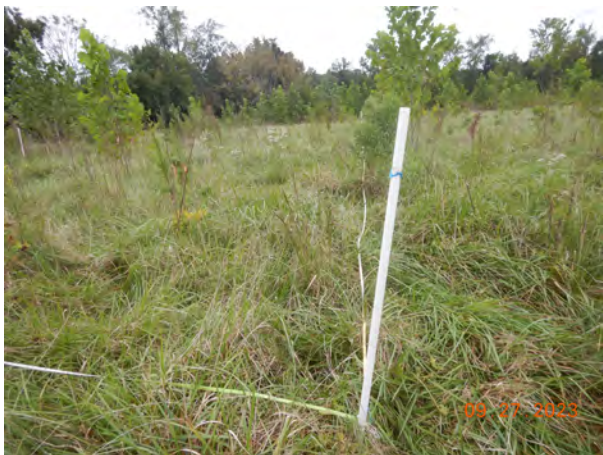
(5) Plot 5

Plot 5 mortality during MY01 was likely a result of dry conditions and the presence of dense grasses post-planting. These conditions persisted throughout MY02 and exhibited higher mortality. Supplement planting occurred within this area in the Winter of 2022 (January – February). Approximately 0.75-acres were supplemented. Additional planted stems were observed with excellent vigor during MY03. Numerous planted stems were observed throughout the area surrounding Plot 5. No additional mortalities were observed for Plot 5 during MY04.

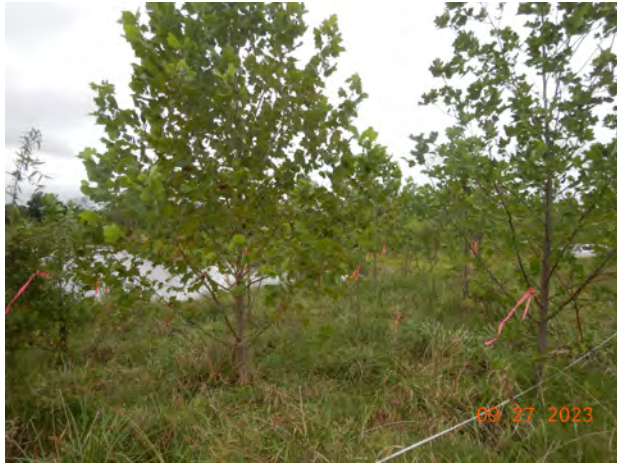
(7) Plot 7

During MY01, relatively higher stem mortality and lower vigor was observed for Plots 7, 9, and 10. Excessive mortality within these plots are likely attributed to dry conditions and competitive fescue post planting. Suggested supplemental planting proposed for these areas in the Winter of 2021 (January – February) did not take place as a selective, broad spectrum, postemergence herbicide (Poast) was implemented. Distribution of Poast successfully controlled fescue grass and ceased additional planted stem mortalities. All planted stems were accounted for and exhibited excellent vigor during MY04 within these plots.
