UT TAR RIVER
FRANKLIN COUNTY
RESTORATION PLAN
2003

FIGURE 1
PROJECT LOCATION MAP
 Unnamed Tributary to Tar River - Mitigation Plan
 Louisburg, North Carolina

The UT Tar River project site is located in the town of Louisburg in Franklin County, North Carolina (Figure 1). Louisburg is located approximately 25 miles north of Raleigh along NC Highway 401. WRP previously obtained a conservation easement on the project from the Town of Louisburg and the Green Hill Country Club, Inc. UT Tar River flows from the southwest to the northeast. The project reach is bound on the west by NC Highway 39, Burnette Road along the left bank, and the country club along the right bank. The project ends at the northeastern extent of the conservation easement where the stream will tie into the old channel located on property owned by Raymond E. Burnette, et al. One small tributary and a small drainage flows off of the country club property and into the conservation easement before entering the UT Tar River from the right bank.

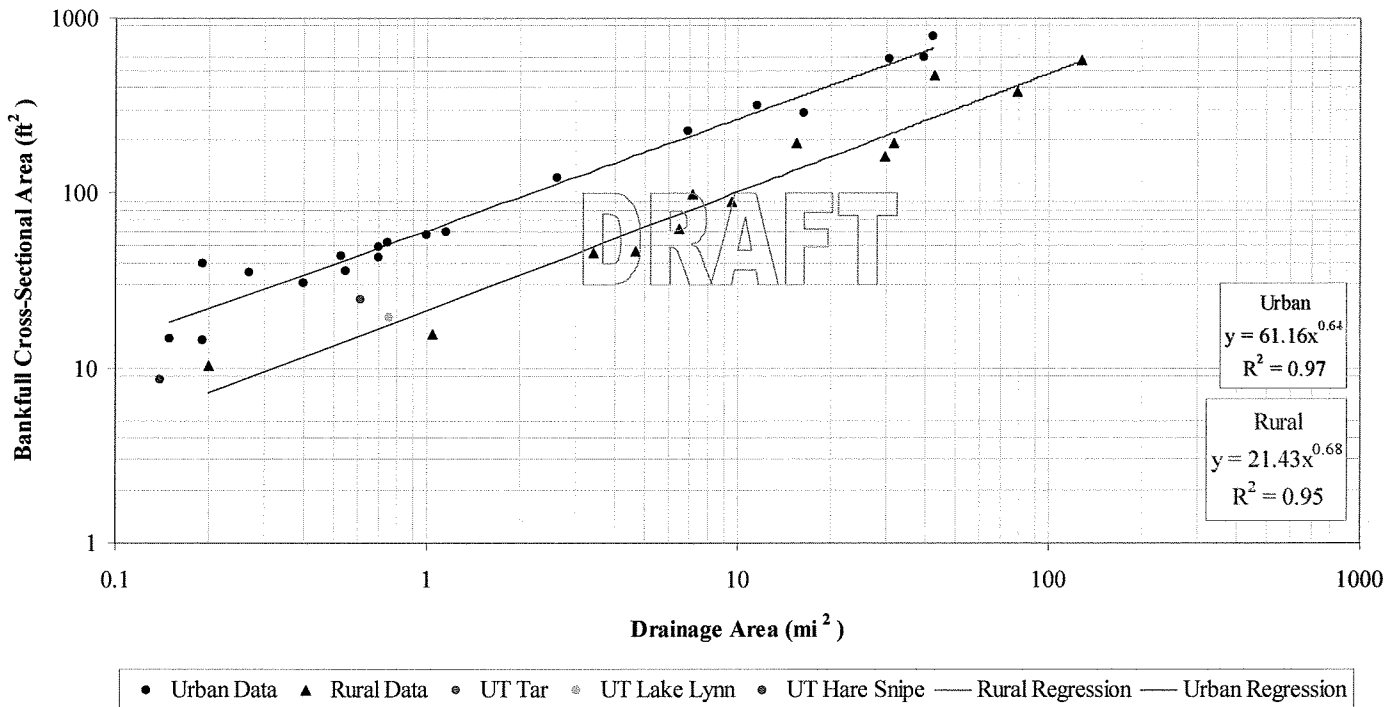
FIGURE 2
NORTH CAROLINA REGIONAL CURVE
Unnamed Tributary to Tar River - Mitigation Plan
Louisburg, North Carolina

In ungaged areas, Dave Rosgen recommends verifying bankfull with the development of regional curves. The regional curves normally plot bankfull discharge (Q_{bkf}), cross-sectional area, width, and depth as a function of drainage area. The cross-sectional areas of UT Tar River and the reference reach site used for this report are plotted on the Rural and Urban, Piedmont Regional Curve of North Carolina developed by the North Carolina State University (NCSU) Water Quality Group, 2000 (Figure 2).

North Carolina Piedmont Regional Curve DRAFT

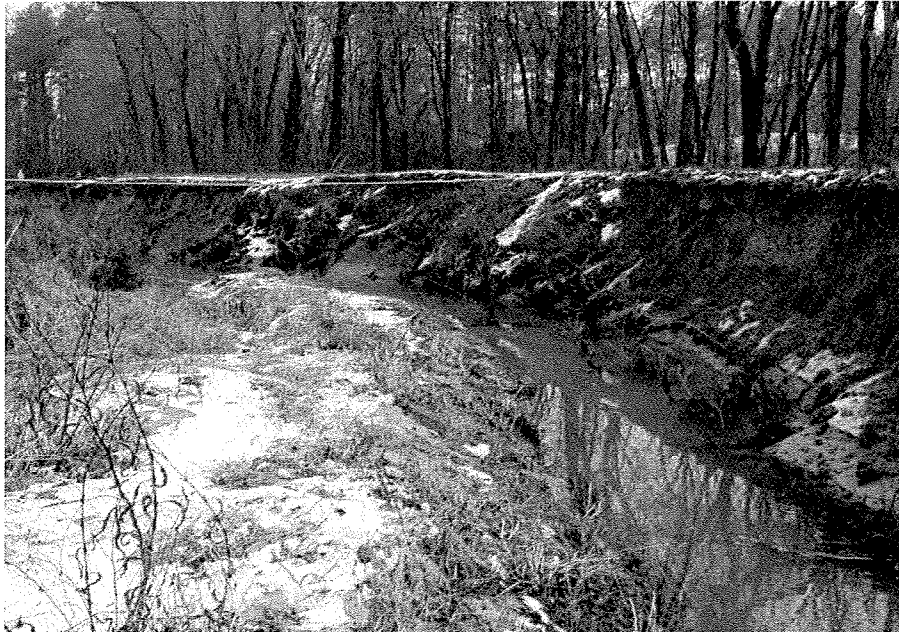
2. Looking downstream from NC 39 at first 100 ft of existing channel.
Notice high vertical banks on right bank and bar on left bank.

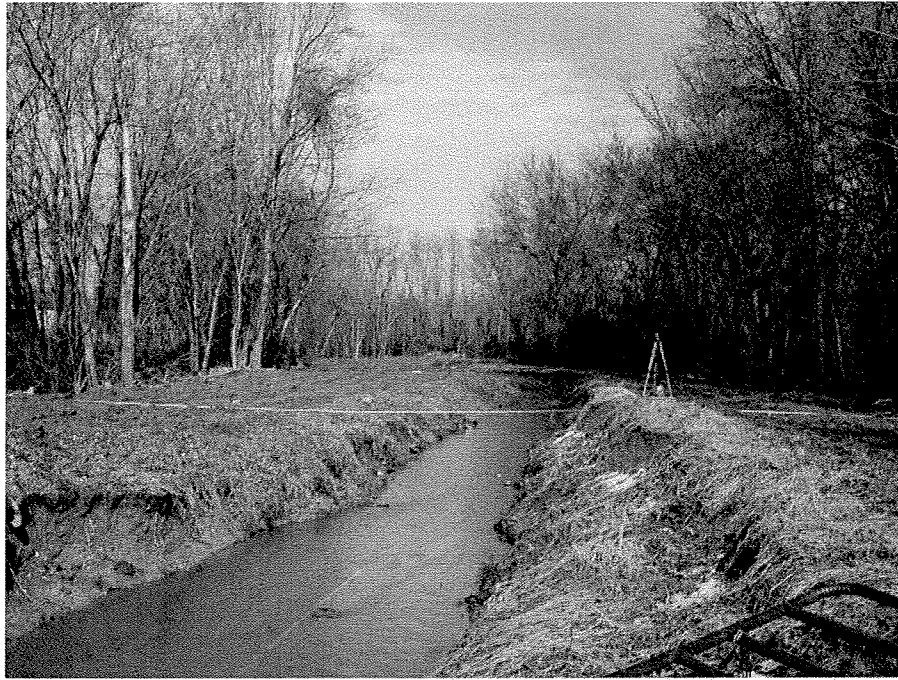
5. Riffle Cross Section. Town dirt access path lies between the treeline on the left and the left streambank.

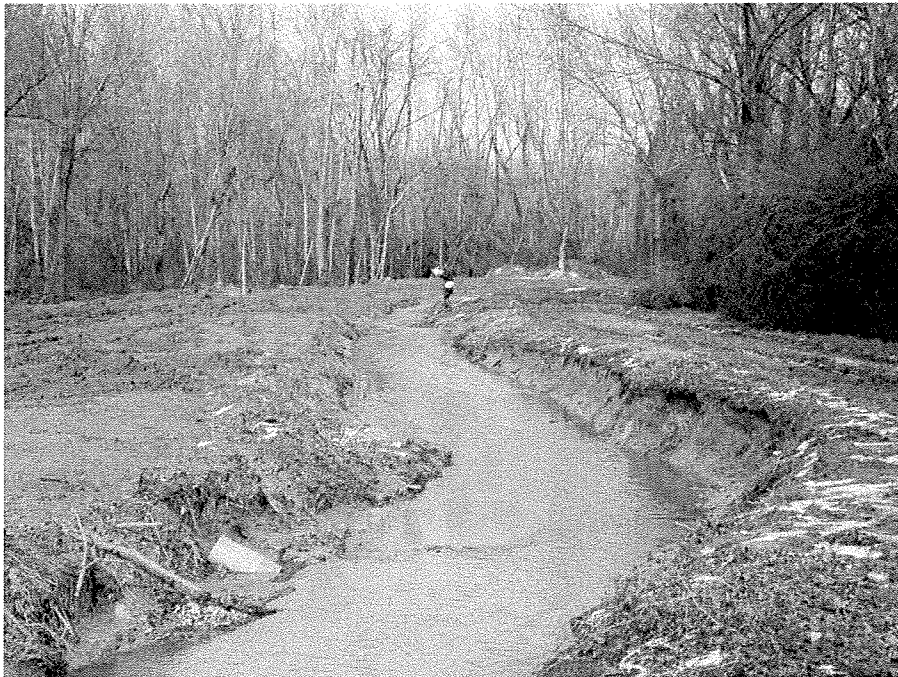
6. Raw streambanks about 100 ft upstream of end of project.

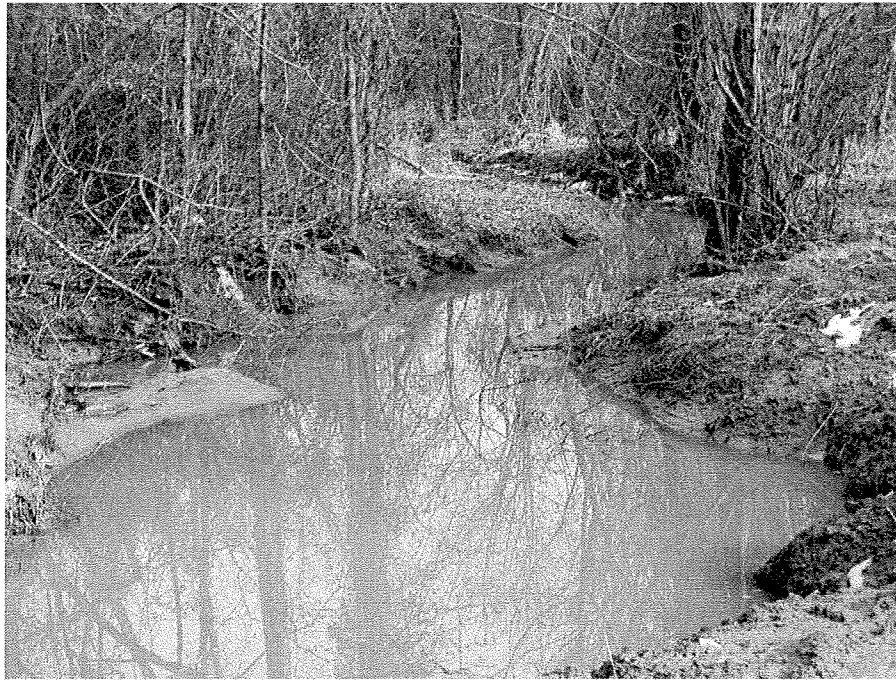
7. Former location of channel where proposed restoration will tie in.

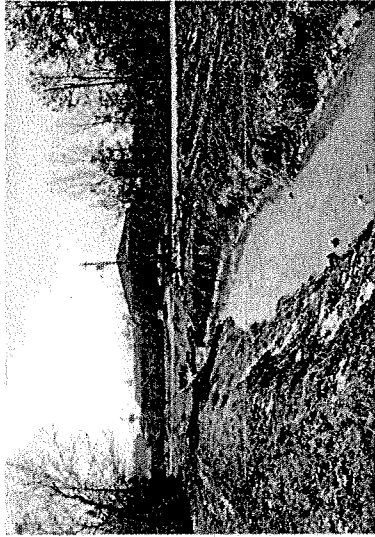
Riffle Cross-Section 13+09

STATION (Feet)	HI (Feet)	FS (Feet)	ELEVATION (Feet)	NOTES	BANKFULL		
					Width (Feet)	Depth (Feet)	Area (Sq. Ft.)
0+00.0	95.75	5.00	90.75	edge dirt road	0.0	0.0	0.0
0+08.0	95.75	5.03	90.72		1.2	2.5	1.5
0+16.0	95.75	4.87	90.88	edge dirt road	1.8	2.4	4.4
0+20.2	95.75	6.02	89.73	LBKF	4.3	2.8	11.1
0+21.4	95.75	8.47	87.28		2.8	2.4	7.3
0+23.2	95.75	8.43	87.32	LEW/WS	1.3	1.2	2.3
0+27.5	95.75	8.79	86.96	TW	2.3	0.1	1.5
0+30.3	95.75	8.43	87.32	REW/WS	0.1	0.0	0.0
0+31.6	95.75	7.22	88.53				
0+33.9	95.75	6.15	89.60				
0+34.0	95.75	6.02	89.73	RBKF			
0+36.0	95.75	4.24	91.51	RTOB			
0+38.0	95.75	4.09	91.66				
0+46.0	95.75	4.33	91.42	Woodline			
0+55.0	95.75	4.46	91.29				
TOTALS					13.8		28.1

SUMMARY DATA (BANKFULL)	
A(BKF)	28.1
W(BKF)	13.8
Max d	2.8
Mean d	2.0
W/D	6.8
Entrenchment Ratio	4.0
Stream Type	degraded E
Bankfull= BKF

CRITERIA	VALUE	INDEX
Bank/BKF Ht	1.0	1
Root Depth/Bank Ht	0.21	7.1
Root Density	<5	10
Bank Angle	110	8.7
Surface Protection	<10	10.0
Bank Materials	Sand	10
		46.8
		Extreme

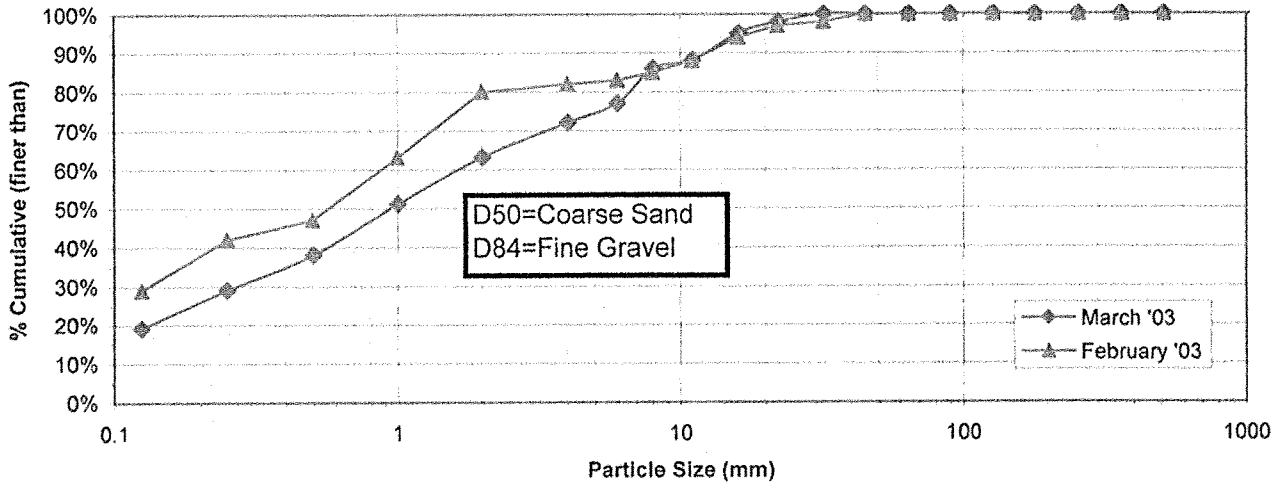
Particle Size Distribution
UT Tar River - Franklin County, NC

PEBBLE COUNT								
Site: Unnamed Tributary to Tar River						3/19/2003		
Party: Jan Patterson				Reach: NC 39 to 1700'				
Particle Counts								
Inches	Particle	Millimeter		Pool	Riffle	Total No.	Item %	% Cumulative
	Silt/Clay	< 0.062	S/C	3	4	7	7%	7%
.04 - .08	Very Fine	.062 - .125	S	6	6	12	12%	19%
	Fine	.125 - .25	A	4	6	10	10%	29%
	Medium	.25 - .50	N	2	7	9	9%	38%
	Coarse	.50 - 1.0	D	2	11	13	13%	51%
	Very Coarse	1.0 - 2.0	S	2	10	12	12%	63%
.08 - .16	Very Fine	2.0 - 4.0	G R A V E L S	1	8	9	9%	72%
.16 - .22	Fine	4.0 - 5.7		5	5	5%	77%	
.22 - .31	Fine	5.7 - 8.0		9	9	9%	86%	
.31 - .44	Medium	8.0 - 11.3		2	2	2%	88%	
.44 - .63	Medium	11.3 - 16.0		7	7	7%	95%	
.63 - .89	Coarse	16.0 - 22.6		3	3	3%	98%	
.89 - 1.26	Coarse	22.6 - 32.0		2	2	2%	100%

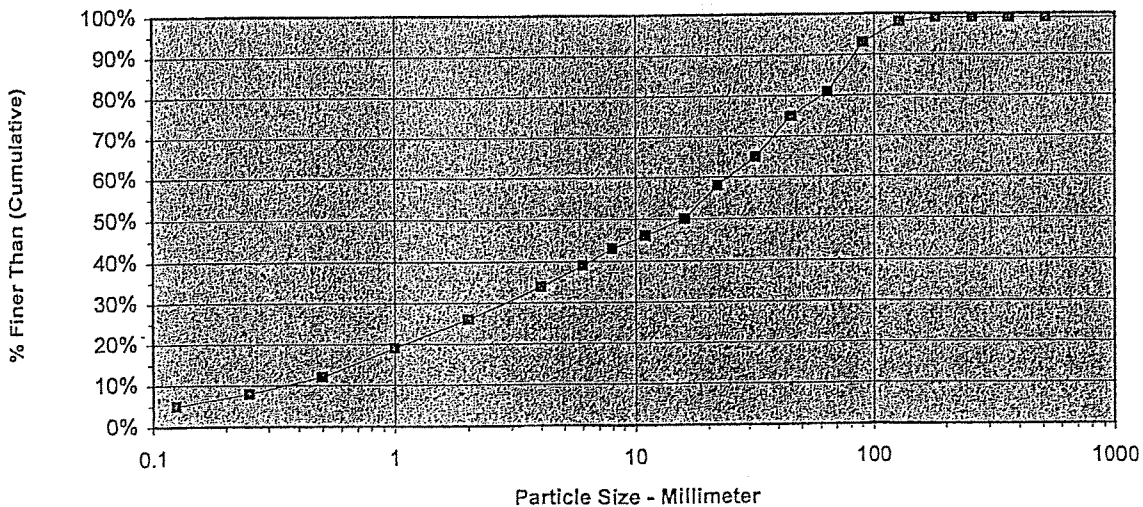
Particle Size Distribution

PEBBLE COUNT								
Site: Brookhaven Nature Park						Date: 8/15/98		
Party: Jim Buck, Karen Hall, Gregg Jennings, Will Harman						Reach: Trib - Hare Snipe Creek		
Particle Counts								
Inches	Particle	Millimeter		Riffles	Pools	Total No.	Item %	% Cumulative
	Silt/Clay	< 0.062	S/C	0	4	4	4%	4%
.04 - .08	Very Fine	.062 - .125	S	1	0	1	1%	5%
	Fine	.125 - .25	A	2	1	3	3%	8%
	Medium	.25 - .50	N	0	4	4	4%	12%
	Coarse	.50 - 1.0	D	0	7	7	7%	19%
	Very Coarse	1.0 - 2.0	S	5	2	7	7%	26%
.08 - .16	Very Fine	2.0 - 4.0		2	6	8	8%	34%
.16 - .22	Fine	4.0 - 5.7	G	0	5	5	5%	39%
.22 - .31	Fine	5.7 - 8.0	R	2	2	4	4%	43%
.31 - .44	Medium	8.0 - 11.3	A	1	2	3	3%	46%
.44 - .63	Medium	11.3 - 16.0	V	2	2	4	4%	50%
.63 - .89	Coarse	16.0 - 22.6	E	4	4	8	8%	58%
.89 - 1.26	Coarse	22.6 - 32.0	L	4	3	7	7%	65%
