**LOWELL MILL DAM-LITTLE RIVER WATERSHED
RESTORATION SITE
2007 Annual Monitoring Report (Year-2)**

**Johnston County, North Carolina
EEP Project No. D04008-2
Design Firm: Milone and MacBroom, Inc.**

November 2007

**Prepared by: ECOSCIENCE CORPORATION
1101 Haynes Street, Suite 101
Raleigh, North Carolina 27604**

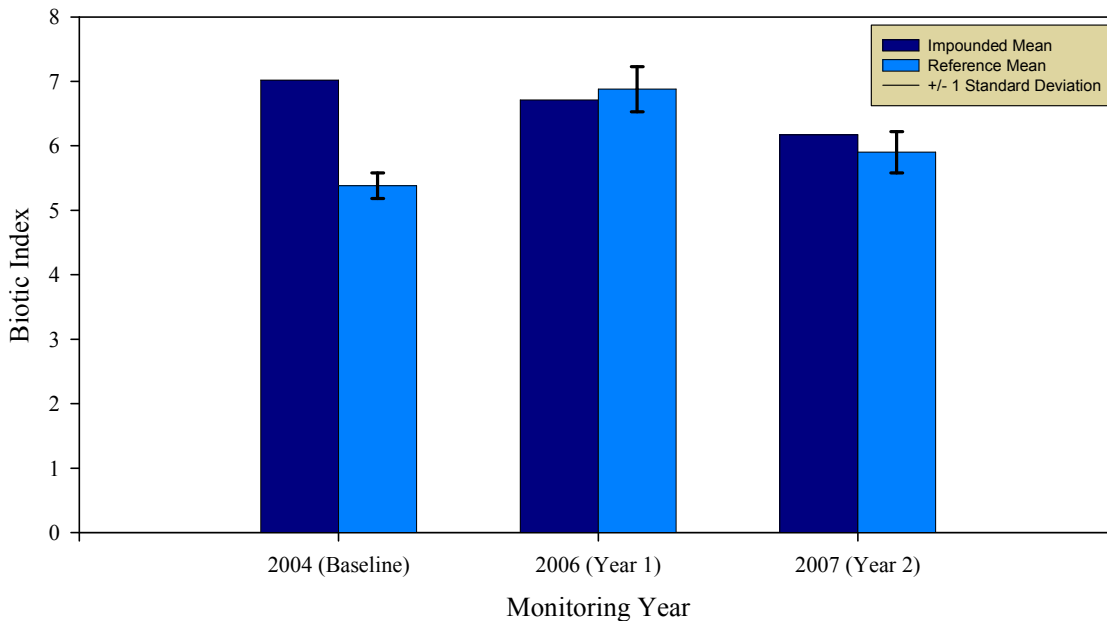
Graph 1: Mean Biotic Index of Formerly Impounded Stations vs. Mean Biotic Index of Reference Stations with Standard Deviation

Since the mean of the biotic index from the formerly impounded stations ($\mu=6.17$) is within one standard deviation of the reference station ($\mu=6.22$), success in this category may be inferred. The mean of the biotic index from the formerly impounded stations has also decreased from baseline and Year-1 monitoring data, showing an improvement since the removal of the dam (i.e., indicative of a benthic community less tolerant of poorer water quality). These trends are illustrated in Graph 1.

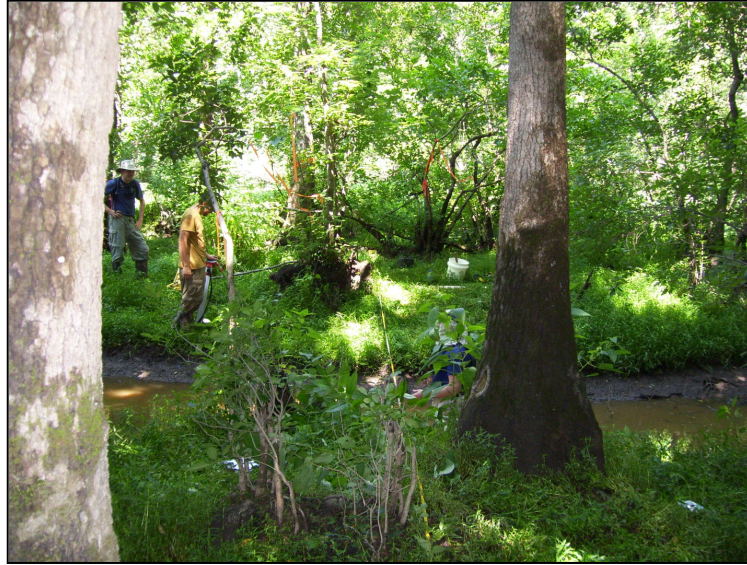
Cross-Section 18 on Little Buffalo Creek in July 2007. This formerly impounded reach now supports emergent vegetation. Note the high water mark on the large gum tree on the right.

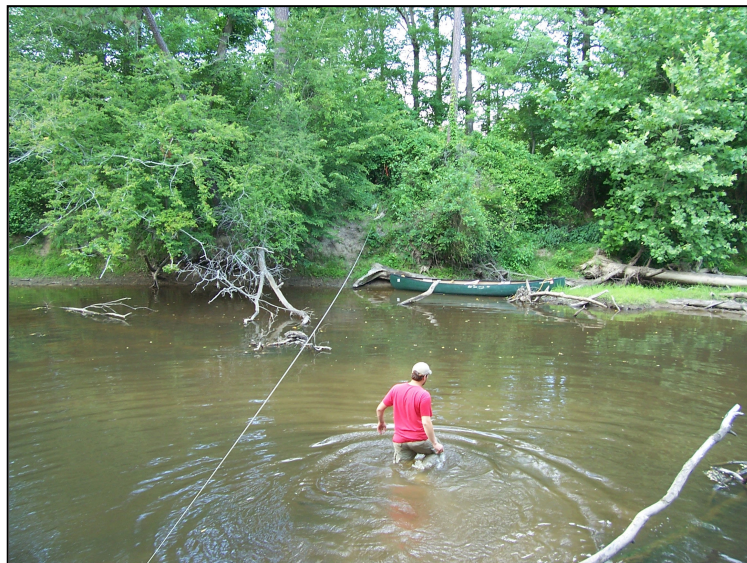
Cross-Section 7 on the Little River. Note the stabilizing vegetation established on the far bank.

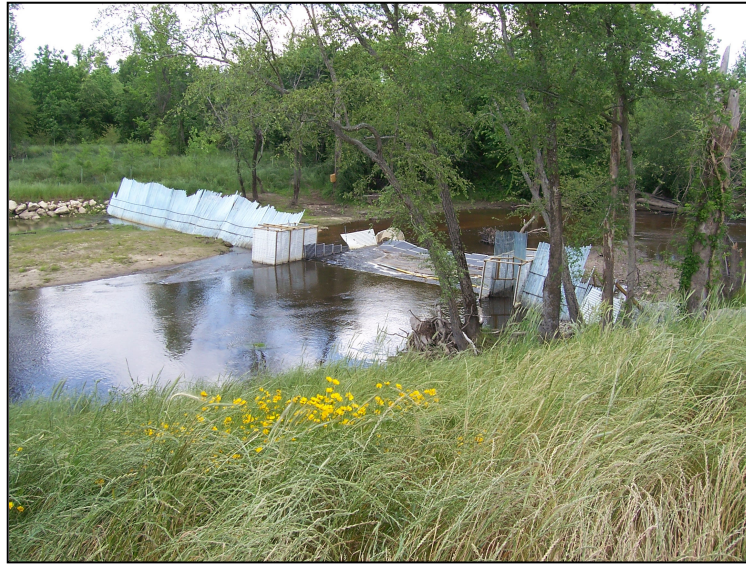
Fish weir for scientific research at the former dam location

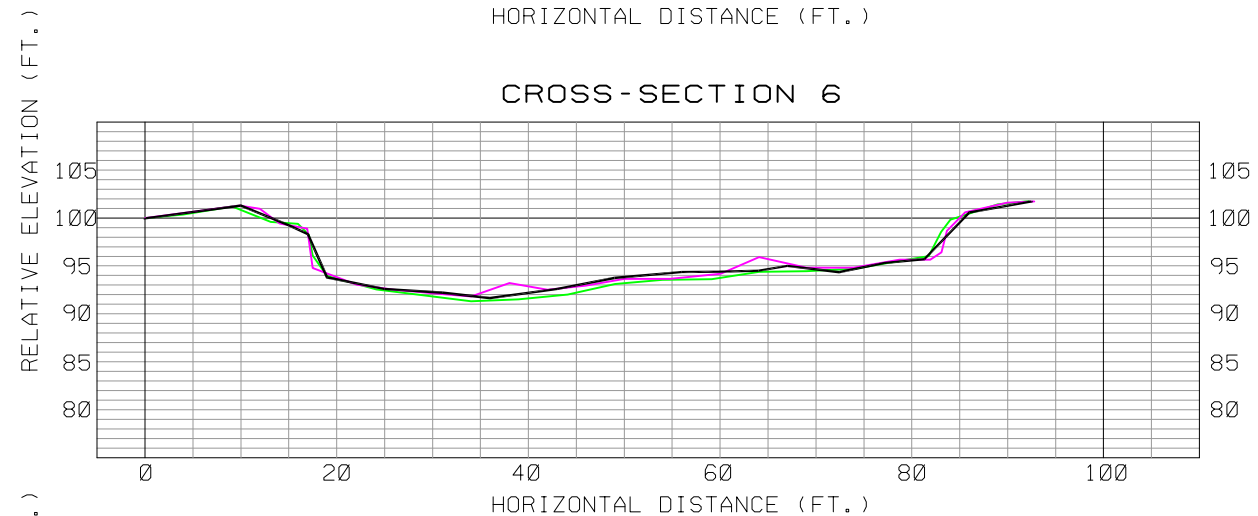
5A

- YEAR 2005 PRE-DAM REMOVAL
- YEAR 2006 MONITORING
- YEAR 2007 MONITORING

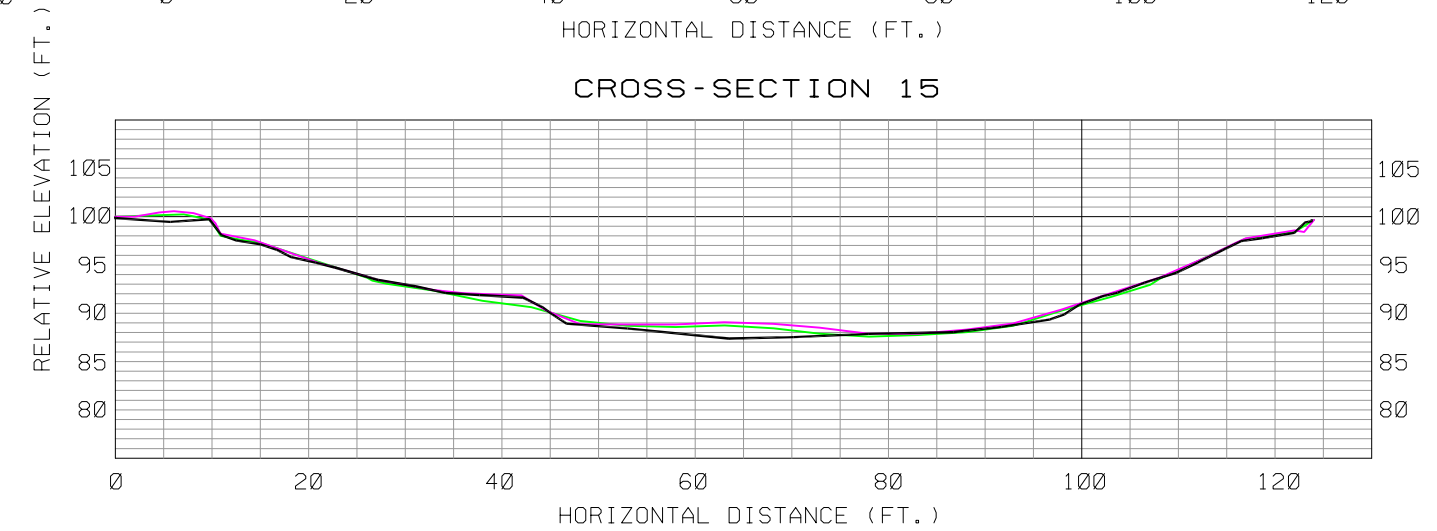
5B

- YEAR 2005 PRE-DAM REMOVAL
- YEAR 2006 MONITORING
- YEAR 2007 MONITORING

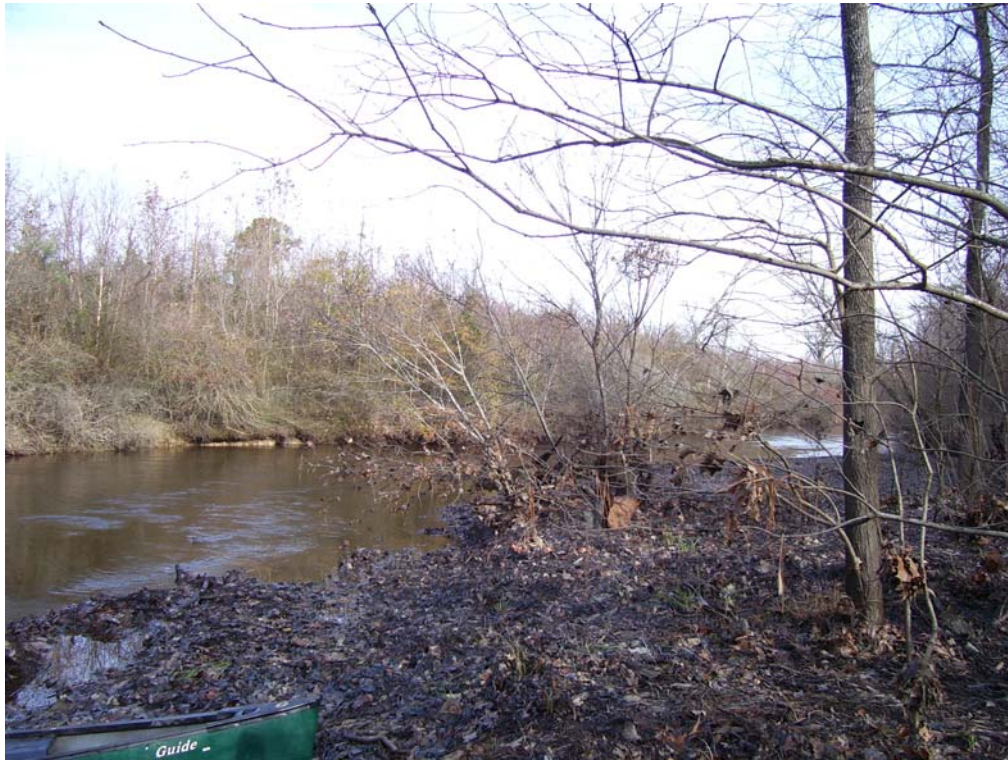
Photo 1. River Observation Point 1. Wrack on vegetation indicating discharge at or near bankfull in Horsehead Bend. Little River, Johnston County.

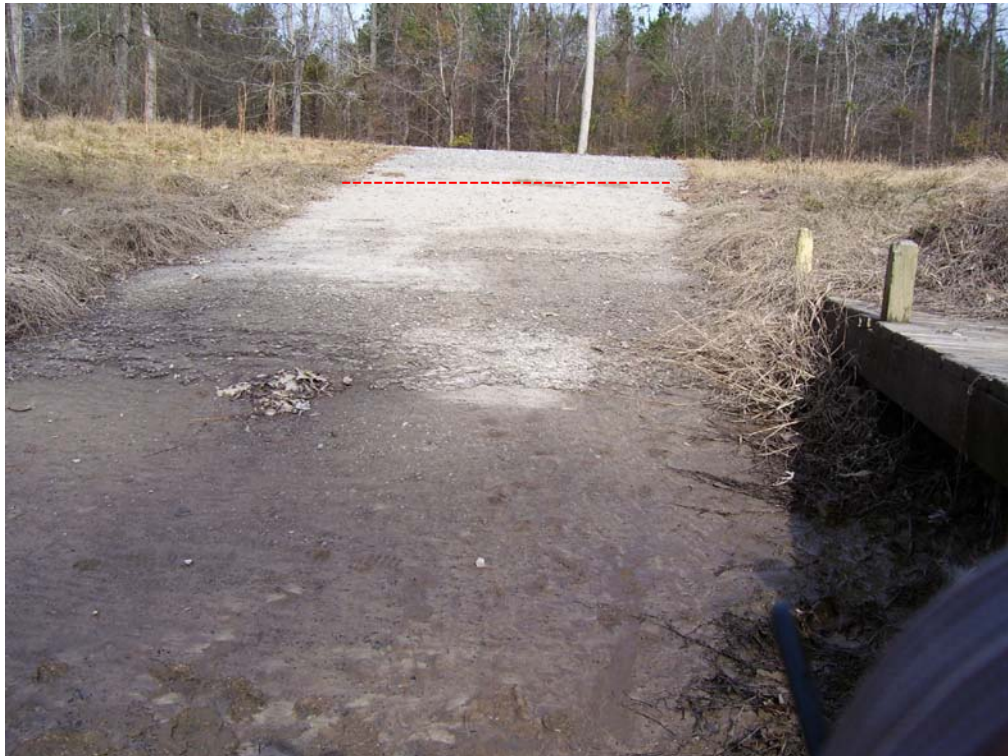
Photo 2. River Observation Point 2. Sediment deposition and high water mark (dashed line) at the Wildlife Resource Commission boat ramp. Little River, Johnston County.

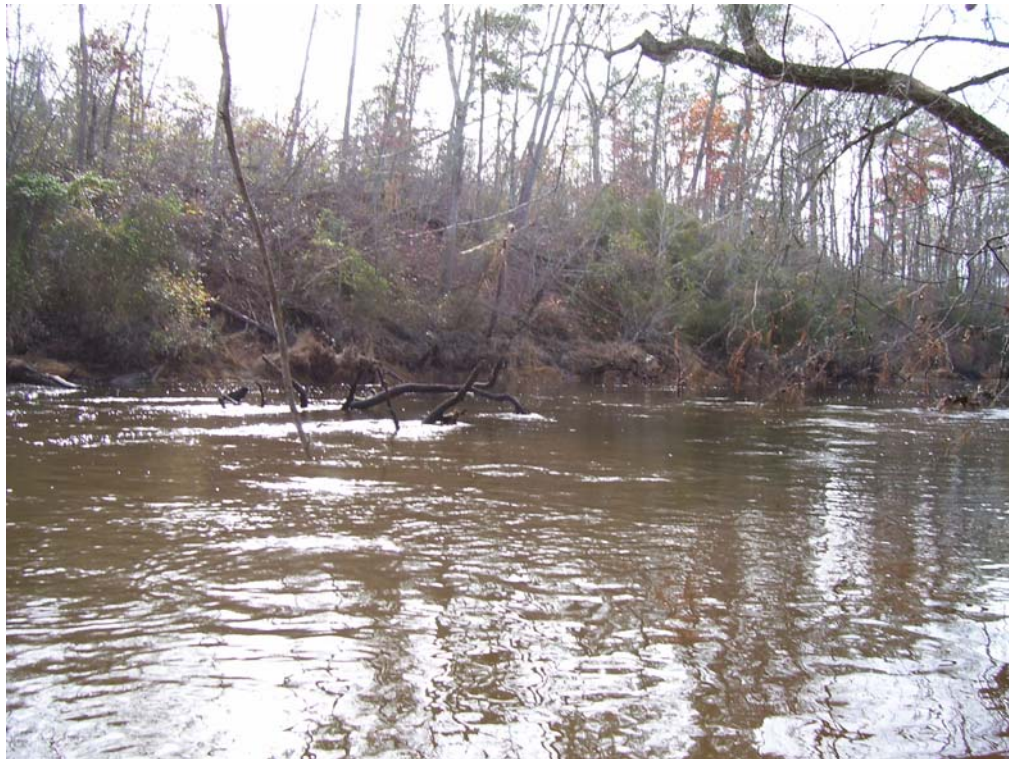
Photo 3. River Observation Point 3. Previous log jam caused by recent tree fall has been dislodged. Little River, Johnston County.

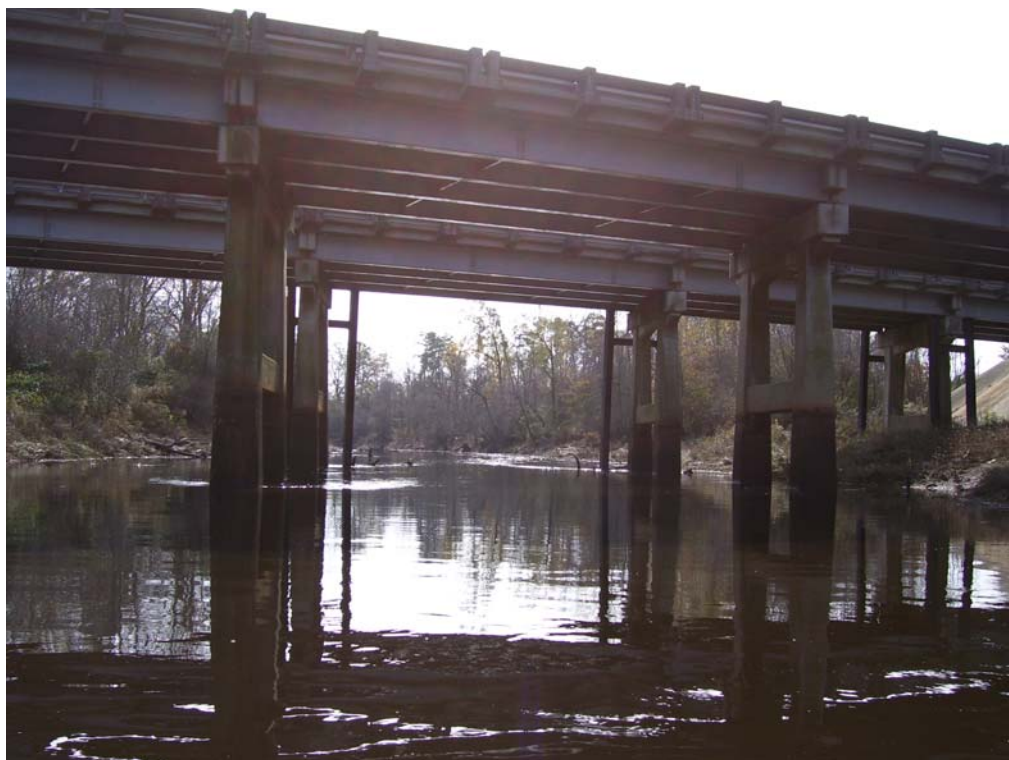
Photo 4. River Observation Point 7. The bridge pilings (I-95) located within the Little River contained only a small amount of debris and no evidence of scouring was observed. Little River, Johnston County.

dislodged. The bridge piers and abutments at the various bridge locations crossing the Little River held only a small amount of woody debris and continue to exhibit no visible evidence of scouring.

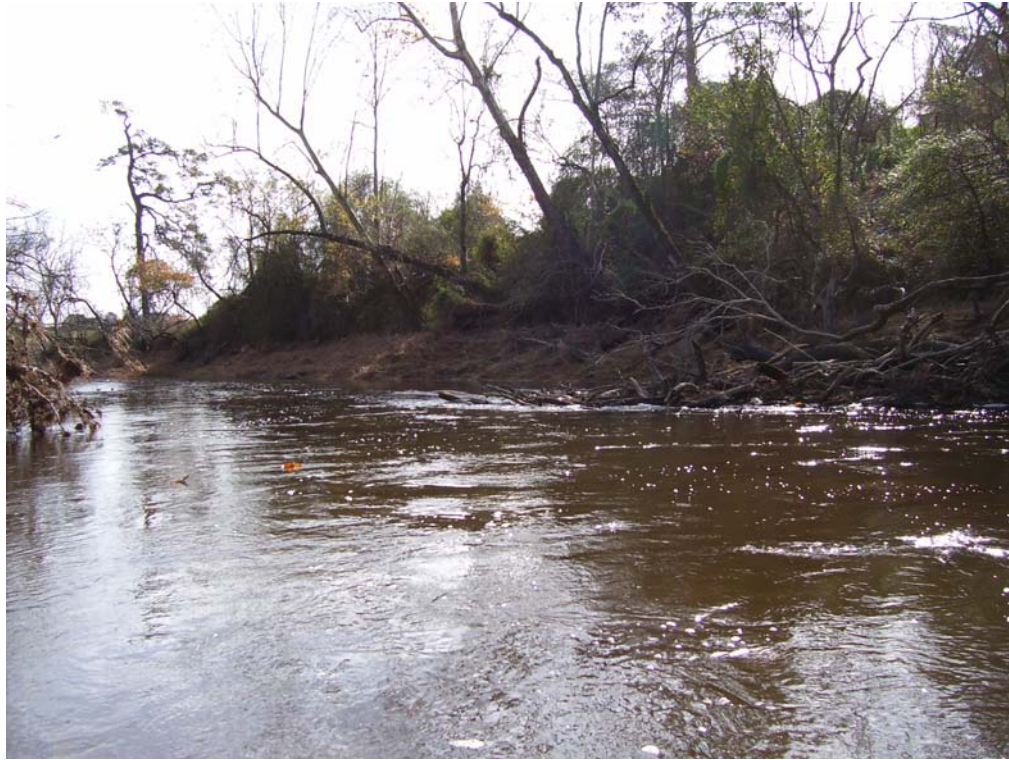
Photo 5. River Observation Point 8. Since the first transit, there has been a significant amount of debris that has built up along the scoured bank that was initially observed during the first transit. Also, water levels were higher than when the first transit was conducted and it was difficult to determine if any additional scouring has occurred. Little River, Johnston County.

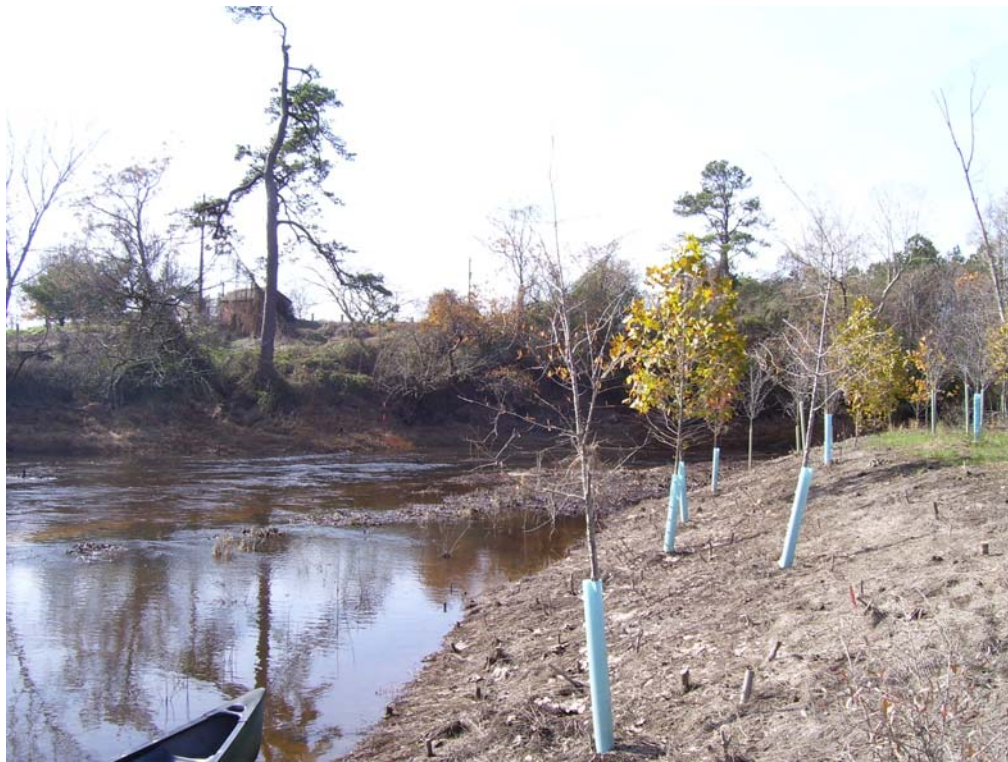
Photo 6. River Observation Point 9. Sediment deposition and elongation of the constructed point bar located at the inside bend of the river at the former dam site. Note the slack water at the over widened reach of river at the toe of the remnant dam structure. Little River, Johnston County.

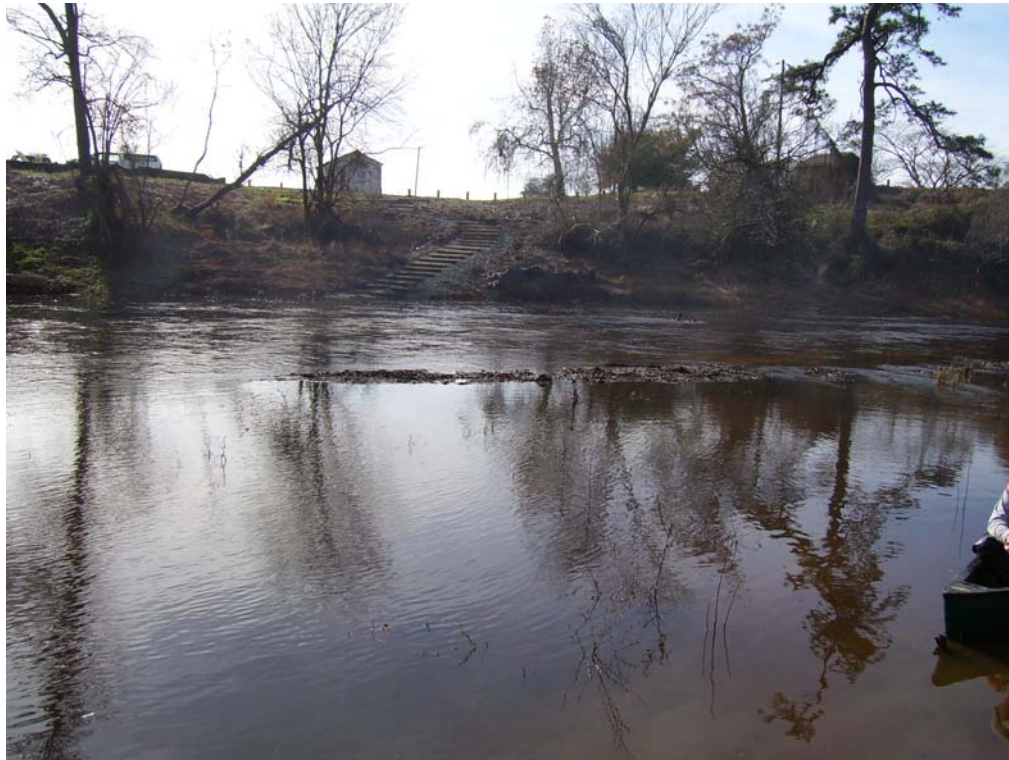
Photo 7. River Observation Point 9. Another picture from Observation Point 9 looking from left bank to right bank with slack water in foreground. Little River, Johnston County.

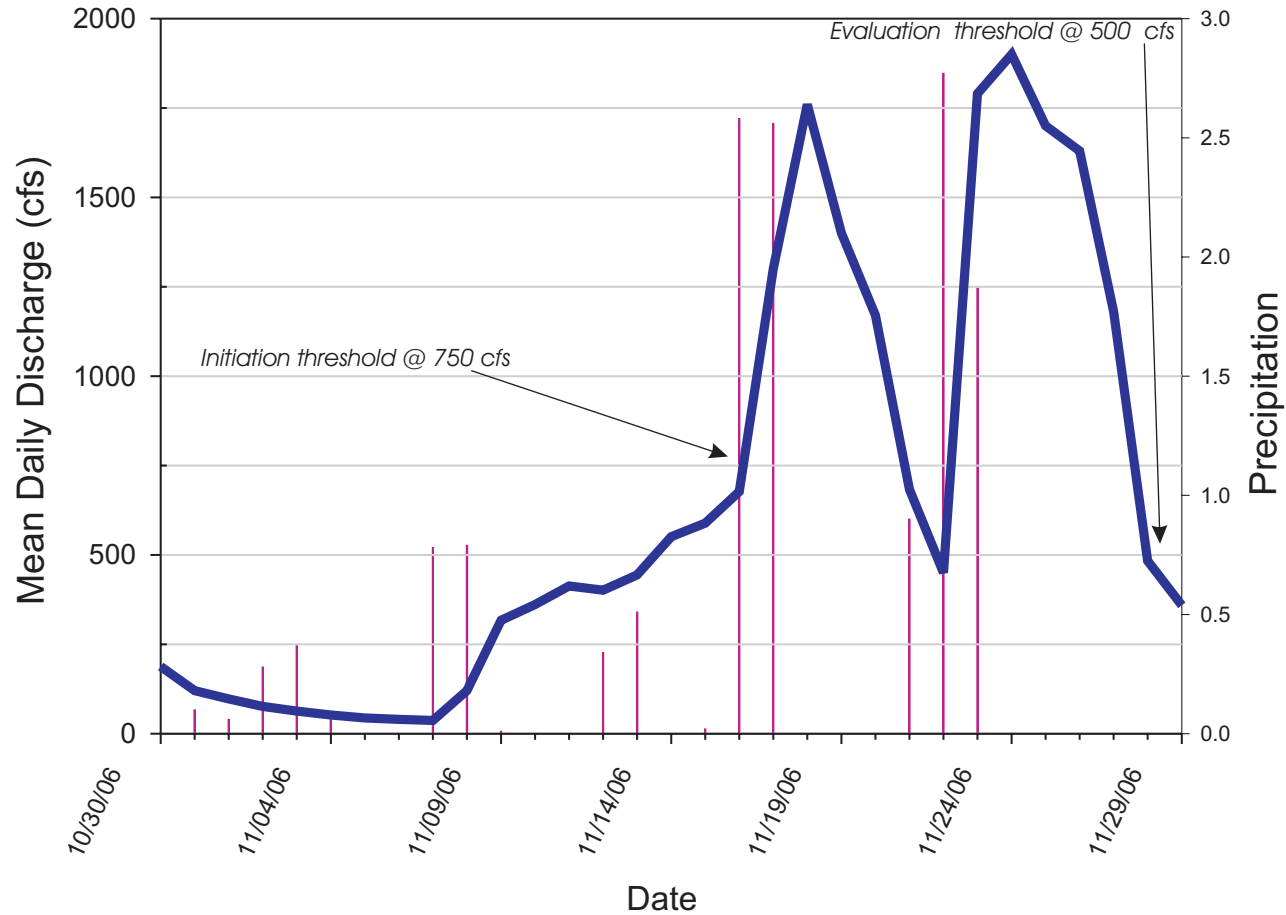
USGS 02088500 Little River near Princeton, NC

■ Precipitation (SCONC Station 317994, Smithfield, NC)
— Daily Discharge

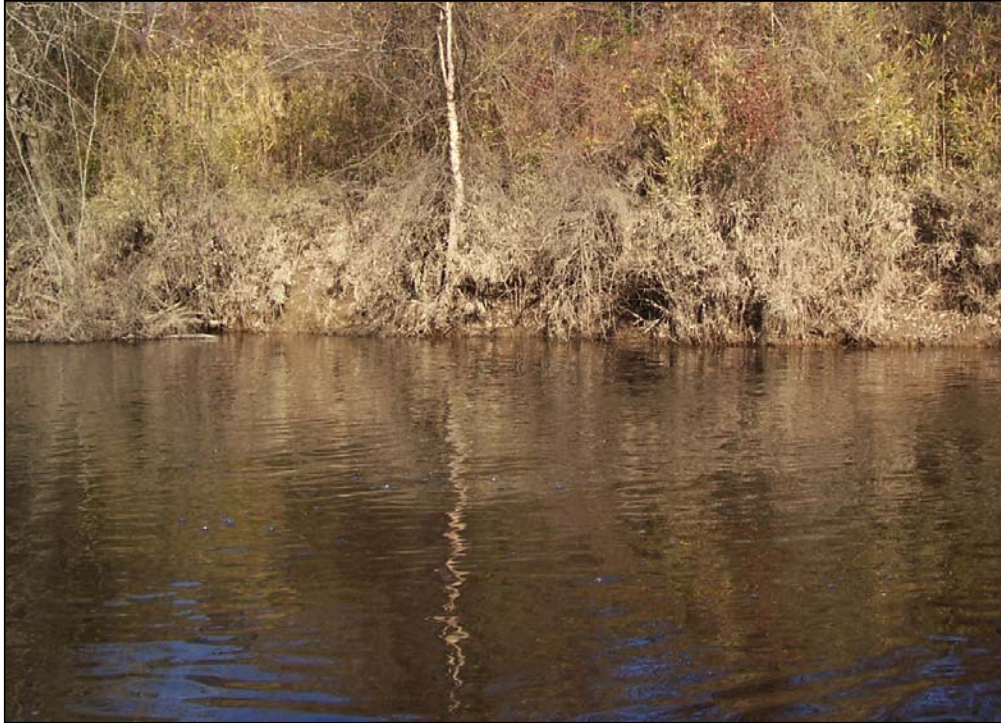
Photo 1. River Observation Point 1: Sediment on vegetation indicating discharge at or above bankfull in Horseshoe Bend. Little River, Johnston County.

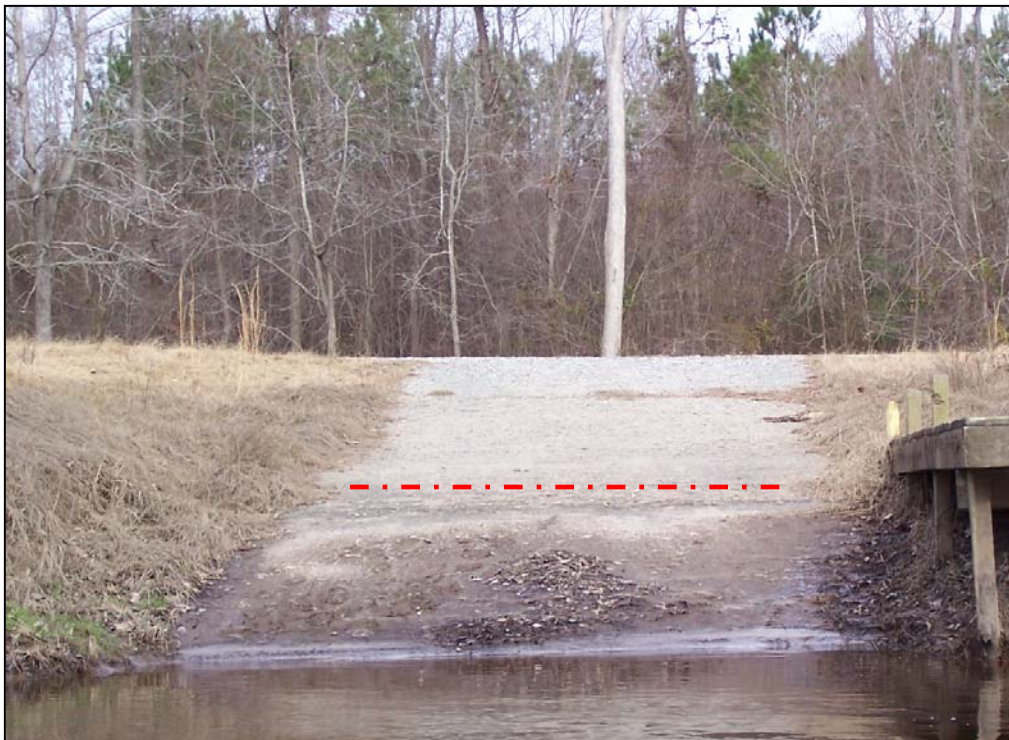
Photo 2. River Observation Point 2: Sediment deposition and high water mark (red line) at the Wildlife Resource Commission boat ramp. Little River, Johnston County.

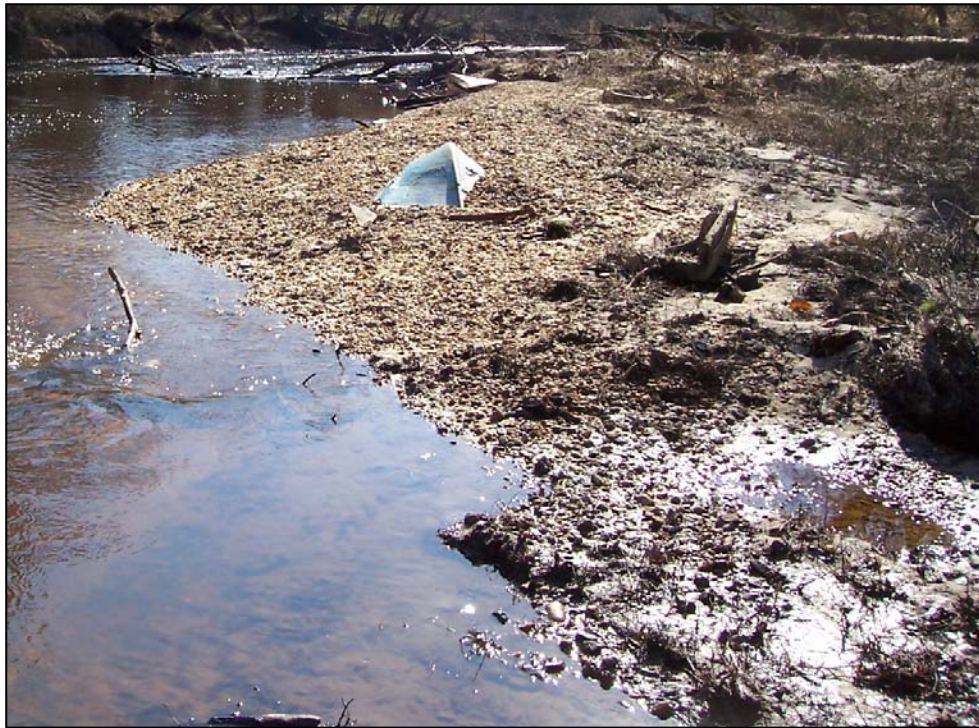
Photo 3. River Observation Point 4: Looking downstream at Battery Bar. Little River, Johnston County.

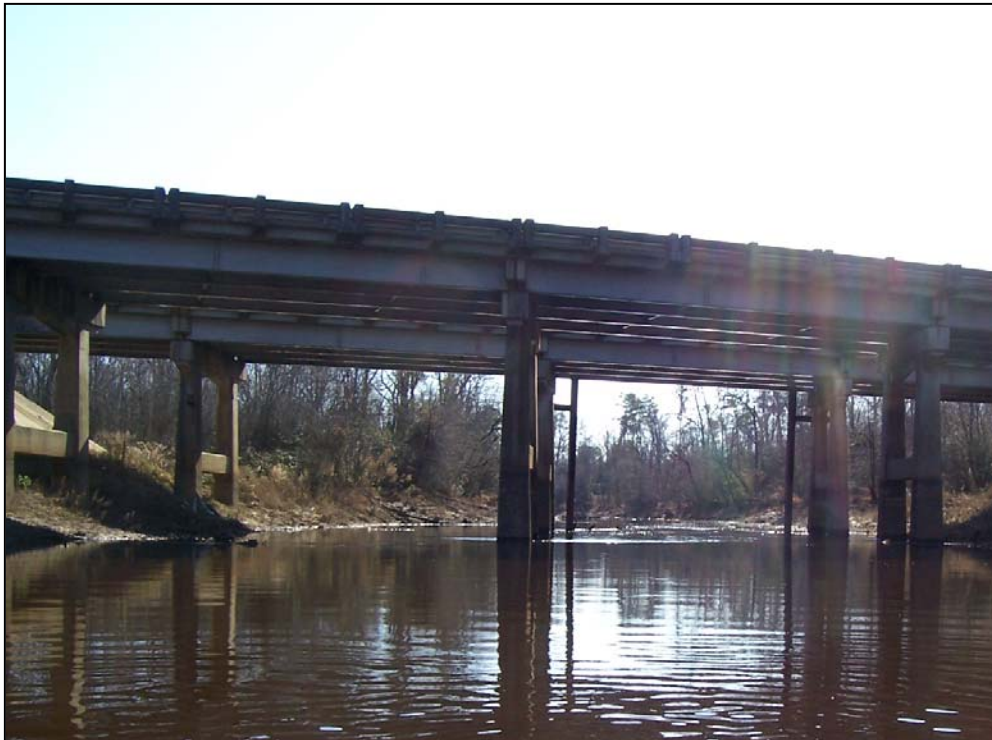
Photo 5. River Observation Point 7: The bridge pilings (I-95) located within the Little River contained no woody debris and no evidence of scouring was observed. Little River, Johnston County.

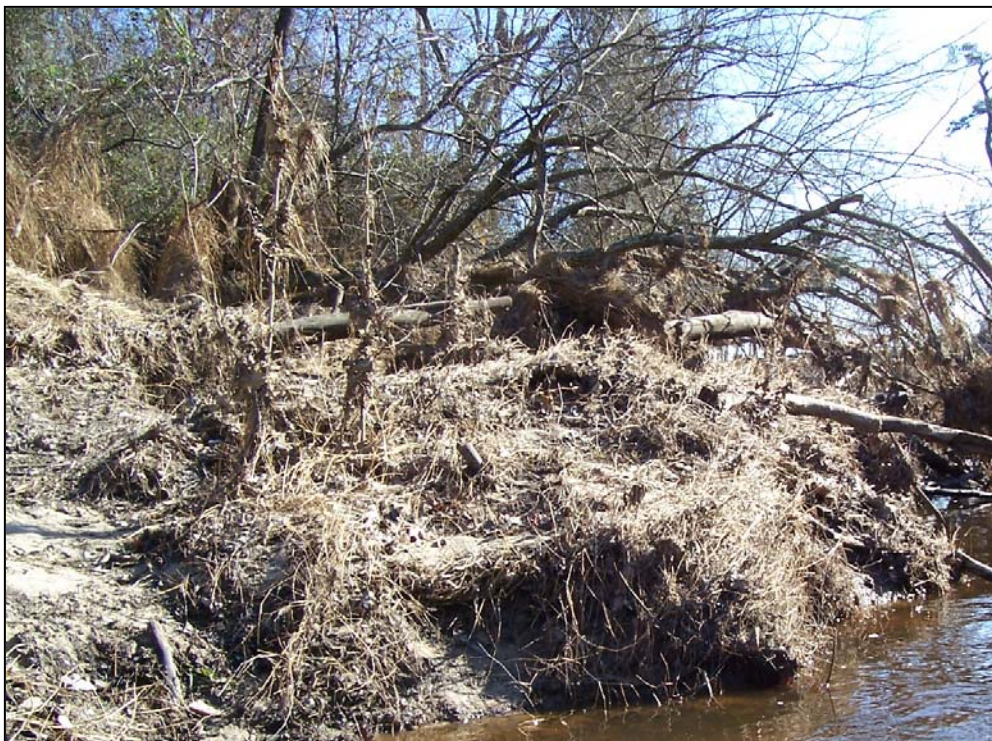
Photo 6. River Observation Point 8: Stable, vegetated bank that was previously a site of erosion. Little River, Johnston County.

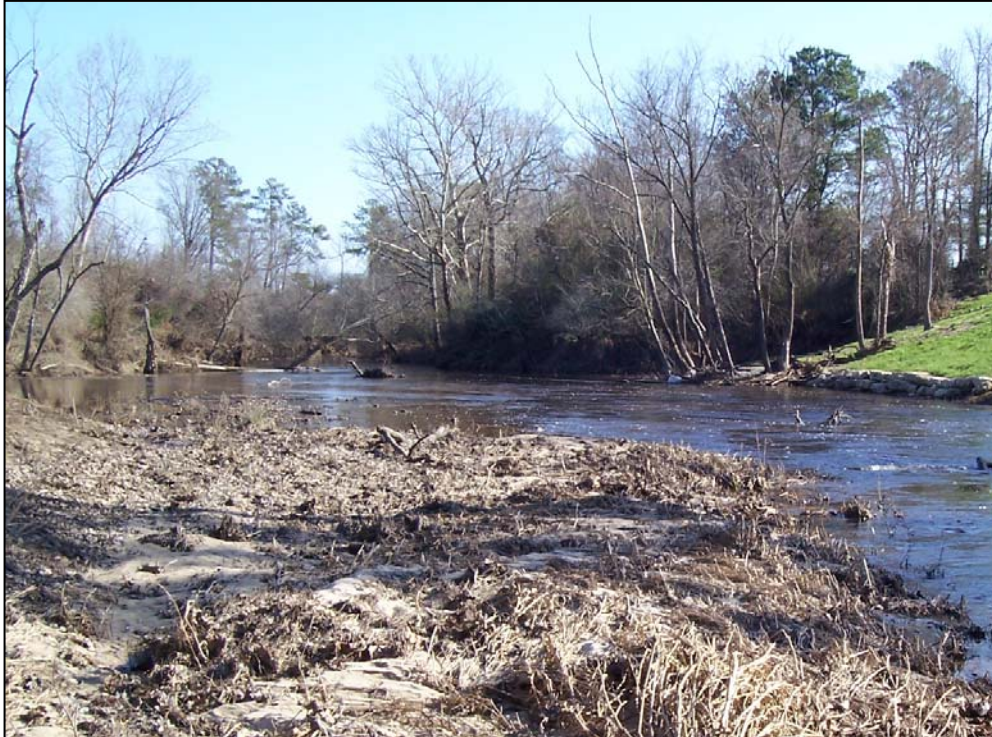
Photo 7. River Observation Point 9: Continued sediment deposition and bar formation along the inside bend of the river at the former dam site. Little River, Johnston County.

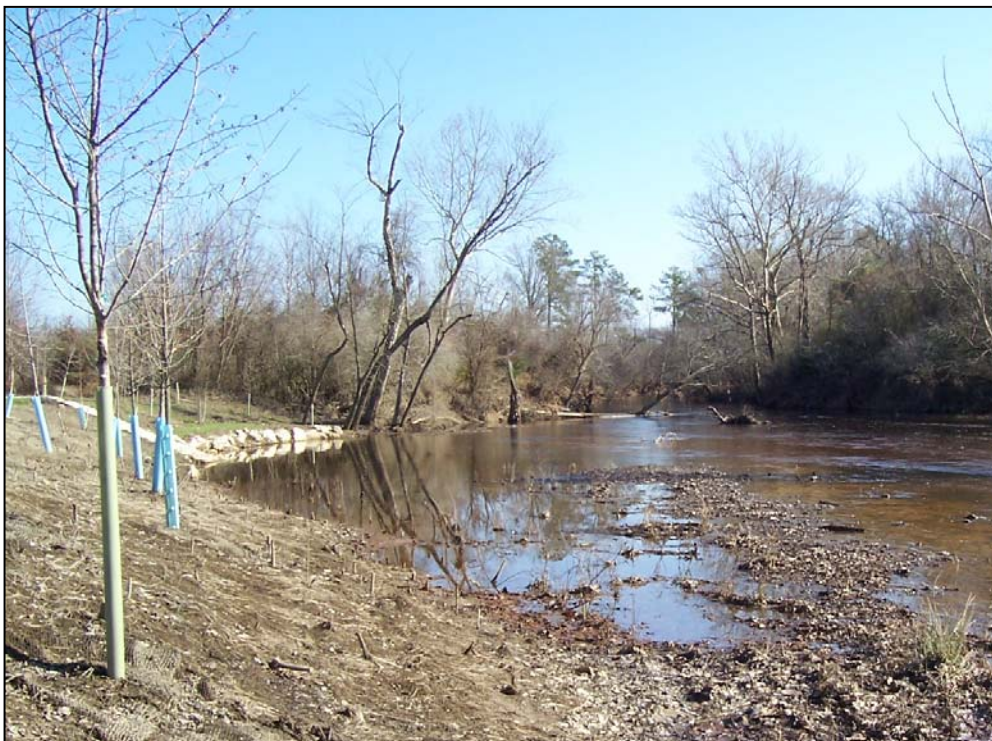
Photo 8. River Observation Point 9: Increasing size of the bar forming as a result of additional sediment deposition. Note slack water the right of the dam remnant from over widened channel. Little River, Johnston County.

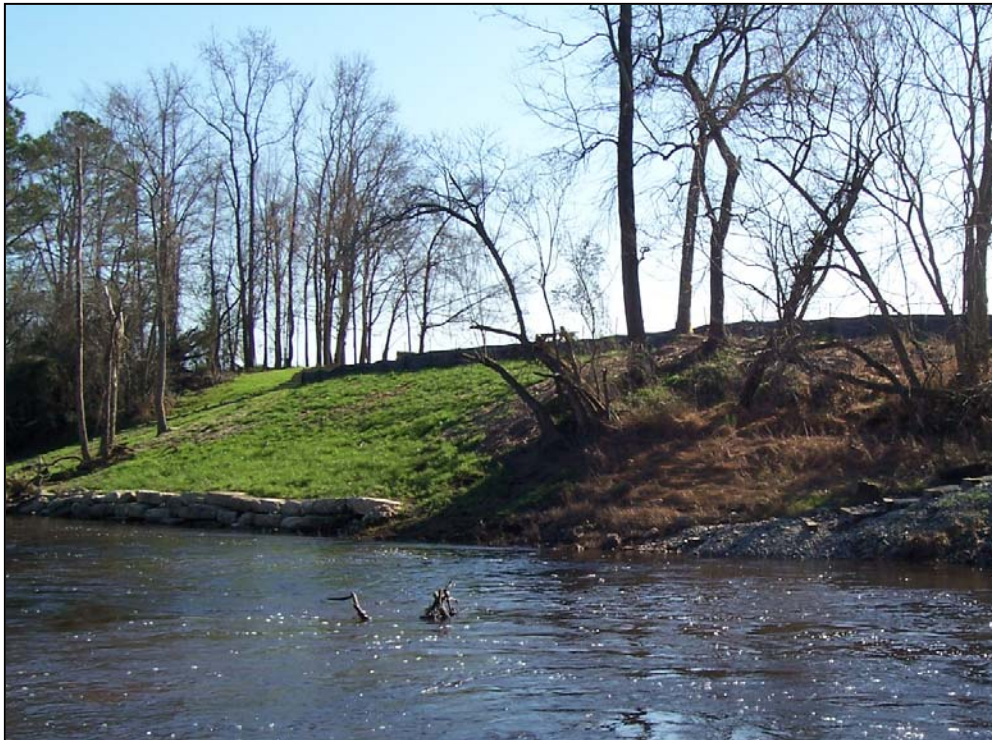
Photo 9. River Observation Point 9: Toe of slope protection and canoe launch staircase along the south embankment. Little River, Johnston County.

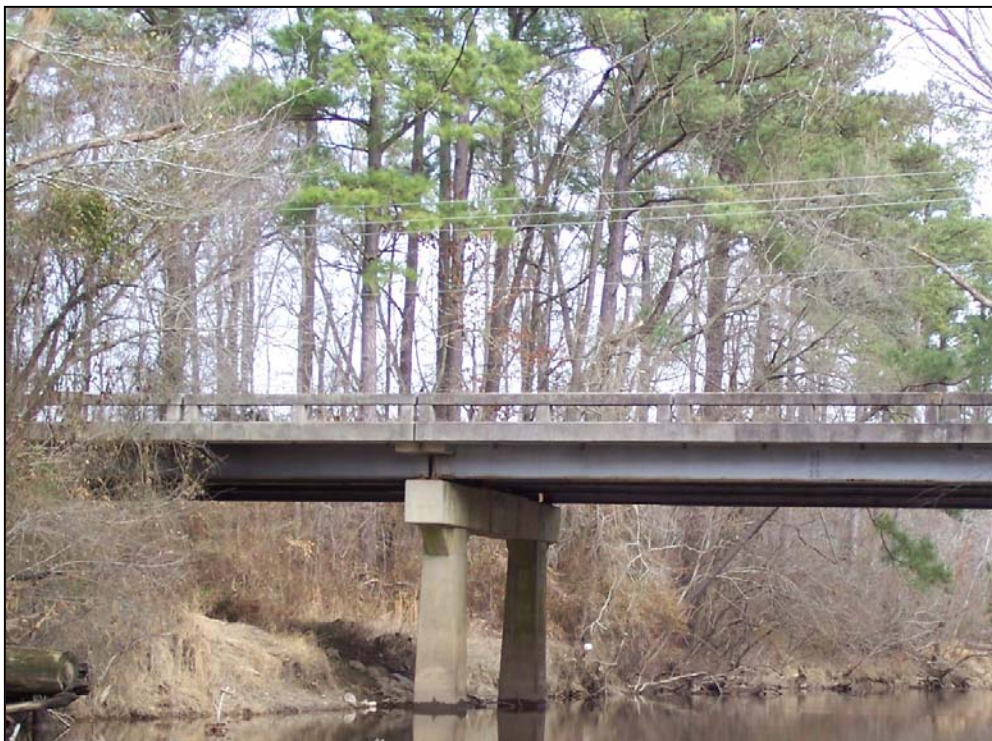
Photo 10. River Observation Point 10: The bridge pilings (Weaver Street) located within the Little River contained no woody debris and no evidence of scouring was observed. Little River, Johnston County.

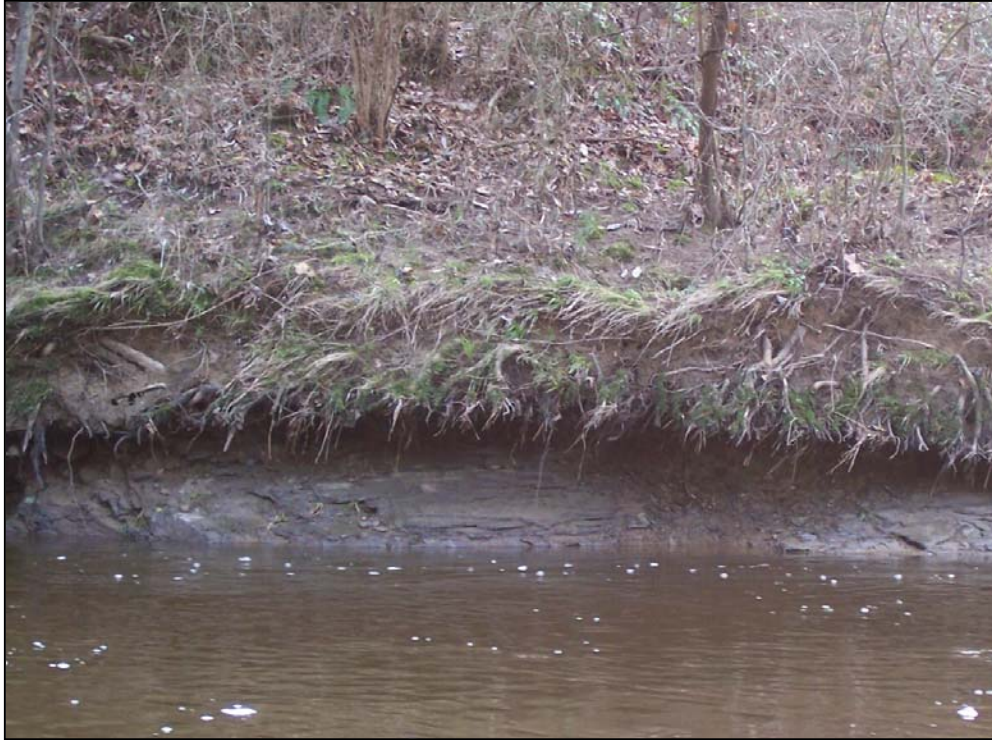
Photo 11. River Observation Point 11: Undercut alluvial banks exposing the underlying bedrock. Little River, Johnston County.

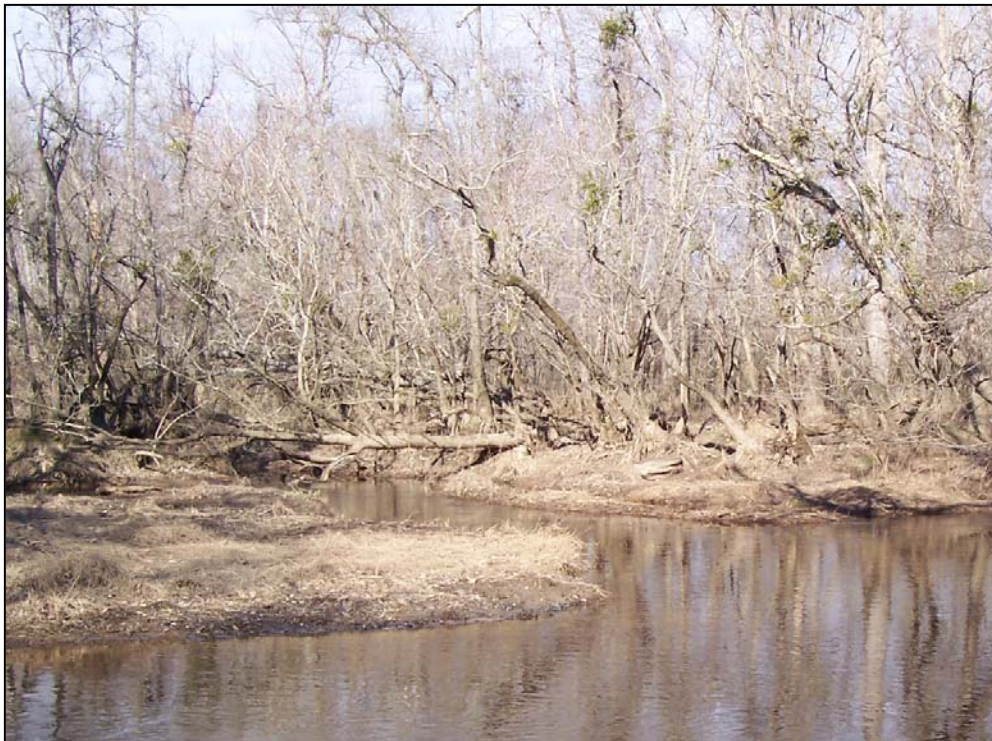
Photo 12. River Observation Point 12: Stable confluence to Little Buffalo Creek. Little River, Johnston County.

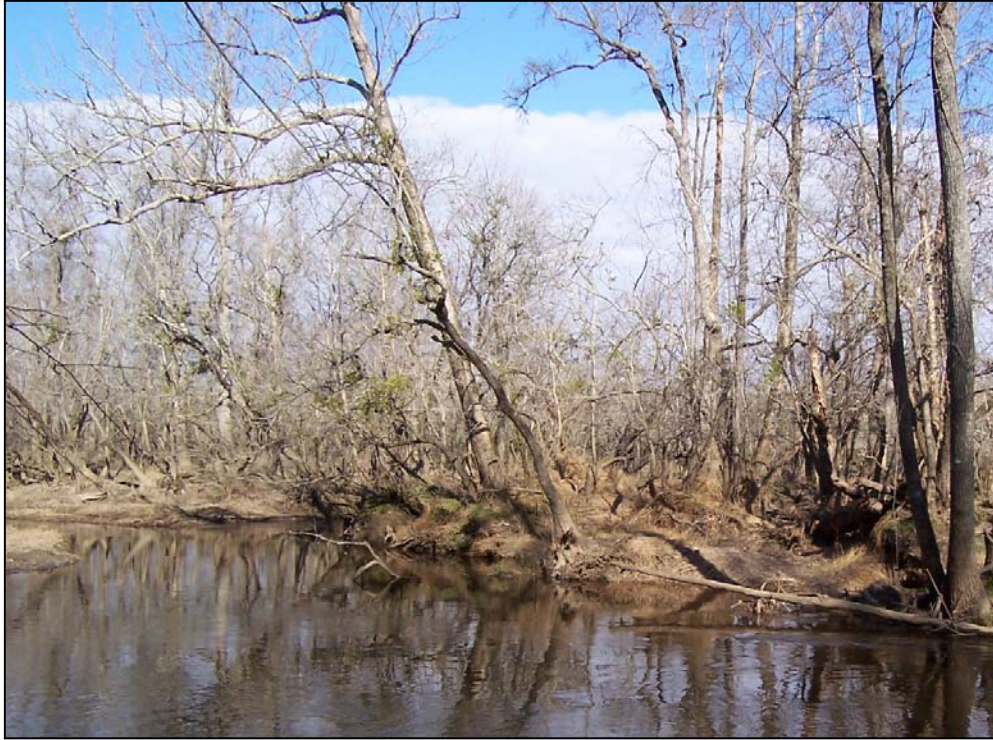
Photo 13. River Observation Point 12: Meander cut-off immediately downstream of the confluence with Little Buffalo Creek. Water flows both behind and in front of the pictured stand of trees. Little River, Johnston County.

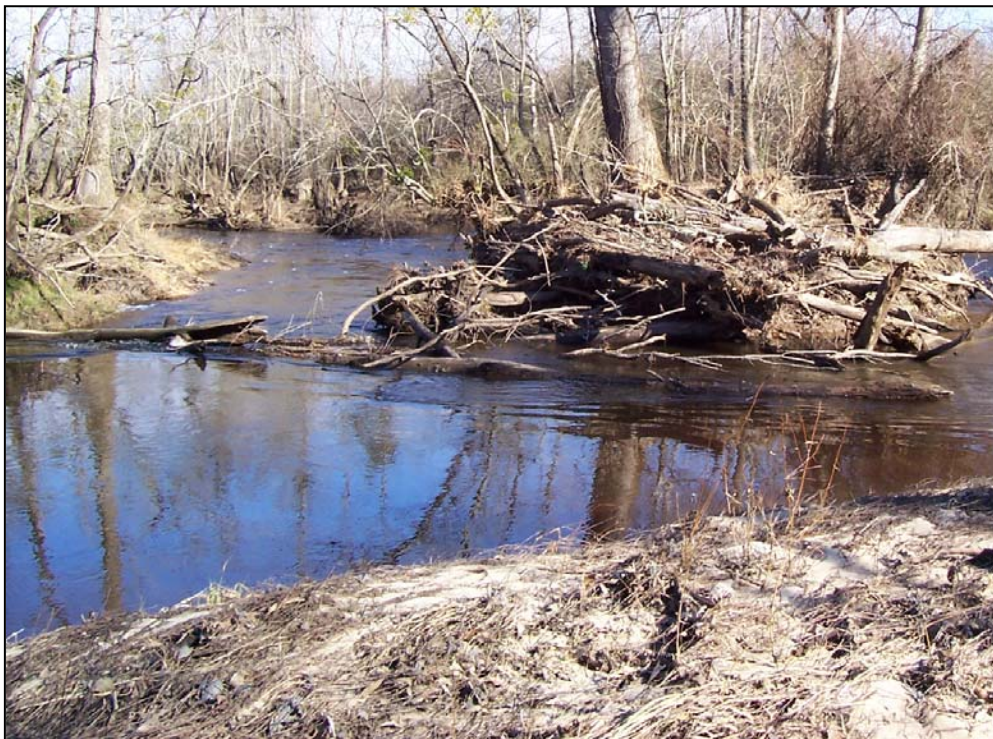
Photo 14. River Observation Point 12: Meander cut-off with woody debris deposition. Little River, Johnston County.

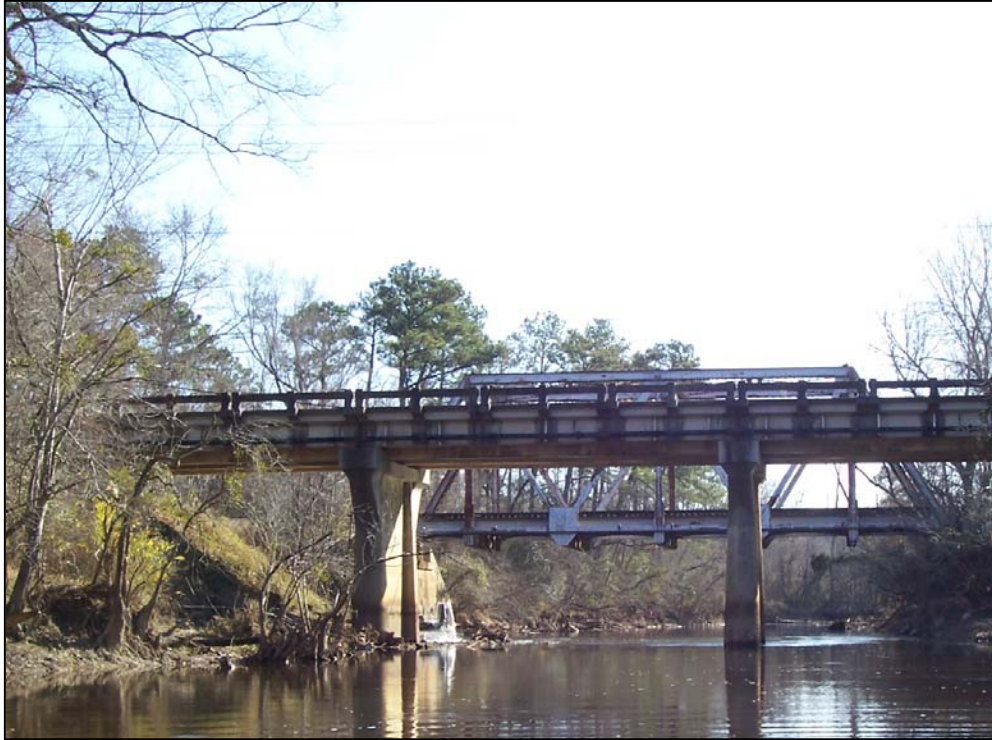
Photo 15. River Observation Point 13: The bridge pilings (US 301) located within the Little River contained no woody debris and no evidence of scouring was observed. Little River, Johnston County.

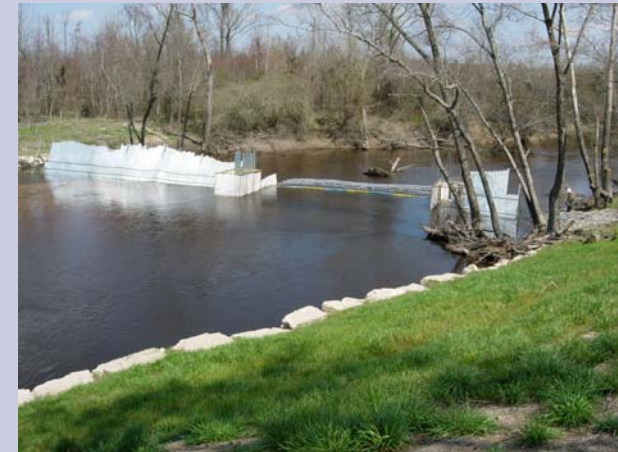
Cover Photo: Weir with cages to collect upstream and downstream migrating fish.

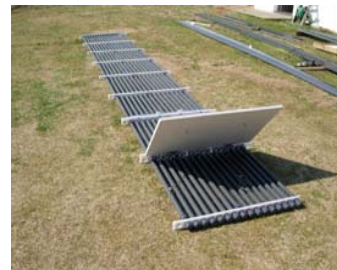
The main approach being used in this study is the operation of a “resistance board” weir. The name comes from the plywood boards underneath the PVC panels (see figure, right). The boards provide lift to the PVC panels but still allow them to rise and fall with the river. The panels are designed to be “self-cleaning” if debris builds up on them. Also, canoes or other boats should be able to drift downstream over the PVC panels.

The PVC sections are located in the strongest river flows. To the sides are stationary panels made up of vertical metal pickets. The weir is completed with two cages, one for upstream and one for downstream moving fish. The weir blocks fish from moving upstream or downstream and funnels them into the respective cages where they will be temporarily captured. After information is recorded about each fish, it will be released to continue its upstream or downstream migration.
