**LOWELL MILL DAM-LITTLE RIVER WATERSHED
RESTORATION SITE
2010 Annual Monitoring Report (Year-5)**

**Johnston County, North Carolina
EEP Project No. D04008-2**

October 2010

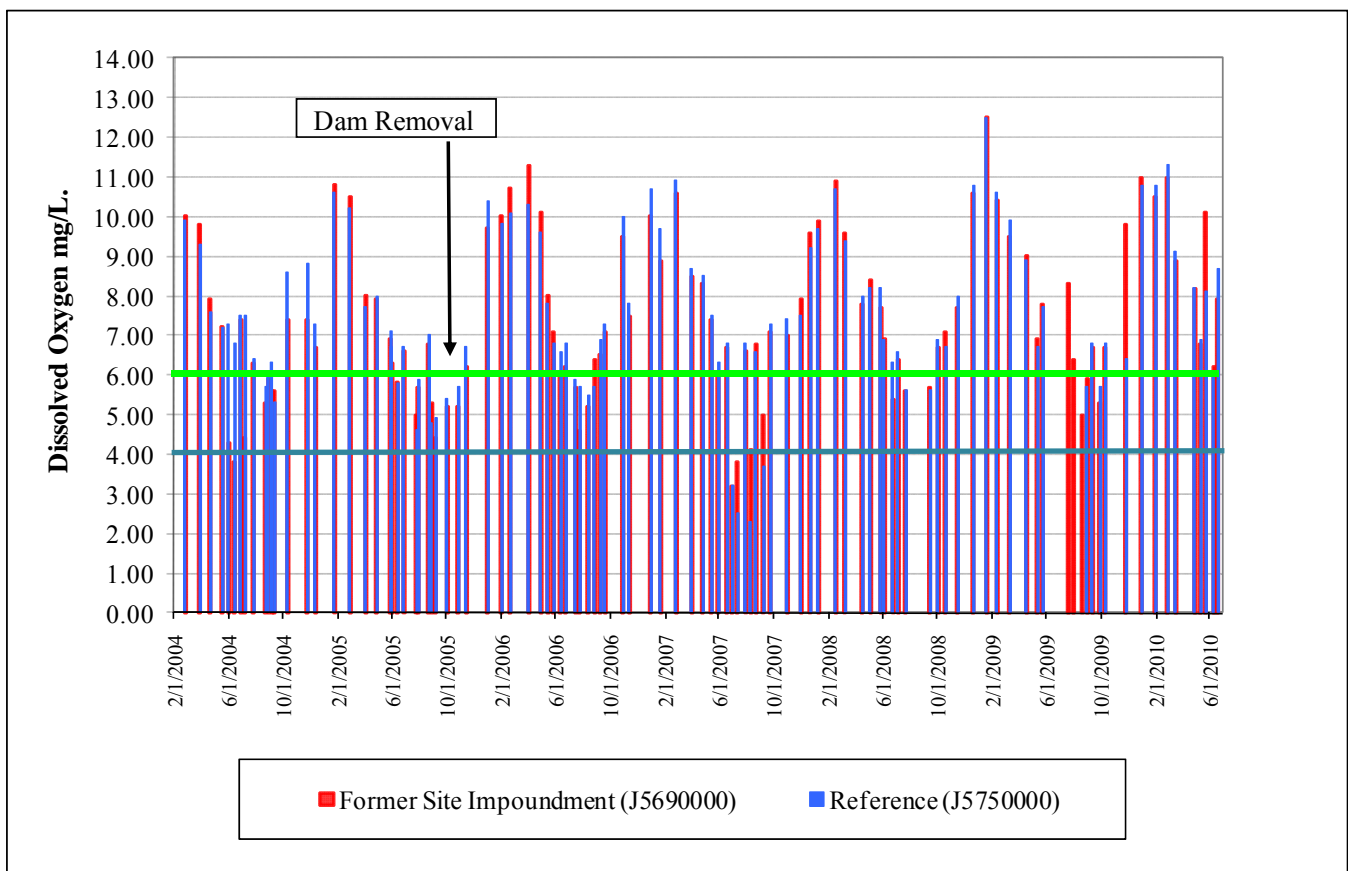
Graph 2. AMS Dissolved Oxygen Concentrations*

The 2006 North Carolina Impaired Waters (303(d)) List (NCDWQ 2006) included a section of the Little River beginning at the confluence of Little Buffalo Creek and extending 20 miles downstream to 4.2 miles upstream of NC 581. The segment was listed as impaired due to low dissolved oxygen. According to standards outlined in the NCDWQ “Redbook” (NCDWQ 2004), dissolved oxygen concentrations within the former Site Impoundment cannot fall below the minimum NCDWQ standard for Class WS-V waters. The NCDWQ standard is an instantaneous value of no less than 4.0 mg/L (daily average no less than 5.0 mg/L). The standard of 4.0 mg/L is used as a criterion for removal from the 303(d) list. Consequently, following dam removal and the subsequent rise in dissolved oxygen values, **the Little River was removed from the 2010 Final 303(d) List.**

*The green line highlights a dissolved oxygen (DO) concentration of 6.0 mg/L, which must be exceeded by J5690000 in order to achieve success criteria (unless DO concentrations at reference J5750000 are also below 6.0 mg/L within the same sampling timeframe). The blue line highlights a DO concentration of 4.0 mg/L, which must be exceeded by J5690000 in order to achieve success criteria according to NCDWQ for WS-V streams (unless DO concentrations at reference J5750000 are also below 4.0 mg/L within the same sampling timeframe.)

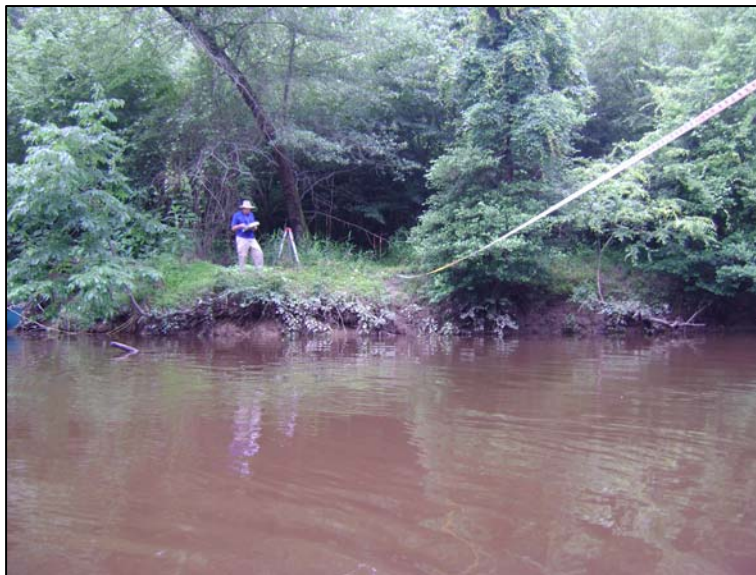
Photo 1: PBS&J Scientist conducting a cross-section survey on the Little River.

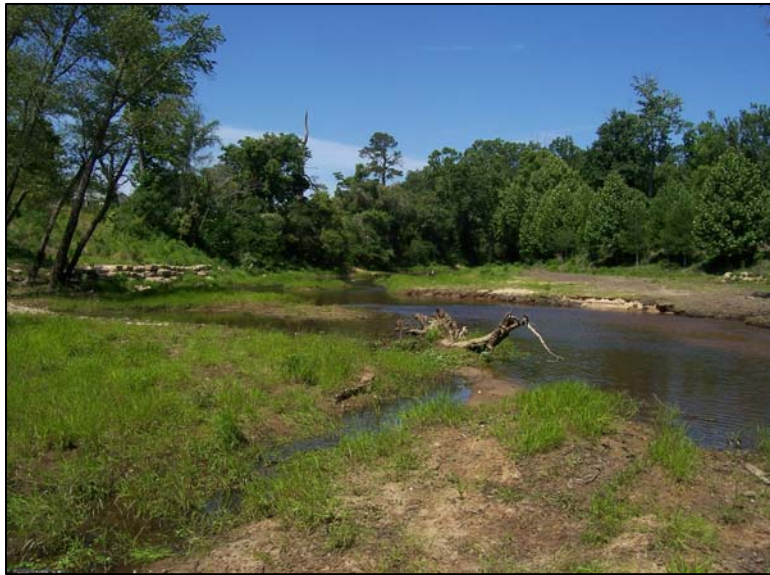
In general, bankfull channel parameters for Year-5 monitoring were largely unchanged from conditions in previous monitoring years. Based on this observation, channel geometry within the former site impoundment is stable. The following should be noted: 1) cross-section 20, which was installed approximately 200 feet downstream of the former Lowell Mill dam on the Little River, was established following dam removal. Thus, there is no baseline bankfull channel geometry data for this station; and 2) cross-section 16, located just upstream of the former dam site, was impacted during dam removal activities. Hence the discrepancies in cross-sectional dimensions and bankfull channel geometry between baseline and Year-1 monitoring data. The bankfull channel parameters for cross-section 16 have stabilized in subsequent monitoring years.

Photo 2: Cross-Section 20 on the Little River. Note the emergent vegetation working to stabilize the banks.
