LYLE CREEK MITIGATION SITE
Catawba County, NC
DENR Contract No. 003241

Mitigation Plan
August 2011

LYLE CREEK MITIGATION SITE

Mitigation Plan

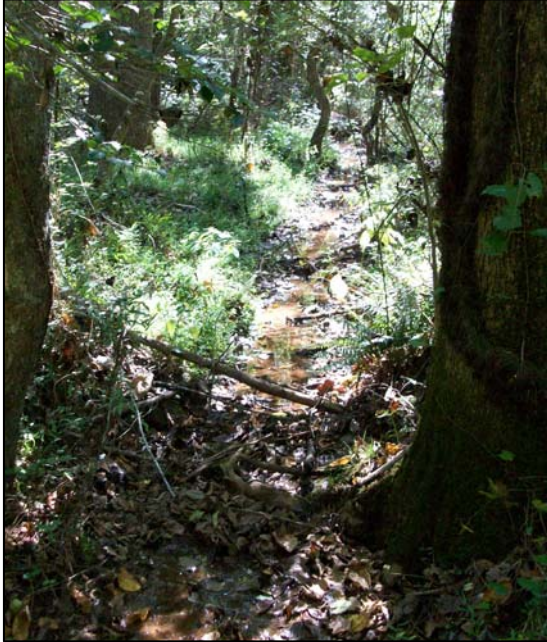
Naturally formed log step (background) and wood debris sill (foreground) at UT to Lyle Reference Site

The in-stream structures proposed on the Lyle Creek project are designed to mimic natural habitat features found in mature streams, particularly on the reference sites after which the project streams were designed. Habitat features observed on reference sites included log steps, root mats, undercut banks, debris jams, and riffles dominated by woody material. In an effort to mimic these structures, log, brush, and rock sills, constructed riffles, and brush toe are proposed on the Lyle Creek site. Log vanes will be used in select locations on UT1 to help turn water and protect the bank while vegetation establishes. Rock and log cross vanes are also proposed in select locations to protect against bed degradation. There are no mature trees to be removed within the construction area; therefore, trees may be selectively harvested from the

The addition of wood provides habitat and cover for fish and macroinvertebrates, in addition to adding a carbon source to the stream system. Structures, including brush toe, will increase the channel roughness and provide areas for leaf packs to catch and form over time. These leaf packs provide habitat for shredders and scrapers, important feeders in the continuum of the ecological community. WEI anticipates that the structures will provide an initial ecological uplift to the newly constructed stream channel.

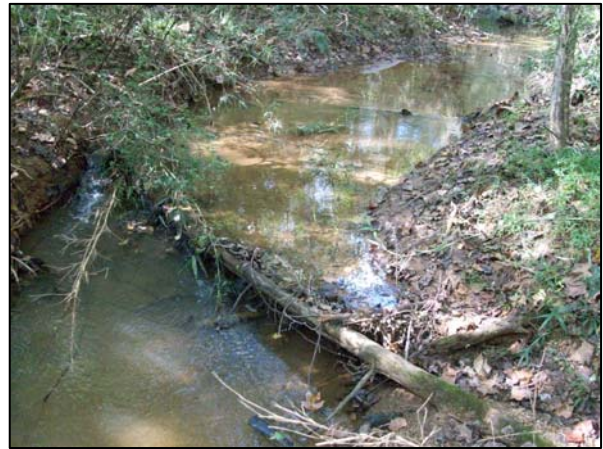
Log step at UT to Catawba River

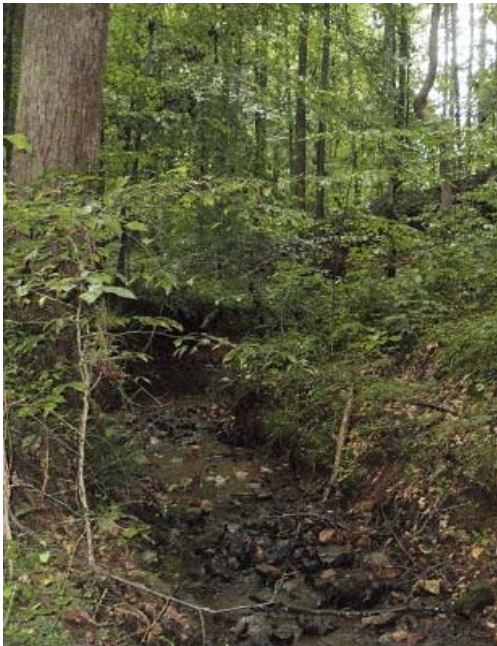
Colluvial riffle, UT1 upstream of railroad culvert

WEI noted colluvial cobble riffles upstream of the project reach on UT1 (see Section 2.4). The substrate does not reach the project site because of the railroad embankment/culverts and the farm culverts; however, some of the smaller gravels would naturally occur on steeper reaches of the project were these man-made obstructions not in place. To provide this habitat, some rock riffles will be built in the upstream reaches of

the project to recreate the habitat. Because upstream supply is limited, these structures will be sized appropriately so they remain in place as grade control. These structures will mimic geologic grade control.

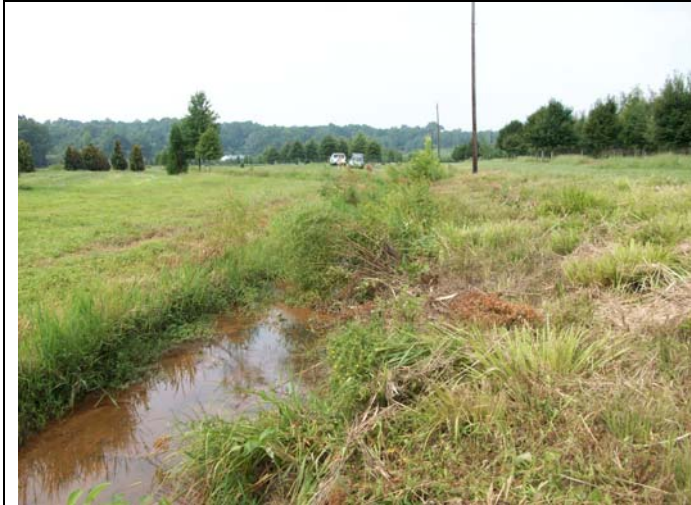
Photo 1-View of Perennial UT1, facing upstream near confluence with UT1a.

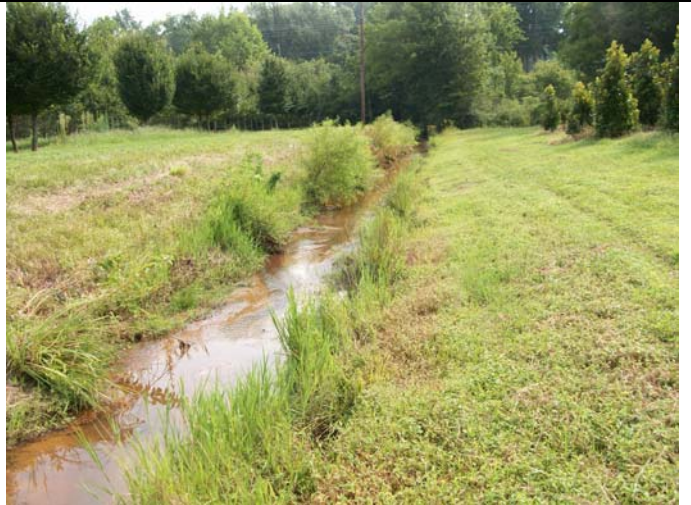
Photo 2-View of downstream portion of Perennial UT1, facing downstream.

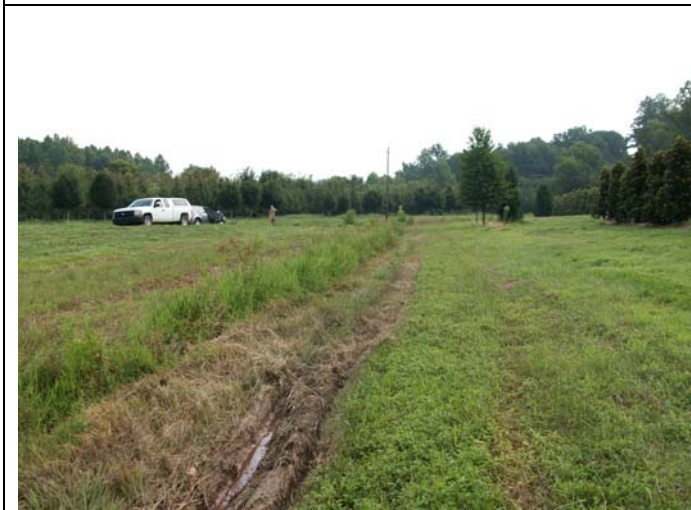
Photo 3-View of Intermittent UT1a, facing downstream near confluence with UT1.

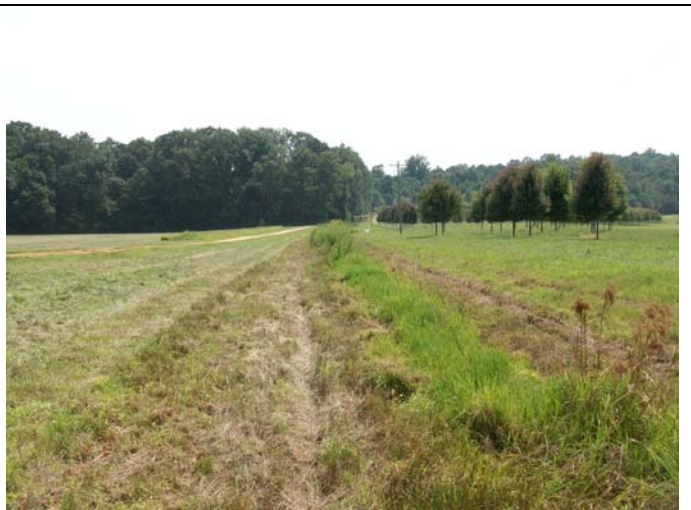
Photo 4-View of Perennial UT1b, facing upstream from existing culvert.

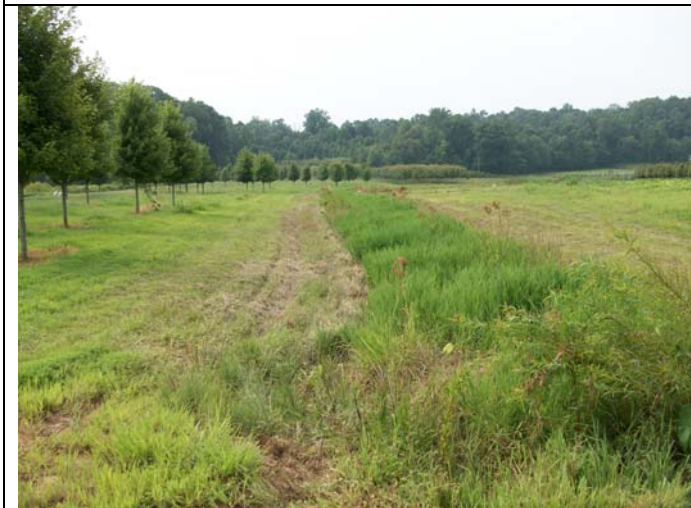
Photo 5- View of Intermittent UT1c, facing upstream from existing culvert.

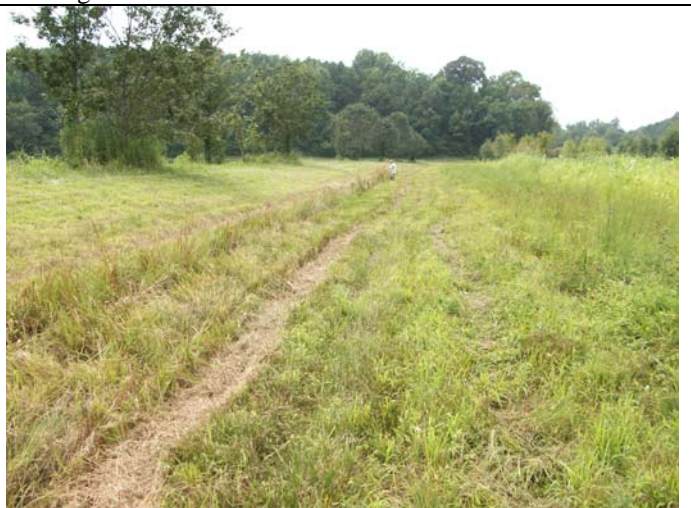
Photo 6-View of Intermittent UT1d, facing upstream.
