**Lyle Creek**  
**Post Closeout Contingency Update**  
**Full Delivery Site**

**DMS ID (IMS) # 94643**  
**Catawba County**  
**Stream & Wetland Mitigation Site**

The Lyle Creek closeout site visit was completed with the Interagency Review Team (IRT) on 6/20/2017. The IRT considered a total of 5,571 SMUs and 7.1 WMUs for closure during the site visit. The site was not approved for closure in June 2017, the following plan of action was approved:

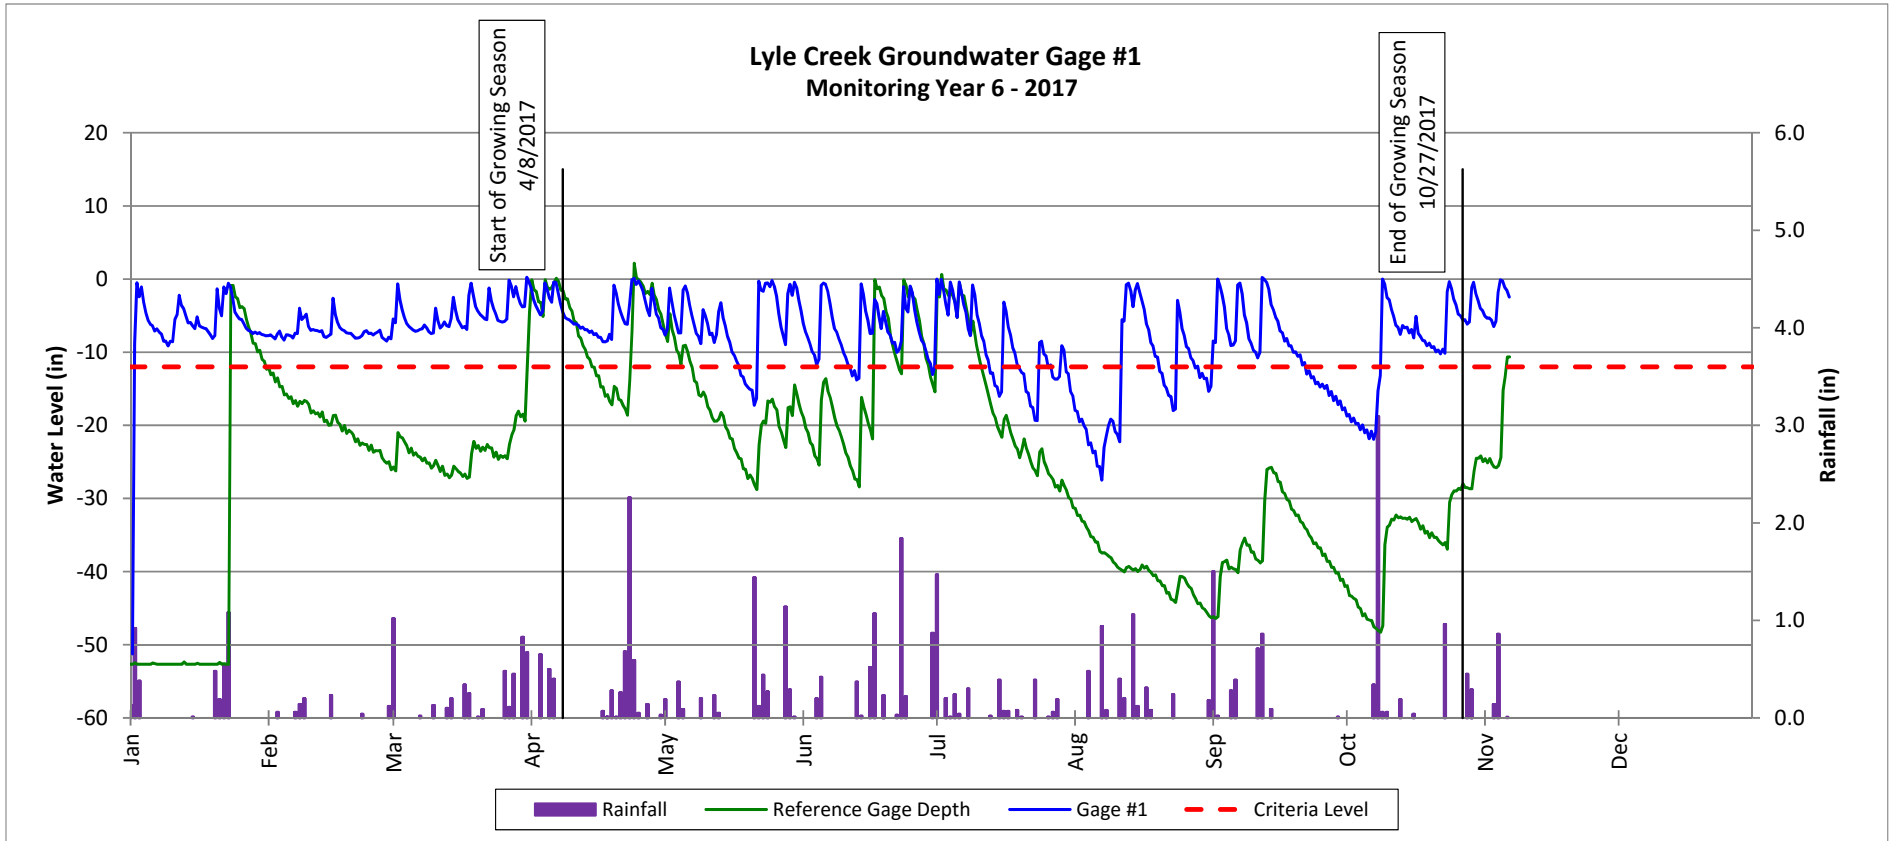
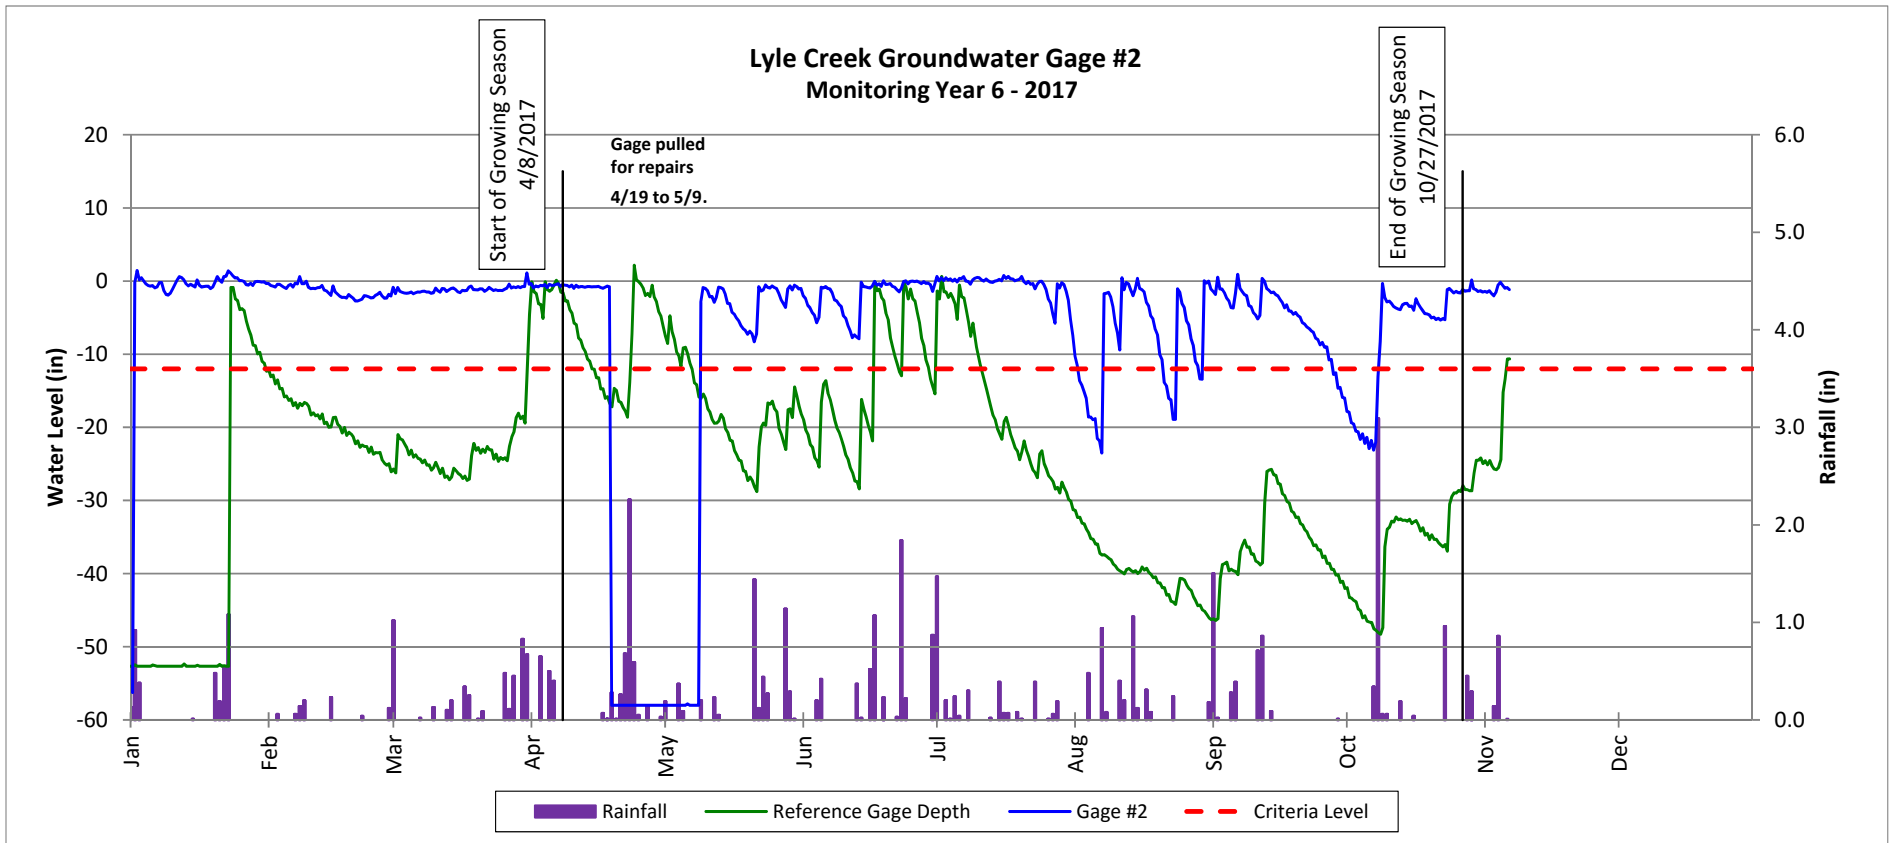
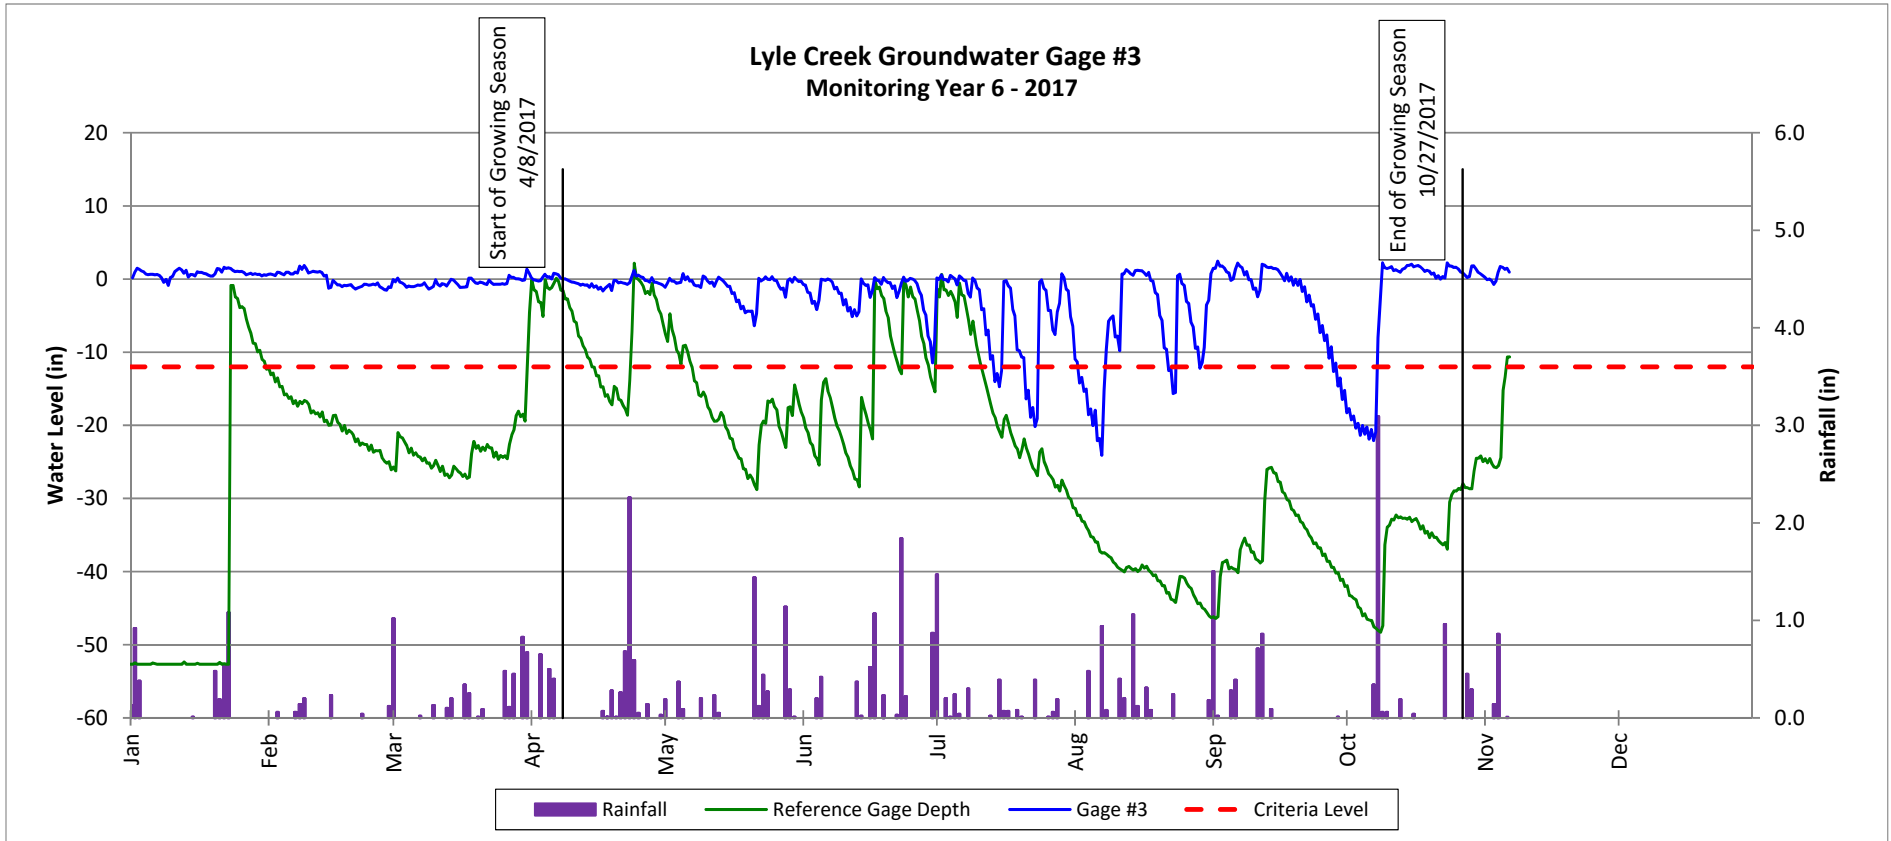
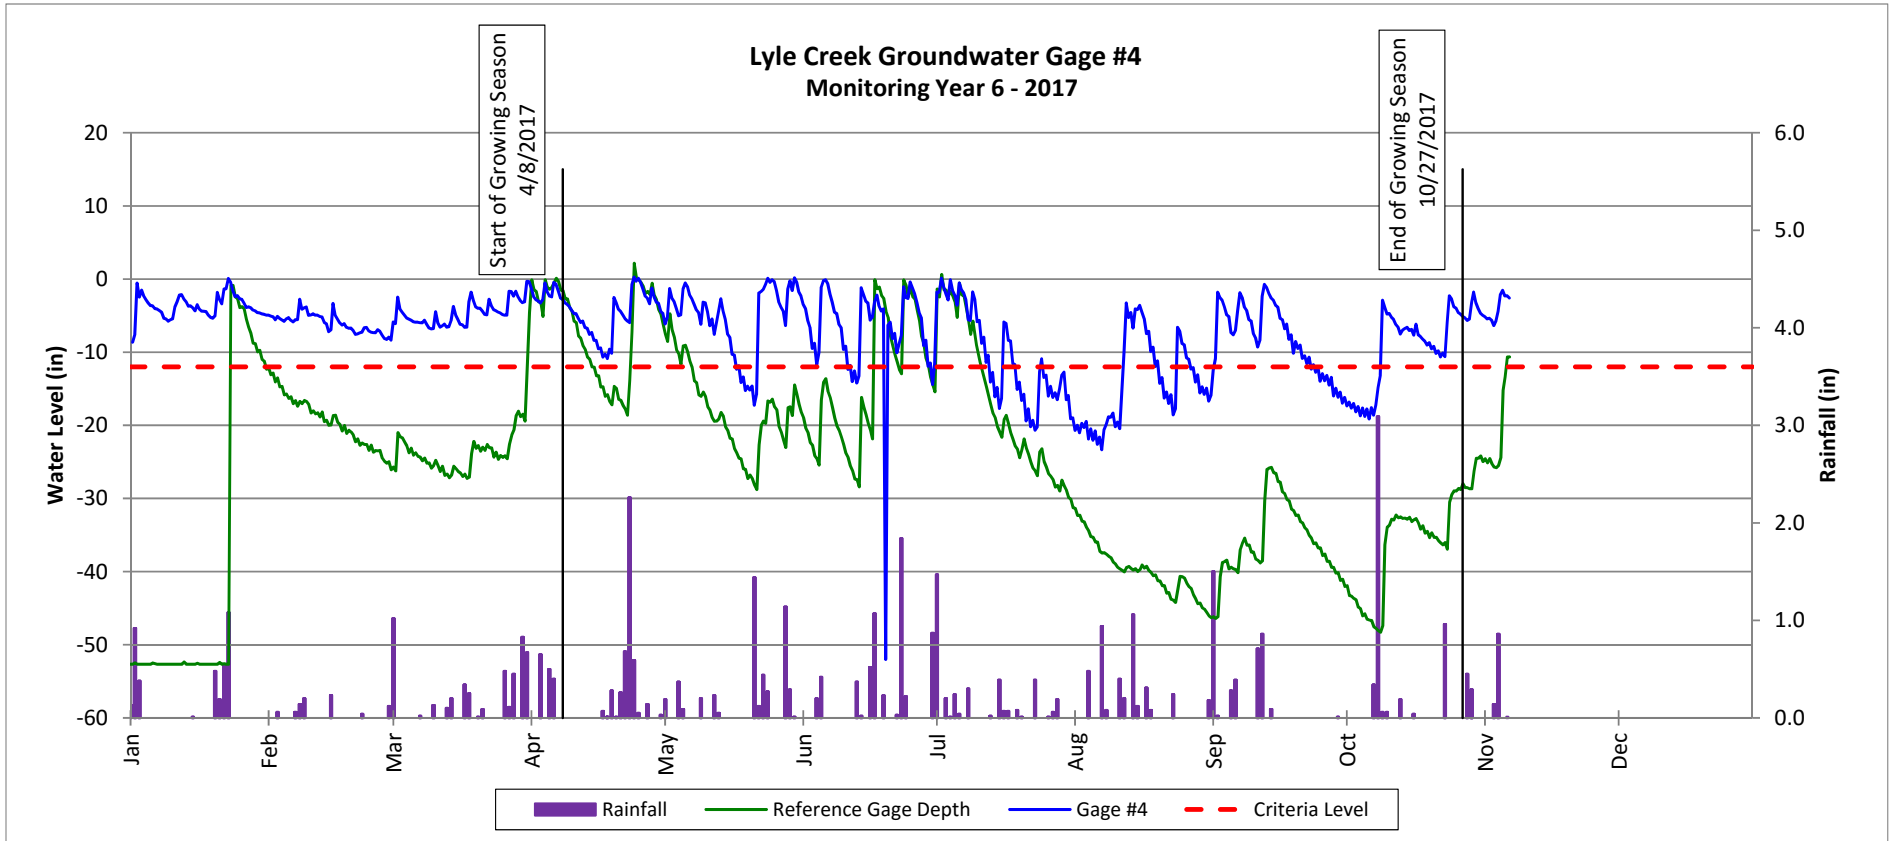
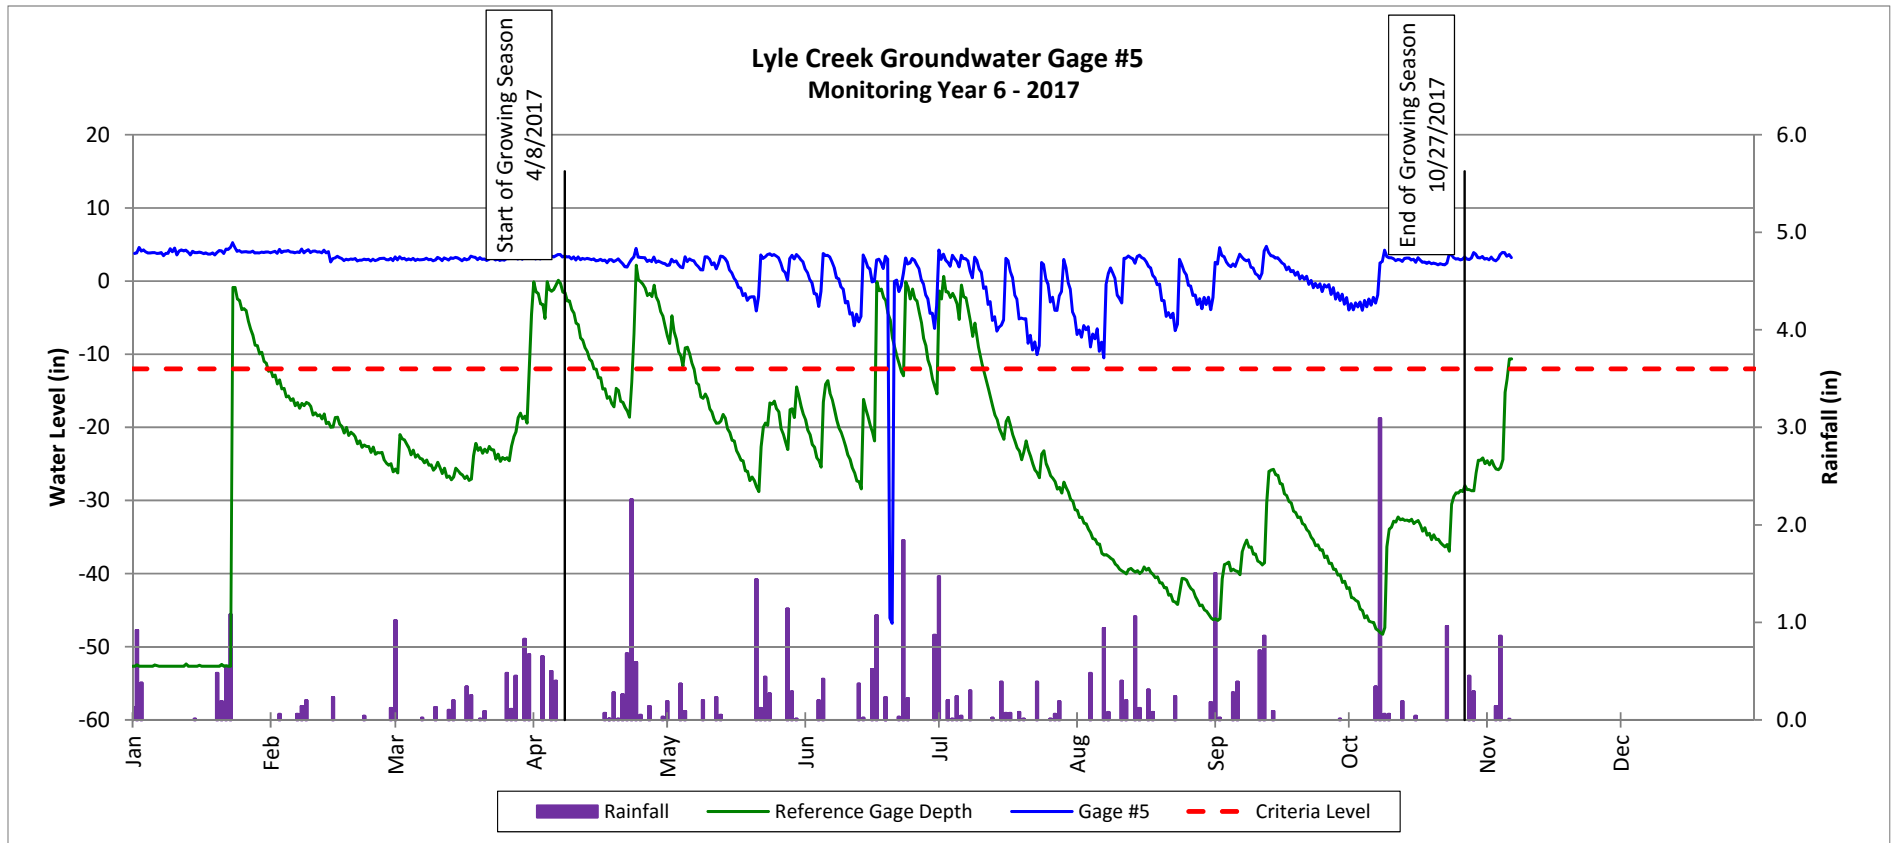
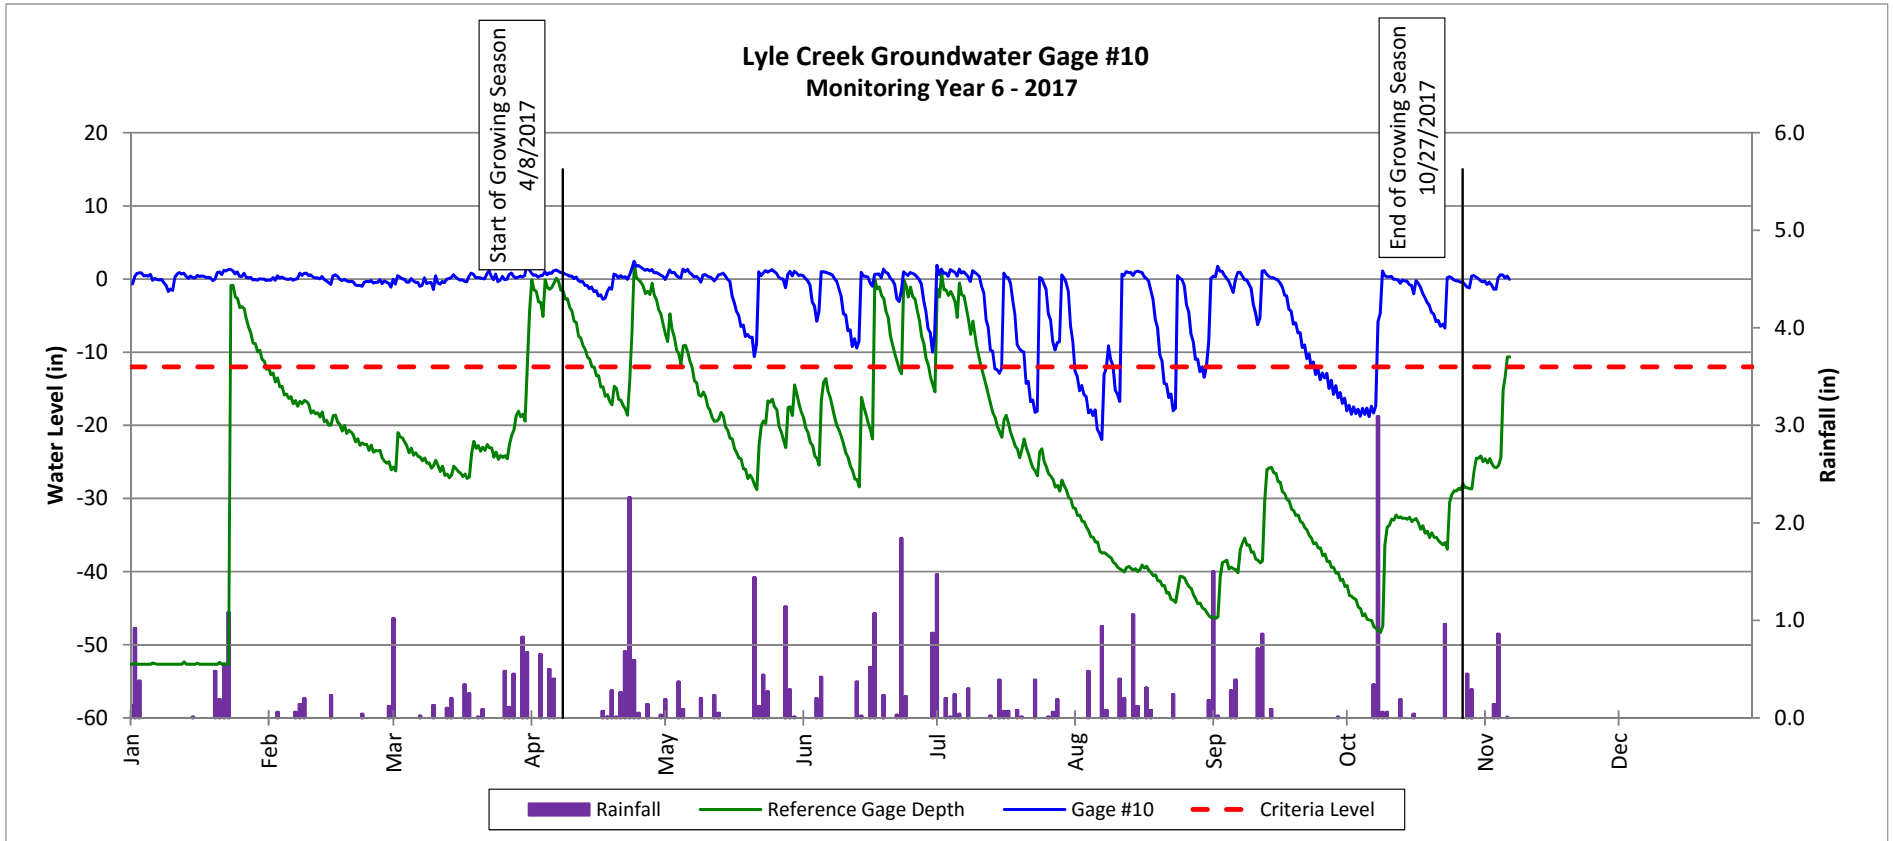
Wetland RW1

1. All groundwater gages within the Site met the project success criteria (14 consecutive days, 7.0% of growing season) for Year 6. Please see attached summary gage table and plots for Year 6 results.

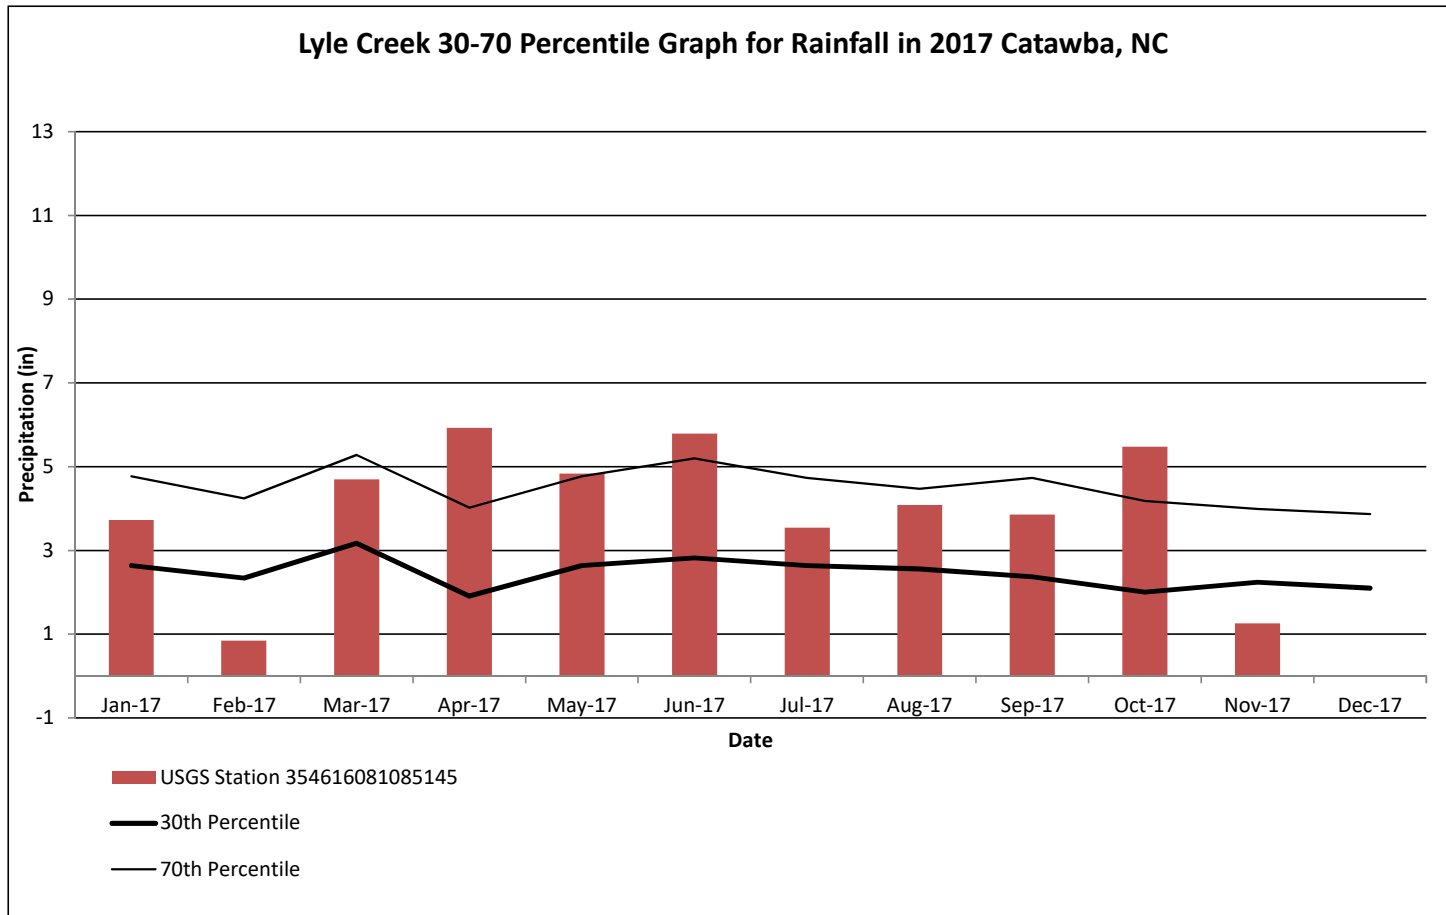
### Monthly Rainfall Data

<sup>1</sup> 2017 rainfall collected by onsite rainfall gage and USGS station 354616081085145

<sup>2</sup> 30th and 70th percentile rainfall data collected from weather station Catawba 3 NNW, NC1579 (USDA, 2002)

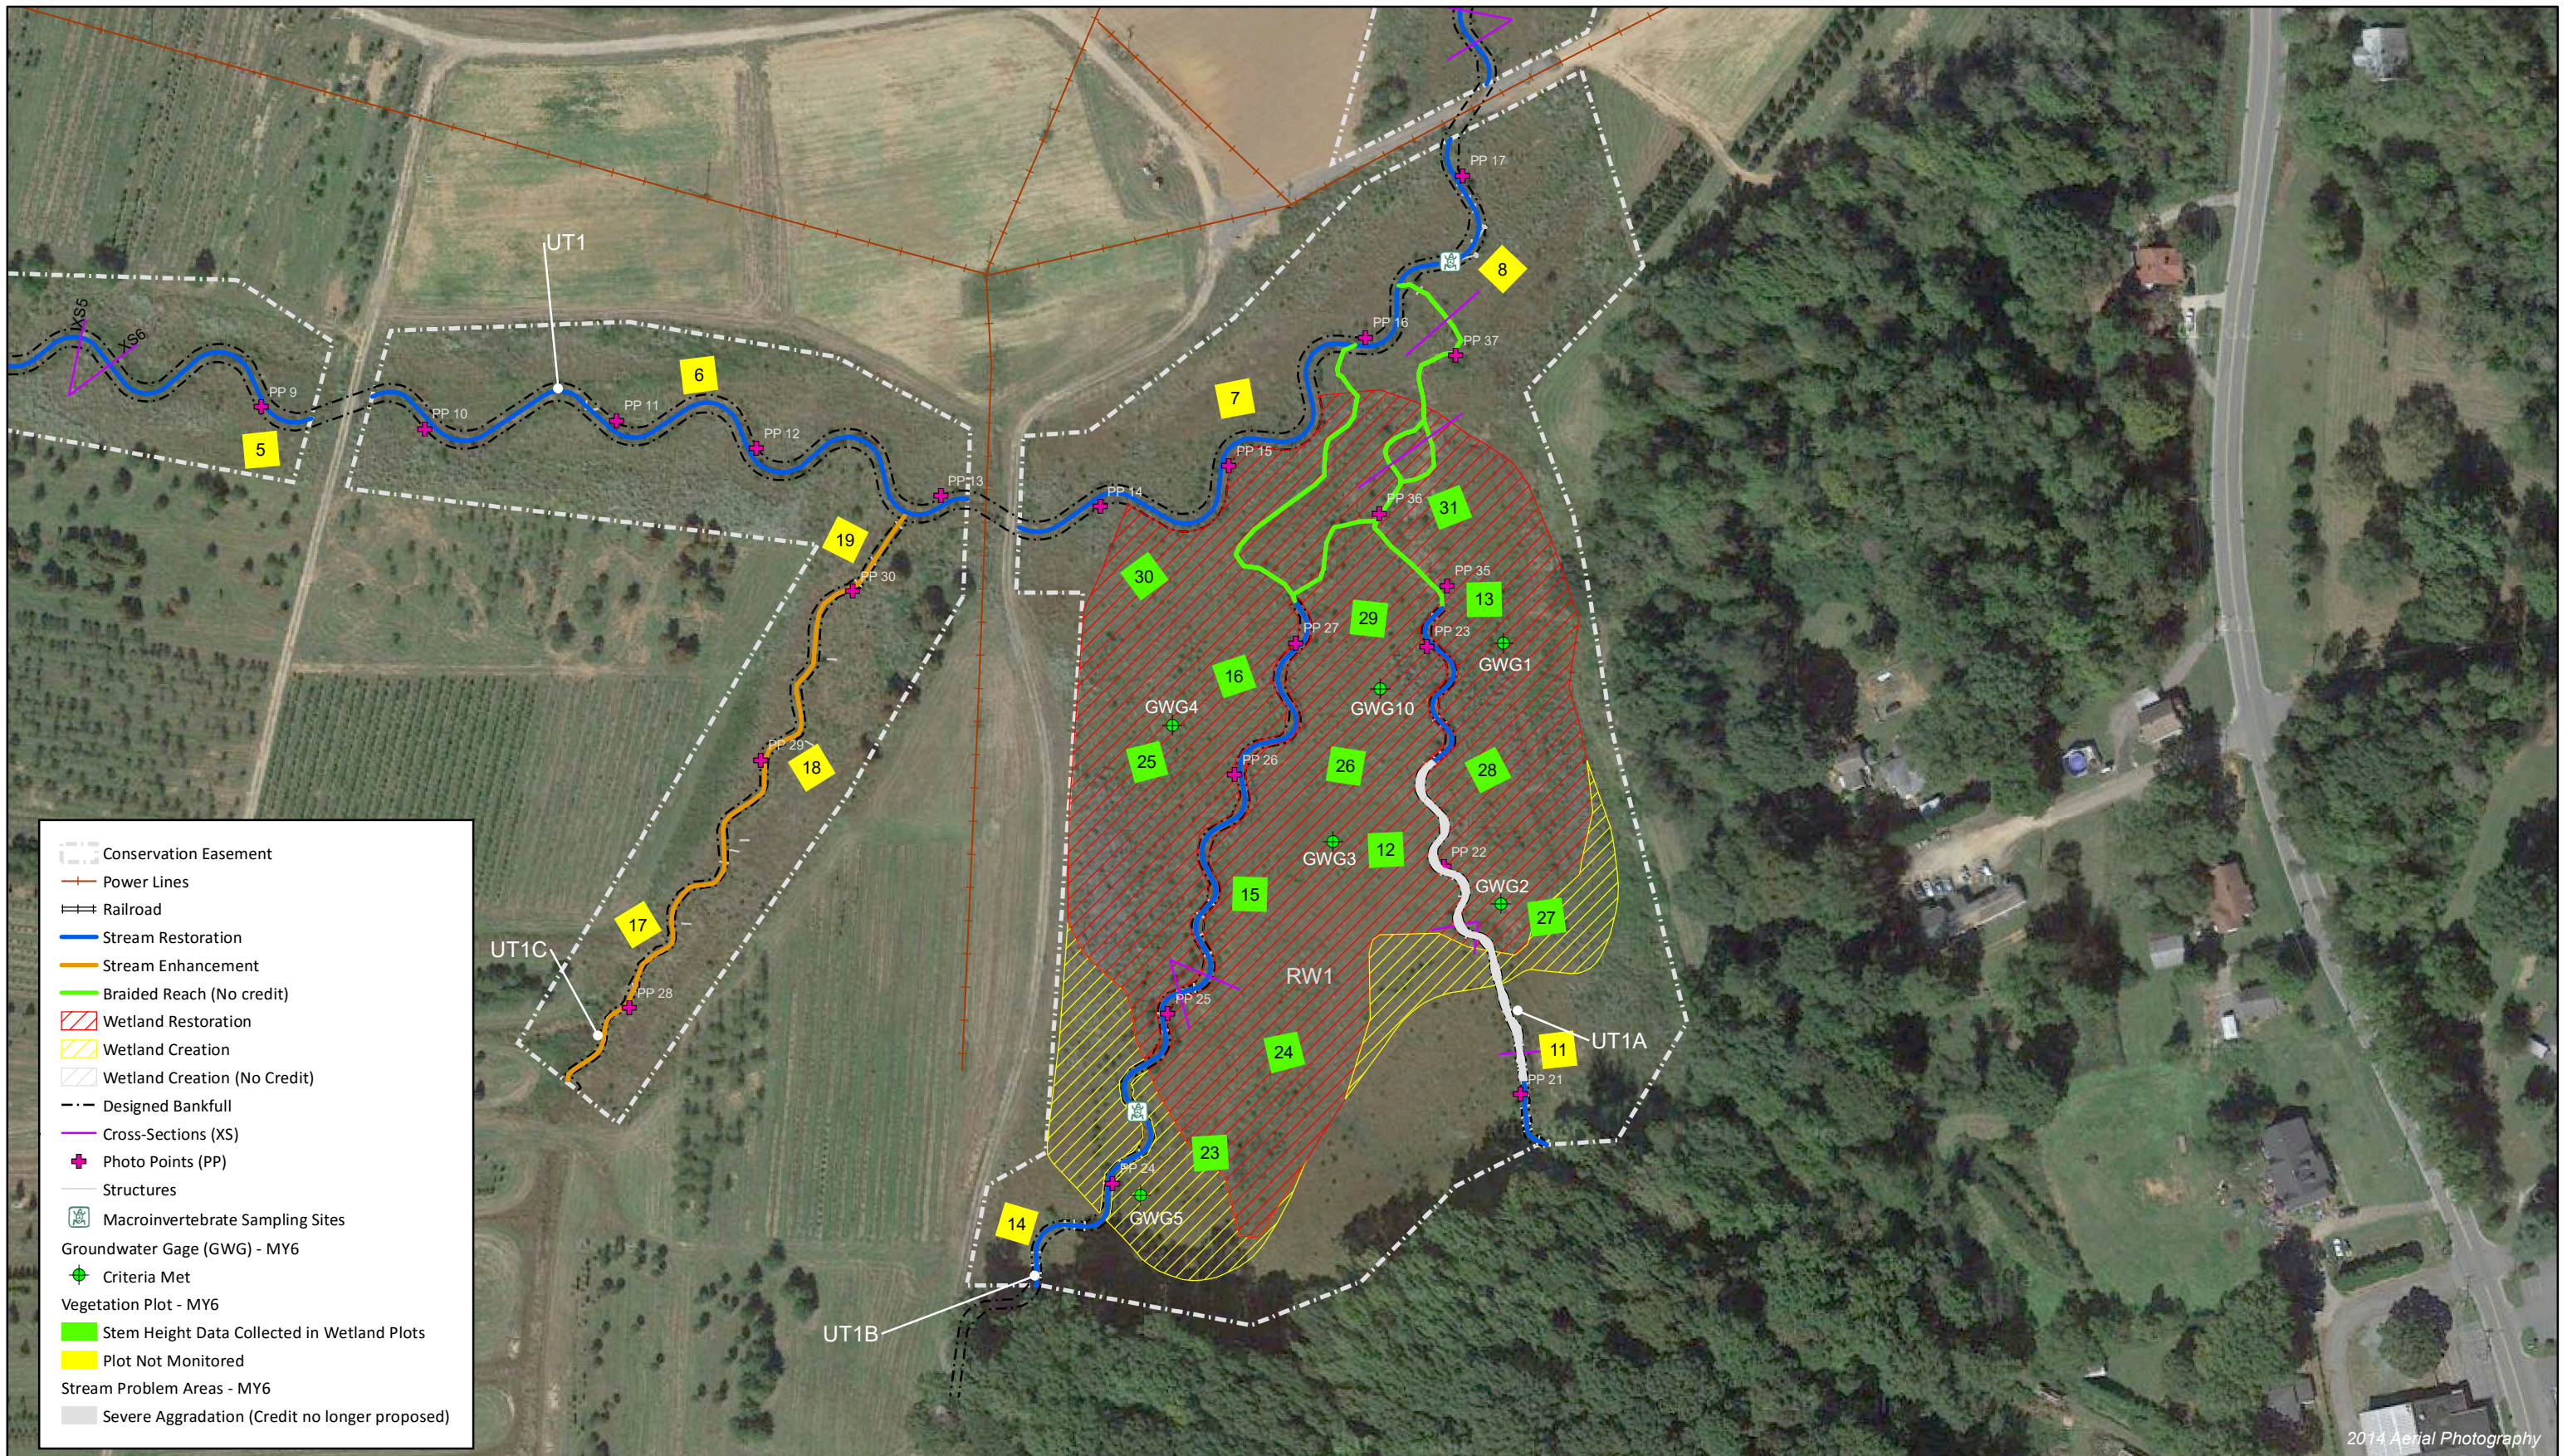
Figure 3.2 Integrated Current Condition Plan View (Sheet 2 of 3)  
 Lyle Creek Mitigation Site  
 DMS Project Number 94643  
 Monitoring Year 6

2. Stream reaches UT1 (upstream reach) and UT1B (upstream reach) were visually monitored during Year 6 between June and November 2017. Both reaches appear stable and are not showing signs of instability. Please refer to the attached Current Condition Plan View Map and site photographs.

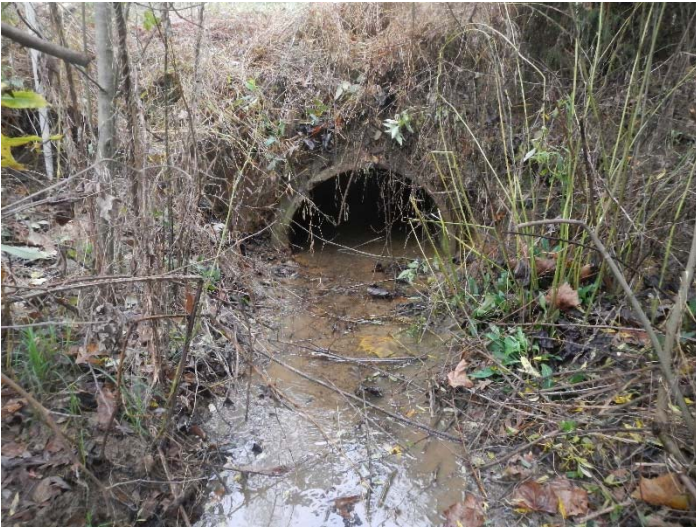
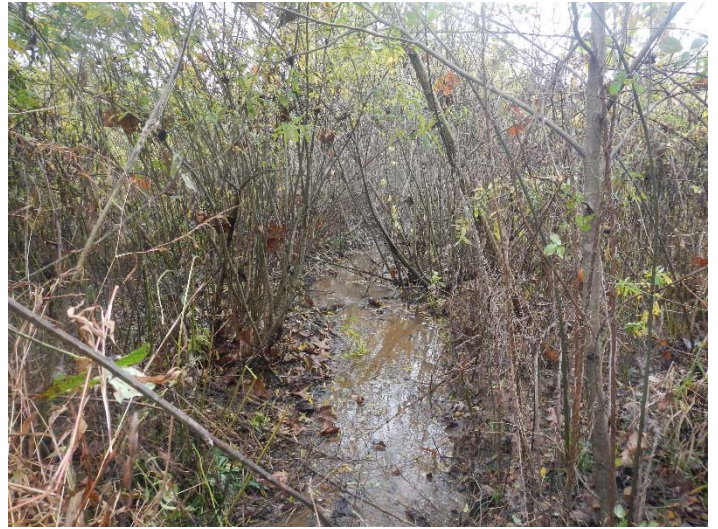
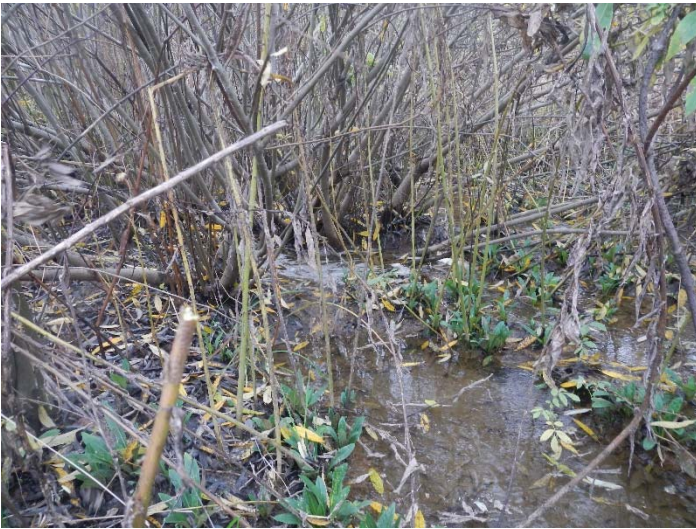
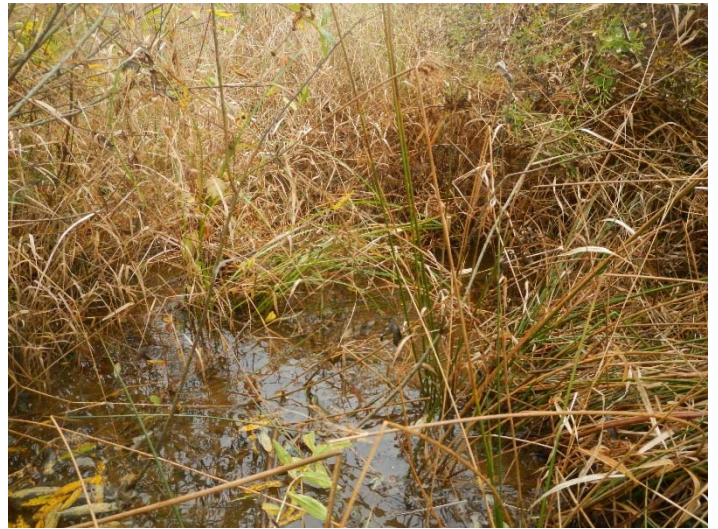
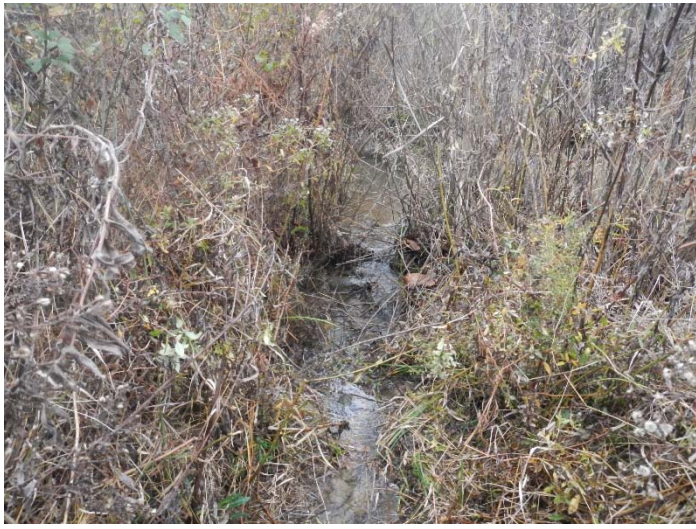
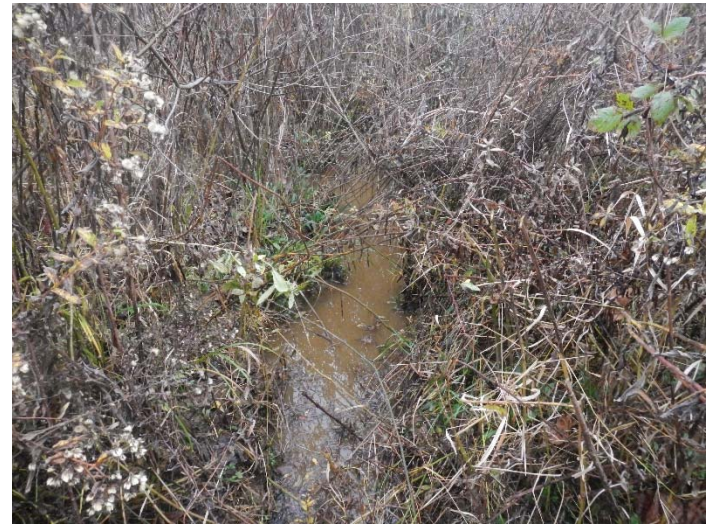
**UT1 Upstream Reach**

**Photo Point 1** – view upstream (11/06/17)

**Photo Point 1** – view downstream (11/06/17)

**Photo Point 2** – view upstream (11/06/17)

**Photo Point 2** – view downstream (11/06/17)

**Photo Point 3** – view upstream (11/06/17)

**Photo Point 3** – view downstream (11/06/17)

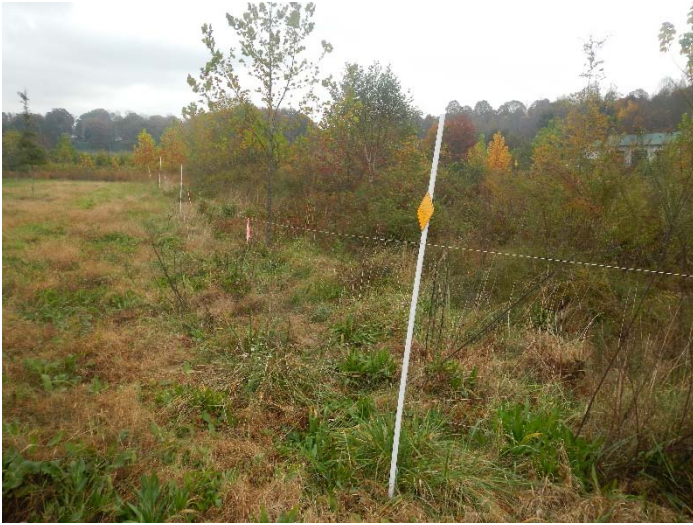
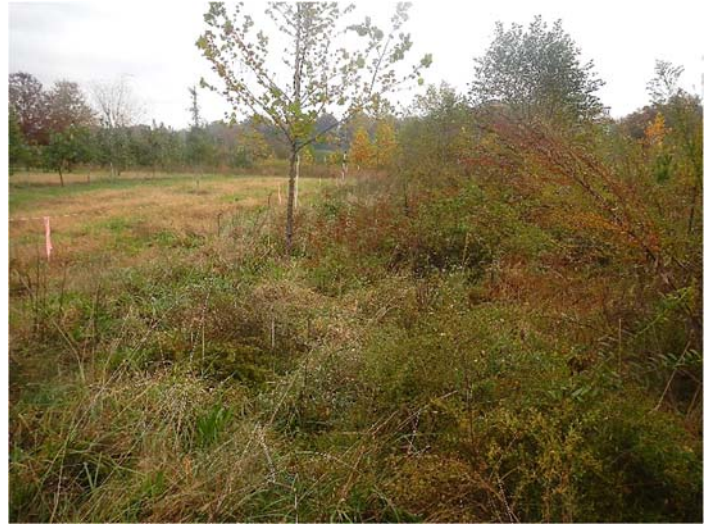
5. Wildlands added additional posts and signs to demarcate the easement boundary (Please refer to attached photographs. Additional plants were installed in 2016 to replace stem loss from encroachment. In addition, herbaceous vegetation and natural recruitment have flourished in MY6. These landowner encroachments have been resolved and are no longer an area of concern.

**Additional Easement Markers and Vegetation Re-established (11/06/17)**

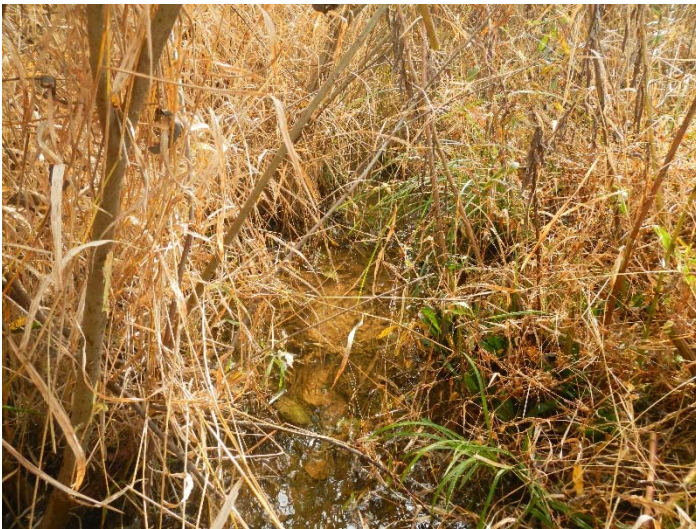
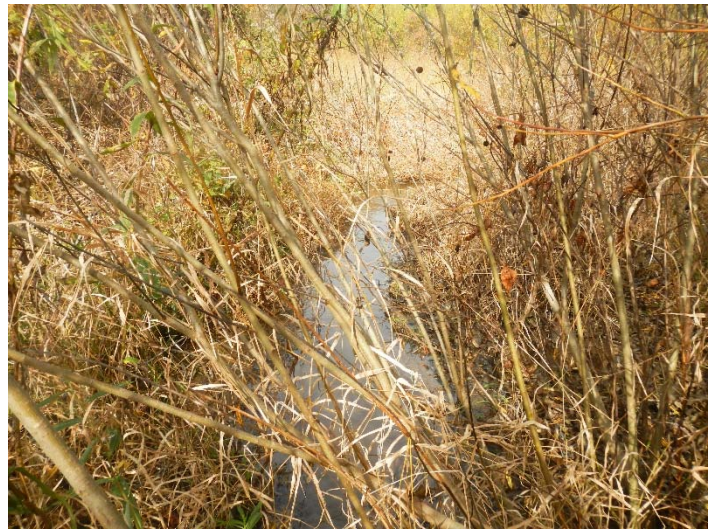
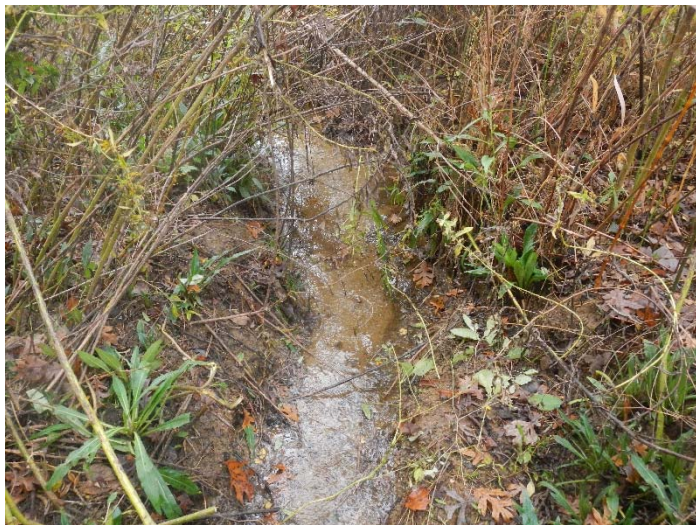
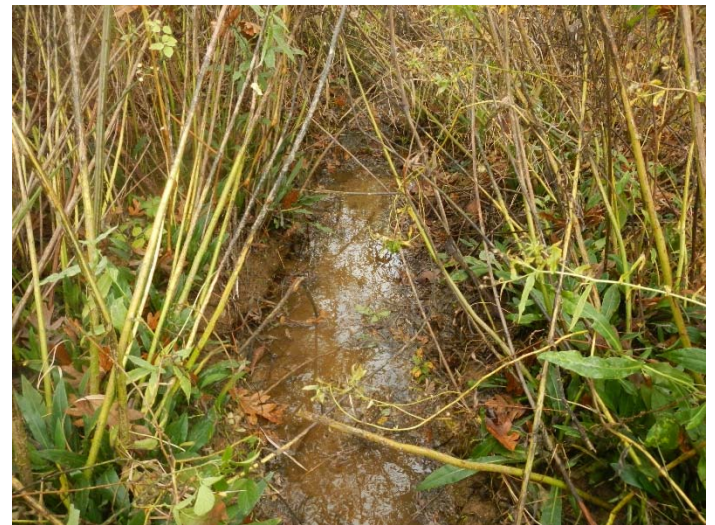
**UT1B Upstream Reach**

**Photo Point 25 – view upstream (11/06/17)**

**Photo Point 25 – view downstream (11/06/17)**

**UT1B – view upstream (11/06/17)**

**UT1B – view downstream (11/06/17)**
