MITIGATION PLAN

Lyon Hills Mitigation Site

Wilkes County, NC
NCDEQ Contract No. 7620
DMS ID No. 100085

Yadkin River Basin
HUC 03040101

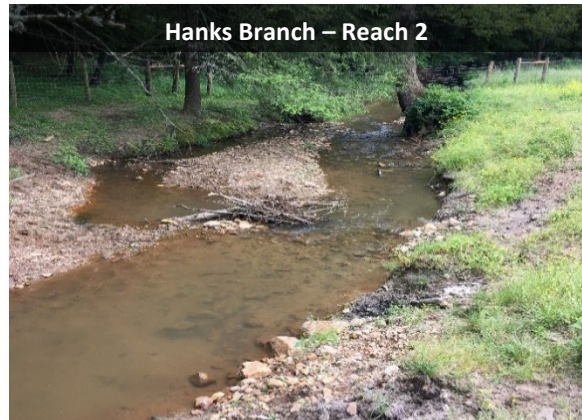
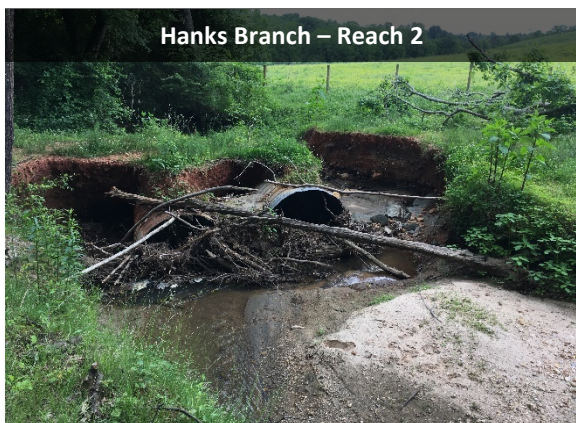
Hanks on the project site is generally vertically and laterally stable. Cattle routinely access Reaches 1 and 2 for water and shade. It does not appear that cattle access Reach 3 as much but Reach 3 is very incised (bank height ratio is 4.6). There are some isolated areas of lateral instability, primarily on Reach 2. The culvert on Reach 2 was destroyed during the storms of Fall 2018. Bank erosion in the vicinity of the culvert became significantly worse during this period. Reach 3 of Hanks Branch is very deep (over 5.5 feet) and narrow (bankfull width is 13.0 feet) and appears to have been channelized. The wooded buffer along much of the right bank of Hanks Branch has been removed or is now very narrow (20 to 25 feet wide). The buffer along the left bank of Reaches 1 and 2 is intact, extending 300 or more feet. The buffer along the left bank of Reach 3 is very narrow.

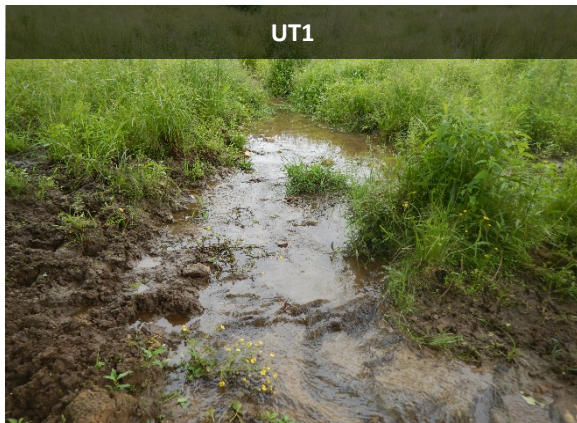
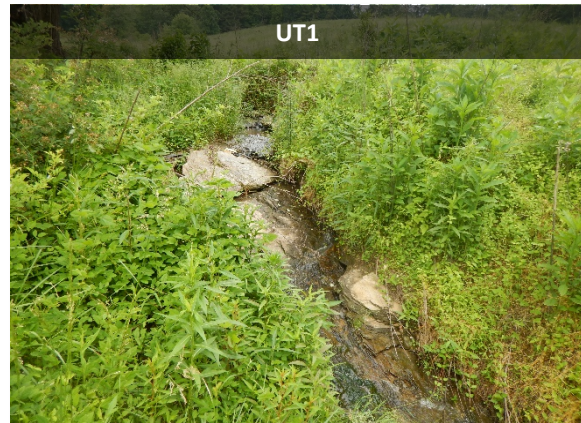
UT1 is a small stream with severe impacts and erosion related to cattle trampling. In some sections the channel has been nearly destroyed by trampling. There is a bedrock slide that provides grade control near the midpoint along the length of the stream. There are pockets of wetlands in the floodplain of this stream. The buffer zone along this stream is mostly devoid of trees.

Reach Summary Information	
Parameters	UT1
Length of Reach (Linear Feet)	930
Valley confinement (Confined, moderately confined, unconfined)	Unconfined
Drainage area (acres)	37.5
Perennial, Intermittent, Ephemeral	Perennial
NCDWR Water Quality Classification	C
Stream Classification (Existing and Proposed)	B4/B4
Evolutionary Trend	I
FEMA zone Classification	X

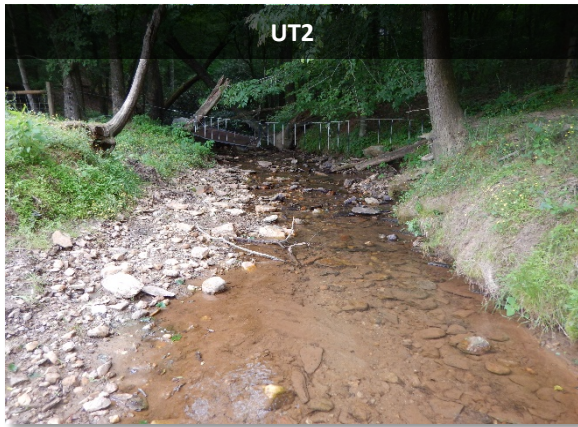
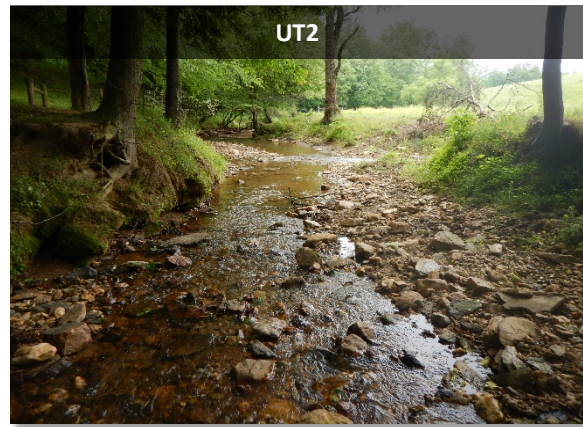
There is only a short section of UT2 on the property that will be included in the project. Cattle have access to this reach, but the damage thus far has not been significant. This stream is buffered by a mature canopy extending the length of the watershed.

Reach Summary Information	
Parameters	UT1
Length of Reach (Linear Feet)	78
Valley confinement (Confined, moderately confined, unconfined)	Unconfined
Drainage area (acres)	231.3
Perennial, Intermittent, Ephemeral	Perennial
NCDWR Water Quality Classification	C
Stream Classification (Existing and Proposed)	C4/C4
Evolutionary Trend	I
FEMA zone Classification	X

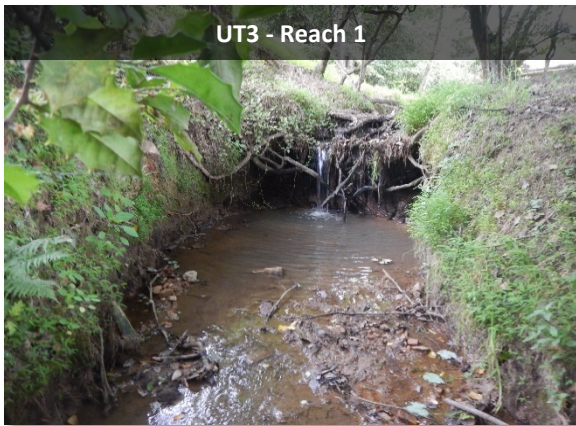
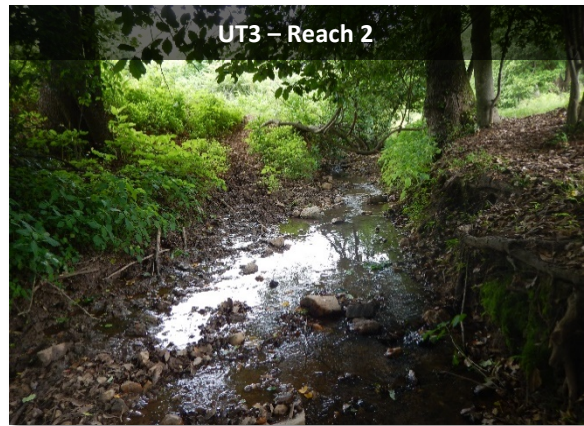
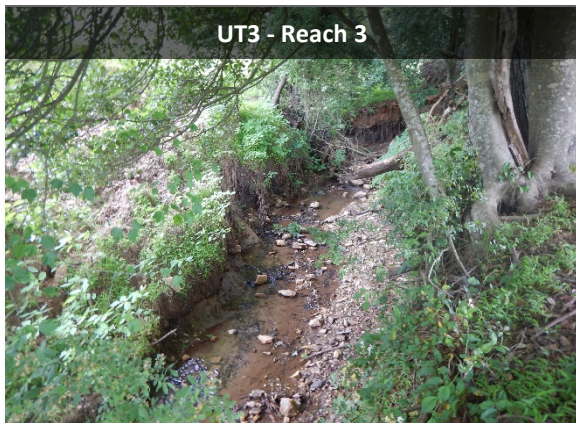
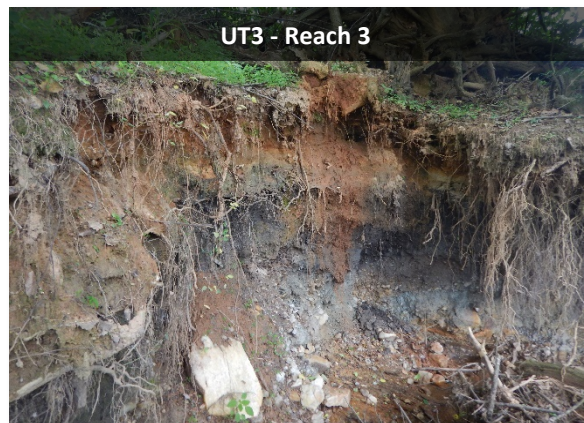
This stream begins on the project property. The watershed is almost entirely on the project property. Cattle have access to the stream and have caused significant damage. Reach 1 is not incised at the upstream end. However, a head cut exists near the downstream end of Reach 1 and below this point, the stream is very incised (bank height ratio is 2.7). Reach 2 also has a head cut. There is exposed bedrock in Reach 2 below the head cut which provides grade control. There is bank erosion and incision along the majority of this stream including some areas of severe erosion on reach 3. Reach 4 is on the Hanks Branch floodplain and has a flatter slope. Most of the damage on this stream is related to cattle access. The buffer zone ranges from a degraded canopy to open pasture.

Reach Summary Information				
Parameters	UT3 Reach 1	UT3 Reach 2	UT3 Reach 3	UT3 Reach 4
Length of Reach (Linear Feet)	702	447	691	272
Valley confinement (Confined, moderately confined, unconfined)	Confined	Confined	Confined	Unconfined
Drainage area (acres)	26.8	37.3	46	47.3
Perennial, Intermittent, Ephemeral	Perennial	Perennial	Perennial	Perennial
NCDWR Water Quality Classification	C	C	C	C
Stream Classification (Existing and Proposed)	B4/B4	B4/B4	B4/B4	B4/B4
Evolutionary Trend	IV	IV	IV	IV
FEMA zone Classification	X	X	X	X

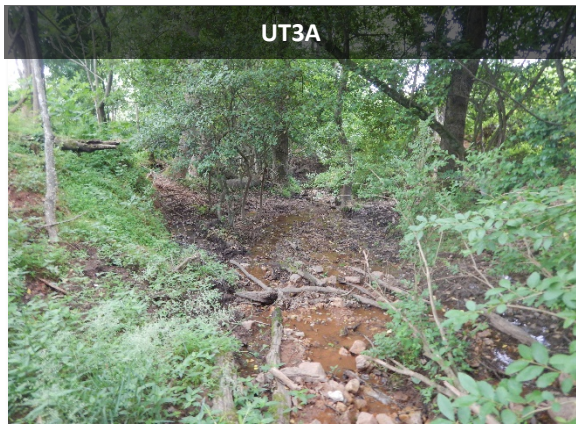
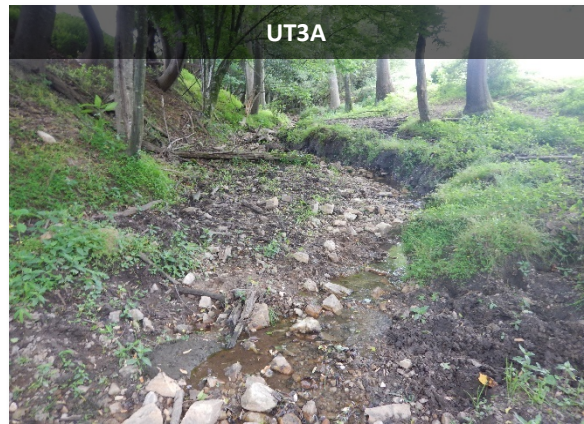
UT3a is a small stream in a deep confined valley. Cattle have access to this stream and have destroyed the stream banks through much of the reach. Large amounts of colluvium have eroded off the hillslopes due to cattle trampling and deposited in the stream. The buffer along this reach is sparse and narrow (approximately 25 feet wide).

Reach Summary Information	
Parameters	UT3a
Length of Reach (Linear Feet)	253
Valley confinement (Confined, moderately confined, unconfined)	Confined
Drainage area (acres)	4.9
Perennial, Intermittent, Ephemeral	Perennial
NCDWR Water Quality Classification	C
Stream Classification (Existing and Proposed)	B4/B4
Evolutionary Trend	IV
FEMA zone Classification	X

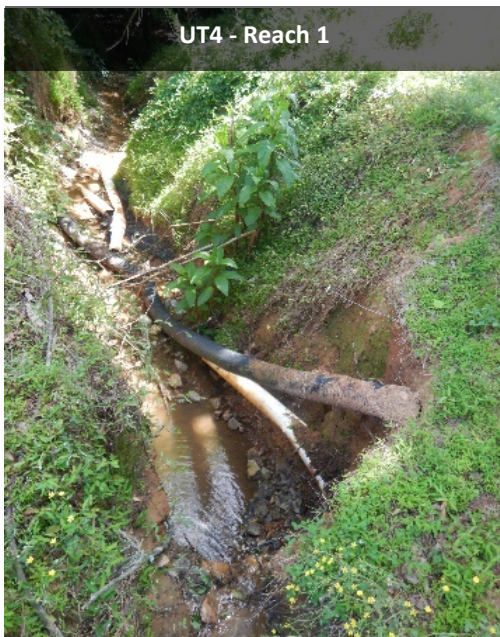
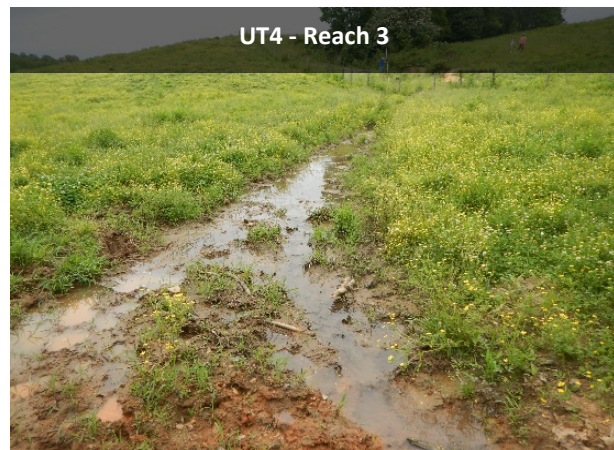
UT4 begins on the project property. The watershed is almost entirely on the project property. Most of UT4 is a steep stream (4.4% to 5.3% slope) in a deep, confined valley; however, the downstream end is flatter as it flows across the Hanks Branch floodplain. Cattle have access to this stream and have destroyed the stream banks and bed forms through much of the reach. There are exposed failed drainpipes along the reach. The buffer along most of this reach is sparse and narrow. The buffer is devoid of trees on the downstream end.

Reach Summary Information			
Parameters	UT4 Reach 1	UT4 Reach 2	UT4 Reach 3
Length of Reach (Linear Feet)	237	323	276
Valley confinement (Confined, moderately confined, unconfined)	Confined	Confined	Confined
Drainage area (acres)	7	10.5	12.3
Perennial, Intermittent, Ephemeral	Perennial	Perennial	Perennial
NCDWR Water Quality Classification	C	C	C
Stream Classification (Existing and Proposed)	B5/B5	B4/B4	B4/B4
Evolutionary Trend	IV	IV	IV
FEMA zone Classification	X	X	X

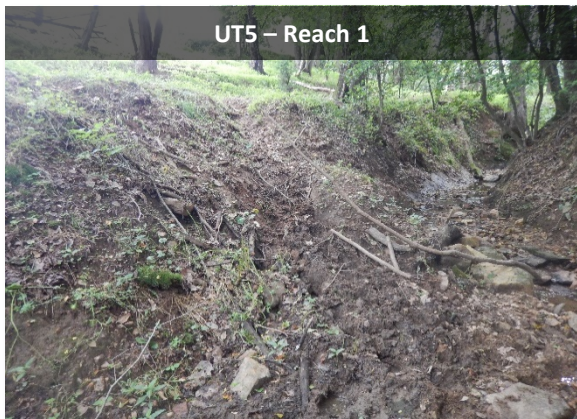
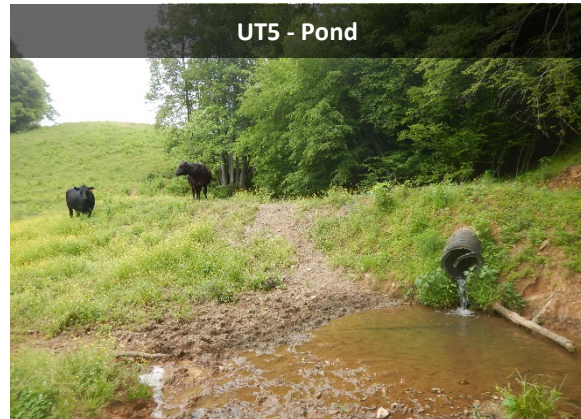
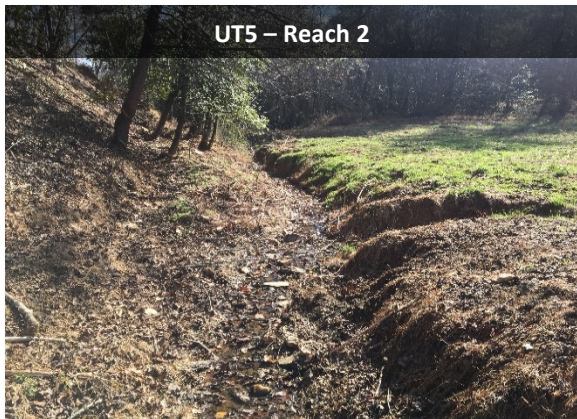
This stream originates on site and most of the watershed is on the property. Reach 1 of UT5 is a small, steep (channel slope of 8.2%) stream entrenched in a deep, confined valley. Reach 2 is less steep (2.5% slope) than Reach 1 and is not entrenched in a narrow valley but is up against a hill slope on the left side. The right floodplain is open and flat. Cattle have access to this stream and have destroyed the stream banks through much of the reach. There is a small pond at the upstream end of Reach 2 used by cattle for water. The buffer along Reach 1 is wooded and approximately 50 feet on both sides. The buffer along Reach 2 is mostly devoid of trees except for the upstream portion of the reach on the left side.

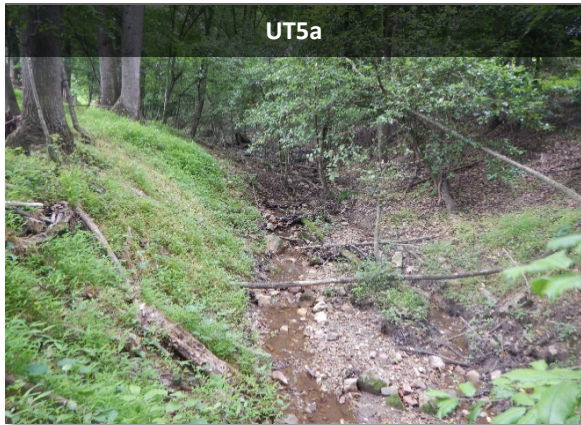
UT5a is a small, steep (9.4% slope) stream in a deep confined valley. Cattle have access to this stream and have destroyed the stream banks through much of the reach. The buffer along this reach is wooded and fairly wide (approximately 50 feet) on both sides.
