ANNUAL REPORT FOR 1998

Mallard Creek Mitigation Site
Mecklenburg County
Project # 8.U670123
TIP # R-211

Prepared By:
Natural Systems Unit
Planning and Environmental Branch
North Carolina Department of Transportation
December 1998

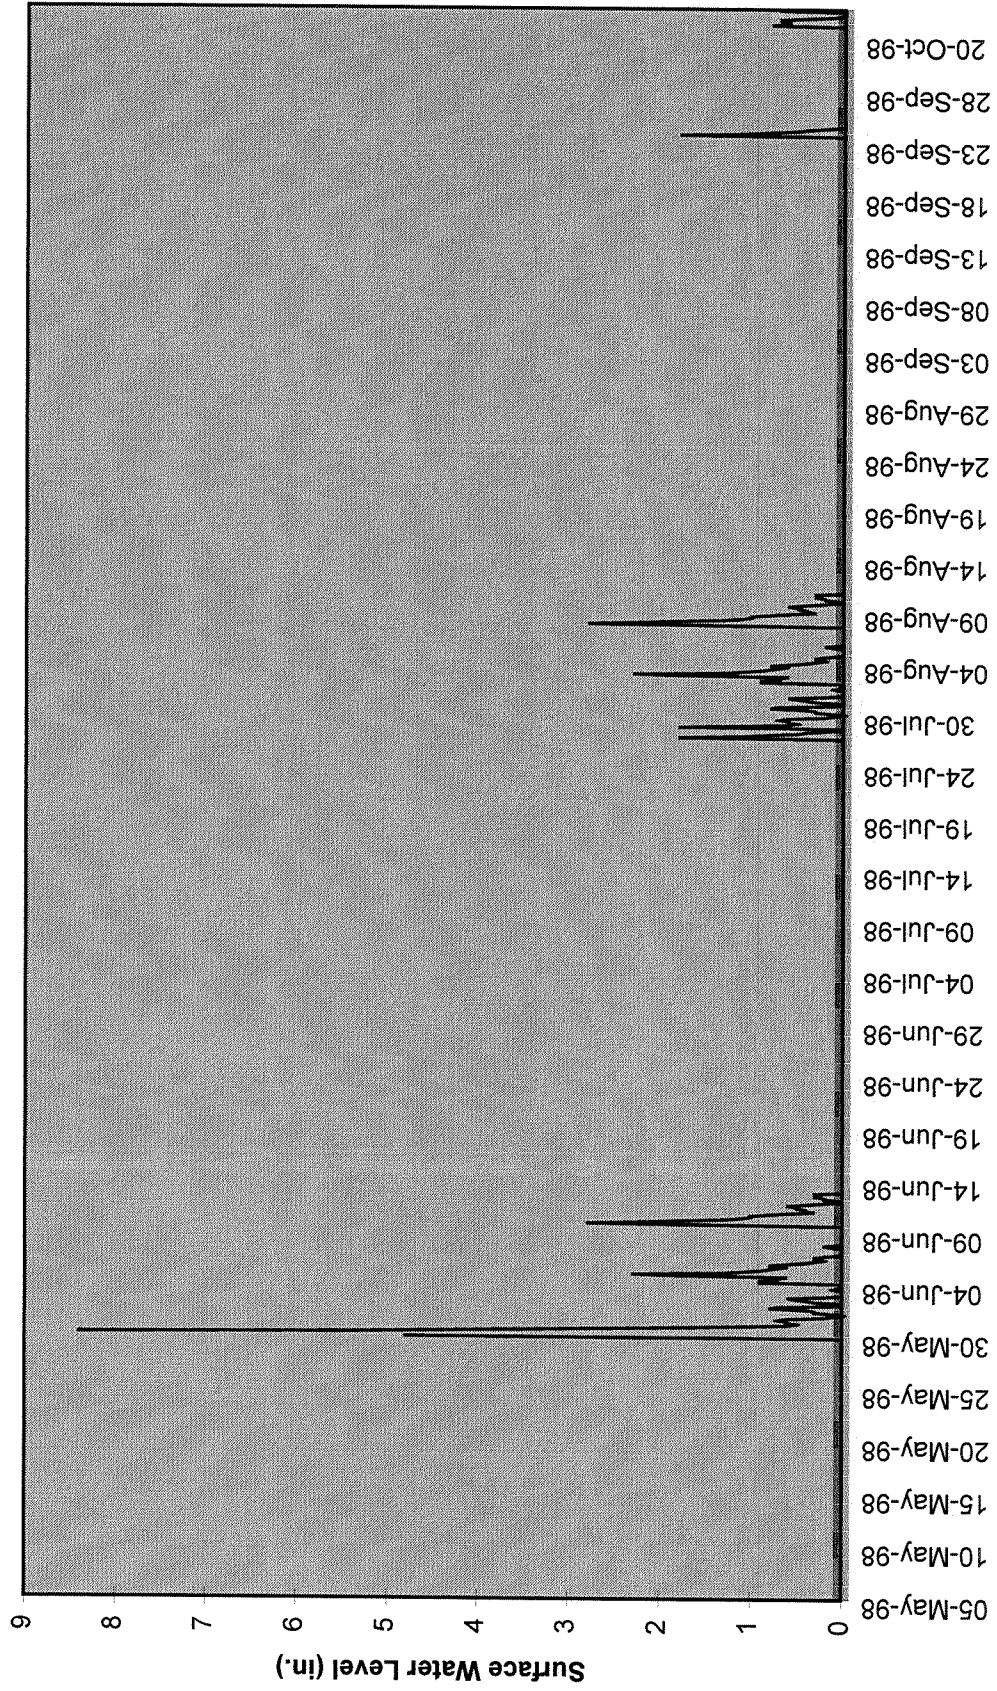
Mallard Creek Surface Gauge

The surface gauge on site has registered no appreciable surface water throughout most of the growing season.
