ANNUAL REPORT FOR 2001

Mallard Creek Mitigation Site
Mecklenburg County
Project No. 8.1999974 (M-316)
TIP No. R-211 WM

Natural Systems Unit & Roadside Environmental Unit
North Carolina Department of Transportation
December 2001

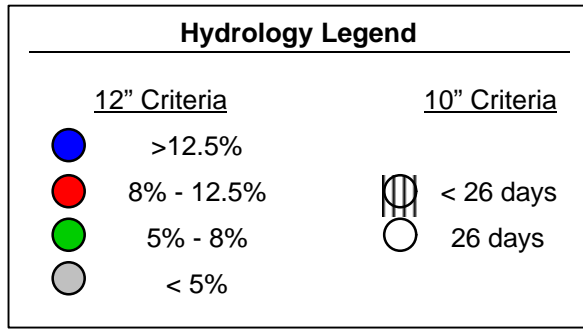
Figure 3. Hydrologic Monitoring Results

Figure 3 is a graphical representation of the hydrologic monitoring results.

Site 1 hydrologic data indicates that the site meets the hydrologic success criteria established by the USACE permit and the Federal guidelines. The site was saturated or inundated for more than 26 consecutive days within 10" of the ground and 12.5% of the growing season within 12" of the ground. All three gauges showed saturation multiple times throughout the growing season. The surface gauge located on Site 1 showed consistent inundation throughout the growing season. A leak in a 12" water main adjacent to this site affected the hydrology at this location prior to 2001; however, the leak was repaired 4 months prior to the growing season.

Site 2 hydrologic data indicates that four of six gauges met the hydrologic success criteria established by the permit for the site and none of the gauges met the Federal guidelines for success. Gauges 5, 6, 7, and 9 showed saturation or inundation greater than 8% of the growing season within 12" of the ground. Gauges 4 and 8 showed saturation for between 5 and 8% of the growing season within 12" of the ground.

Gauge 12 showed saturation for less than 5% of the growing season. The data for Site 2 still indicates that the groundwater levels drop quickly after rainfall.

Wetland hydrology was not observed in the six groundwater gauges for Site 2. The site experienced below average rainfall for 2001. In the future, the site will receive increased hydrology from the widening of Mallard Creek Church Road (U-2508C, let to construction on November 20, 2001). NCDOT recommends the continued monitoring of the two sites.
