ANNUAL REPORT FOR 2003

Mallard Creek Mitigation Site
Mecklenburg County
Project No. 8.U670123
TIP No. R-211 WM

Office of Natural Environment & Roadside Environmental Unit
North Carolina Department of Transportation
December 2003

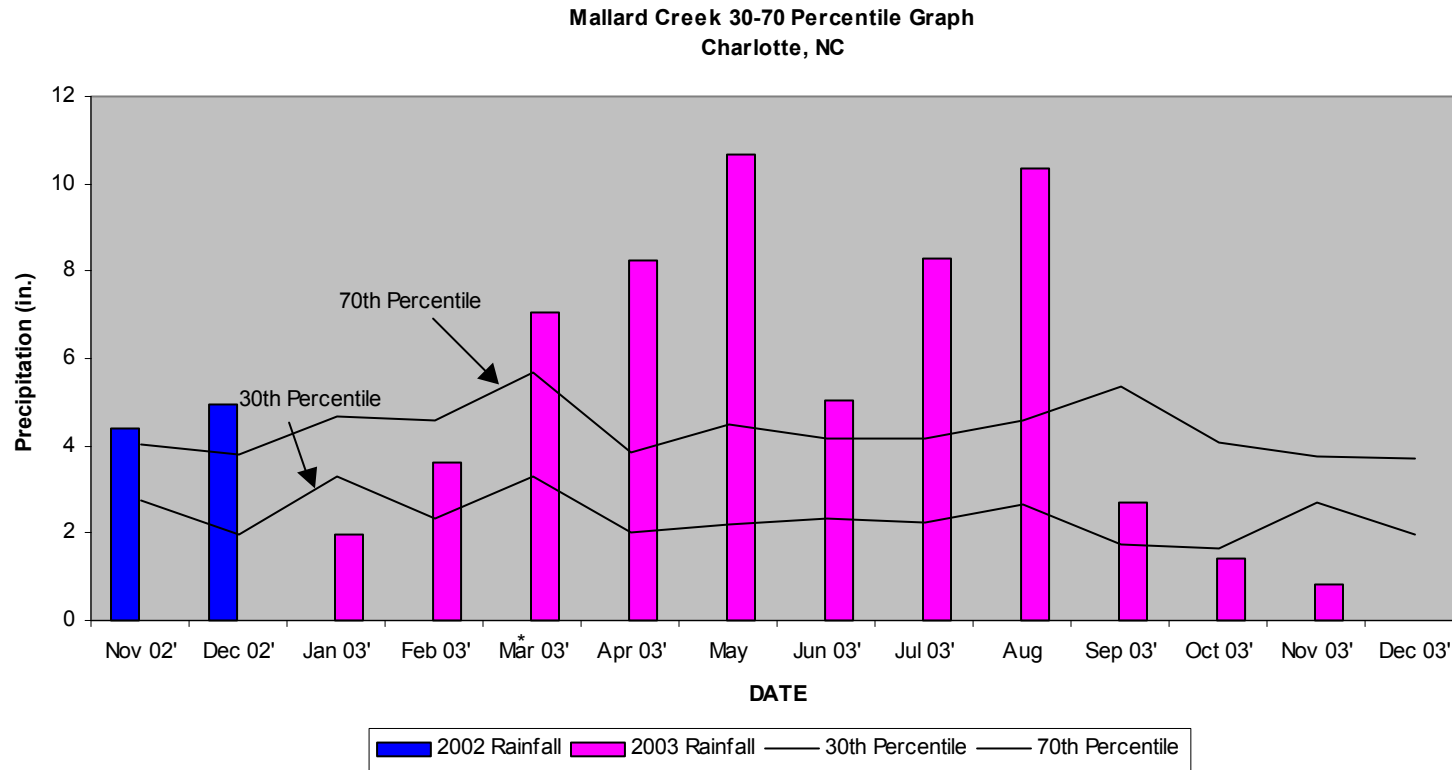
Figure 4. 30-70 Percentile Graph

Figure 4 is a comparison of 2002 and 2003 monthly rainfall to historical precipitation for the area. This comparison indicates whether 2003 was “average” in terms of climate conditions by comparing the rainfall to that of historical rainfall (data collected between 1972 and 2003). The NC State Climate Office provided all of the historical data.

For the 2003-year, November (02’), December (02’), March, April, May, June, July, and August experienced above average rainfall. The months of January, October, and November recorded below average rainfall for the site. February and September experienced average rainfall. Overall, 2003 experienced an average to above average rainfall year.
