ANNUAL REPORT FOR 2004

Mallard Creek Mitigation Site
Mecklenburg County
Project No. 8.U670123
TIP No. R-211 WM

Office of Natural Environment & Roadside Environmental Unit
North Carolina Department of Transportation
December 2004

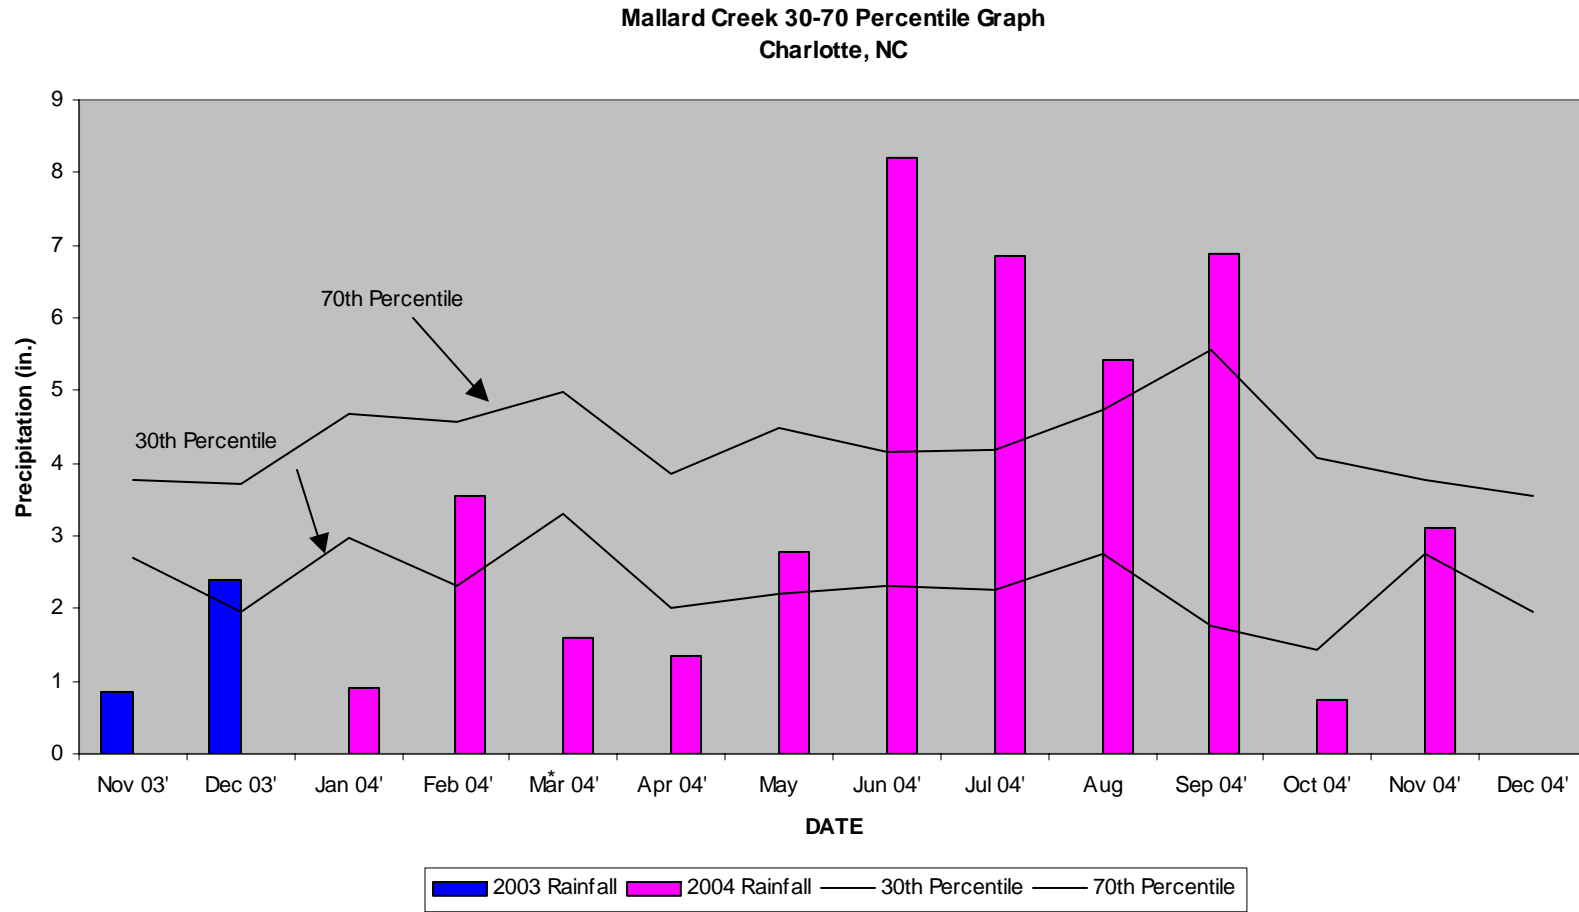
Figure 4. 30-70 Percentile Graph

Figure 4 is a comparison of 2003 and 2004 monthly rainfall to historical precipitation for the area. This comparison indicates whether 2004 was “average” in terms of climate conditions by comparing the rainfall to that of historical rainfall (data collected between 1973 and 2004). The NC State Climate Office provided all historical data.

For the 2004-year June, July, August and September experienced above average rainfall. The months of November (03’), January, March, April, and October recorded below average rainfall for the site. December (03’), February, May, and November experienced average rainfall. Overall, 2004 experienced an average to above average rainfall year.
