Year 8 Monitoring Report

Mallard Creek Wetland Mitigation

February 2006

S&EC Project No. 9441.D1

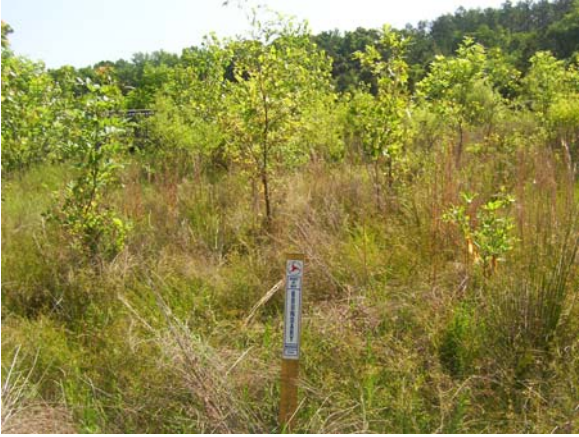
Plot Location		
Plot ID	Species	Stem #
1	Green Ash	11
1	Black Gum	7
1	Overcup Oak	2
1	Water Oak	0
1	Green Ash - recruit	19
1	Black Gum - recruit	7
1	Overcup Oak - recruit	1

Year 8 - Vegetation Plot 1 – 5/27/2005

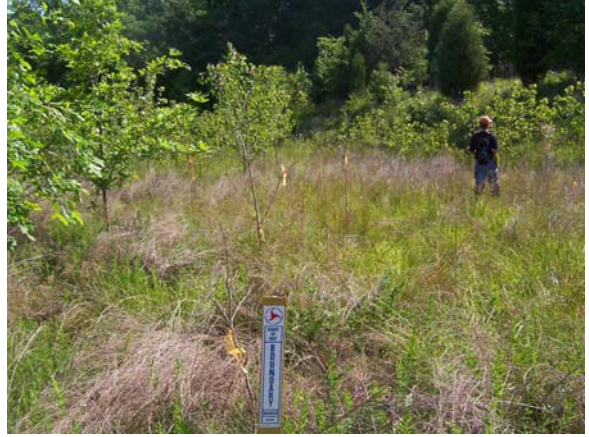
Plot Location		
Plot ID	Species	Stem #
2	Green Ash	9
2	Black Gum	3
2	Overcup Oak	12
2	Water Oak	1
2	Green Ash - recruit	5
2	Black Gum - recruit	3
2	Overcup Oak - recruit	0

Year 8 – Vegetation Plot 2 – 5/27/2005

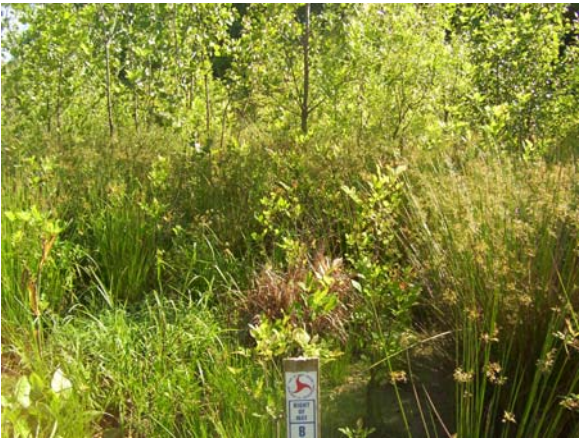
Plot Location		
Plot ID	Species	Stem #
3	Green Ash	12
3	Black Gum	7
3	Overcup Oak	7
3	Water Oak	0
3	Green Ash - recruit	29
3	Black Gum - recruit	4
3	Overcup Oak - recruit	0

Year 8 – Vegetation Plot 3 – 5/27/2005

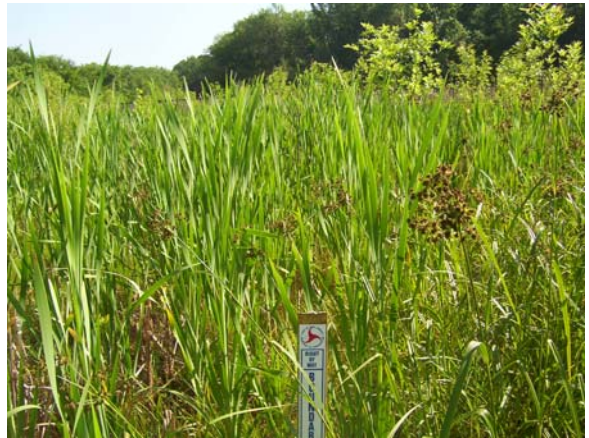
Plot Location		
Plot ID	Species	Stem #
4	Green Ash	7
4	Black Gum	0
4	Overcup Oak	3
4	Water Oak	2
4	Green Ash - recruit	5
4	Black Gum - recruit	0
4	Overcup Oak - recruit	0

Year 8 – Vegetation Plot 4 – 5/27/2005

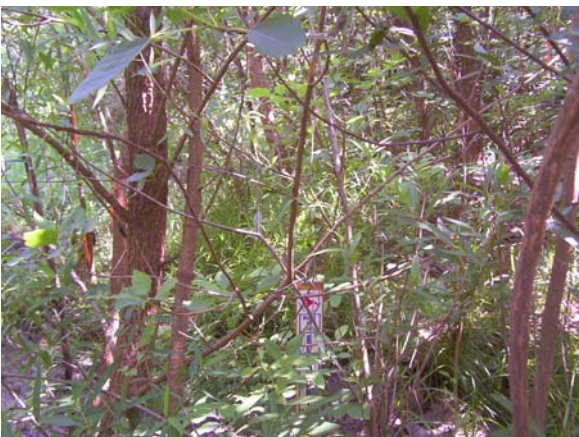
Plot Location		
Plot ID	Species	Stem #
5	Green Ash	18
5	Black Gum	0
5	Overcup Oak	1
5	Water Oak	1
5	Green Ash - recruit	109
5	Black Gum - recruit	27
5	Overcup Oak - recruit	0

Year 8 – Vegetation Plot 5 – 5/27/2005

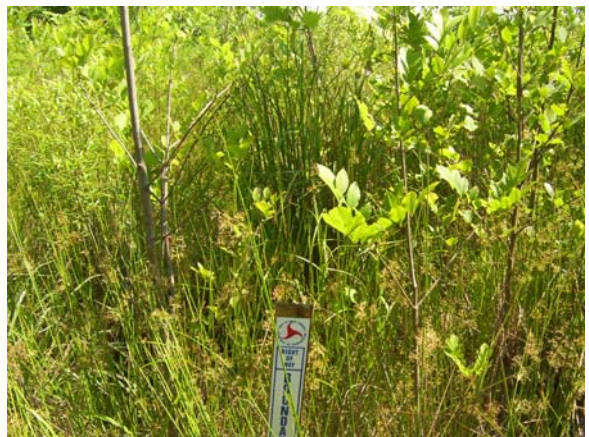
Plot Location		
Plot ID	Species	Stem #
6	Green Ash	18 (77)
6	Black Gum	2
6	Overcup Oak	0
6	Water Oak	0
6	Green Ash - recruit	84
6	Black Gum - recruit	0
6	Overcup Oak - recruit	0

Year 8 – Vegetation Plot 6 – 5/27/2005
