Mitigation Plan Draft

Maney Farm Mitigation Project

Chatham County, NC
DENR Contract No. 005793
DMS ID No. 96314

Cape Fear River Basin
HUC 03030002

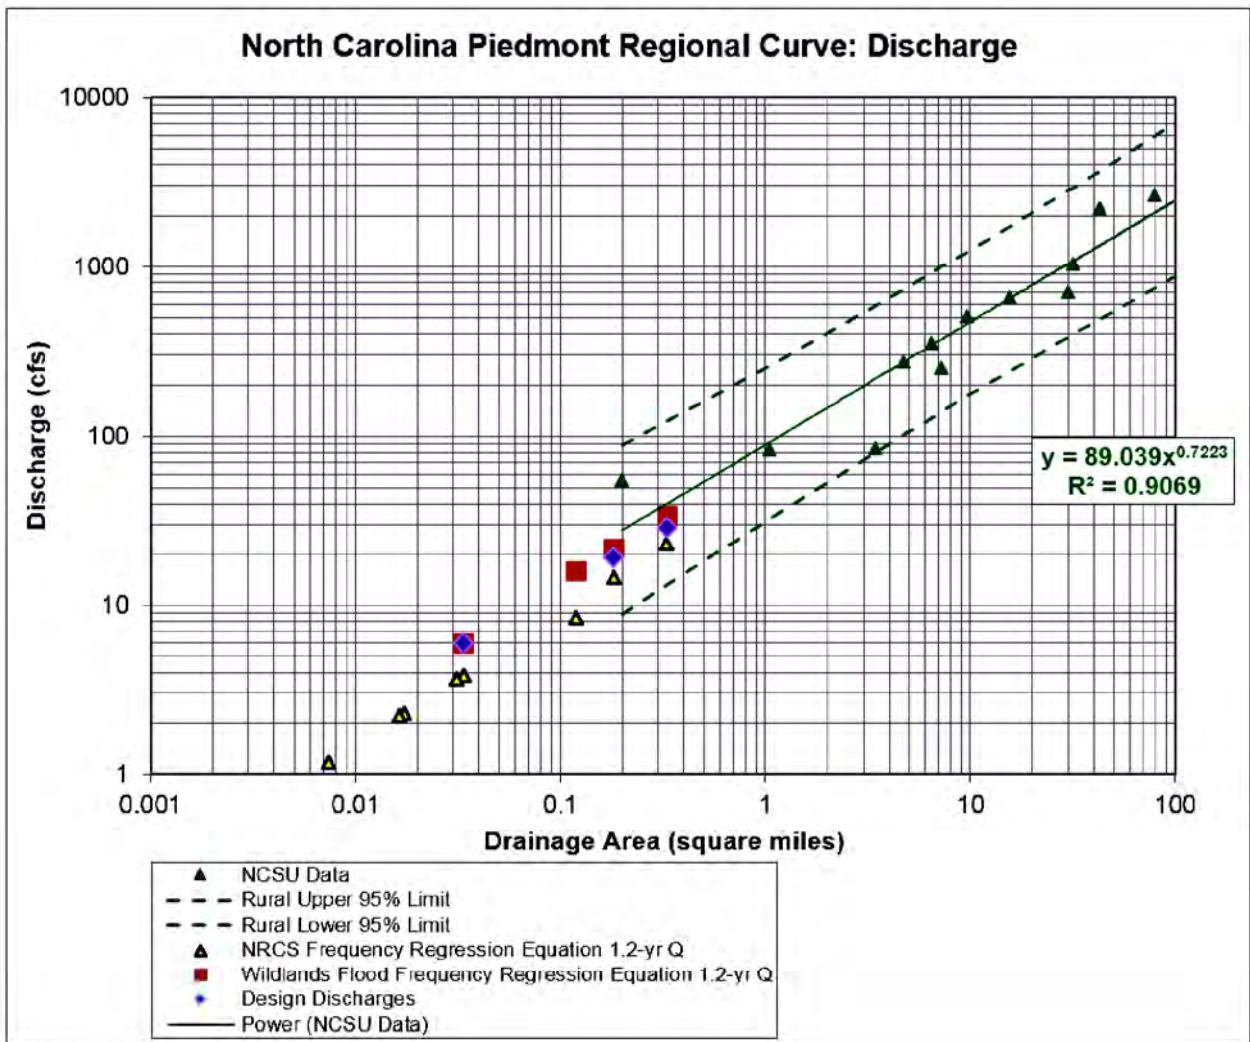
Figure 10: NC Piedmont Regional Curves with Project Data Overlay
 Maney Farm Stream Mitigation Site
 Cape Fear River Basin 03030002

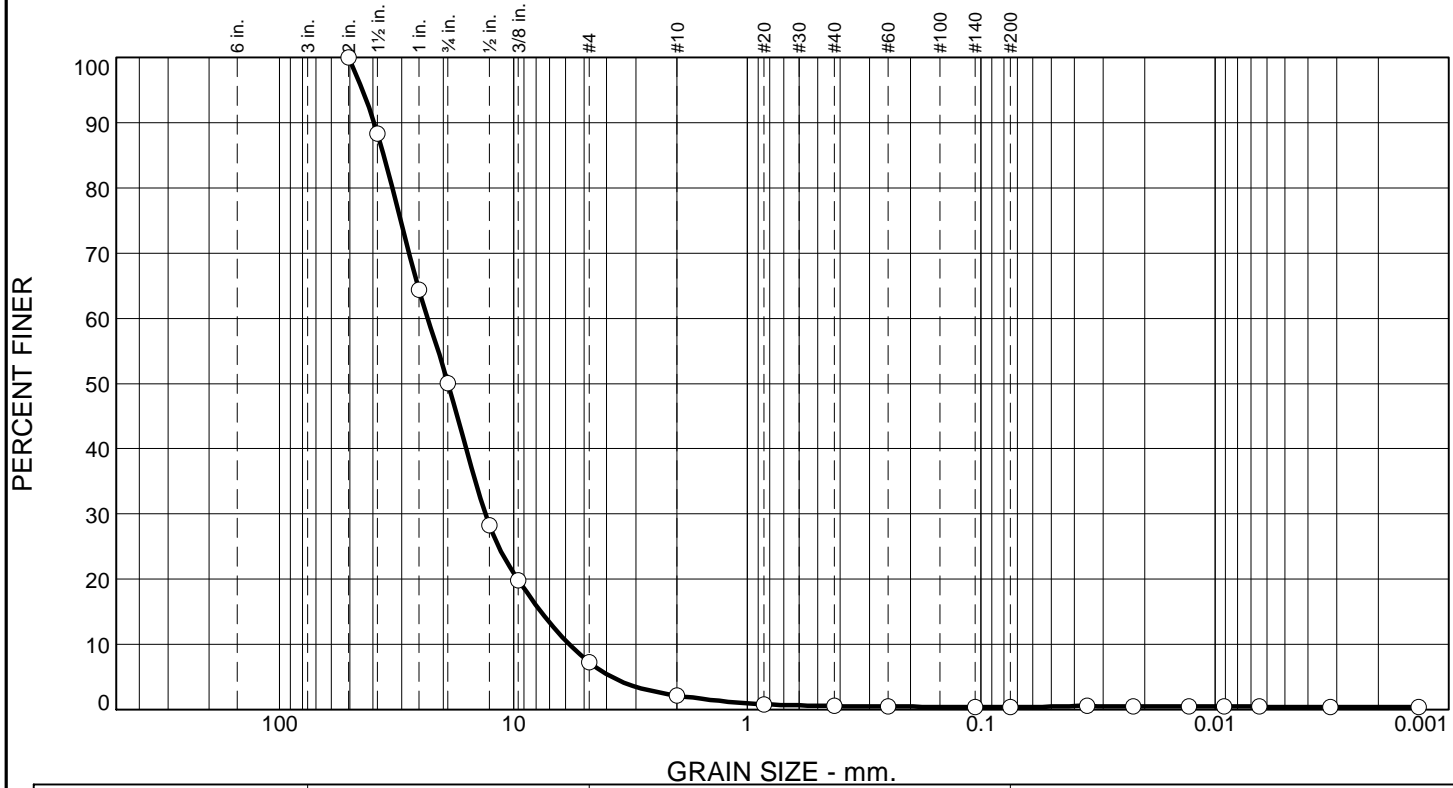
Particle Size Distribution Report

%	+3"	% Gravel		% Sand			% Fines			
		Coarse	Fine	Coarse	Medium	Fine	Silt	Clay		
○	0.0	49.9	42.9	5.0	1.7	0.2	0.3			
⊗	LL	PL	D ₈₅	D ₆₀	D ₅₀	D ₃₀	D ₁₅	D ₁₀	C _c	C _u
○			35.8191	23.3347	19.0257	13.2068	7.6002	5.7722	1.29	4.04

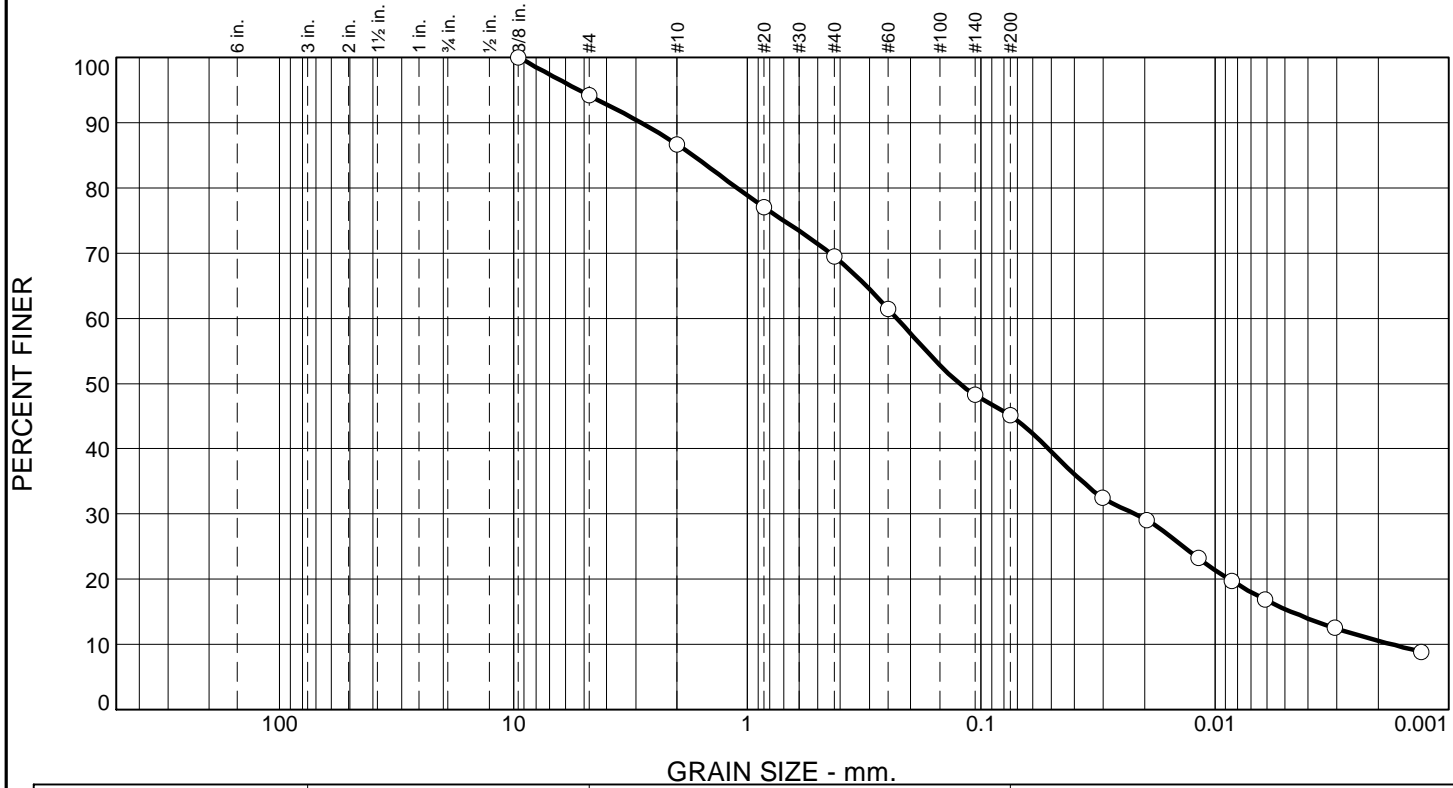
Particle Size Distribution Report

% +3"		% Gravel		% Sand			% Fines			
		Coarse	Fine	Coarse	Medium	Fine	Silt	Clay		
<input type="radio"/>	0.0	0.0	5.8	7.5	17.2	24.4	29.7	15.4		
<input type="checkbox"/>										
<input type="checkbox"/>										
<input checked="" type="checkbox"/>	LL	PL	D ₈₅	D ₆₀	D ₅₀	D ₃₀	D ₁₅	D ₁₀	C _c	C _u
<input type="radio"/>			1.7066	0.2291	0.1231	0.0220	0.0047	0.0017	1.21	130.96
<input type="checkbox"/>										
<input type="checkbox"/>

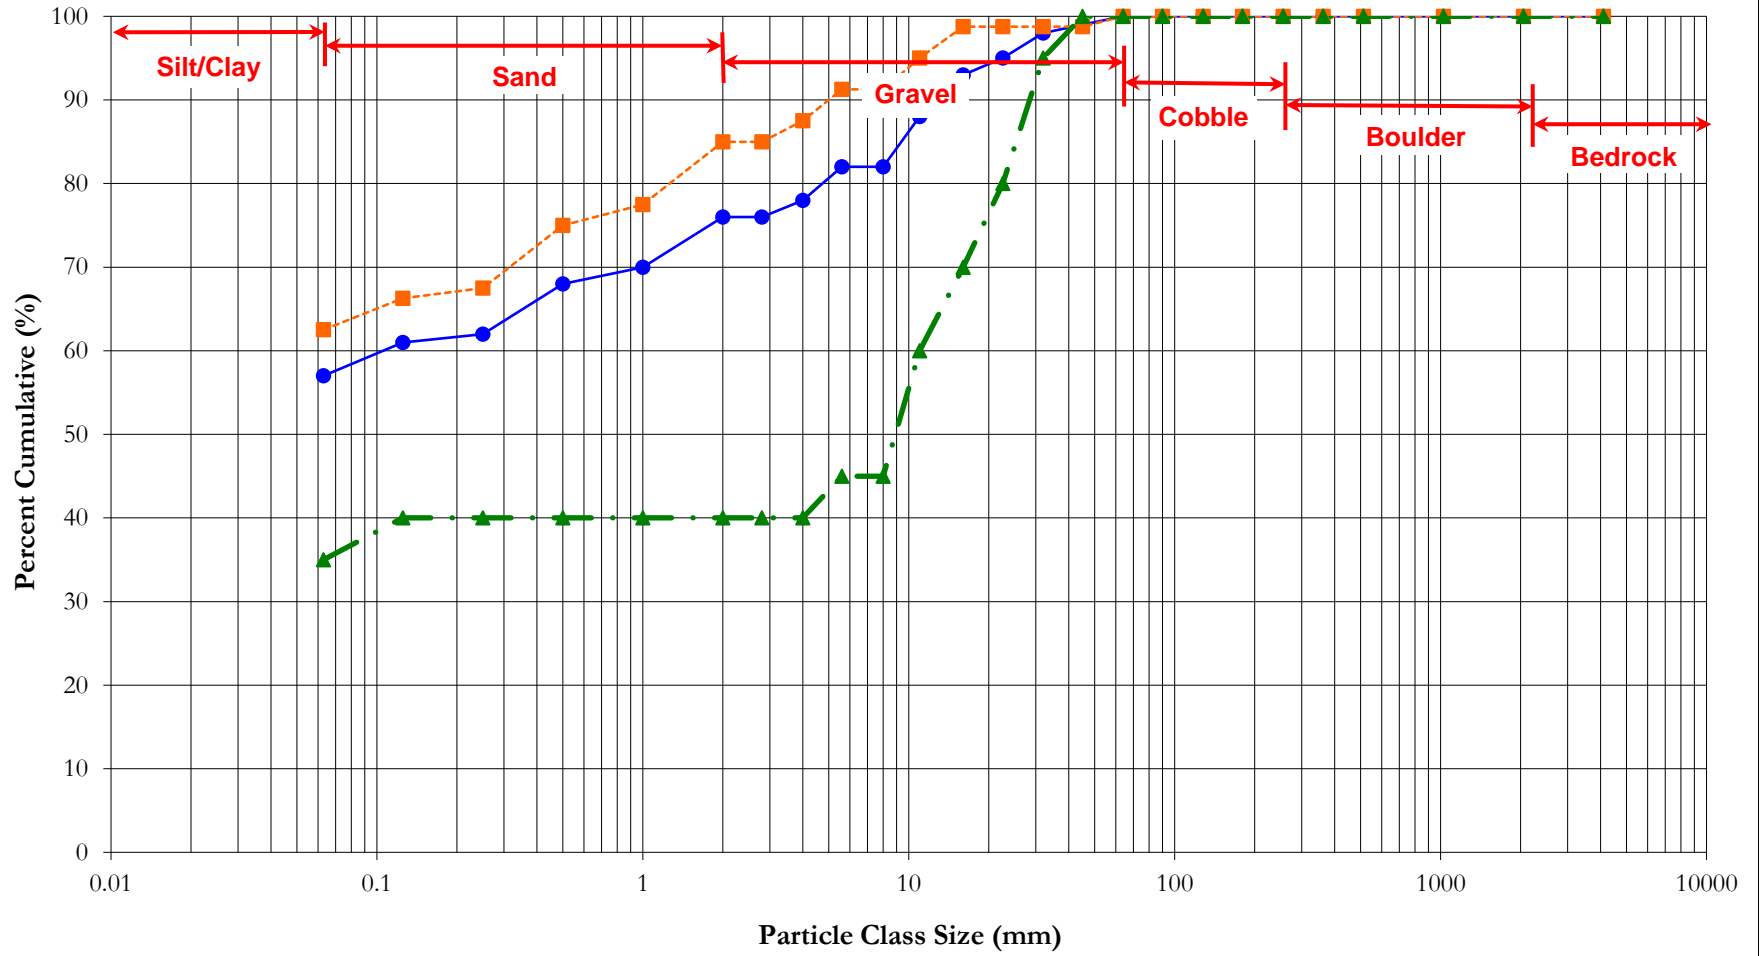
UT5

Reach-Wide Pebble Count Particle Distribution

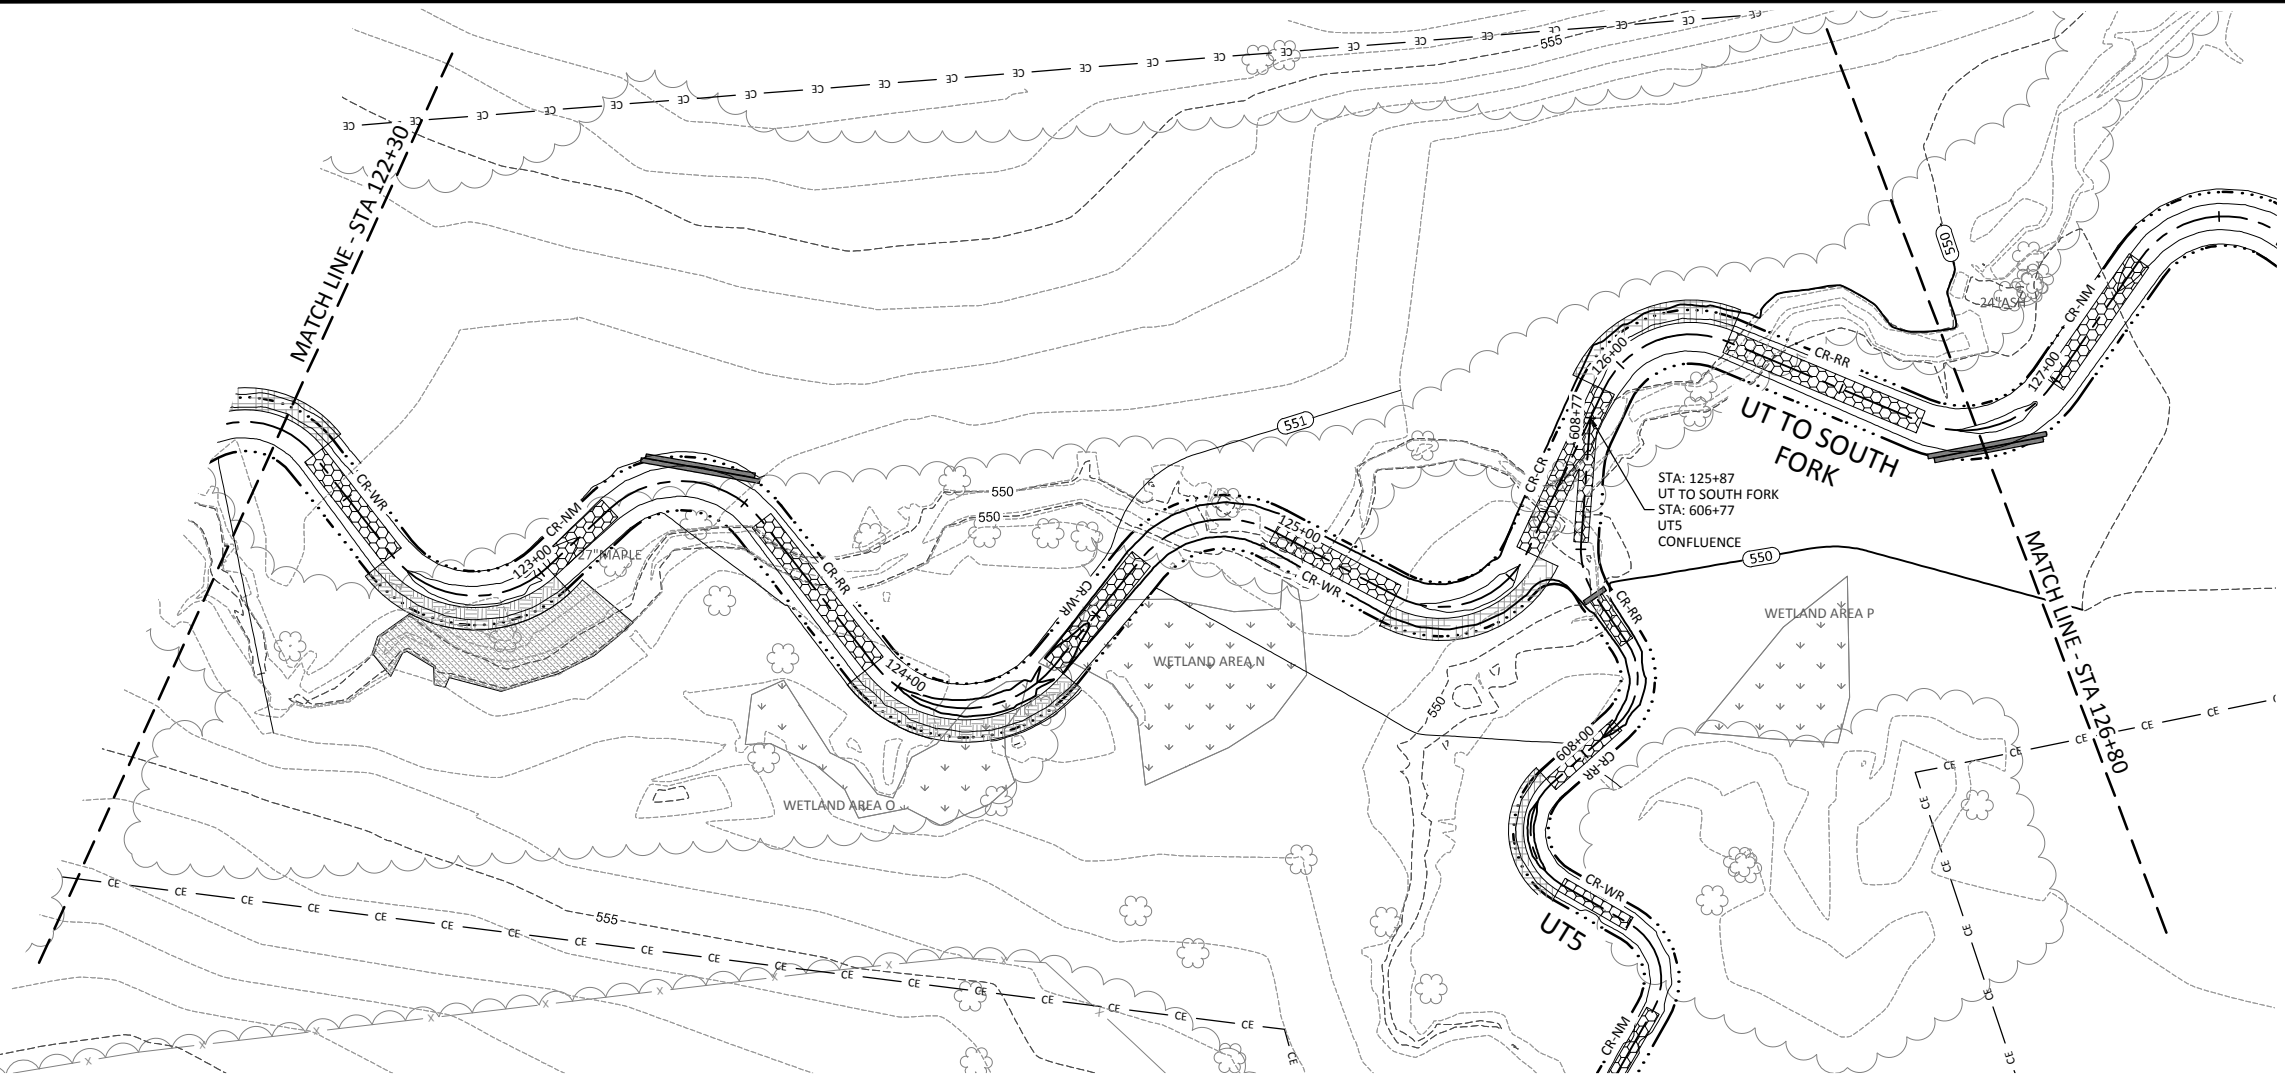
Maney Farm Stream Mitigation Site
 Chatham County, North Carolina
 UTSF Reach 2
 Stream Plan and Profile
