# MONITORING YEAR 2 ANNUAL REPORT

## Mangum Homestead Mitigation Site

Orange County, NC  
NCDEQ Contract No. 7859  
DMS ID No. 100107  
DWR No. 2019-0645

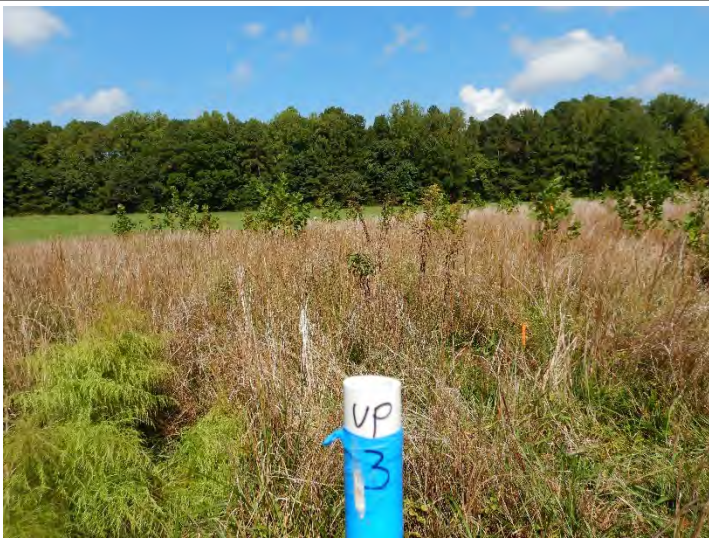
**VEG PLOT 3** (10/5/2021)

Vegetation plots 3 and 11 have stem densities of 202 stems per acre and therefore do not meet the final success criteria of 260 stems per acre. Baseline monitoring data showed approximately 31% of stems in vegetation plot 3 to be willow oak, each of which died. In vegetation plot 9, the planted stem count at baseline monitoring was 9, which is significantly lower than the approximate 15-17 typically seen at that time. It is believed that these factors have contributed to the failure of these plots to meet success criteria.

The cause of tree loss, particularly with willow oak stems, during monitoring year 2 is currently under evaluation. Soil tests will be performed to help inform any remedial actions that will be taken. Ring sprays were conducted shortly after planting in May 2020 to reduce competition that could hinder growth of planted stems. Furthermore, competition does not appear to be a primary cause of tree mortality.
