# MONITORING YEAR 4 ANNUAL REPORT

## Mangum Homestead Mitigation Site

Orange County, NC  
NCDEQ Contract No. 7859  
DMS ID No. 100107  
DWR No. 2019-0645

Data Collection Period: September 2023  
Draft Submission Date: October 25, 2023  
Final Submission Date: December 5, 2023

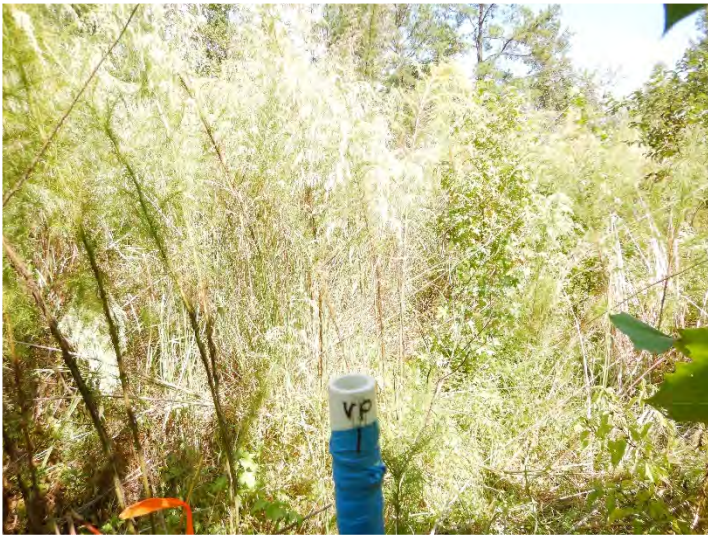
**VEG PLOT 1 (10/4/2023)**

Vegetation plots 1 and 2 have 30 or more sweetgum (*Liquidambar styraciflua*) stems. Most of these stems are under 100 centimeters in height and do not appear to be negatively affecting planted stems; however, the plot will be monitored in future years to ensure that volunteer stems do not begin to out-compete planted stems.
