**“Manning Farm Property”  
Buffer Restoration Project**

**Edgecombe County, NC  
Tar-Pamlico River Basin  
(Cataloging Unit #03020103)**

**2006 Annual Monitoring Report (Year 1 of 5)  
(Task 7)**

**NC EEP Contract #D05026**

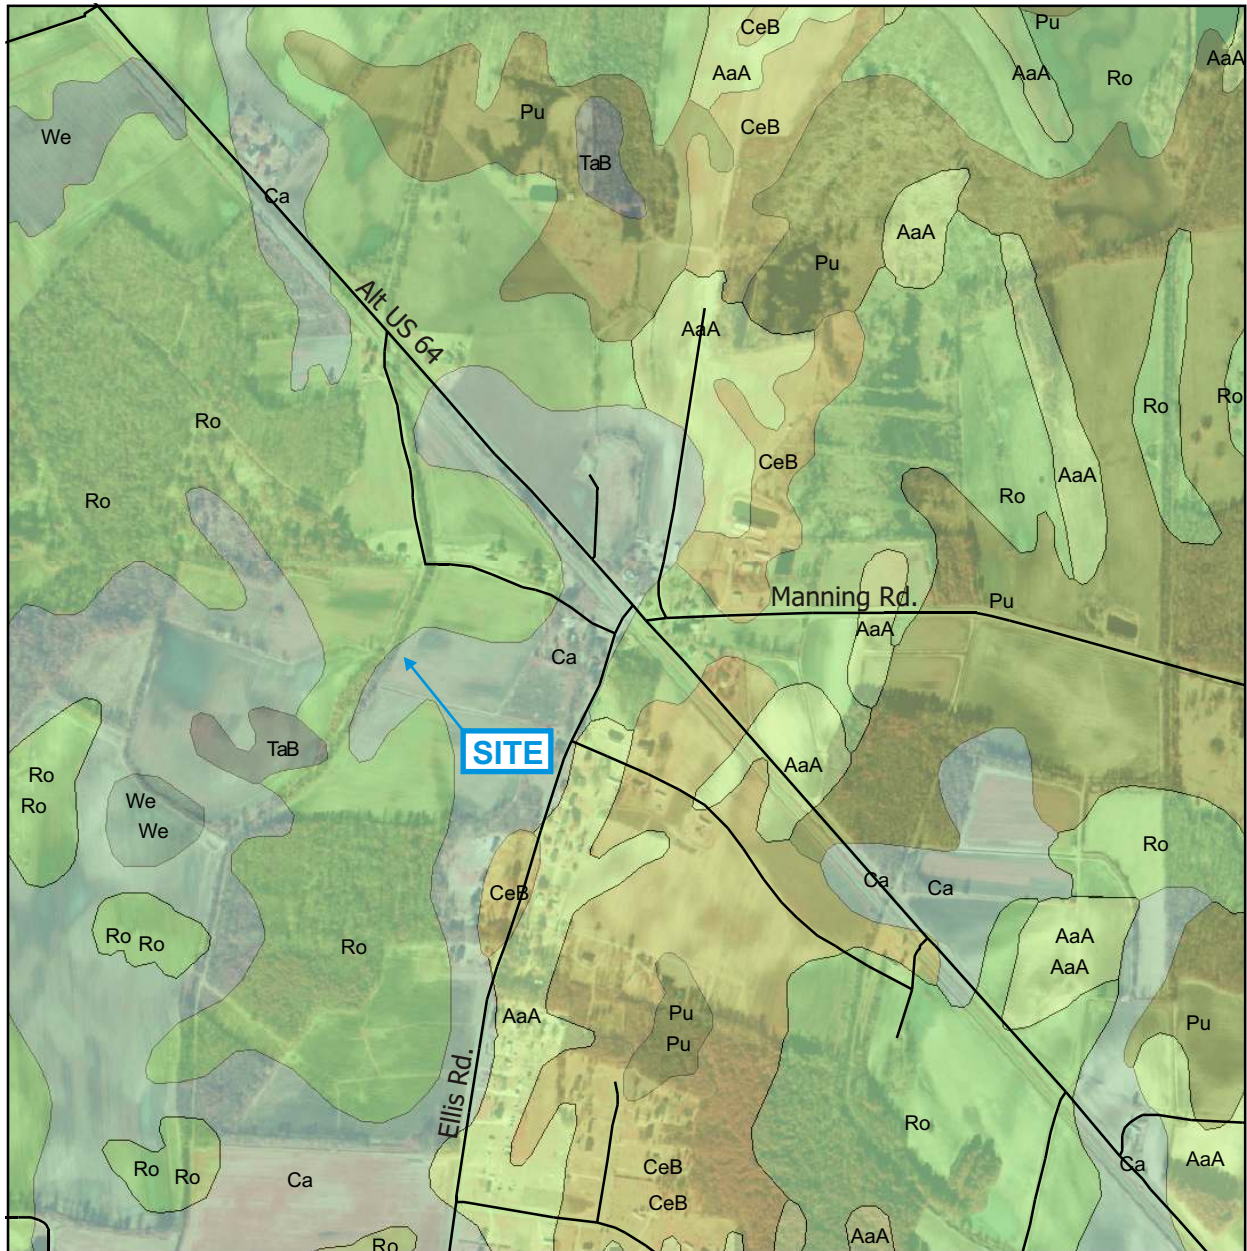
**Figure 3.**  
Generalized Soil Map  
Edgecombe County, NC

The site consists predominantly of Cape Fear loam, a very poorly drained soil occurring along stream terraces and depressional drainageways. Infiltration is slow and surface runoff is slow in these areas. The seasonal high water table occurs at or near the soil surface, assuming no ditching in the vicinity. The remaining portion of the buffer area consists of Roanoke loam – a poorly drained soil characteristic of broader flats of stream terraces. Roanoke soils exhibit slow infiltration with a seasonal high water table occurring at or near the soil surface (Figure 3).

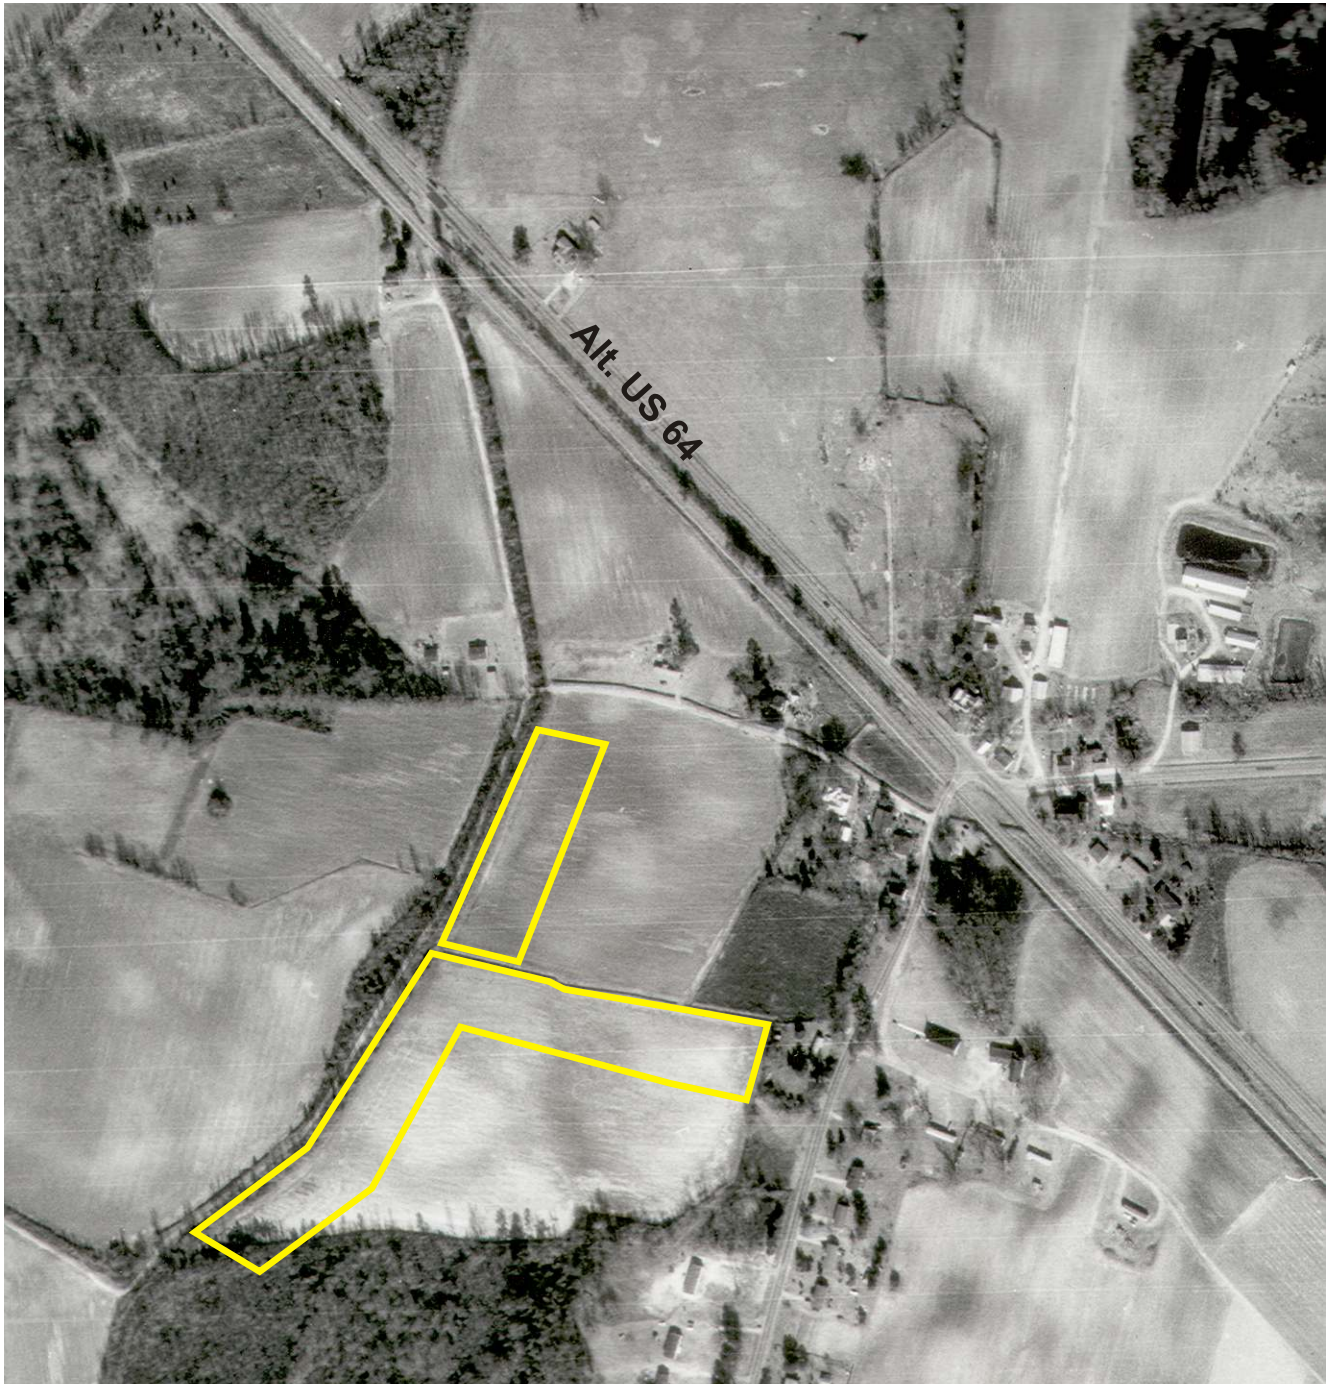
**Figure 4.**  
Buffer Planting Overview

The restoration project included the planting of characteristic tree and shrub seedlings adjacent to open ditches and blue-line streams on the 10.0-ac restoration site (refer to Figure 4). No federal or state permits were necessary to conduct the restoration activities. The riparian buffer was planted with characteristic tree species including river birch (*Betula nigra*), sycamore (*Platanus occidentalis*), water oak (*Quercus nigra*), overcup oak (*Quercus lyrata*), tulip poplar

200' Buffer Planting Area (10.0 acres)

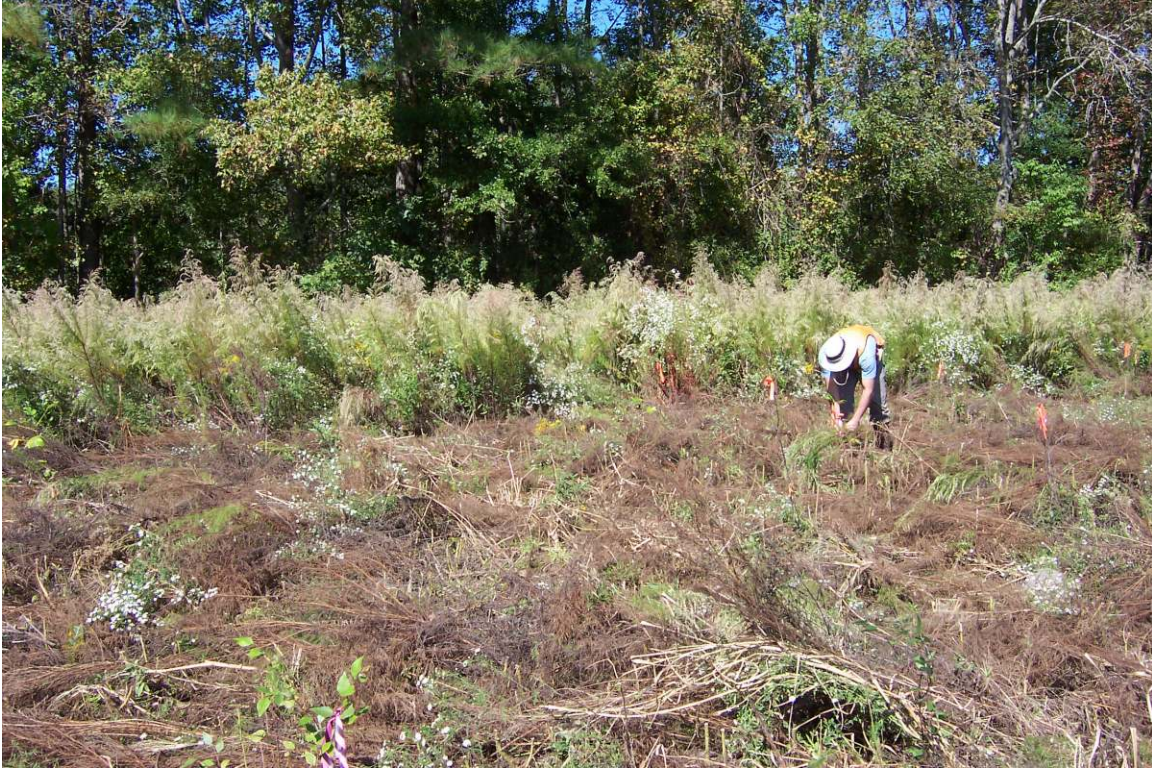
**(1) View of Plot #1 directly adjacent to Knight Canal**

**MANNING FARM RIPARIAN BUFFER SITE**  
**ANNUAL MONITORING DATA SHEET - VEGETATION PLOTS**  
**PLOT#: 1**

Baccharis	SH	2	2.5ft	Volunteer	2
Baccharis	SH	1	3.0ft	Volunteer	1
Sweet Gum	SA	12	<2.0ft	Volunteer	0
Sweet Gum	SA	5	2.0ft	Volunteer	0
Tulip Poplar	SA	9	<2.0ft	Volunteer	9
Tulip Poplar	SA	5	2.0ft	Volunteer	5
Tulip Poplar	SA	1	2.5ft	Volunteer	1
	<b>TOTAL SHRUBS</b>	<b>9</b>		<b>OBSERVED DENSITY (PER PLOT)</b>	<b>76</b>
	<b>TOTAL TREES OF PLANTED SPECIES</b>	<b>52</b>		<b>OBSERVED DENSITY (PER ACRE)</b>	<b>760</b>
	<b>TOTAL TREES OF VOLUNTEER SPECIES</b>	<b>33</b>			
	<b>TOTAL INDIVIDUALS</b>	<b>94</b>

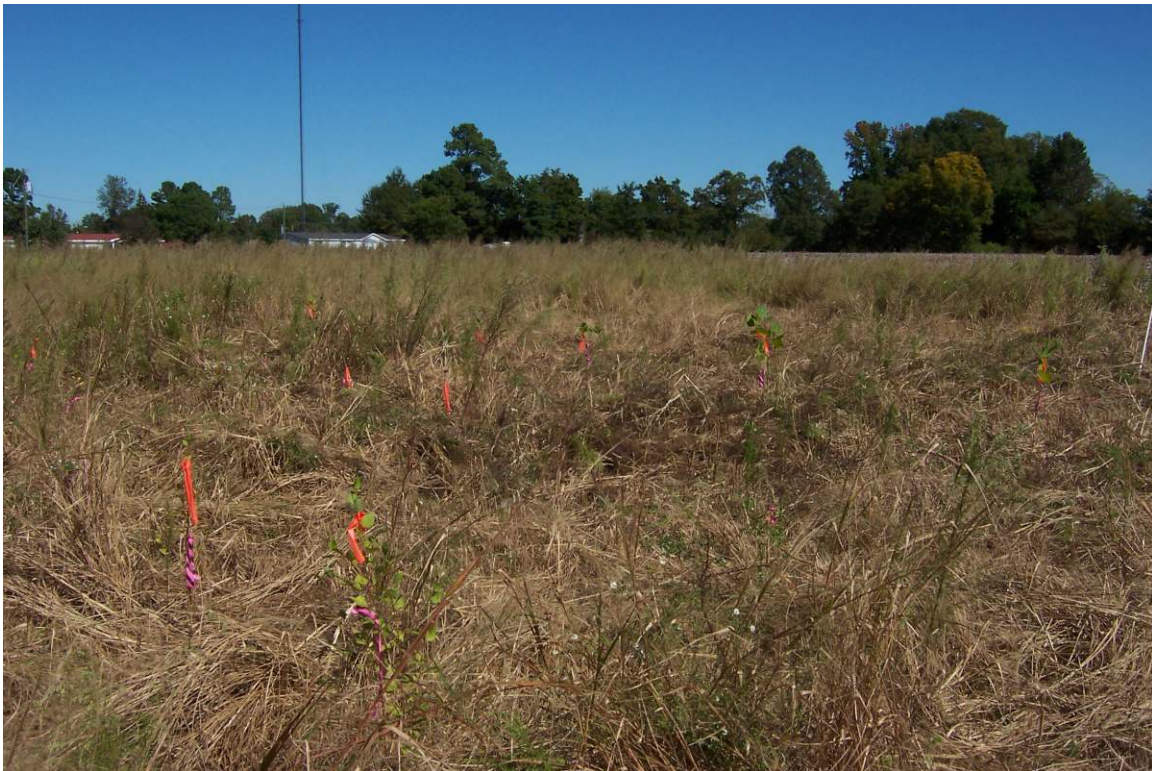
**(2) View of Plot #2**

SPECIES	STRATUM (T, SA, or SH)	Number of Individuals	HEIGHT	Planted vs. Volunteer Species	Number of Individuals Counted toward Success Criteria
River Birch	SA	1	<2.0ft	Planted	1
River Birch	SA	3	2.0ft	Planted	3
River Birch	SA	2	3.0ft	Planted	2
River Birch	SA	1	4.0ft	Planted	1
Sycamore	SA	7	2.5ft	Planted	7
Sycamore	SA	1	3.0ft	Planted	1
Sycamore	SA	5	3.5ft	Planted	5
Sweet Pepperbush	SH	9	<2.0ft	Planted	9
Elderberry	SH	23	<2.0ft	Planted	23
Elderberry	SH	5	2.0ft	Planted	5
Privet	SH	1	<2.0ft	Volunteer	0
Baccharis	SH	3	<2.0ft	Volunteer	3
Baccharis	SH	2	2.0ft	Volunteer	2
Tulip Poplar	SA	3	2.0ft	Volunteer	3
Tulip Poplar	SA	2	2.5ft	Volunteer	2
Sweet Gum	SA	8	<2.0ft	Volunteer	0
	<b>TOTAL SHRUBS</b>	<b>43</b>		<b>OBSERVED DENSITY (PER PLOT)</b>	<b>67</b>
	<b>TOTAL TREES OF PLANTED SPECIES</b>	<b>20</b>		<b>OBSERVED DENSITY (PER ACRE)</b>	<b>670</b>
	<b>TOTAL TREES OF VOLUNTEER SPECIES</b>	<b>13</b>			
	<b>TOTAL INDIVIDUALS</b>	<b>76</b>

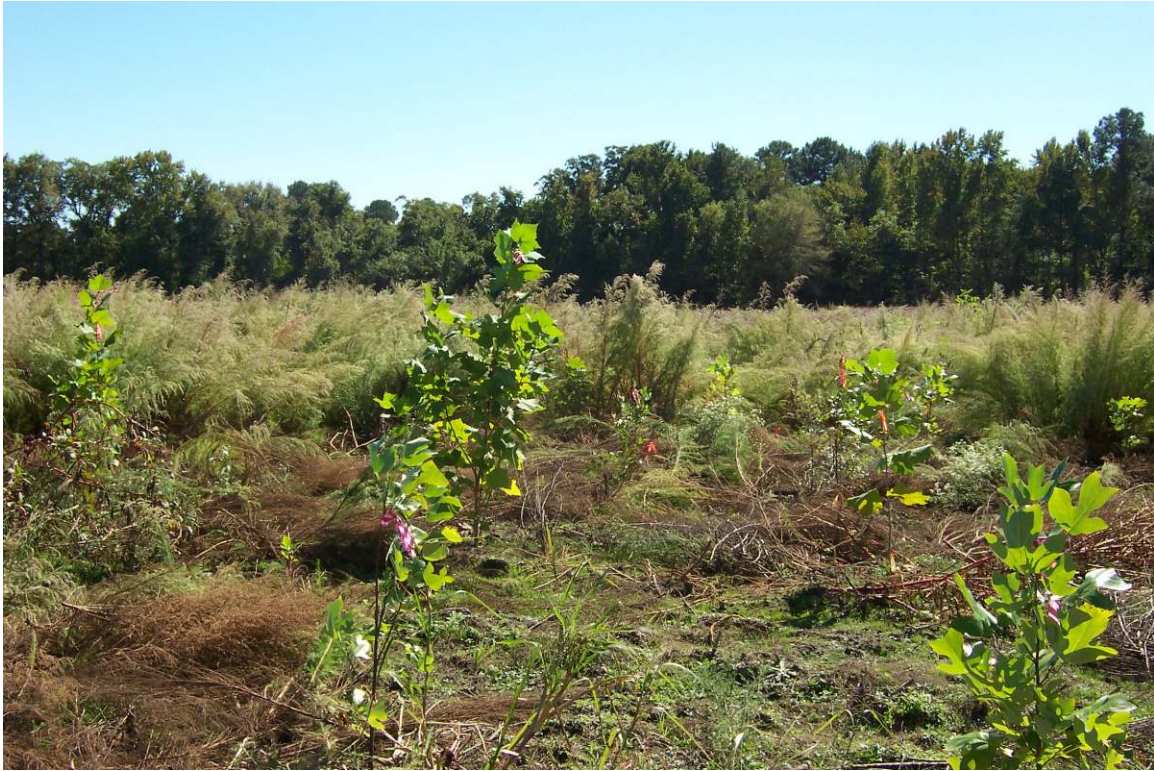
(3) View of Plot #3

SPECIES	STRATUM (T, SA, or SH)	Number of Individuals	HEIGHT	Planted vs. Volunteer Species	Number of Individuals Counted toward Success Criteria
River Birch	SA	2	<2.0ft	Planted	2
River Birch	SA	5	2.0ft	Planted	5
River Birch	SA	3	3.0ft	Planted	3
River Birch	SA	1	3.5ft	Planted	1
River Birch	SA	10	4.0ft	Planted	10
Sycamore	SA	3	3.0ft	Planted	3
Sycamore	SA	3	4.0ft	Planted	3
Sycamore	SA	6	5.0ft	Planted	6
Sycamore	SA	5	5.5ft	Planted	5
Sycamore	SA	2	6.5ft	Planted	2
Overcup Oak	SA	3	2.5ft	Planted	3
Tulip Poplar	SA	3	<2.0ft	Volunteer	3
Tulip Poplar	SA	2	2.0ft	Volunteer	2
Tulip Poplar	SA	4	2.5ft	Volunteer	4
Tulip Poplar	SA	9	3.0ft	Volunteer	9
Tulip Poplar	SA	1	3.5ft	Volunteer	1
Tulip Poplar	SA	2	4.0ft	Volunteer	2
Tulip Poplar	SA	1	5.0ft	Volunteer	1
Willow Oak	SA	1	<2.0ft	Volunteer	1
Baccharis	SH	1	2.0ft	Volunteer	1
Sweet Gum	SA	7	<2.0ft	Volunteer	0
	<b>TOTAL SHRUBS</b>	<b>1</b>		<b>OBSERVED DENSITY (PER PLOT)</b>	<b>67</b>

<b>TOTAL TREES OF PLANTED SPECIES</b>	<b>43</b>		<b>OBSERVED DENSITY (PER ACRE)</b>	<b>670</b>
	<b>TOTAL TREES OF VOLUNTEER SPECIES</b>	<b>30</b>			
	<b>TOTAL INDIVIDUALS</b>	<b>74</b>

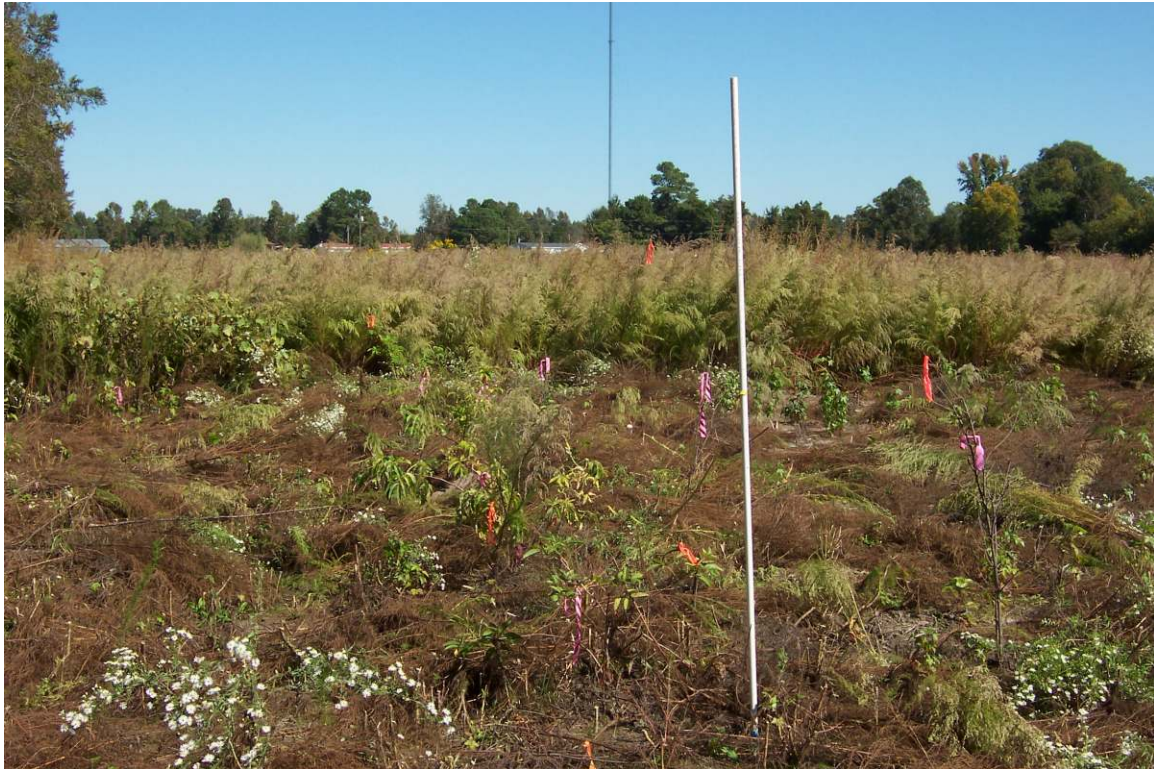
(4) View of Plot #4

SPECIES	STRATUM (T, SA, or SH)	Number of Individuals	HEIGHT	Planted vs. Volunteer Species	Number of Individuals Counted toward Success Criteria
American Beautyberry	SH	1	<2.0ft	Planted	1
American Beautyberry	SH	4	2.0ft	Planted	4
American Beautyberry	SH	9	3.0ft	Planted	9
Overcup Oak	SA	1	<2.0ft	Planted	1
Overcup Oak	SA	6	2.0ft	Planted	6
Overcup Oak	SA	6	3.0ft	Planted	6
Green Ash	SA	4	3.0ft	Planted	4
Green Ash	SA	3	4.0ft	Planted	3
Elderberry	SH	2	2.0ft	Planted	2
Elderberry	SH	1	3.0ft	Planted	1
Willow Oak	SA	1	3.0ft	Volunteer	1
Baccharis	SH	1	<2.0ft	Volunteer	1
Sweet Gum	SA	24	<2.0ft	Volunteer	0
	<b>TOTAL SHRUBS</b>	<b>18</b>		<b>OBSERVED DENSITY (PER PLOT)</b>	<b>39</b>
	<b>TOTAL TREES OF PLANTED SPECIES</b>	<b>20</b>		<b>OBSERVED DENSITY (PER ACRE)</b>	<b>390</b>
	<b>TOTAL TREES OF VOLUNTEER SPECIES</b>	<b>25</b>			
	<b>TOTAL INDIVIDUALS</b>	<b>63</b>

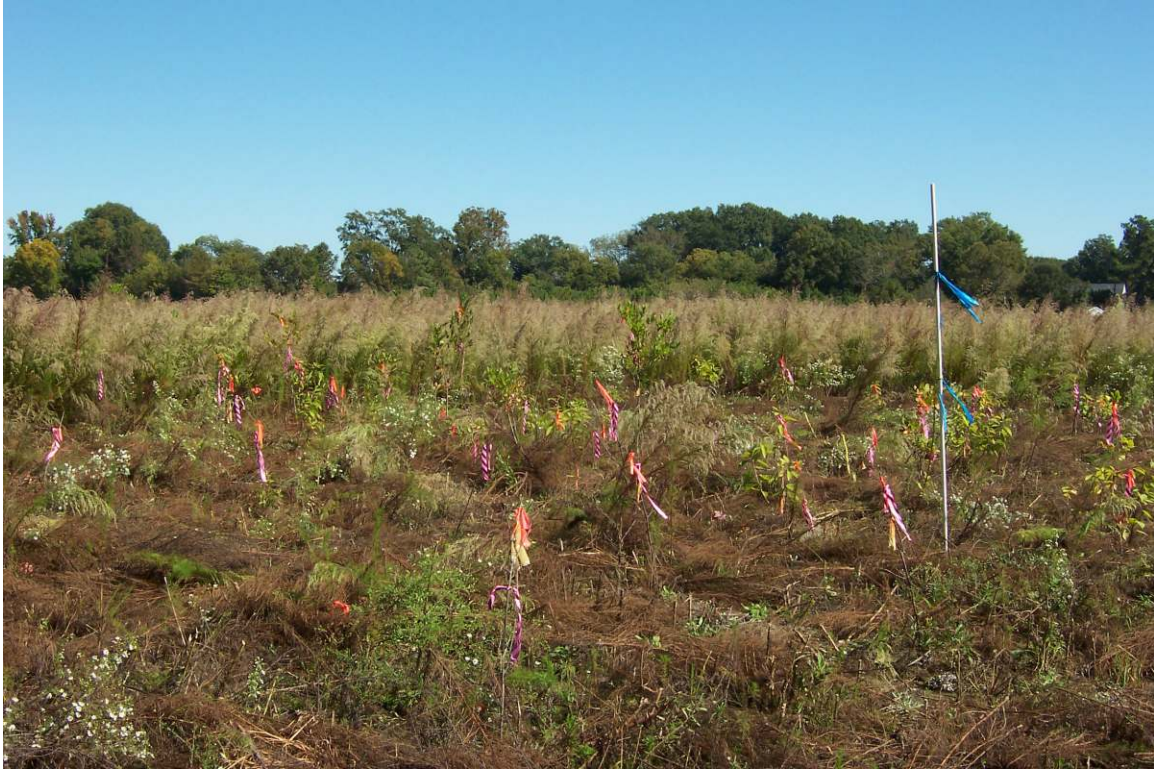
(5) View of Plot #5

SPECIES	STRATUM (T, SA, or SH)	Number of Individuals	HEIGHT	Planted vs. Volunteer Species	Number of Individuals Counted toward Success Criteria
Overcup Oak	SA	2	<2.0ft	Planted	2
Overcup Oak	SA	15	2.0ft	Planted	15
Overcup Oak	SA	22	3.0ft	Planted	22
Overcup Oak	SA	2	4.0ft	Planted	2
American Beautyberry	SH	3	<2.0ft	Planted	3
American Beautyberry	SH	20	2.0ft	Planted	20
American Beautyberry	SH	5	3.0ft	Planted	5
American Beautyberry	SH	2	4.0ft	Planted	2
Green Ash	SA	1	<2.0ft	Planted	1
Green Ash	SA	1	2.0ft	Planted	1
Green Ash	SA	6	3.0ft	Planted	6
Green Ash	SA	3	4.0ft	Planted	3
Green Ash	SA	4	5.0ft	Planted	4
Elderberry	SH	3	<2.0ft	Planted	3
Elderberry	SH	12	2.0ft	Planted	12
Water Oak	SA	1	2.0ft	Planted	1
Water Oak	SA	1	3.0ft	Planted	1
Water Oak	SA	1	4.0ft	Planted	1
Willow Oak	SA	1	2.0ft	Planted	1
Willow Oak	SA	2	4.0ft	Planted	2
	<b>TOTAL SHRUBS</b>	<b>45</b>		<b>OBSERVED DENSITY (PER PLOT)</b>	<b>107</b>
	<b>TOTAL TREES OF PLANTED SPECIES</b>	<b>62</b>		<b>OBSERVED DENSITY (PER ACRE)</b>	<b>1,070</b>

<b>TOTAL TREES OF VOLUNTEER SPECIES</b>	<b>0</b>			
	<b>TOTAL INDIVIDUALS</b>	<b>107</b>

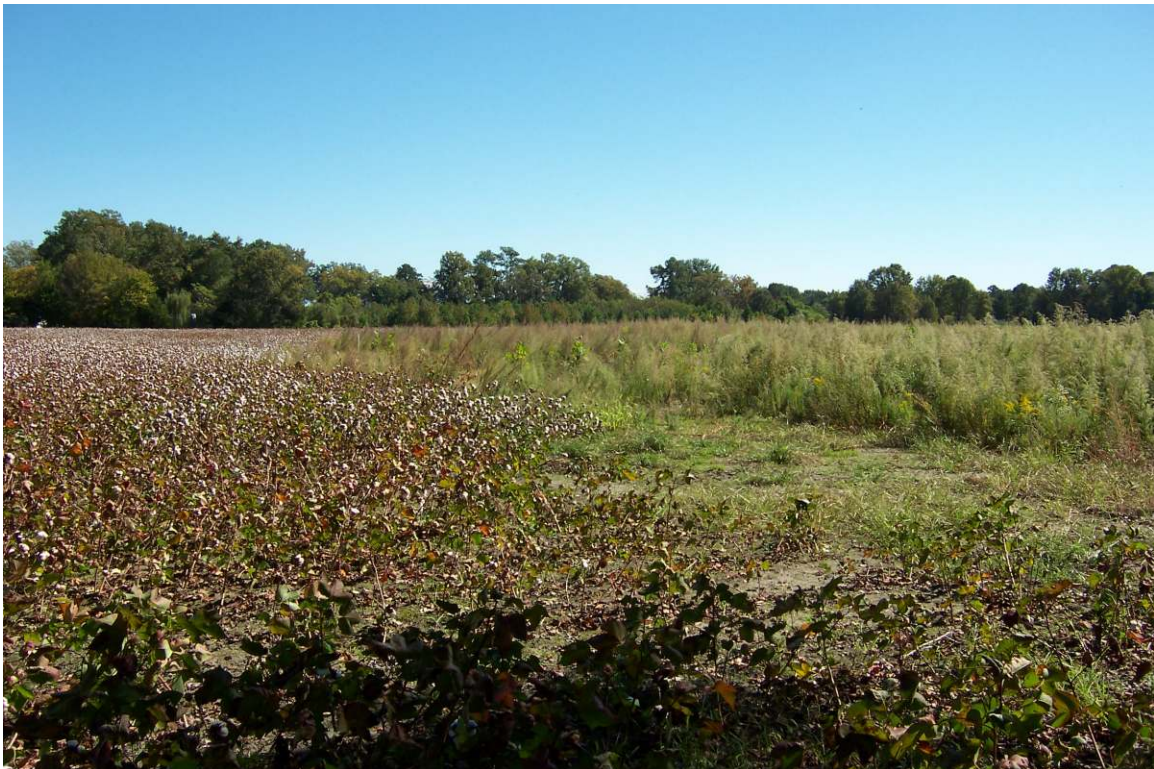
(6) View of cotton fields directly adjacent to project area
