**“Manning Farm Property”
Buffer Restoration Project**

**Edgecombe County, NC
Tar-Pamlico River Basin
(Cataloging Unit #03020103)**

**2007 Annual Monitoring Report (Year 2 of 5)
(Task 8)**

NC EEP Contract #D05026

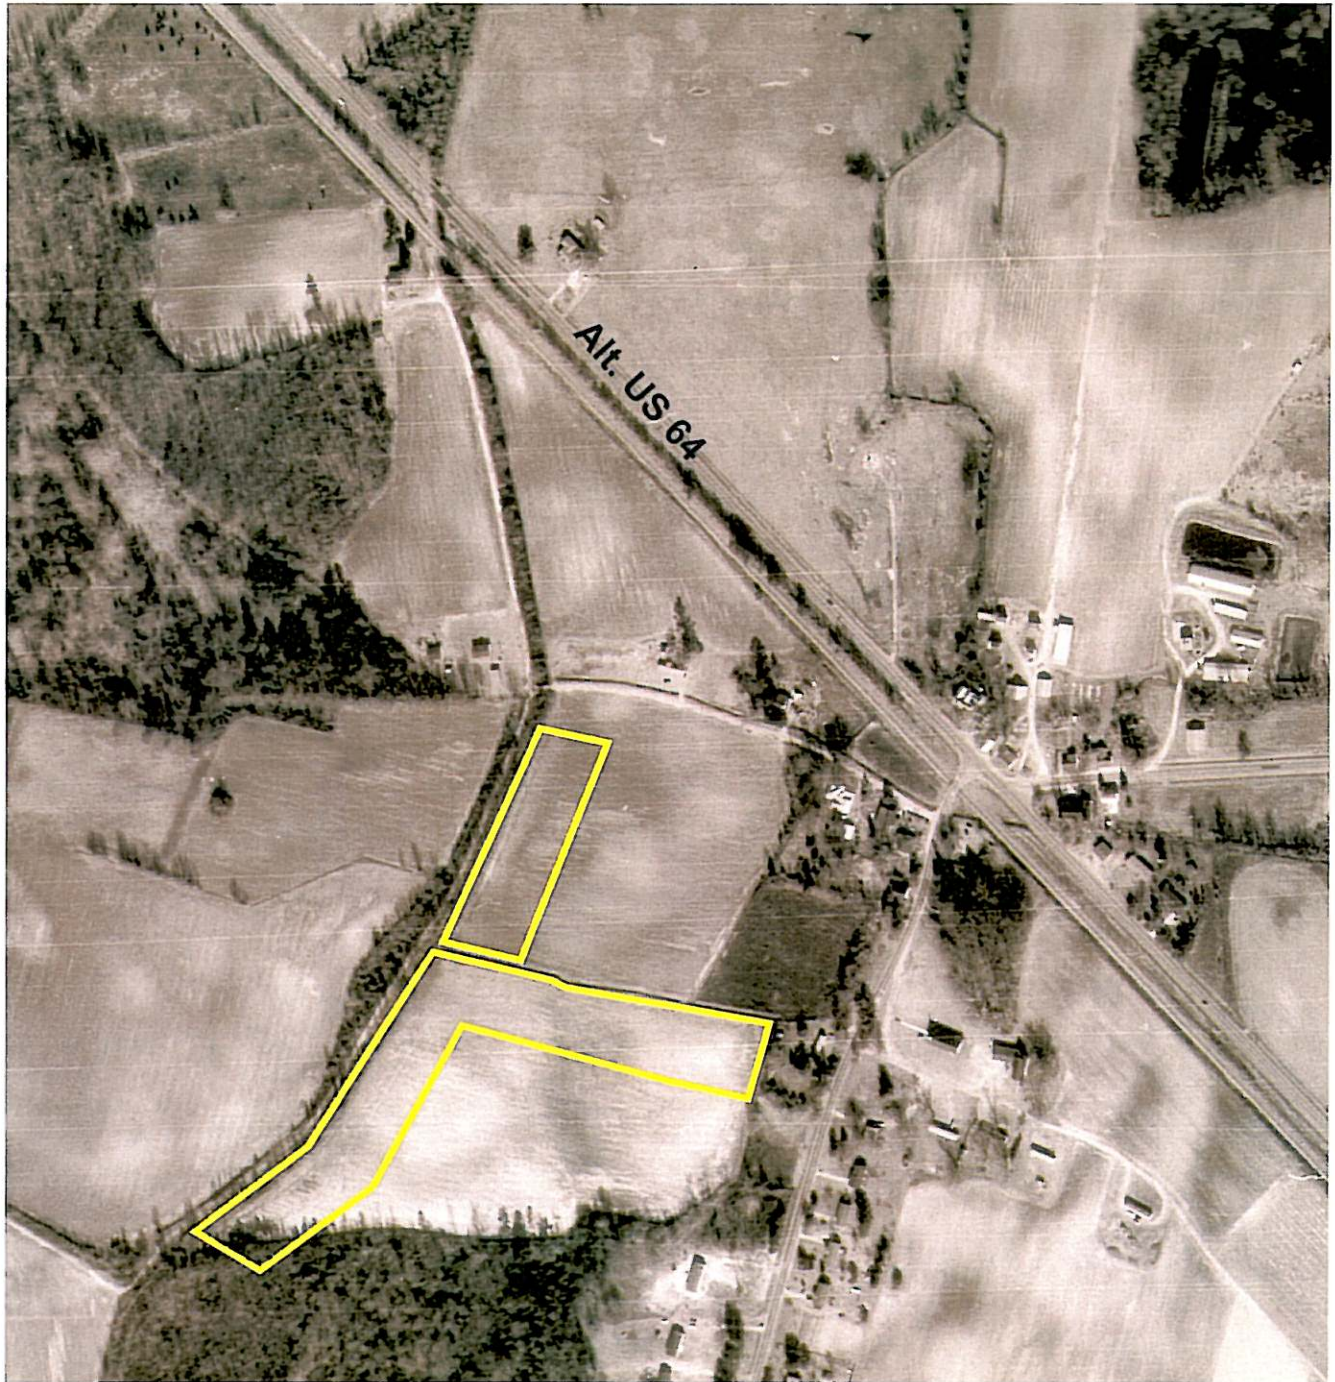
Figure 4.
Buffer Planting Overview

The restoration project included the planting of characteristic tree and shrub seedlings adjacent to open ditches and blue-line streams on the 10.0-ac restoration site (refer to Figure 4). No federal or state permits were necessary to conduct the restoration activities. The riparian buffer was planted with characteristic tree species including river birch (*Betula nigra*), sycamore (*Platanus occidentalis*), water oak (*Quercus nigra*), overcup oak (*Quercus lyrata*), tulip poplar

200' Buffer Planting Area (10.0 acres)

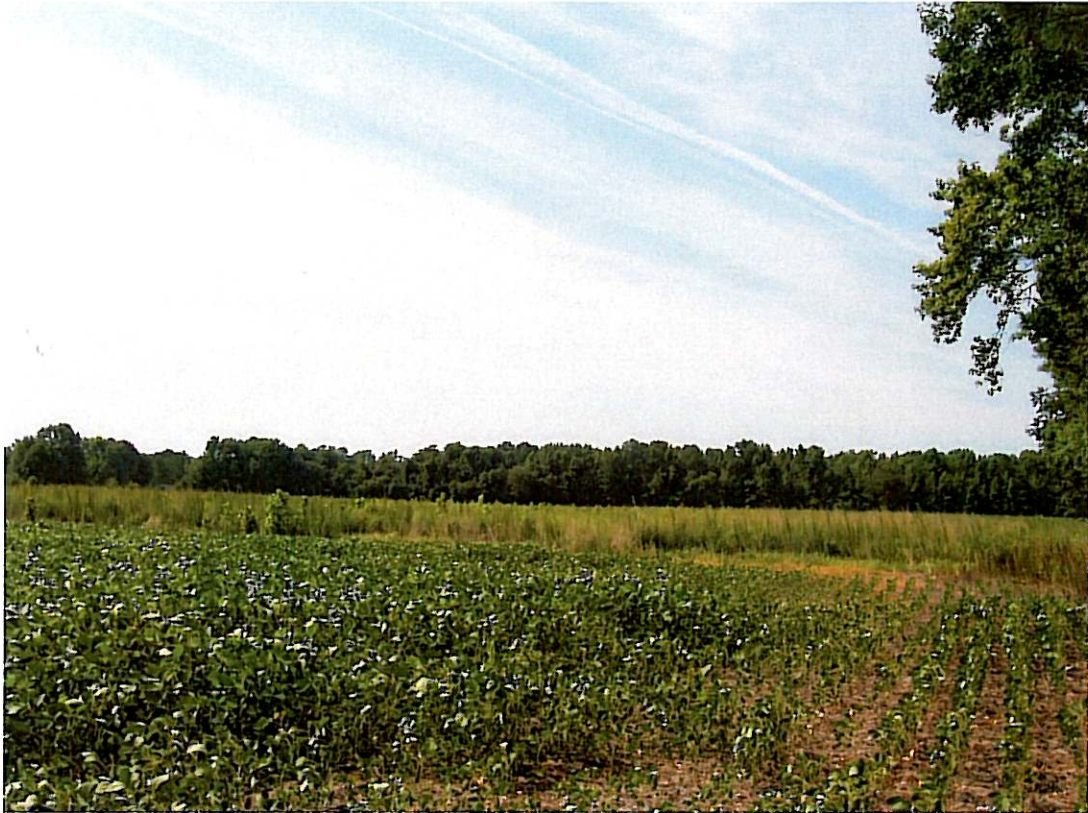
**(1) Overview of buffer restoration project area
with the agricultural field in the foreground adjacent
to Plot 1**

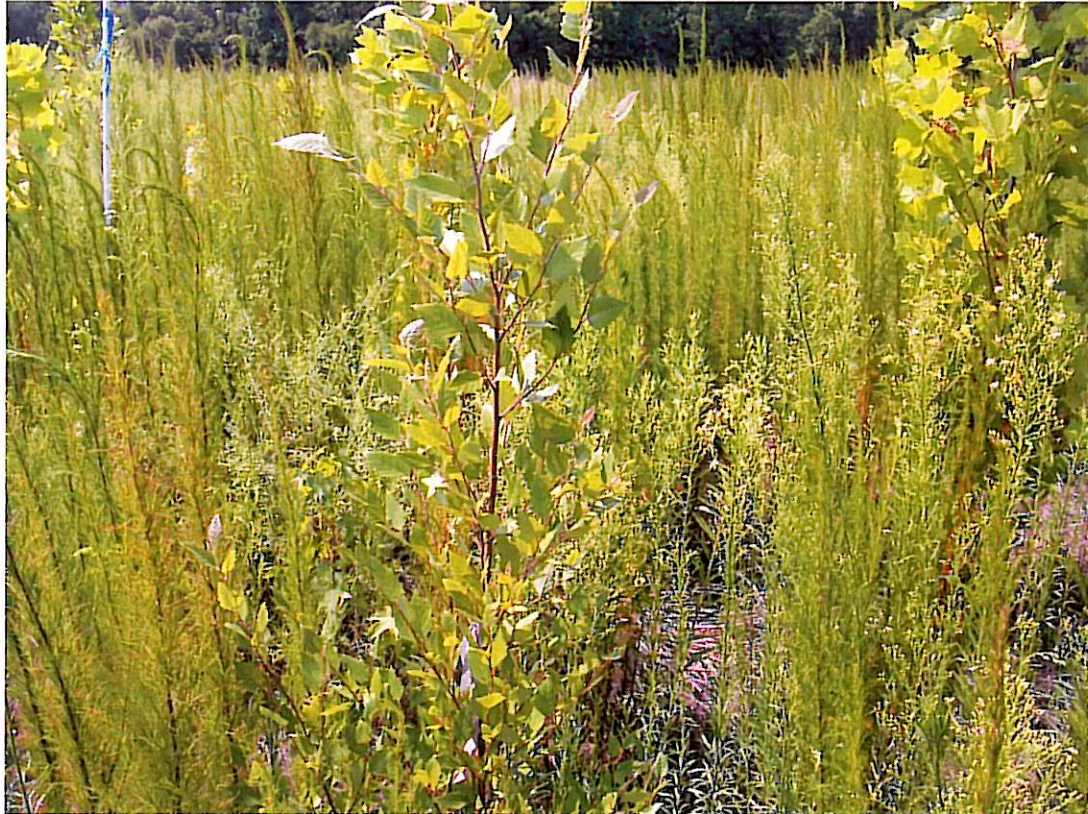
(2) Typical view of a 2nd year River Birch in Plot #2

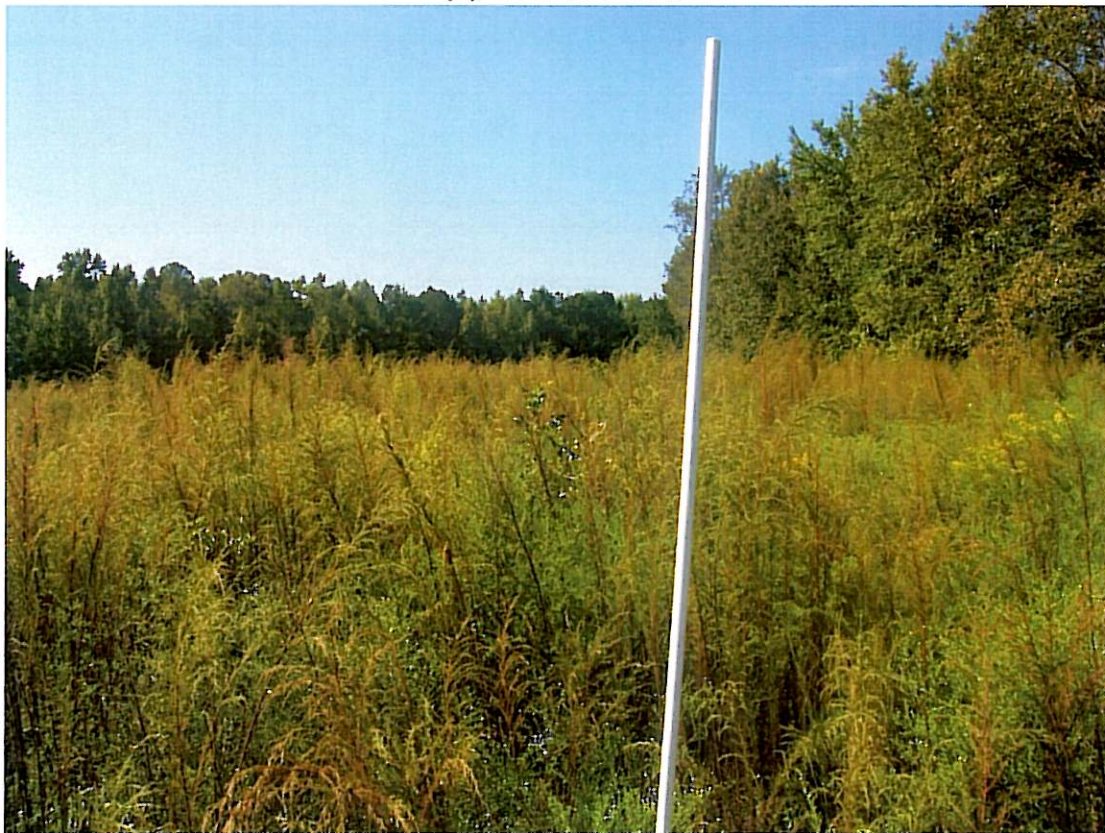
(4) View of Plot #4

While the observed totals were sufficient to meet the success criteria, Plot #4 registered the lowest total with only 25 individuals. This represents a 36% decline in density compared to Year 1 results. Poor survivorship within the plot is likely due to the exceptional drought (D4) conditions occurring in Edgecombe County where current precipitation totals are 20 inches below average.

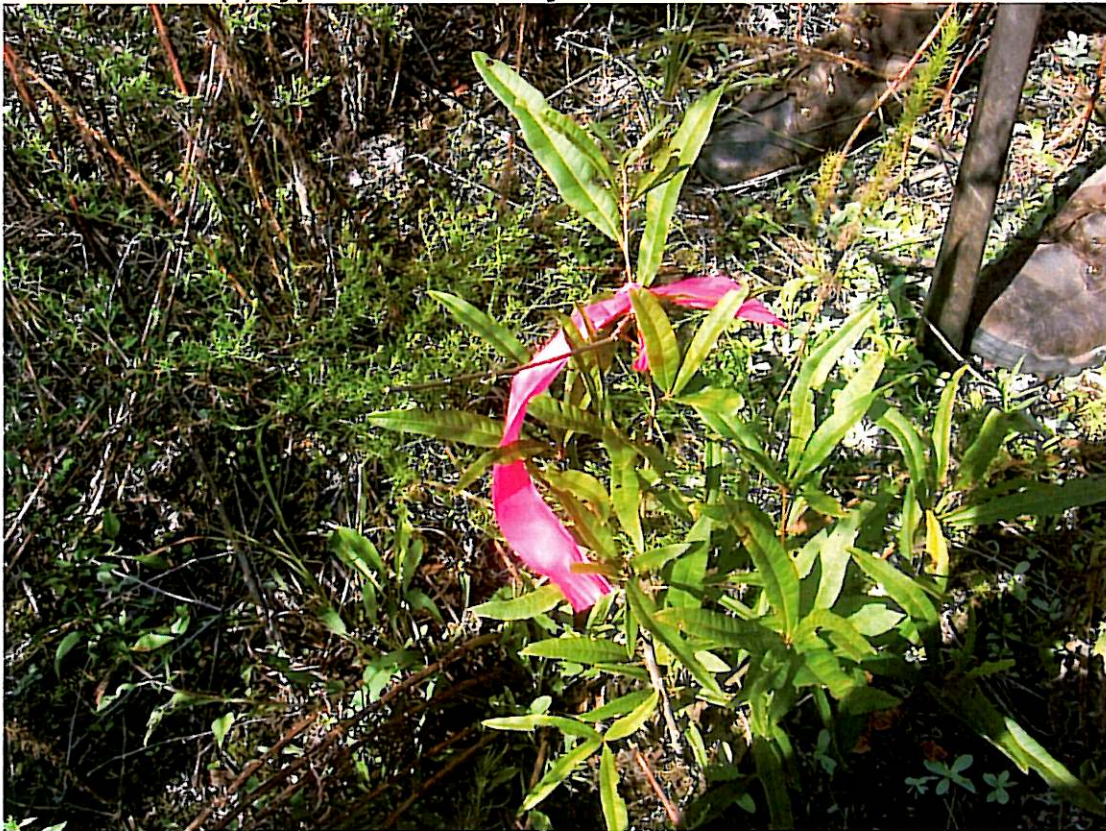
(6) Typical view of 2nd year Willow Oak in Plot #5
