Annual Monitoring Report (MY1)

MAPLE SWAMP BUFFER MITIGATION SITE

Edgecombe County, NC

DMS ID No. 100189

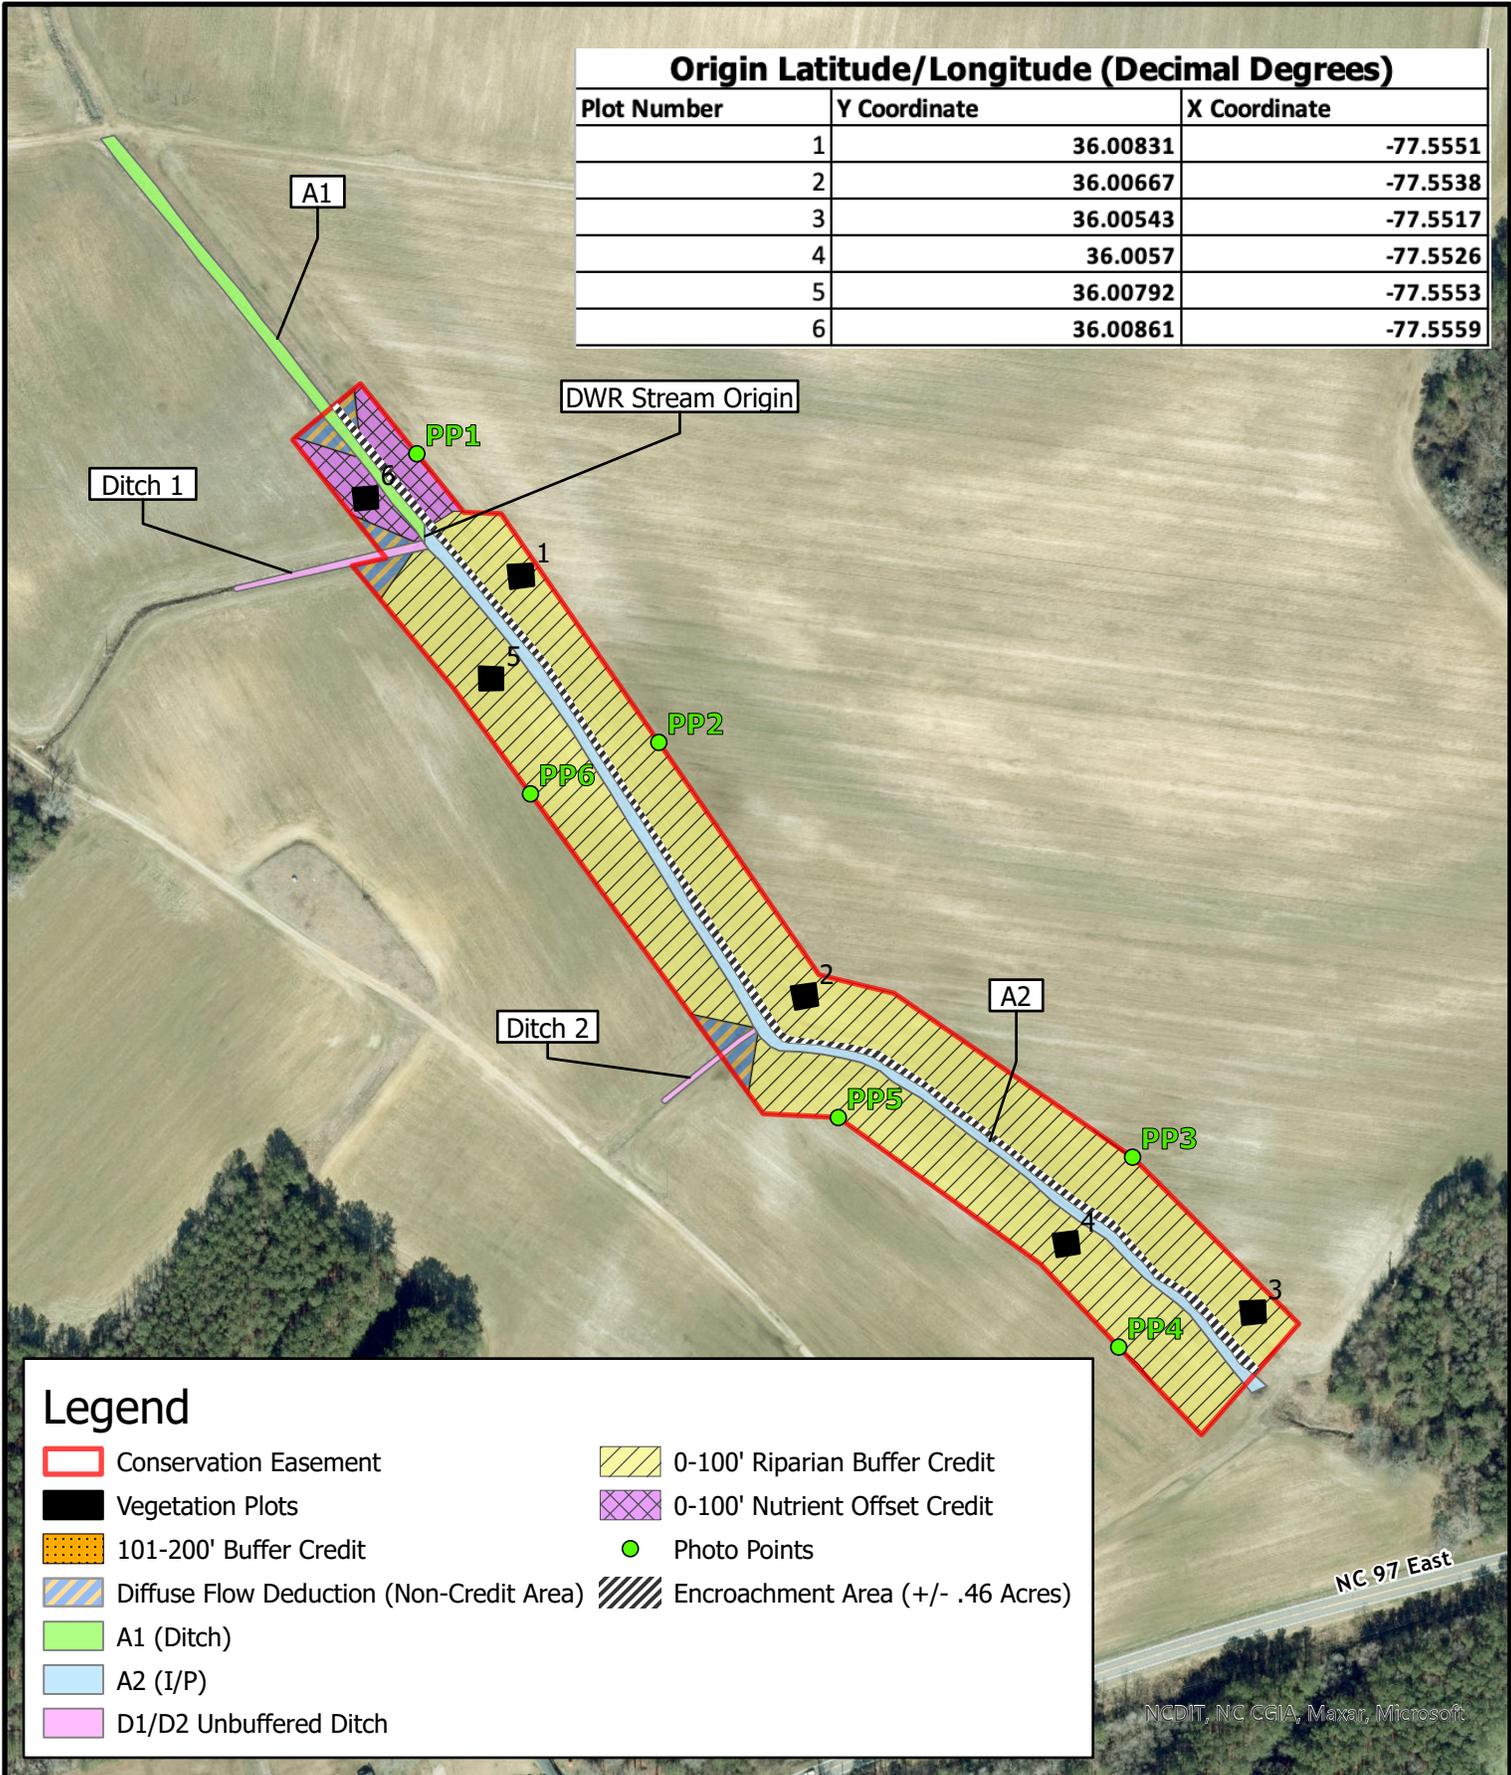
Current Condition Plan View
Maple Swamp Buffer Mitigation Site
Tar-Pamlico 03020102
Edgecombe County, North Carolina
January 2023

During biannual site inspection and first year monitoring, one area of encroachment was observed where a farmer accidentally mowed the historic farm path adjacent to the stream feature (see Figure 1). The landowner has been informed of his responsibility for this loss of trees, and Eco Terra is working with both the landowner and tree supplier to replant as soon as possible. The trees will sprout back, but additional trees will be supplementally planted in this area to ensure vegetation plots met success criteria across the site and no further supplemental planting is anticipated in MY2.

Additional observations were made of site conditions and vegetation conditions outside of monitoring plots. Overall, the implementation and planting of the project resulted in a full stocking of native tree species. One exception was observed – an incidental mowed area along the north side of the stream feature. The encroachment is illustrated and

quantified in the CCPV and Table 3 (Appendix 1). Biannual visual assessments will continue in order to appropriately monitor changing site conditions and address any issues to ensure Site success and performance criteria are met in subsequent monitoring years. Any additional Site problems will be noted and discussed in the annual reports, addressed in a remedial action plan if necessary, and monitored biannually to ensure performance criteria are met following any remedial action.

- Add visual assessment table for planted area.
[Visual assessment table has been added to the Appendix as requested.](#)
- The narrative briefly mentions a small area of low stem density (check typo). However, looking at the CCPV it appears that 1 row of trees along the entirety of the easement may have been mowed. Assuming trees planted on 6' centers, and the length of the ditch being around 1,500 feet, this area should be about 0.2 acres and be noted as an encroachment, which is not typically considered a small area. Please measure this area and update with the area of encroachment described in the narrative, on the CCPV, and in the visual assessment table as an encroachment. Provide photo of the area for documentation purposes. Provide description of what was communicated to the landowner to ensure it does not happen again (additional marking, phone call, etc).
[The encroachment has been noted in the narrative, CCPV, and visual assessment table as requested. Most of the trees are alive with good root structure and will resprout. Out of an abundance of caution, the area will be supplementally planted with trees approved in the Final Mitigation Plan to ensure adequate stocking of the impacted area in MY2. The landowner has been informed of his responsibility for this loss of trees, and Eco Terra is working with both the landowner and tree supplier to replant as soon as possible. A photo documenting the area has been provided. Additional temporary easement marking has occurred, and more permanent easement marking will be established following supplemental planting.](#)

- Please note that if any encroachment occurs again on this site, Eco Terra should notify and work with DMS to communicate easement restrictions to the landowner. [We thank DMS for this note and will again advise the landowner and farm tenants of their responsibilities. Should this happen again, Eco Terra will advise DMS as soon as possible and coordinate with DMS on an acceptable course of action.](#)

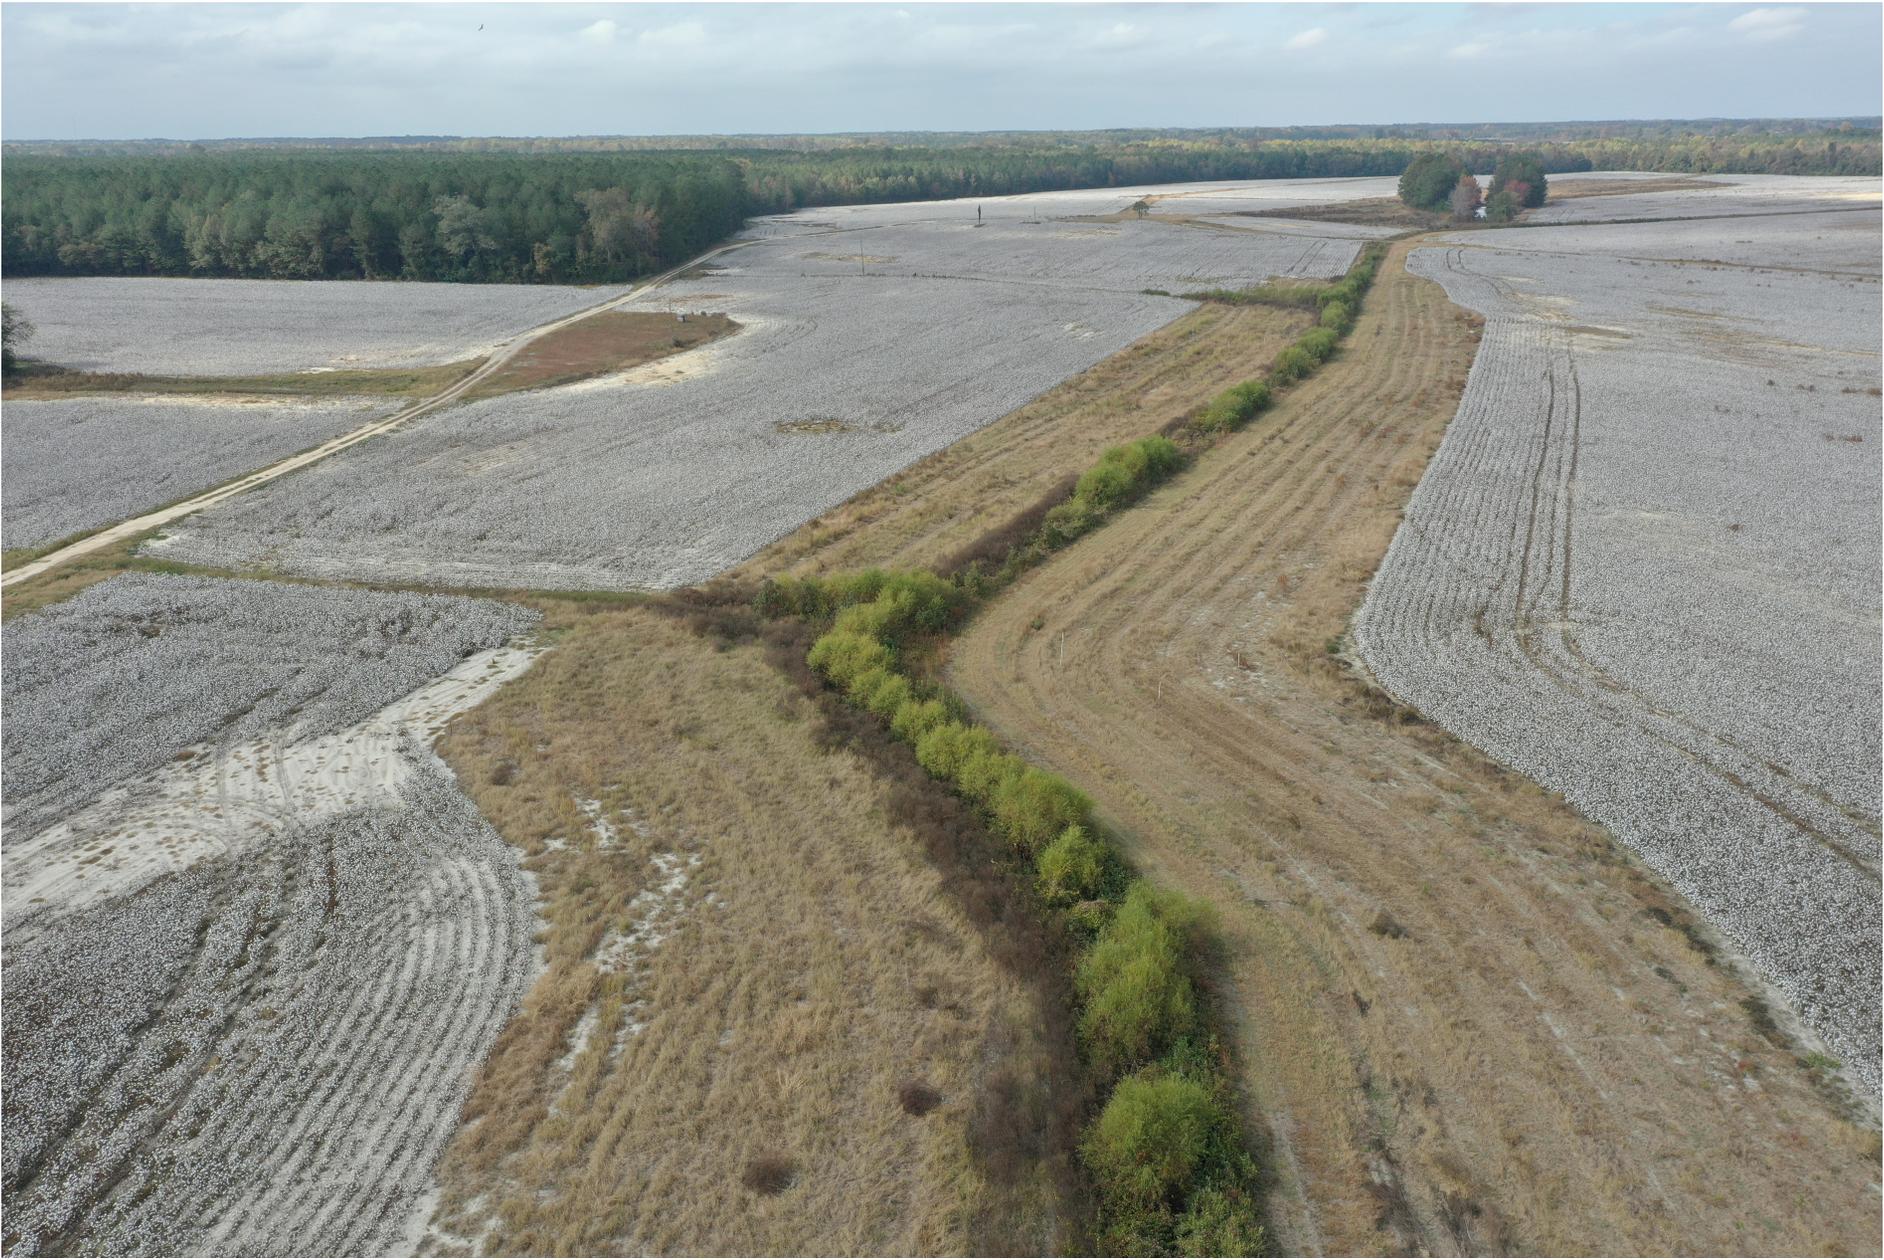
Site post construction (October 2022)
