**MAPLE SWAMP WETLAND MITIGATION SITE
ANNUAL MONITORING REPORT – YEAR 1**

Edgecombe County, NC

NCDMS ID No. 100190

January 2023

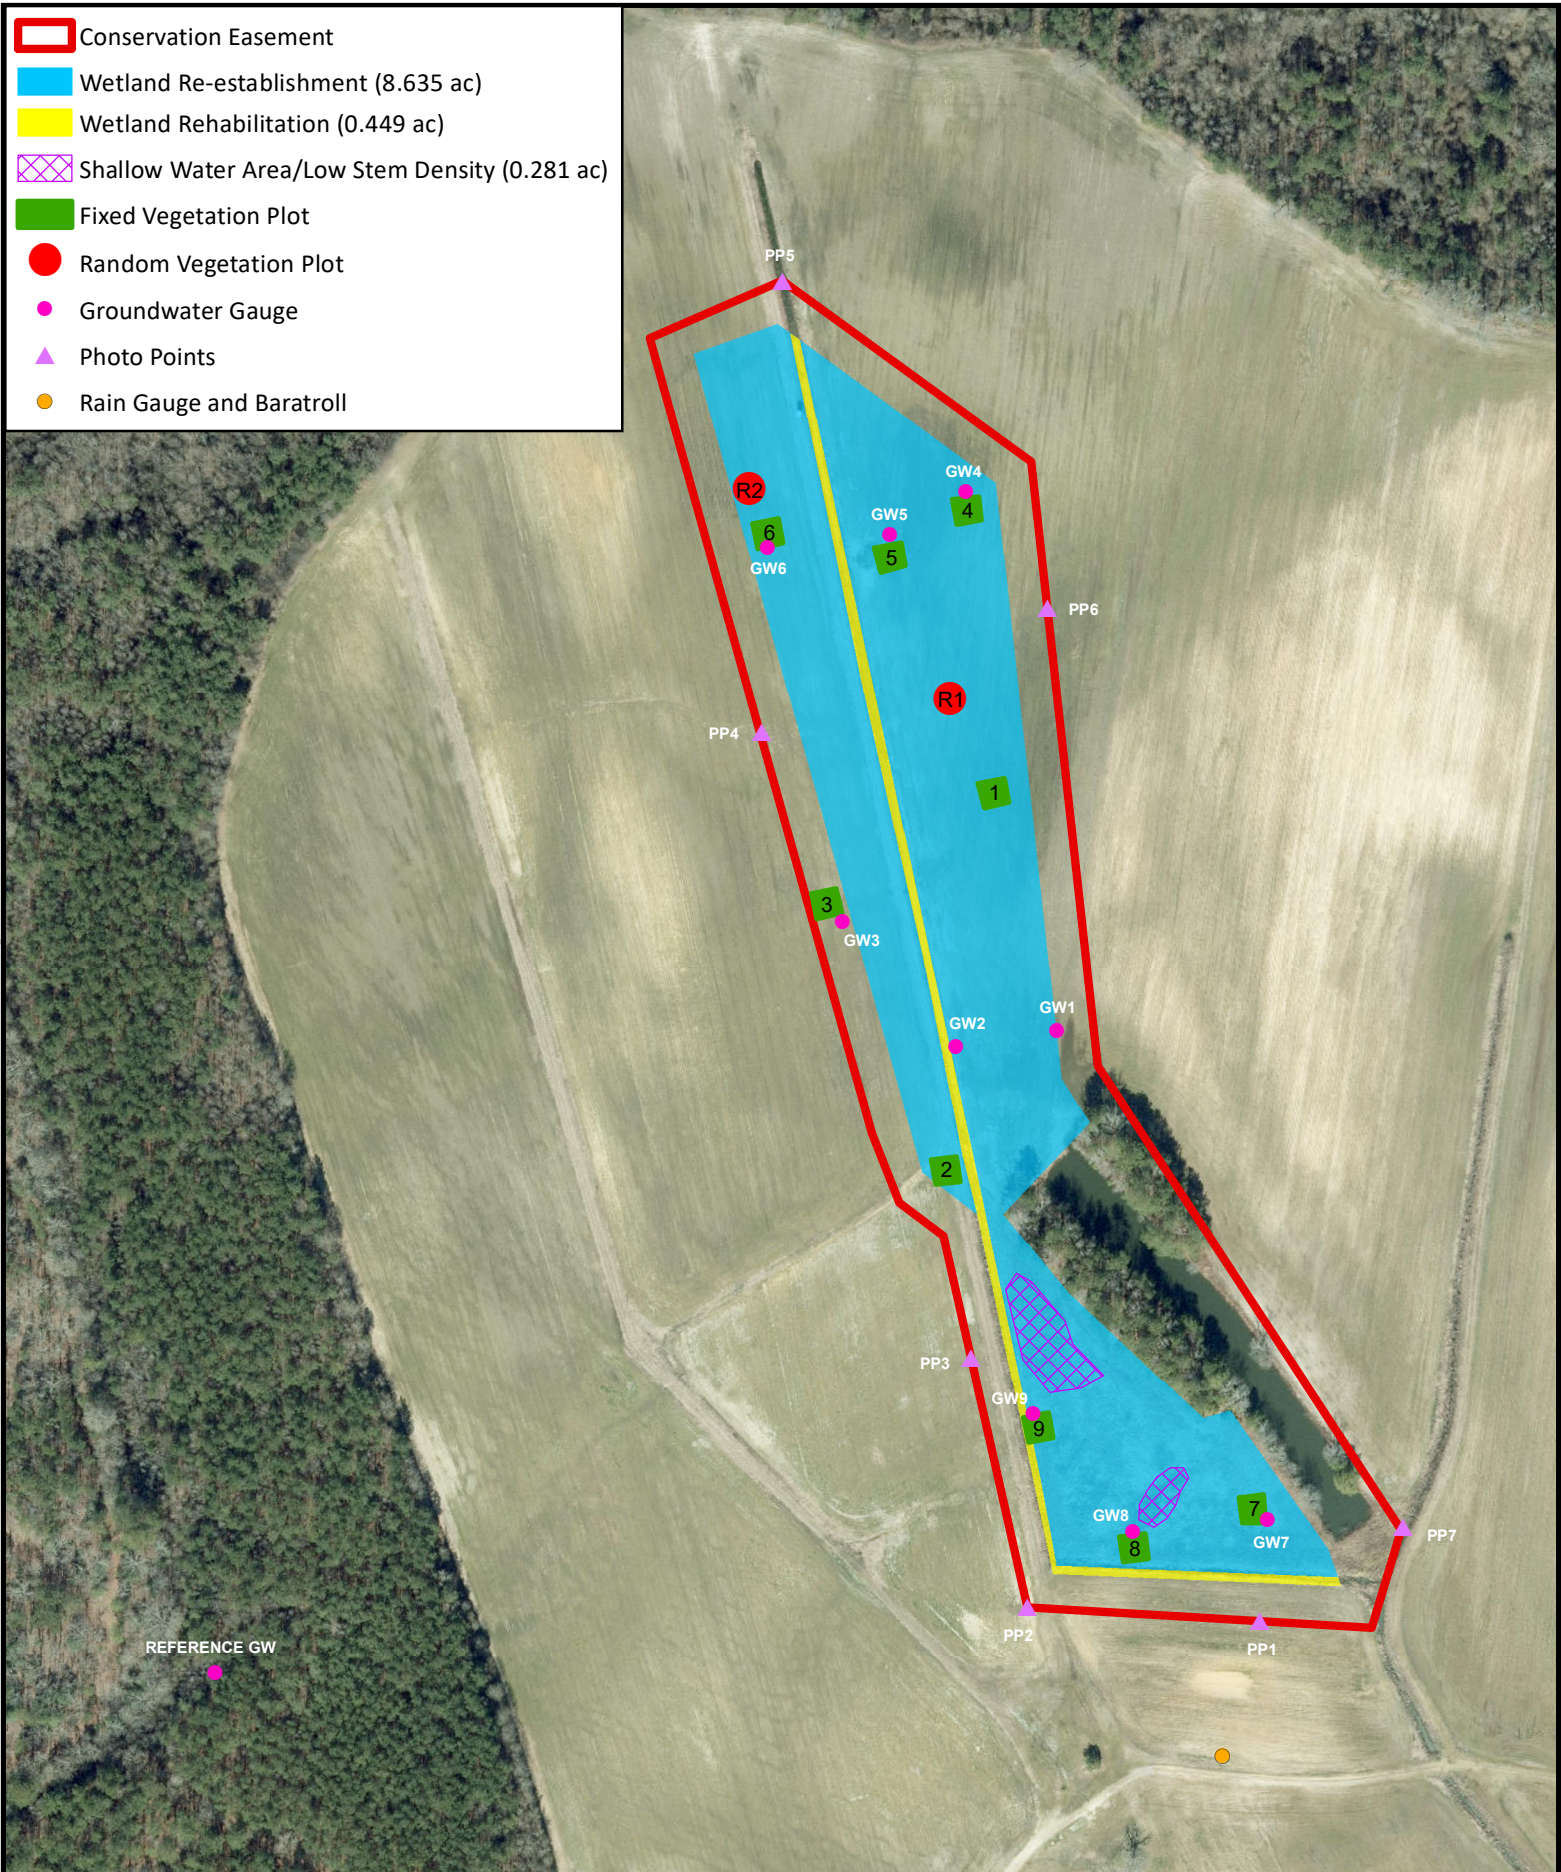
FIGURE
1

MAPLE SWAMP WETLAND MITIGATION SITE
MONITORING YEAR 1 - CURRENT CONDITIONS SITE MAP
 Tar-Pamlico 03020102
 Edgecombe County, North Carolina

- Site grading during construction and uplift of the water table due to Site planting and ditch plugging was led to the formation of two shallow water areas in the southern portion of the Site (see Figure 1). Members of the IRT and Eco Terra noted during the as-built site walk that these two areas exhibited lower than average stem survival as compared to the remainder of the Site. Eco Terra plans to supplementally plant these areas with hydrophytic species included in the Final Mitigation Plan and place a random vegetation plot in these areas in MY2. Description of the supplemental planting, including species, quantity, and area, will be included in the MY2 annual monitoring report.

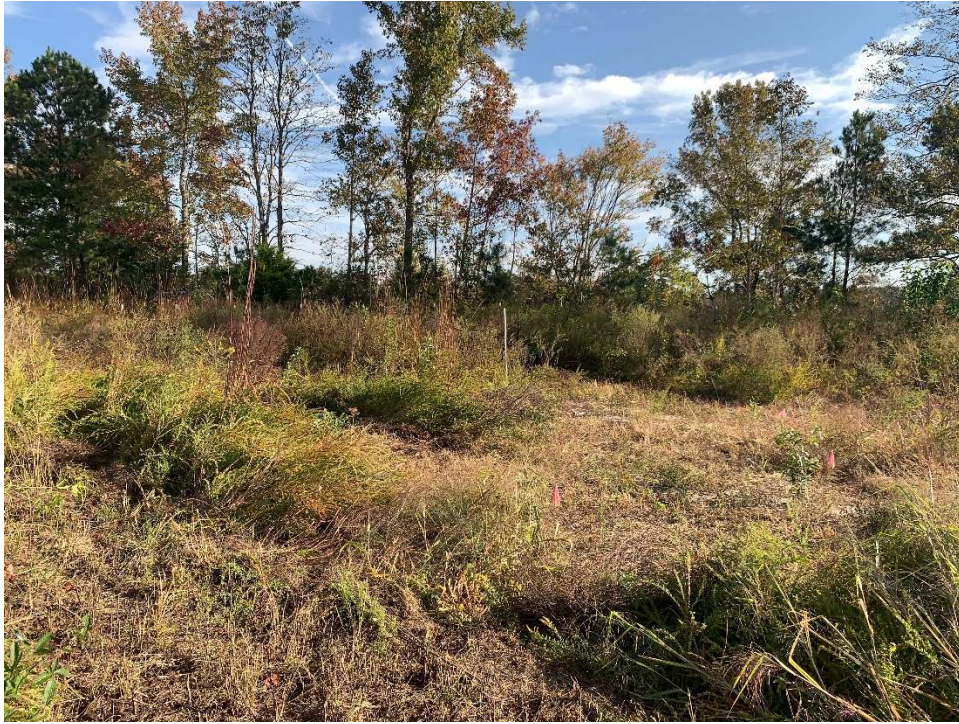
Vegetation Plot 7 – taken 10/12/2022

- *Diospyros virginiana* (American Persimmon) volunteers were observed in fixed vegetation plot 7. *D. virginiana* was not included in the Final Mitigation plan and was not planted at the Site. Eco Terra requests that the IRT approve occurrences of *D. virginiana* to count towards the stem count and overall success criteria of the Site. Occurrences of *D. virginiana* were noted in reference forest communities to the north and west of the Site.

- Sporadic growth of *Lespedeza cuneata* was observed in the vicinity of vegetation plot 7. The current state and growth rate of the invasive species does not warrant any treatment or remedial action in the area. Eco Terra will continue to monitor *Lespedeza cuneata* in this area

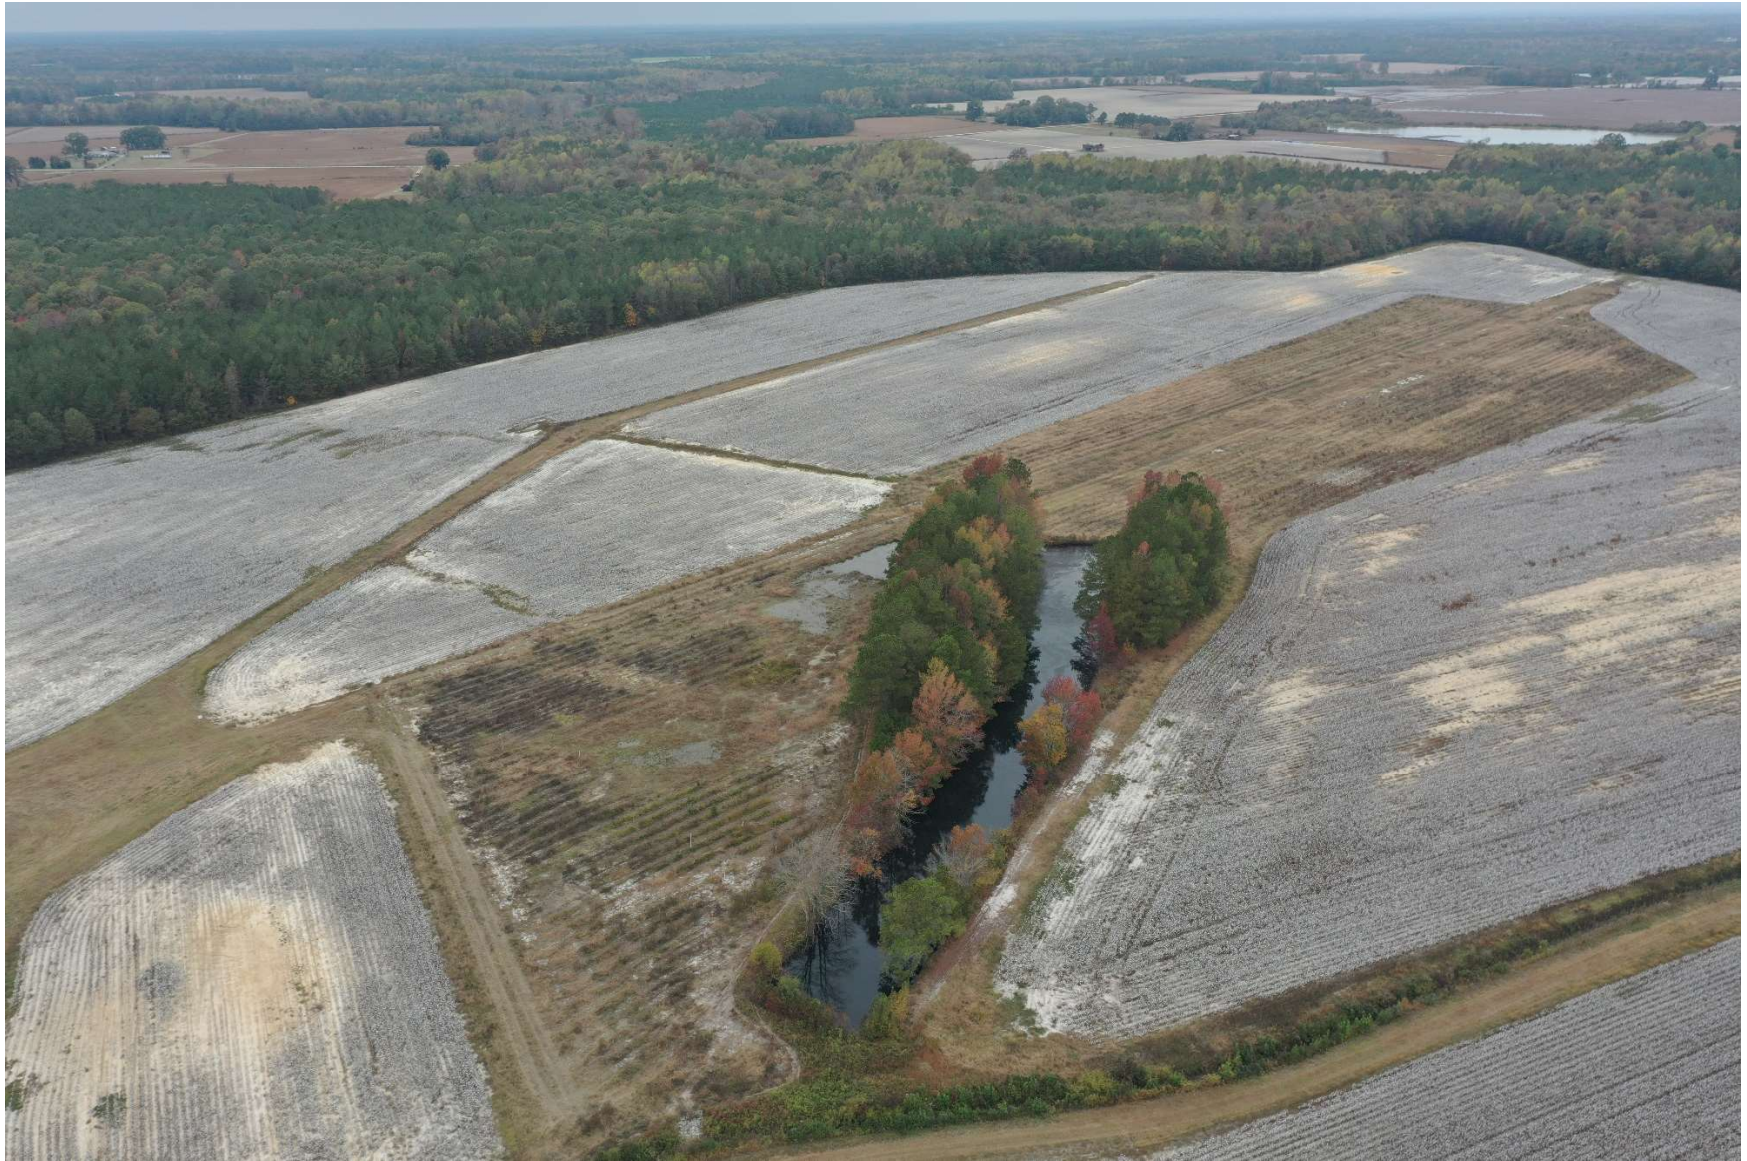
View of Site facing northwest (taken 10/26/2022)
