**MONITORING YEAR 4  
ANNUAL REPORT**  
Final

**MARTIN DAIRY BUFFER MITIGATION SITE**

Orange County, NC  
NCDEQ Contract No. 006831  
DMS Project No. 97087  
NCDWR Project No. 2016-0366

Data Collection Period: September 2021  
Draft Submission Date: November 2021  
Final Submission Date: November 23, 2021

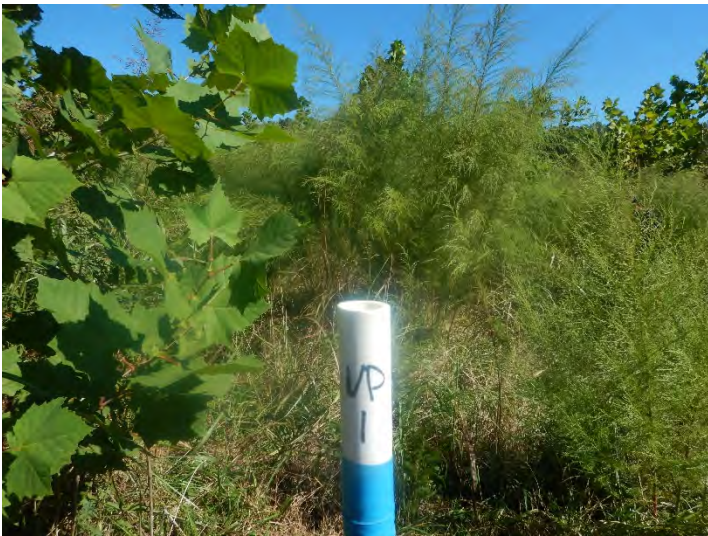
**VEG PLOT 1 (09/24/2021)**

<i>Pinus taeda</i>	Loblolly Pine	Tree												
<i>Platanus occidentalis</i>	Sycamore	Tree	4	4	5	4	4	4	5	5	5	2	2	13
<i>Prunus serotina</i>	Black Cherry	Tree												
<i>Pyrus calleryana</i>	Bradford Pear	Exotic			3									
<i>Quercus lyrata</i>	Overcup Oak	Tree												
<i>Quercus palustris</i>	Pin Oak	Tree												
<i>Quercus phellos</i>	Willow Oak	Tree	2	2	2	3	3	3	1	1	1	1	1	1
<i>Quercus rubra</i>	Northern Red Oak	Tree												
<i>Salix nigra</i>	Black Willow	Tree			2									
<i>Ulmus</i>	Elm	Tree												
<i>Ulmus alata</i>	Winged Elm	Tree												
<i>Ulmus americana</i>	American Elm	Tree												
<i>Ulmus rubra</i>	Slippery Elm	Tree												2
<b>Stem count</b>			10	10	14	10	10	28	11	11	25	9	9	73
<b>size (ares)</b>			1			1			1			1		
<b>size (ACRES)</b>			0.02			0.02			0.02			0.02		
<b>Species count</b>			4	4	6	4	4	5	5	5	5	5	5	7
<b>Stems per ACRE</b>			405	405	567	405	405	1,133	445	445	1,012	364	364	2,954
