MITIGATION PLAN

MARTIN DAIRY MITIGATION PLAN

Orange County, NC
NCDEQ Contract No. 6831
DMS ID No. 97087

Wildlands Engineering, Inc.

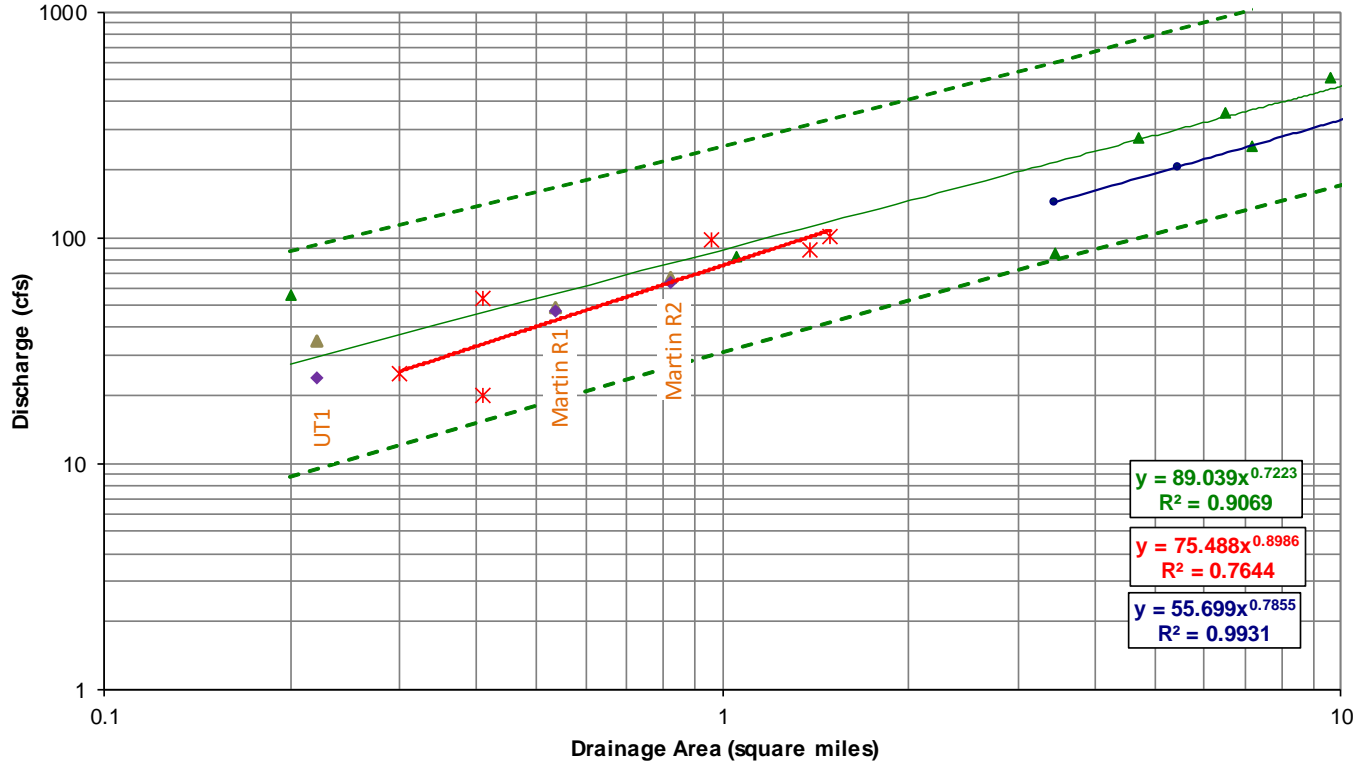
Figure 10 Discharge Analysis
Martin Dairy Mitigation Site
Neuse River Basin 03020201

Martin Dairy Design Discharge Plot

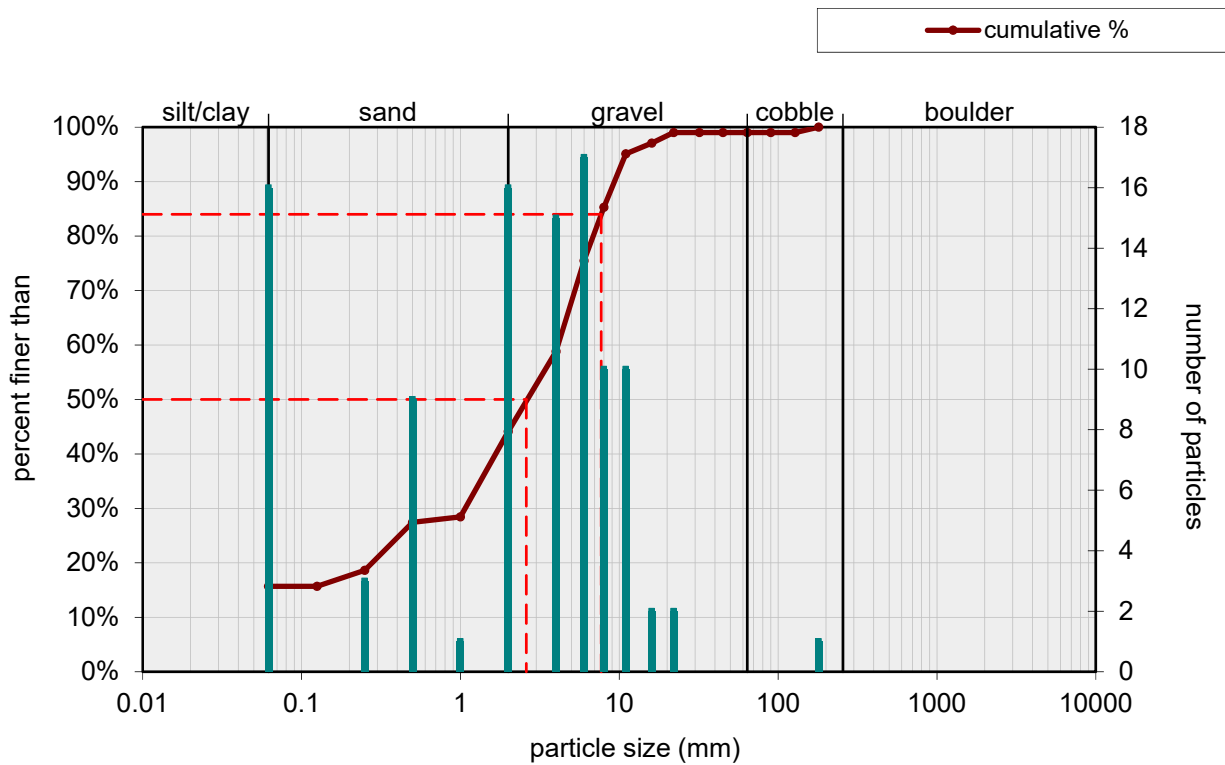
Riffle Surface Pebble Count, Martin R1, XS1

Size (mm)	Type	
D16	0.13	silt/clay	16%
D35	1.3	sand	28%
D50	2.6	gravel	55%
D65	4.6	cobble	1%
D84	7.7	boulder	0%
D95	11

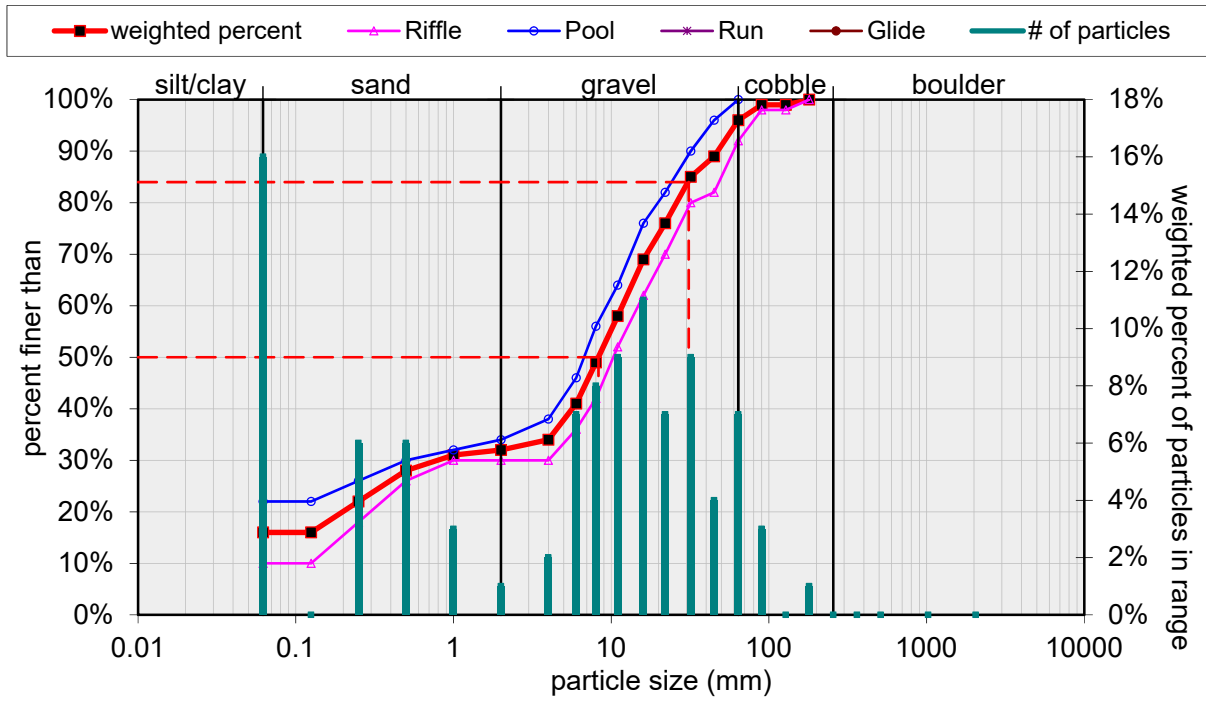
Weighted pebble count by bed features , Martin Dairy Reachwide

50% riffle 50% pool

Size (mm)	Type	
D16	0.062	silt/clay	16%
D35	4.2	sand	16%
D50	8.3	gravel	64%
D65	14	cobble	4%
D84	31	boulder	0%
D95	61
