**MONITORING YEAR 5
ANNUAL REPORT
Final**

MARTIN DAIRY BUFFER MITIGATION SITE

Orange County, NC
NCDEQ Contract No. 006831
DMS Project No. 97087
NCDWR Project No. 2016-0366

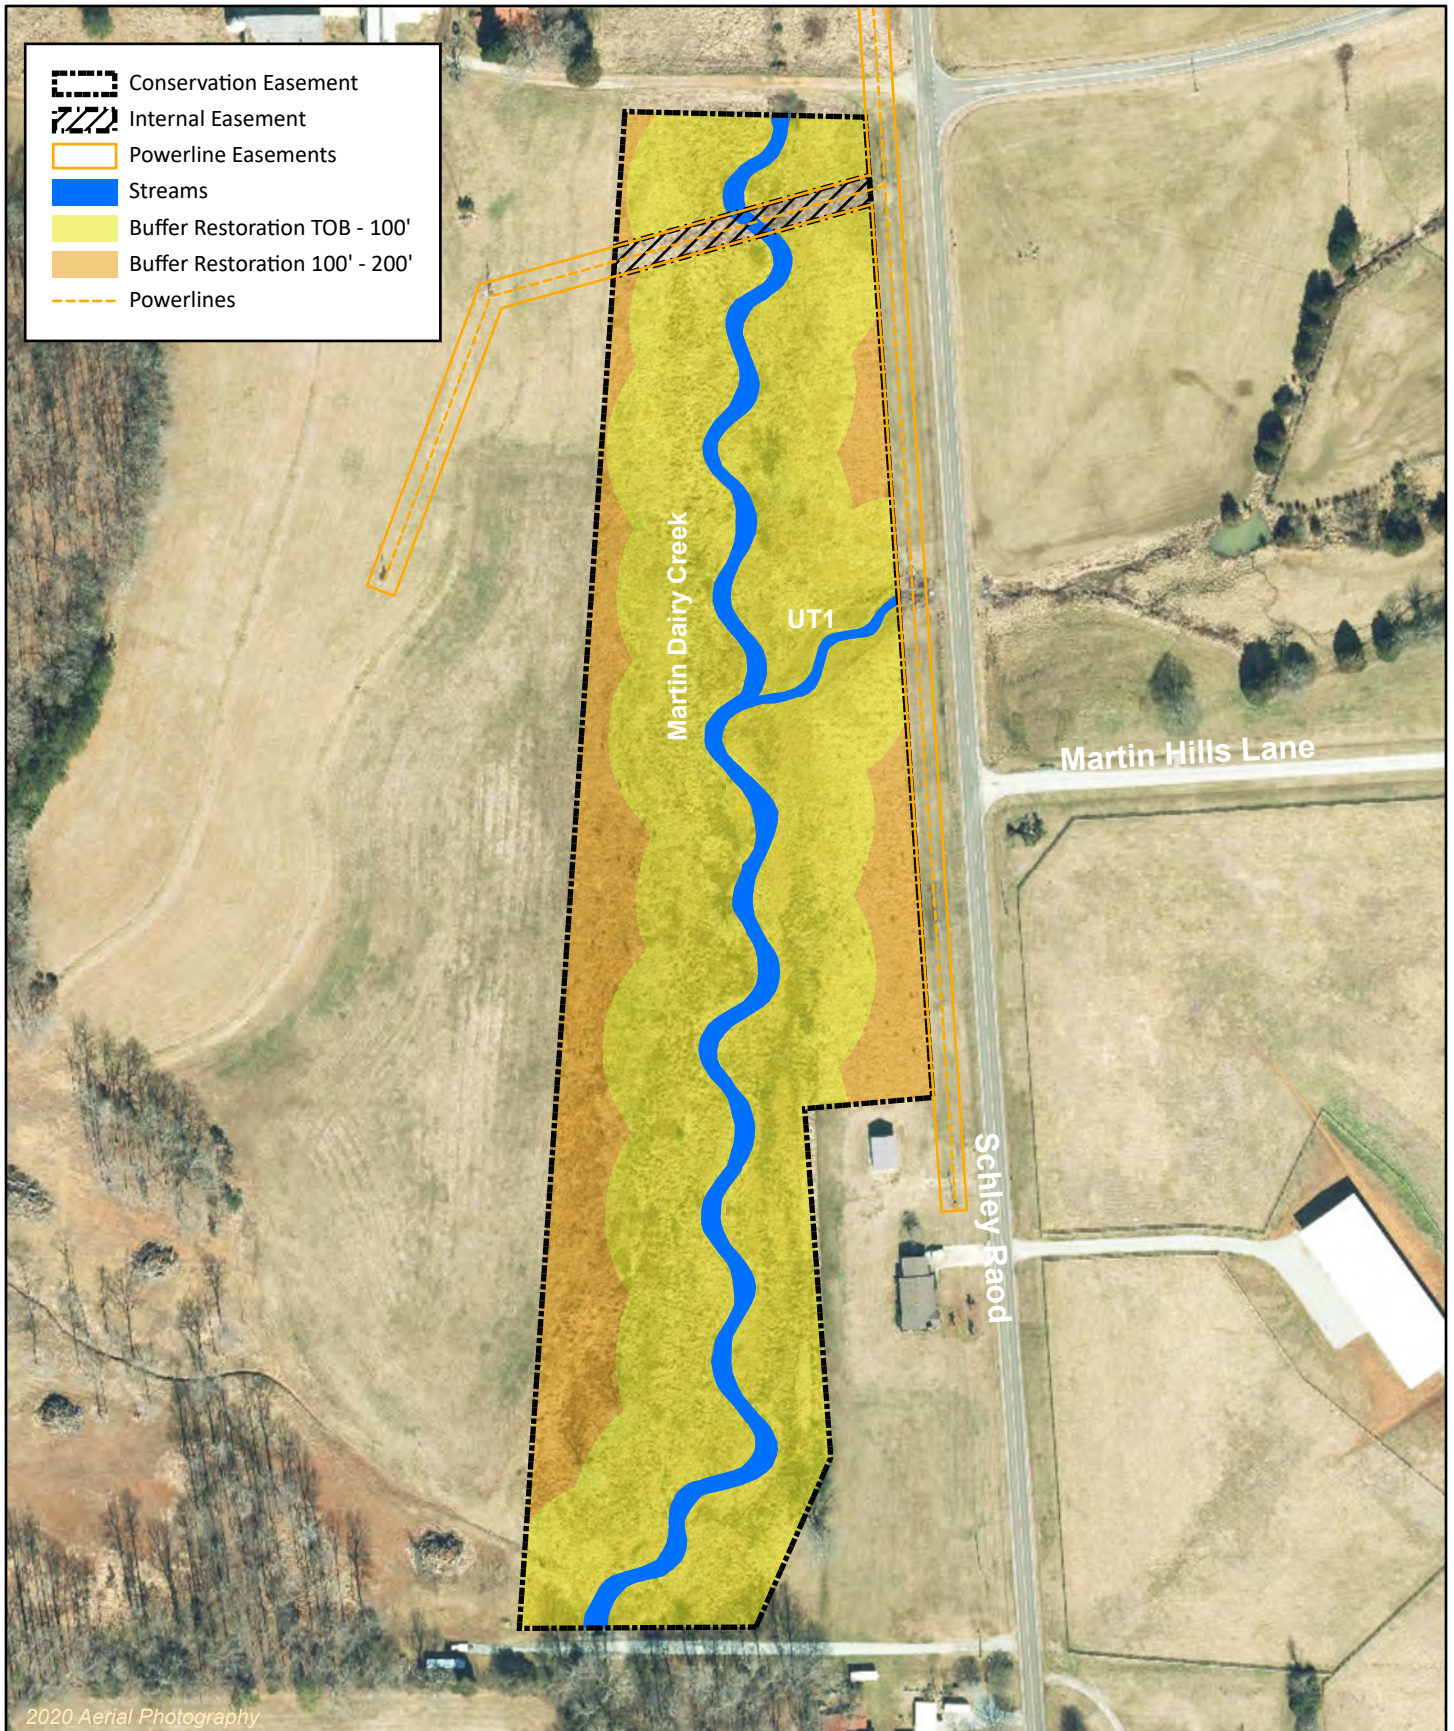
Figure 3. Project Component / Asset Map
 Martin Dairy Buffer Mitigation Site
 DMS Project No. 97087
 Monitoring Year 5 - 2022
 Orange County, NC

The Site is protected with a 11.155 acre conservation easement. Out of the 11.155 acres, 10.139 acres were restored for Neuse River buffer credit and 1.017 acres will not generate buffer mitigation credit. In general, riparian buffer restoration area widths on streams extend out to 200 feet from top of bank for Neuse River buffer credits. Maps detailing the credit generation are provided in Figure 3.

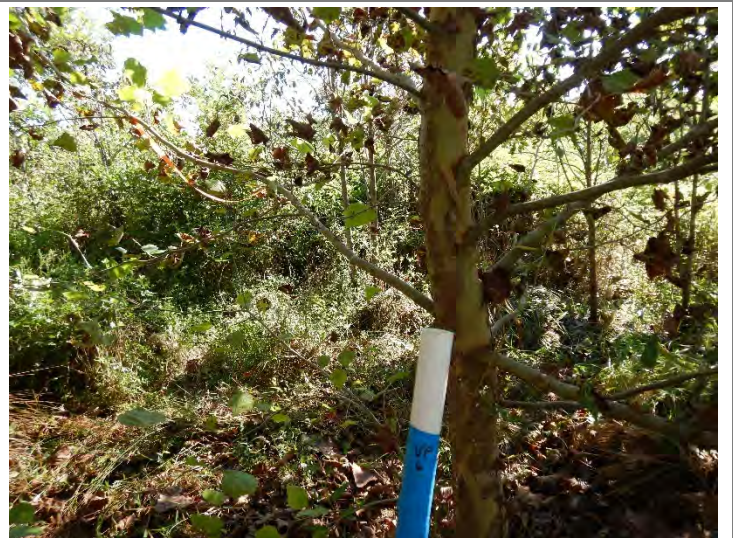
VEG PLOT 6 (09/13/2022)

Overall, the 2022 vegetation monitoring data reflects that the Site meets the performance criteria. Although excessive deer browsing had an effect on planted trees, six out of eight vegetation plots met the MY5 success criteria. While the tree mortality rate of planted stems in vegetation plots 6 and 8

increased, the number of volunteer species have also increased. Despite the mortality of planted stems in vegetation plots 6 and 8 the total number of stems per acre and species diversity in each of the plots remains high. When including volunteer species, all vegetation plots meet and exceed performance criteria. In April 2022, an invasive vegetation treatment occurred across the Site to treat sporadic populations of invasive species. The Site will continue to receive follow up invasive treatment in winter 2022. Additionally, in April 2022, Wildlands experimented with capsaicin tablets as a deer deterrent along the northeast side of the project. In May 2022, soil amendments were added across the east side of the project to further combat deer browse and ensure tree height success. Overall, the Site has met its goals of preventing excess nutrients from entering the Falls Lake Water Supply Watershed and Neuse River tributaries. The Site is being proposed for 2023 closeout.

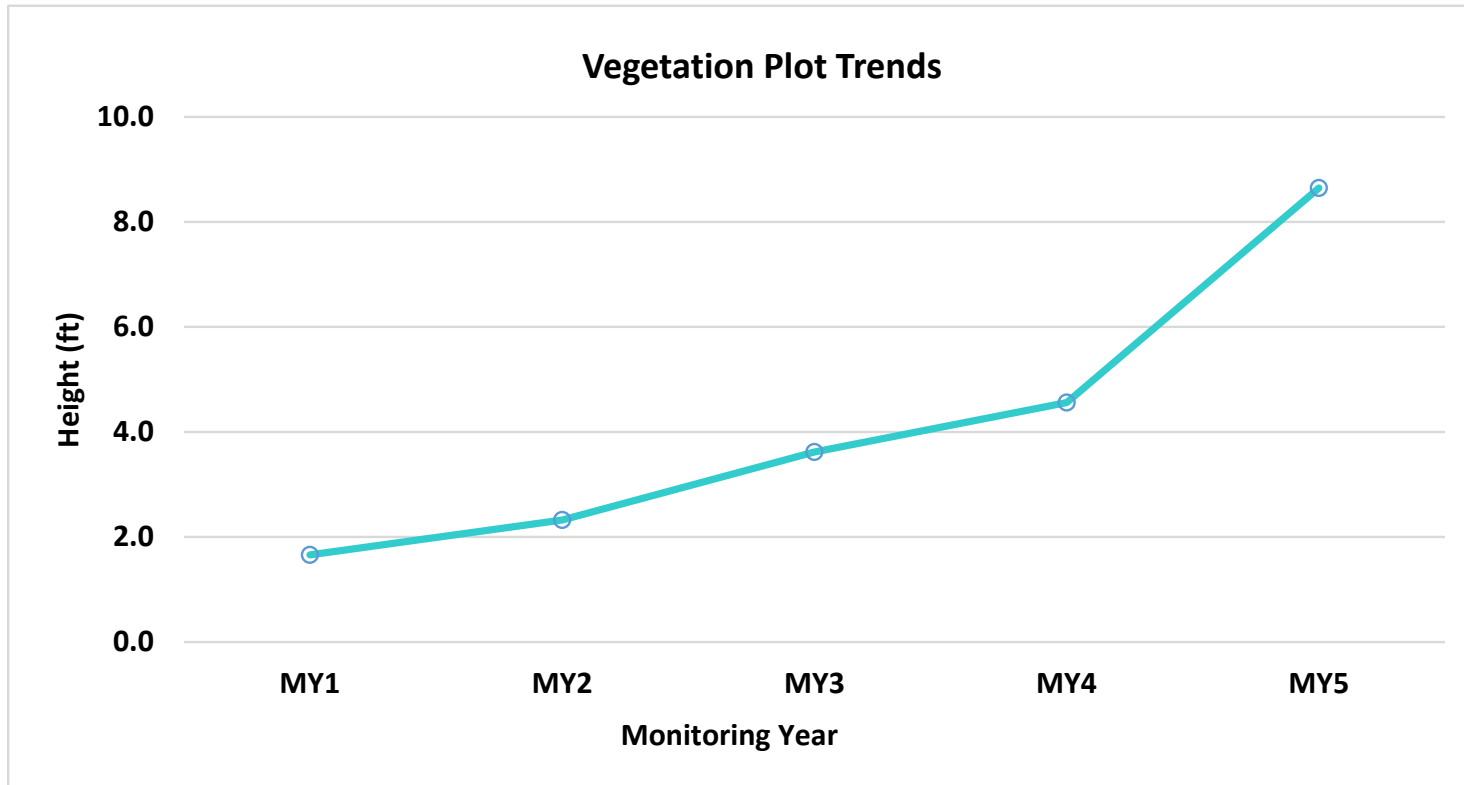
Graph 1. Vegetation Plot Trends

The MY5 vegetative survey was completed in September 2022. The 2022 vegetation monitoring resulted in an average stem density of 334 stems per acre, which exceeds success criteria of 260 planted stems per acre required at MY5 and 39% less than the baseline density recorded January 2018 (597 stems per acre). There is an average of 9 stems per plot in MY5 compared to 14 stems per plot in MY0. Vegetation plots 6 and 8 did not meet the final success criteria of 260 stems per acre, with vegetation plot 6 having 242 planted stems per acre, and vegetation plot 8 having 202 planted stems per acre. Despite the mortality of planted stems in these plots the number of desirable volunteer species remains high. When accounting for volunteers each of these plots surpass the success criteria with the number of stems per acre totaling 850 and 1,214 respectively. Volunteer species include persimmon (*Diospyros virginiana*), sycamore (*Platanus occidentalis*), and green ash (*Fraxinus pennsylvanica*). Along with a diverse successional canopy developing, the herbaceous vegetation is dense and providing wildlife habitat. The Site is being proposed for 2023 closeout.
